SEISMIC PERFORMANCE OF REINFORCED CONCRETE BUILDINGS DURING BHUJ EARTHQUAKE OF JANUARY 26, 2001

Pankaj Agarwal*, S.K. Thakkar** and R.N. Dubey*

ABSTRACT

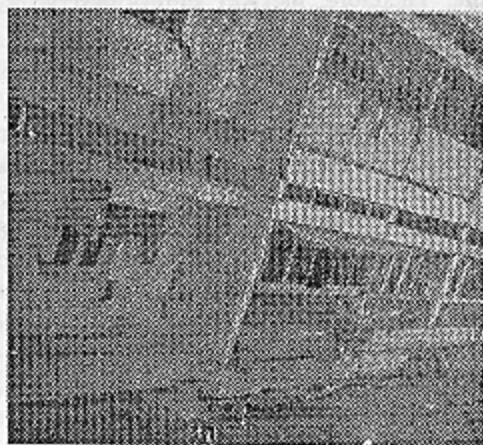
Figure 9 shows some of the examples of soft/flexible storeys and/or weak storey failure in Bhuj earthquake. The Apollo Apartment (Figure 9a) in Ahmedabad, nearly 15-20 years old where ground floor is used for parking purposes, got significantly damaged. The two blocks of this apartment at the entrance have completely collapsed, and the upper floors are resting on ground in significantly tilted condition.

(a) Apollo Apartment at Ahmedabad; ground floor completely collapsed

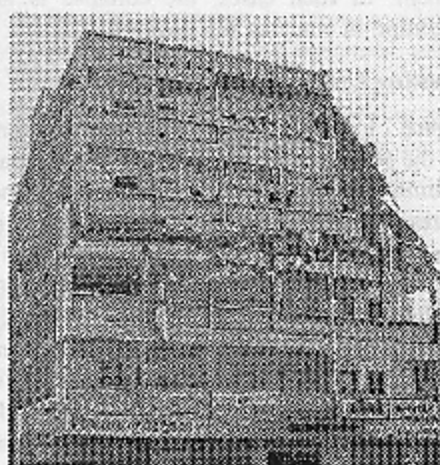
Figure 9b shows the example of intermediate weak storey failure in a G+6 reinforced concrete framed building in Bhuj.

(b) G+6 RC framed building at Bhuj; intermediate weak-storey failure

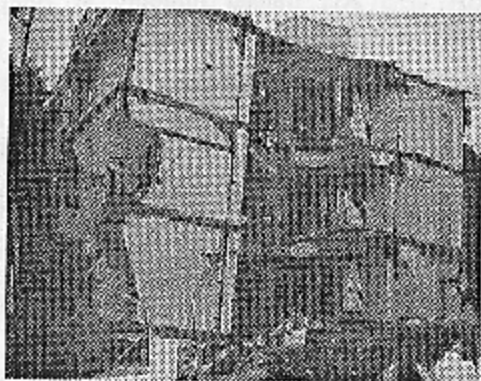
Figure 11 shows damage in reinforced concrete residential buildings (G+4) due to floating columns. This is the second most notable and spectacular cause of failure in buildings. The 15th August Apartment and Nilima Park Apartment buildings at Ahmedabad are the typical examples of failure, in which infill walls present in upper floors are discontinued in the lower floor. This type of construction does not create any problem under vertical loading conditions. However, during an earthquake, a clear load path is not available for transferring the lateral forces to the foundation. Lateral forces accumulated in upper floors during the earthquake have to be transmitted by the projected cantilever beams. Overturning forces thus developed overwhelm the columns of the ground floor. Under this situation, the columns begin to deform and buckle, resulting in total collapse. This is because of primary deficiency in the strength of ground floor columns, projected cantilever beam and ductile detailing of beam-column joints. Ductile connection at the exterior beam-column joint is indispensable for transferring these forces.

(a) 15th August Apartment, Ahmedabad; collapse of building on floating columns

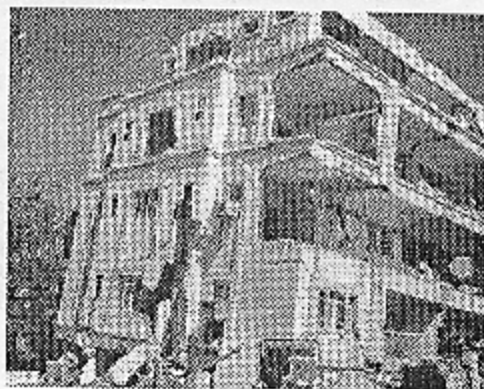
(b) Nilima Park Apartment, Ahmedabad; large scale damage in the upper floors

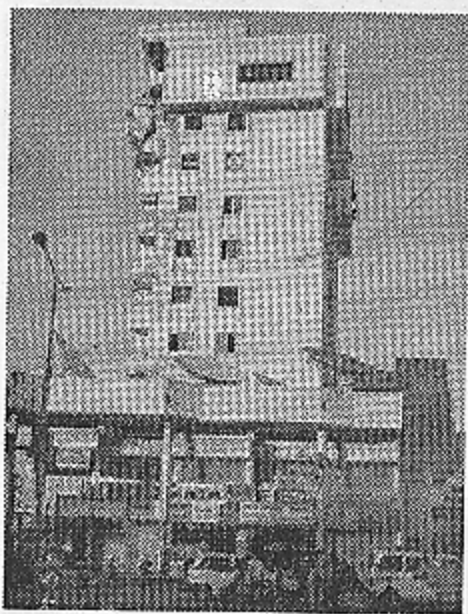
Figure 12 shows the failure of two most famous multi-storeyed buildings, i.e. Mansi Complex (Figure 12a) and Shikhar Apartment (Figure 12b), during Bhuj earthquake with their exposed isolated footings (Figure 12, c and d). Mansi Complex is a residential building in Vastrapura village consisting of two blocks A & B with 40 units in each block. Shikhar Apartment is also a newly constructed residential complex, approximately one year old in Vejalpur under Ahmedabad Urban Development Authority (AUDA), consisting of four blocks with 40 flats in each. Both the buildings are G+10 and are located in the satellite town of Ahmedabad. The plans of both the buildings are irregular. The Mansi Complex has C shaped plan, while the Shikhar Apartment has U-shaped plan with no expansion or separation joint as reported (Sinvhal et al., 2001). In A-Block of Mansi Complex, the staircase was in the central portion of the building, while in the D-Block of Shikhar Apartment, the staircase was located at the extreme end. Irregularities in plan (C and U shape), mass, stiffness and strength result in significant torsional response. These associated torsional effects may be attributed to collapse of buildings. Presence of a massive swimming pool at 10th floor, a fancy penthouse, and some rooms that were not mentioned in original plan, are also believed to be cause of failure of Mansi Complex. Excess mass leads to increase in lateral inertia forces, reduced ductility of vertical load resisting elements and increased propensity toward collapse due to P- Δ effect. Irregularity of mass distribution results in irregular response and complex dynamics. It may be inferred from the characteristic-sway mode of a building that the excessive mass on higher floors

(a) Total collapse of half portion of A-Block of Mansi Complex, Ahmedabad

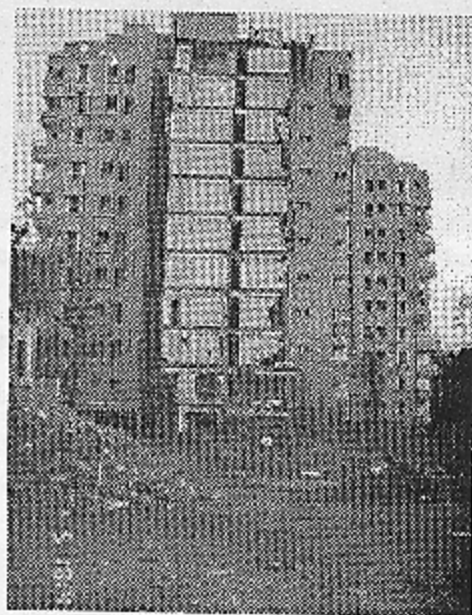
(b) Collapse of D-Block of Shikhar Apartment, Ahmedabad

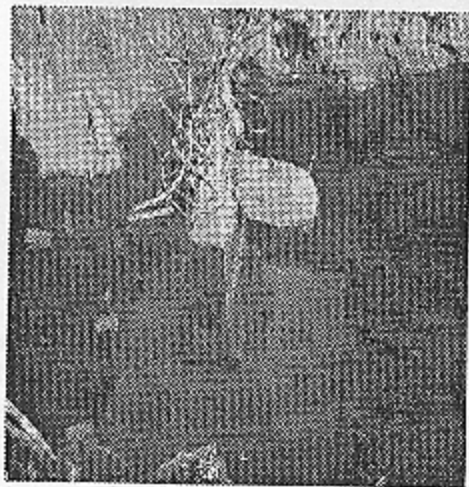
(c) Oblong, isolated footing of a column; A-Block of Mansi Complex, Ahmedabad

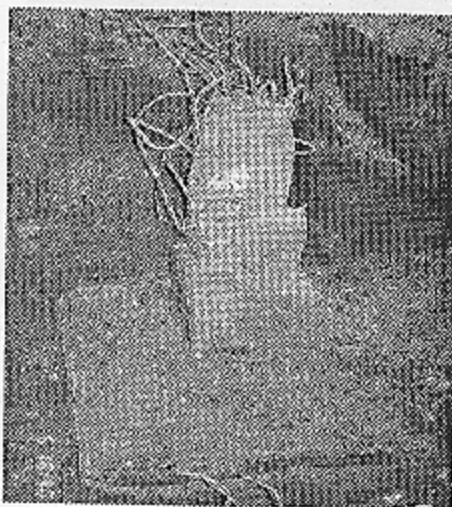
(d) Exposed isolated footing of a column of Shikhar Apartment, Ahmedabad

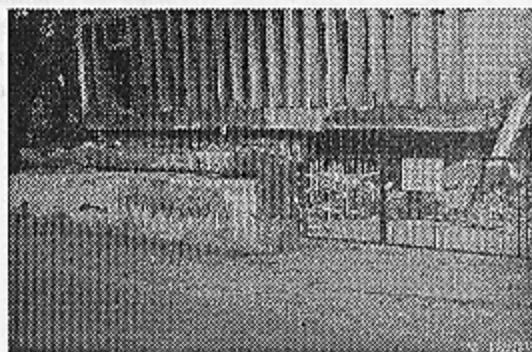
Figure 13 shows some typical examples of building failure due to poor quality of construction material. The failure of Mehta Chambers, G+3, housing morning daily newspaper 'Karnvati Express' (Figure 13a) and a RC building (Figure 13b) at Ahmedabad was due to poor quality of material and corrosion of reinforcement.

(a) Old construction, corroded reinforcement prior to earthquake, Mehta Chambers, Ahmedabad

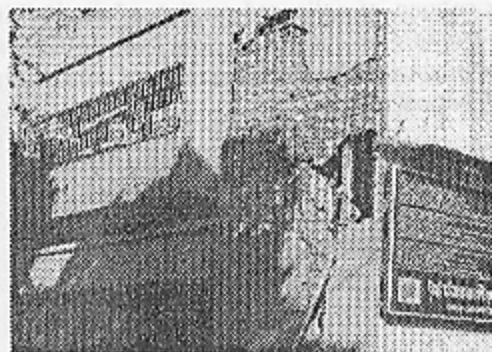
(b) Poor quality of material, corrosion of reinforcement

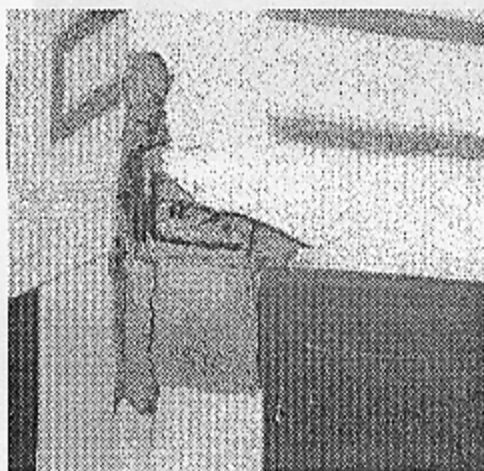
Figure 14 shows typical examples of damage due to corrosion of reinforcement at beam column joint, slab of staircase and column face.

(a) Damage due to corrosion of steel at beam column joint

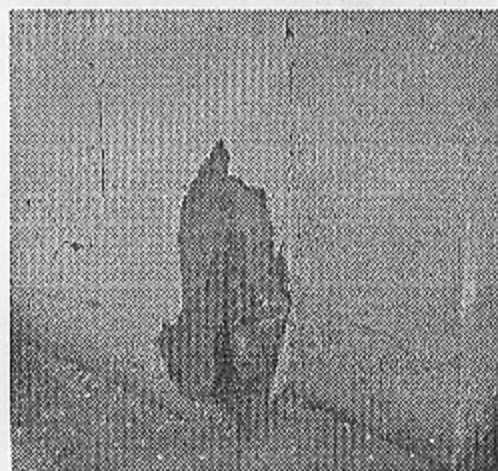
(b) Damage due to corrosion of steel at column face

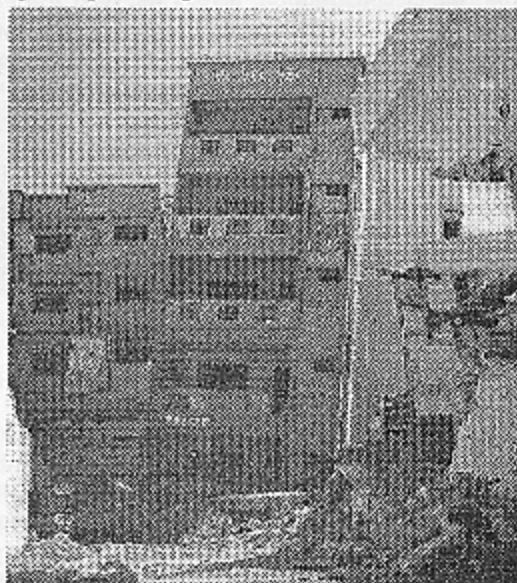
Although the number of buildings damaged by pounding is small, there are few examples in which the primary cause of damage in buildings is hammering of adjacent buildings. Anand building, G+5, (Figure 15) at Bhuj is an example of pounding failure.

Fig. 15 Anand building, Bhuj; damage resulting from pounding

Pounding is the result of irregular response of adjacent buildings of different heights and of different dynamic characteristics. When the floors of adjacent buildings are at different elevations, the floors of each building act like rams, battering the columns of the other building. When one of the buildings is higher than the other, the building of lower height acts as a base for the upper part of the adjacent taller building. The low-height building receives an unexpected load, while the taller building suffers from a major stiffness discontinuity at the level of the top of the lower building. Pounding may also occur because of non-compliance of codal provisions, particularly for lateral and torsional stiffnesses, and cumulative tilting due to foundation movement. Damage due to pounding can be minimized by drift control, building separation, and by aligning floors in adjacent buildings.

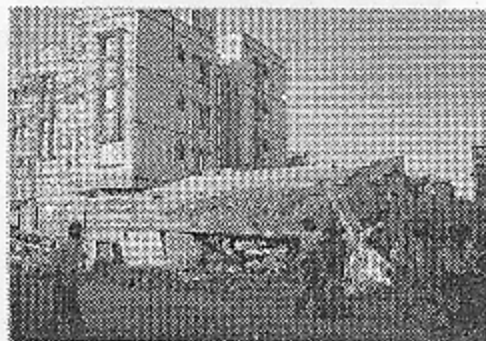
(a) Swaminarayan school building collapsed while the adjacent building suffered minor damages

Swaminarayan Higher Secondary School in Mani Nagar at Ahmedabad, a four storeyed RC building, collapsed (Figure 16a), while nearby buildings suffered minor damages. Similarly, B-Block of Mansi Complex in satellite town sustained only minor damage, while the adjacent half-portion of the A-Block completely collapsed (Figure 16b).

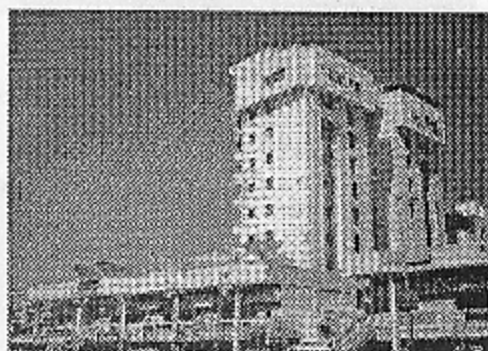
(b) Collapse of A-Block of Mansi Complex while B-block suffered minor damage

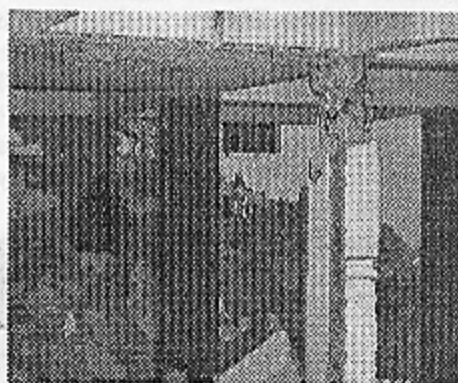
Figure 17 shows failures in reinforced concrete columns in reinforced concrete buildings. Oblong cross-section, a space left at the top of column called 'topi' during casting, and relatively slender column sections compared with beam sections are the main structural defects in columns. These columns are neither designed nor detailed for ductility. Lack of confinement due to large tie spacing, insufficient development length, inadequate splicing of all columns bars at the same section, and hook configurations of reinforcement do not comply with ductile detailing practices. Figure 17 shows the failures at the top and bottom of the column due to poor quality of concrete, inadequate spacing of ties in the critical areas, and the presence of strong beams.

(a) Cracking and spalling of concrete in first storey column

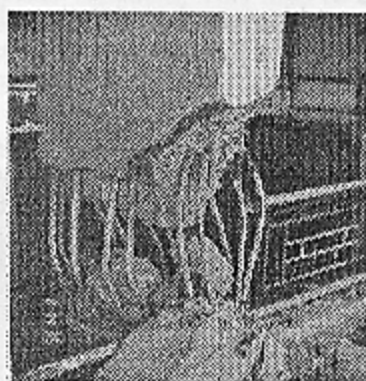
(b) Base of first storey column with widely-spaced ties and spalled concrete

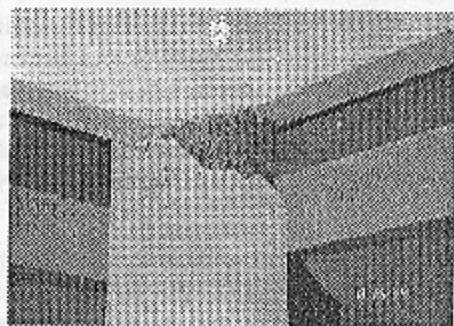
Buildings which were inspected during the team's visit, have been found with little evidence of failure of beams. There are numerous cases in which the beam-column joints of multi-storeyed buildings have been damaged. Figure 18a shows an example of damage at beam-column joint in a reinforced concrete building. One typical feature of joints constructed in RC buildings is shown in Figure 18b, where

(a) Minor damage at beam-column joint

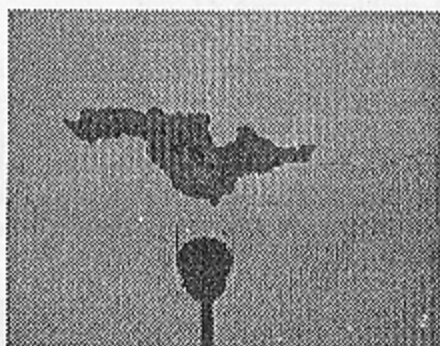
Figure 19 shows cracking of reinforced concrete slab and beam-slab joints in buildings. It is mainly due to widening of existing micro cracks, which were formed either because of bending action or temperature/shrinkage. These cracks are further widened and become visible due to strong ground shaking. Damage in slab is generally not considered to be dangerous for the stability of the structure. However, it creates serious functional and aesthetic problems.

(a) Cracks at ceiling - existing micro cracks

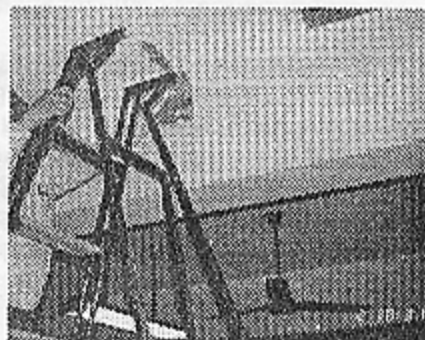
(b) Cracks at slab-beam junction

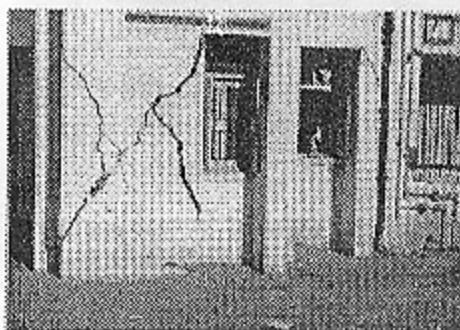
(a) Shear (X) cracking of masonry infill

During the excitation of the structure, the reinforced concrete frame begins to deform, and initially the first cracks appear on the plaster along the line of contact of the masonry infill with the frame. As the deformation of the frame becomes larger, the cracks penetrate into the masonry, and are manifested by the detachment of the masonry infill from the frame. Subsequently, diagonal cracks (X-shaped) appear because of the strut action of the infill. To avoid this type of failure, either interaction of infill wall with the frame should be considered in design or a movable joint between infill and frame should be provided. Sometimes, perimeter infill walls are pierced with many closely spaced windows. The piers enclosed between the windows are called as 'captive' columns. The shear required to develop flexural yield in the effectively shortened column is substantially higher than the shear required for developing flexural yield of full-length column. If the designer has not considered this effect of the infill, shear failure may occur before the flexural yield (Figure 20b). The cracking in 'captive' column generally initiates from window headers and sill levels (Mochle and Mahin, 1991).

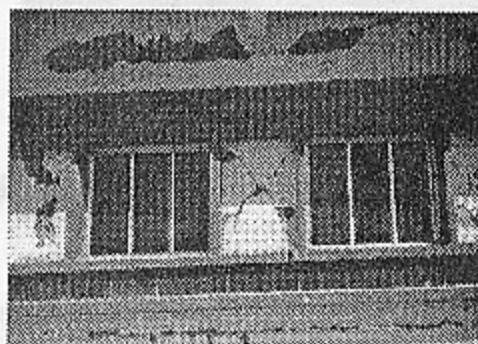
(b) Shear failure in "captive column"

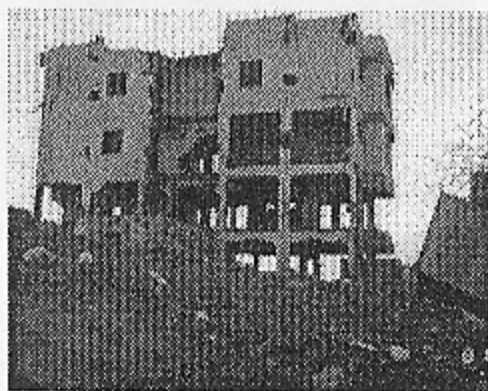
Figure 21 illustrates characteristic examples of damage to exterior walls that are poorly connected with the RC frame. These walls are subjected to out-of-plane vibrations. This form of construction of large exterior walls creates a weak plane around the perimeter. When subjected to intense shaking, these large un-reinforced masonry panels confined by stiff frame members have a tendency to resist large out-of-plane vibrations with little sign of distress. When the flexure strength of these panels becomes insufficient to resist these forces, the entire infill panels fail. The magnitude of damage is found to be dependent on the quality of materials and method of construction.

(a) Collapse of exterior wall due to restricted ductility of concrete frame

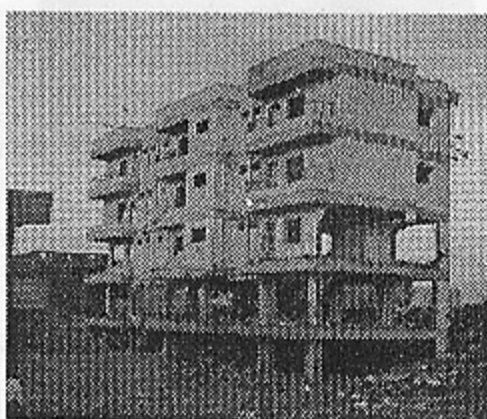
(b) Damage to walls of ground and first floor

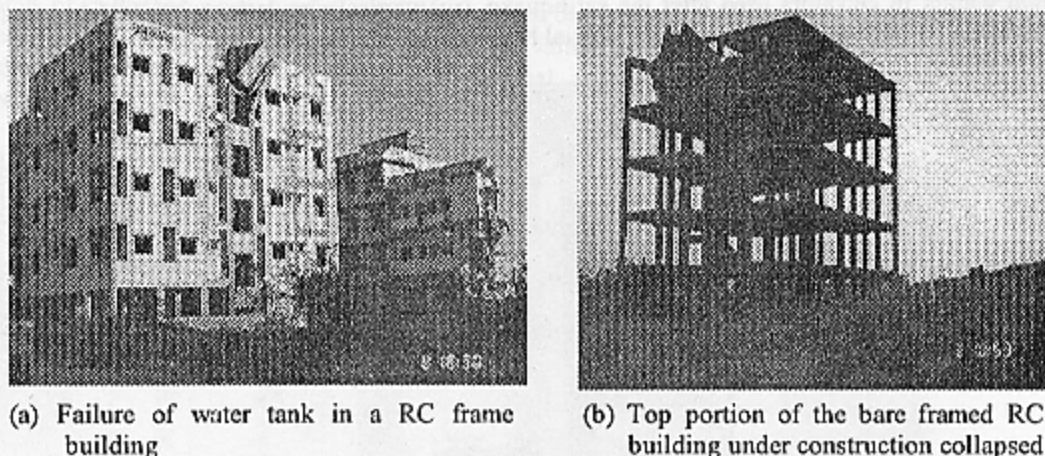
Figure 22a shows a reinforced concrete building, Prabhu Kripa at Bhuj, in which failure of water tank at the roof of the building was observed. Figure 22b shows the failure of the top portion of a bare framed

reinforced concrete building under construction. Water tanks constructed at the roof level of buildings experience large inertia forces due to amplification of the ground acceleration along the height of the building. Un-reinforced concrete parapets, with large height-to-thickness ratio and not properly anchored to the roof diaphragm, may also constitute a hazard. The hazard posed by a parapet increases in direct proportion to its height above building base. This has been observed at several places.

Fig. 22 Amplification effects of acceleration in RC frame buildings

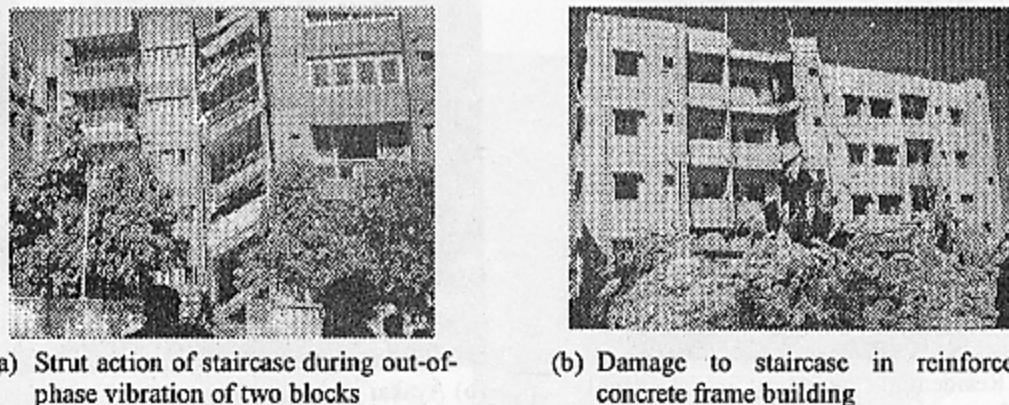
Figure 23 shows typical examples of failures of staircases in Vishram Flat, G+5, in Navarangpura, Ahmedabad and in a RC building at Bhuj, due to out-of-phase vibrations of two blocks.

Fig. 23 Failure of staircase in reinforced concrete framed buildings

In quite a few multi-storey complexes, failure of staircase is a major cause of damage. Staircases and corridors are found to have been blocked by the failures of the unreinforced masonry enclosure walls. Many exit doors are found to be jammed due to racking of doorframes. Stairs can start acting as diagonal-bracing elements during earthquake-induced motion, and therefore, should be used with sliding joints in the seismic design of buildings. Isolation of stairs from the primary structural system may also minimise the damage to the stair system.

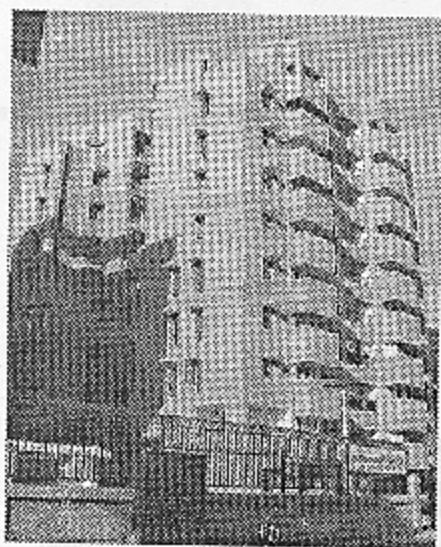
(a) Residential quarters for Regional Passport Office (G+9), Ahmedabad; minor cracking in filler walls

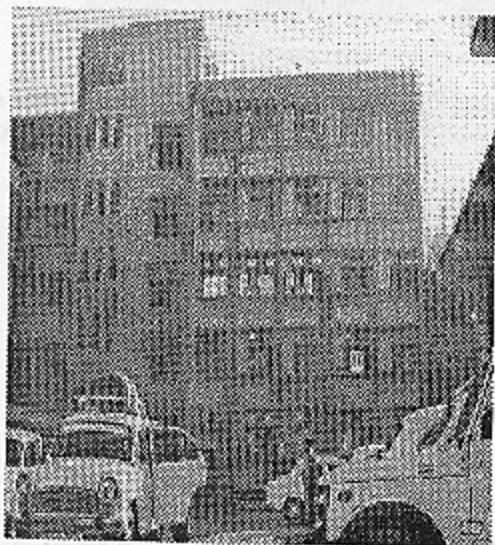
(b) Ayakar Bhawan (G+3), a RC building, Ahmedabad; diagonal and junction cracks in filler brick wall
