EFFECTS OF THE DECEMBER 26, 2004 SUMATRA EARTHQUAKE AND TSUNAMI ON PHYSICAL INFRASTRUCTURE

Murat Saatcioglu*, Ahmed Ghobarah** and Ioan Nistor*

ABSTRACT

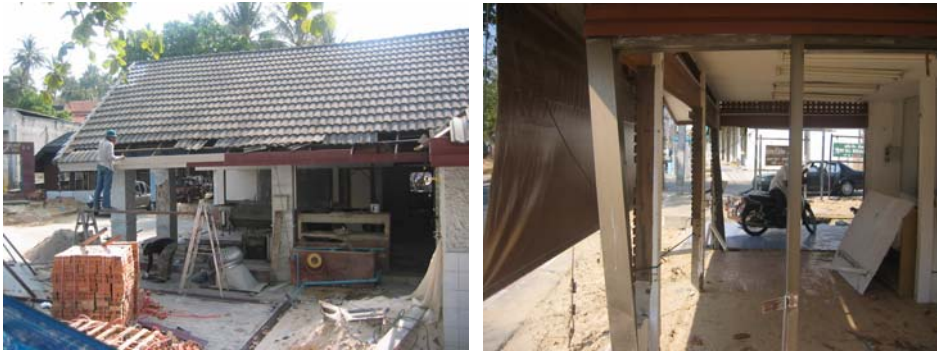
Damage along southern Phuket beaches was limited to coastal erosion and partial failures of non-engineered reinforced concrete and timber frame structures along the coast. The term non-engineered implies structures built without engineering design. The measured water height was approximately 4.0 m from the ground in Kata Beach, causing damage to low-rise buildings, including roof tiles, as illustrated in Figure 4. The most populated beach town along the west coast of Phuket was Patong Beach, which suffered extensive damage to low-rise buildings. The measured water mark on buildings was found to

Fig. 4 Damage to single story non-engineered buildings in Kata Beach

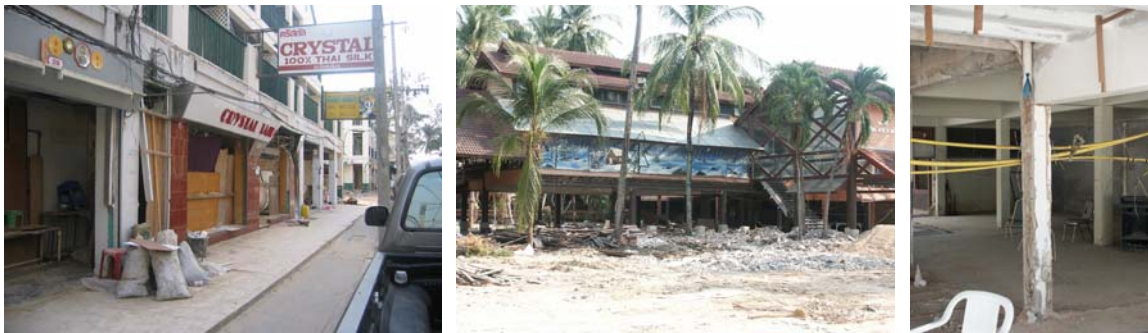
vary between 2.0 m to 4.0 m from the ground. The building inventory in Patong Beach consisted of a large number of non-engineered one to two story reinforced concrete and timber frame shops and hotels. There were also a number of multistory engineered reinforced concrete hotels. Extensive damage to masonry infill walls was observed. Limited damage occurred in reinforced concrete structural elements, though significant damage was seen in timber structural elements. The entire shopping district of Patong Beach was destroyed within an area extending approximately two kilometers inland from the shore, as illustrated in Figure 5.

Fig. 5 Damage in Patong Beach

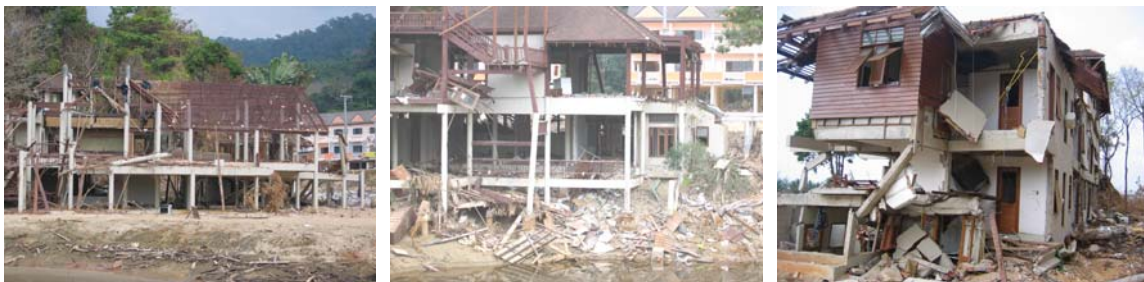
Nai Thon Beach, further north of Patong Beach on the island of Phuket, suffered extensive structural and non-structural damage to reinforced concrete frame buildings. The water height, relative to ground, was in excess of 10 m, especially in areas between the shore and the nearby hilly terrains, which led to water run-ups. Figure 6 illustrates the extent of structural damage observed in this area.

Fig. 6 Structural damage in Nai Thon Beach due to tsunami waves

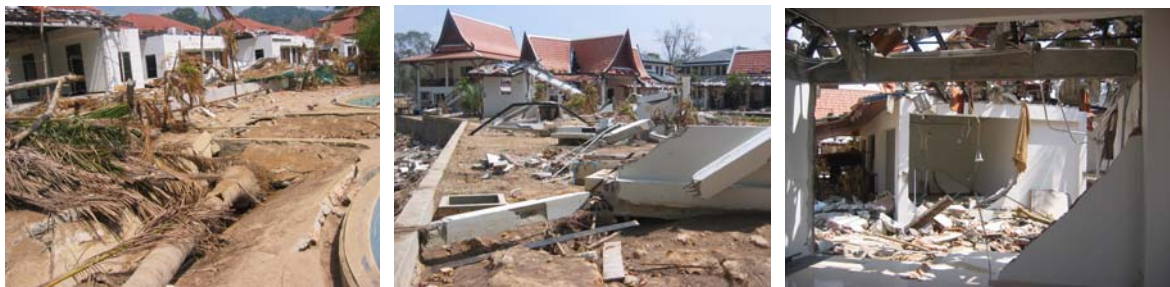
failure of first-story masonry infill walls and structural collapse of low-rise reinforced concrete frame buildings are shown in Figure 7. Many resort hotels were completely destroyed. Some multistory reinforced concrete hotels survived the tsunami pressure, with damage limited to the first-story infill walls.

Fig. 7 Structural and nonstructural damage in Khao Lak Beach

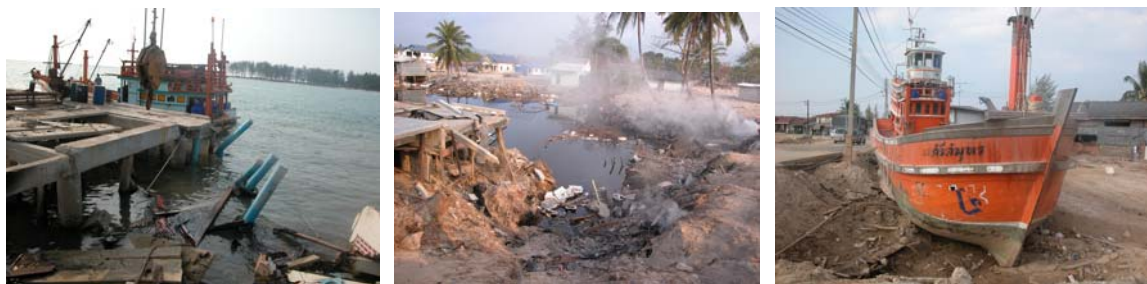
Further north of Khao Lak Beach is the harbor. This area was also hard hit by the tsunami, destroying the harbor and floating boats inland. The town near the harbor was devastated as shown in Figure 8.

Fig. 8 Damage to Khao Lak harbor town

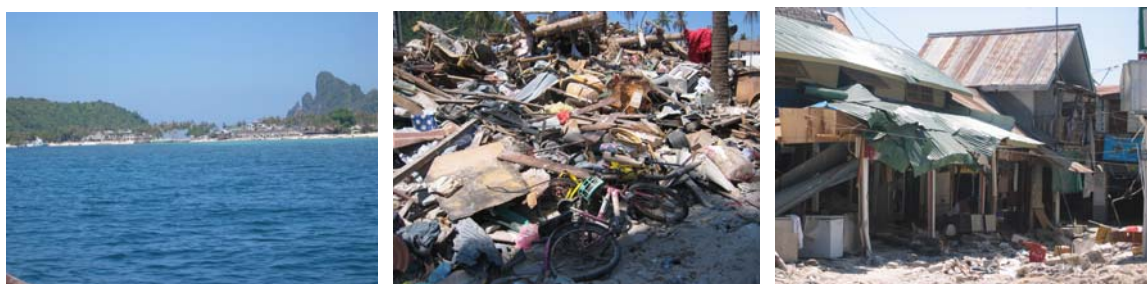
Phi Phi Island is a small island located about 48 km south east of Phuket. The topography of the island is such that east and west sides are entirely covered with steep hills, with a low laying area between the two, where most of the island's inhabitants live (Figure 9, left). This area is only a few meters above the sea level and was hit by the tsunami from both sides. Most structures on the island were destroyed, with the exception of a few well built reinforced concrete frame buildings, a steel frame building and some non-engineered construction. Many of the one and two story non-engineered reinforced concrete and timber frame buildings of the island collapsed entirely due to tsunami wave pressures. Figure 9 illustrates the extent of damage on the island.

Fig. 9 Damage to Phi Phi island, Thailand

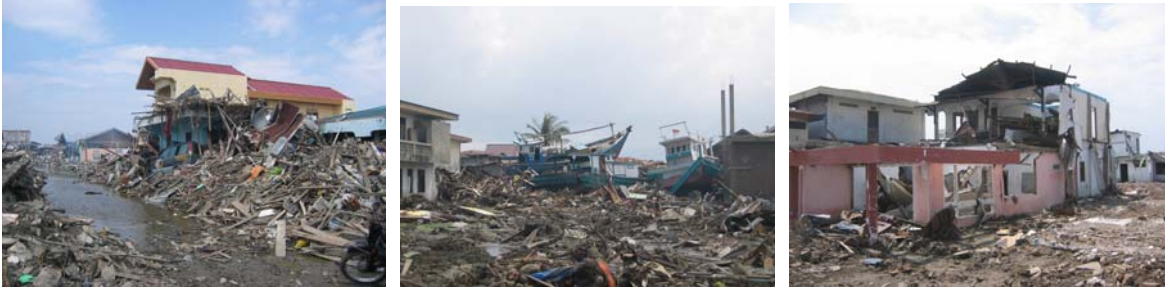
Banda Aceh, Indonesia is a city with a population of about 300,000 inhabitants before the tsunami. It was subjected to damaging forces of not only the tsunami but also the earthquake. The majority of casualties were in this city. Coastal areas were entirely swept away by tsunami waves, leaving piles of timber as the remains of building infrastructure. A large number of non-engineered reinforced concrete buildings suffered structural damage, especially in their first floor columns. Multi-story engineered reinforced concrete government buildings suffered seismic damage due to poor seismic design and

Fig. 10 Tsunami damage in Banda Aceh, Indonesia

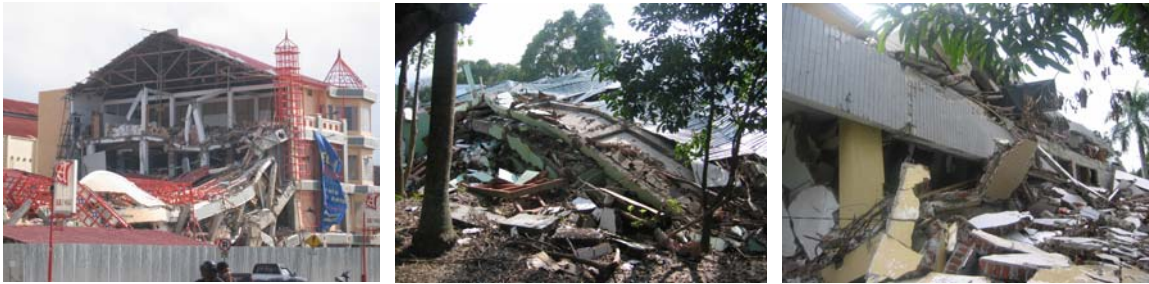
detailing practices. A large number of mosques survived the disaster, though they also suffered damage to masonry walls. Figures 10 and 11 illustrate the extent of damage observed in Banda Aceh.

Fig. 11 Earthquake damage in Banda Aceh, Indonesia

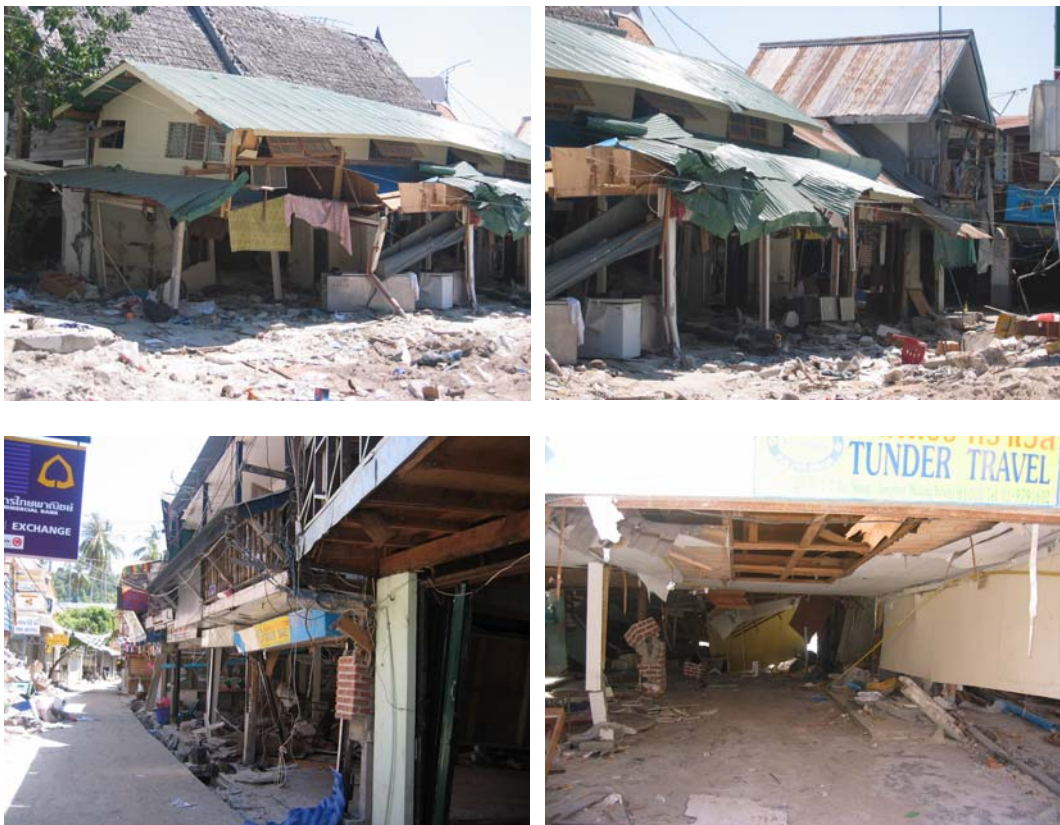
Both Thailand and Indonesia coastal towns had a large number of low-rise timber frame buildings. These buildings had timber columns and beams, supporting timber joist floor systems. The roofs either had light corrugated tin coverage or clay roofing tiles. Figure 14 illustrates the framing system used and the types of damage observed.

Fig. 14 Damage to timber frame buildings in Phi Phi Island, Thailand

- Light timber frame buildings are extremely vulnerable to tsunami wave pressures. Many residential districts with timber residential buildings in Banda Aceh were entirely wiped out by tsunami waves.

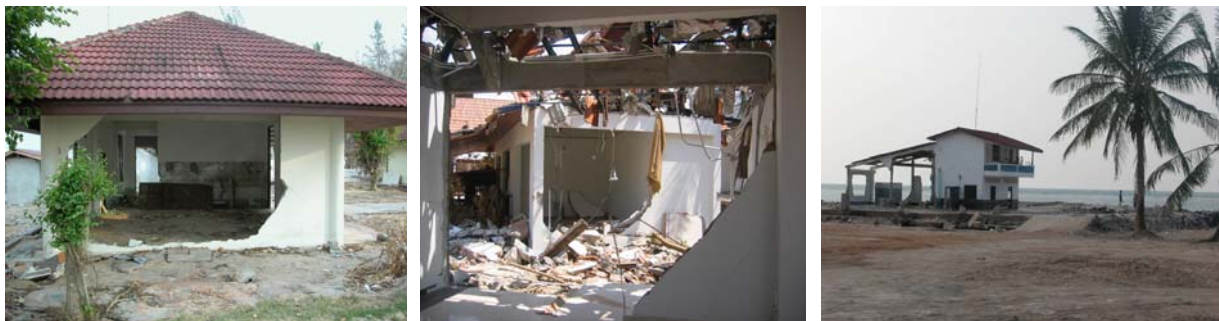
The majority of buildings in Thailand and Indonesia had frames infilled with unreinforced masonry walls. The masonry units used were consistently of the same type, with 50 mm thickness. Both hollow clay bricks and concrete masonry blocks of the same thickness were used, as illustrated in Figure 15. These walls suffered punching shear failures due to the tsunami wave pressure applied perpendicular to the wall plane. These resulted in large holes in walls, sometimes removing the masonry almost entirely. The remaining walls around the frames did not show any sign of diagonal tension cracks, contrary to expectations, unless the failure was caused by seismic excitations, which was limited to Banda Aceh only. Figure 16 shows the type of punching failures observed in masonry infill walls.

(a) Kamala Beach (b) Khao Lak Beach (c) Banda Aceh

Fig. 16 Punching failure of masonry infill walls caused by tsunami wave pressure

- Lateral forces generated by tsunami wave pressure can be significantly higher than typical design wind pressures, generating out of plane forces high enough to damage unreinforced masonry walls within the wave height. The observations indicated widespread failure of masonry infill

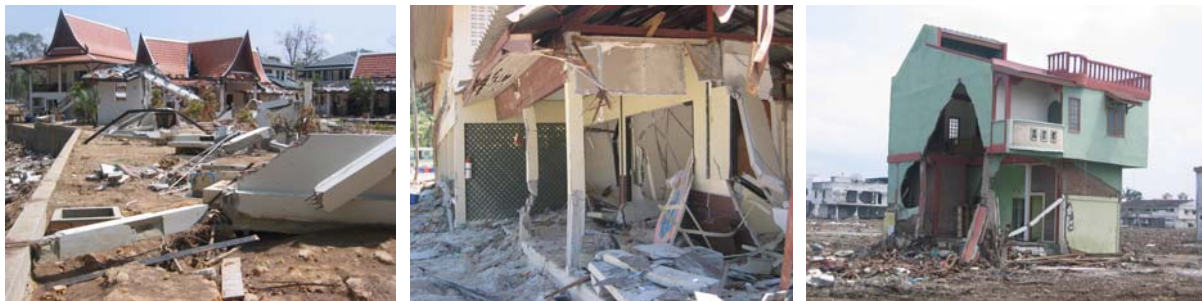
(a) Khao Lak Beach (b) Phi Phi Island (c) Banda Aceh

Fig. 17 Column failures in non-engineered reinforced concrete constructions

The majority of one to two story low-rise buildings were constructed using site-cast concrete, without much evidence of engineering design. The columns were of very small cross-section (about 200 mm square), containing 4 smooth or deformed corner bars with 8 mm diameter, resulting in approximately 0.5% reinforcement ratio. Their flexural capacity, based on 4 columns per frame providing resistance, was computed to be significantly below the moments imposed by tsunami waves as computed by Equation (2) and water height of 3.0 m (assumed tributary area of 4.5 m²). The column flexural capacity was slightly below the moments imposed by hydrostatic pressure of 3.0 m water height. Figure 17 illustrates column failures in non-engineered reinforced concrete frame buildings due to the tsunami wave pressure.

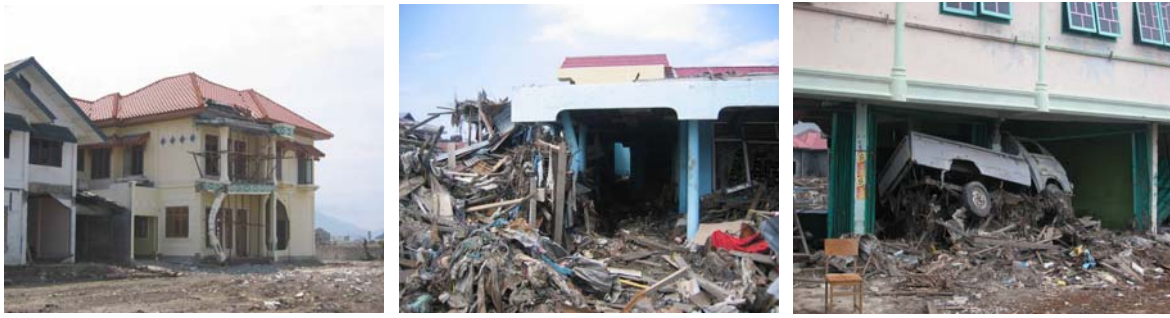
Observations on column behavior indicated that many failures occurred at mid-height, especially in Banda Aceh. This was attributed to the effects of debris impact, over and above the tsunami wave pressure. Indeed, floating building remains, as well as floating large objects like fishing boats and cars impacted on the columns, causing column failures near their mid-heights. This is illustrated in Figure 18.

Fig. 18 Column failures due to debris impact in Banda Aceh

- Non-engineered low-rise reinforced concrete frame buildings, with small size structural elements, are vulnerable to partial or full collapse due to lateral tsunami pressures. Columns of such buildings are further vulnerable to impact forces generated by floating debris caused by tsunami, often leading to flexural failures of columns within their mid-heights.

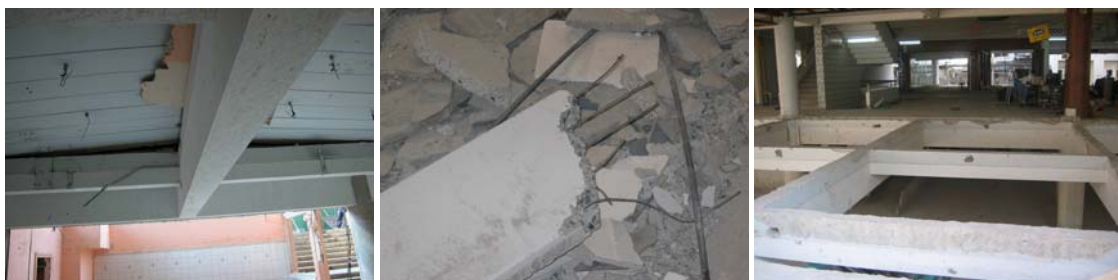
A common precast slab system that was used in Thailand consisted of prefabricated reinforced concrete strips, supported by cast-in-place beams. These strips had 50 mm thickness, 300 mm width and 2.0 m length, reinforced with 4-6 mm diameter smooth wires, equally spaced in the centre of the section. Figure 20 shows the specifics of the slab system. Because of lack of proper connection to the supporting beams, these strips lifted up due to water pressure, causing slab failures. One good example was a shopping centre in Patong Beach on Phuket Island, Thailand, where the lower level below grade was filled up with water, lifting and destroying the first floor slab panels, as illustrated in Figure 20. A similar type of slab failure was also observed in the concrete dock of the Kao Lak Harbor, as shown in Figure 21, though the strips used in the harbor dock were slightly thicker.

Fig. 20 Failure of precast slab strips in Patong Beach

- Prefabricated reinforced concrete slab strips, commonly used in the area, suffered from uplift forces caused by hydrostatic pressures. Lack of proper anchorage to the supporting beams was blamed for the failure of these slab systems.

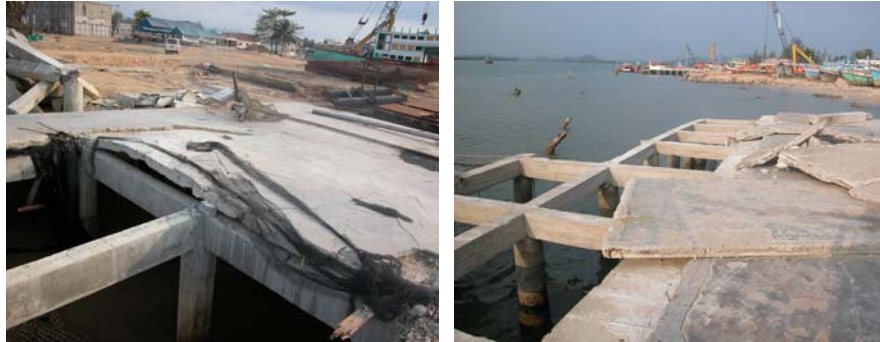
Fig. 21 Failure of Kao Lak Harbor dock

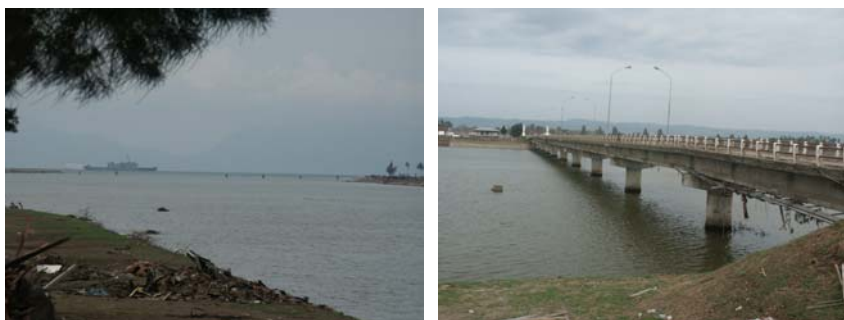
Fig. 24 Multi-span reinforced concrete bridges in eastern Banda Aceh: (a) bridge completely swept off by tsunami; (b) bridge that survived the tsunami

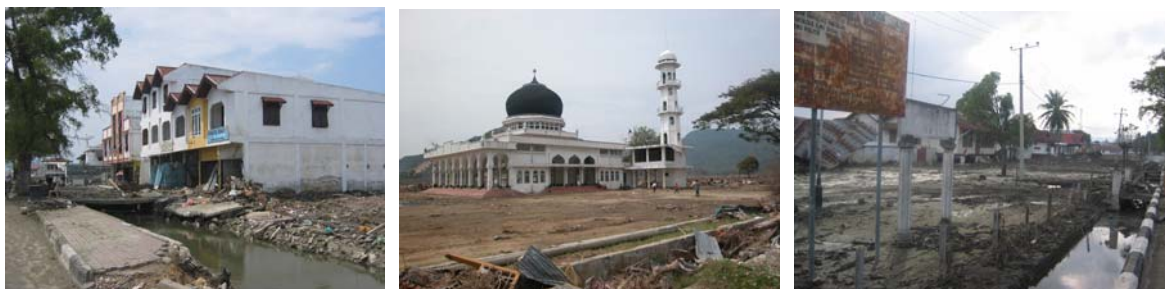
The storm drainage system in Banda Aceh, as well as in Medan, Indonesia consists of concrete open channels located along main streets. These channels are sometimes covered with prefabricated concrete slabs, especially in populated regions. This drainage system suffered extensive damage in Banda Aceh. Cover slabs were broken and displaced and the channels were blocked by mud and debris, further contributing to flooding. A major part of the clean-up operation was to clean the drainage channels to make them functional again, as illustrated in Figure 25.

Fig. 25 Open channel drainage system in Banda Aceh

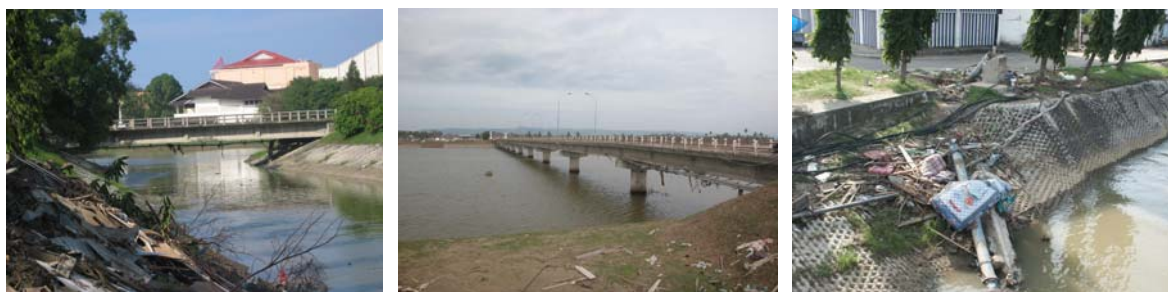
Fig. 26 Damage to pipeline attached to the underside of bridge girders in Banda Aceh

Water supply in Banda Aceh was disrupted due to the failure of water mains. A number of main pipelines were broken as they were attached to bridges to cross the rivers that pass through the city. These pipes were damaged either by the floating debris or collapsed bridge components. Figure 26 illustrates damaged pipelines attached to bridges.

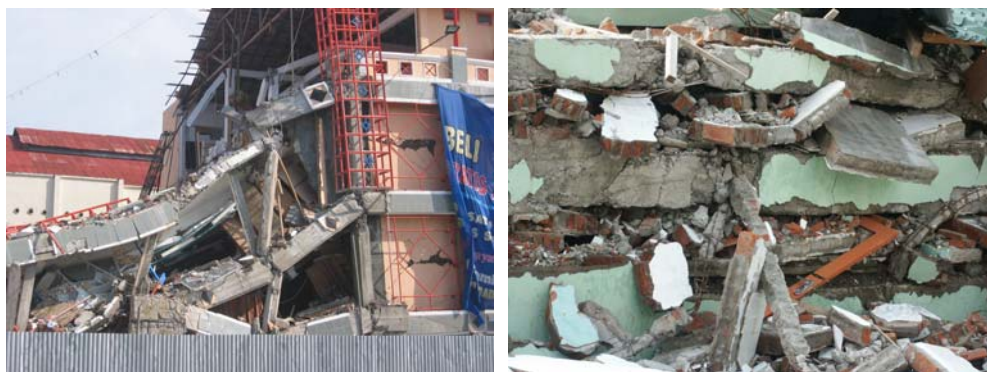
Most of the reinforced concrete frame buildings, which appeared to have been engineered, had strong and relatively deep beams supported by smaller-size columns. Therefore, hinging of columns was widespread throughout the area while the majority of the beams remained elastic until the collapse of the structure, triggering overall stability failures of frames. Figure 27(a) shows an example of this type of failure of a shopping centre located in downtown Banda Aceh, although this building also suffered from an additional problem of lack of joint reinforcement. Hinging of weak columns relative to beams also resulted in the pancaking of slabs, as illustrated in Figure 27(b).

(a) Shopping centre in Banda Aceh (b) Office building in Banda Aceh

Fig. 27 Deep and strong beams supported by smaller-size and weak columns

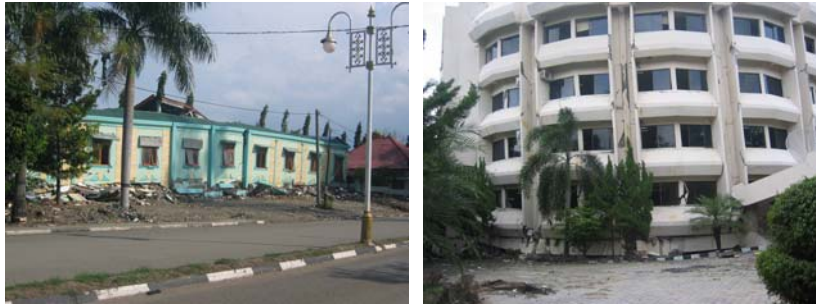
Open spaces at entrance levels resulted in soft stories in most commercial buildings. Increased deformation demands on the first story columns of these buildings, coupled with lack of confinement and column deformability, resulted in column failures. The failure of first story columns triggered the collapse of entire story. Older and newer buildings alike suffered from soft story failures as illustrated in Figure 28 (left and right, respectively).

Fig. 28 Soft story failures in Banda Aceh

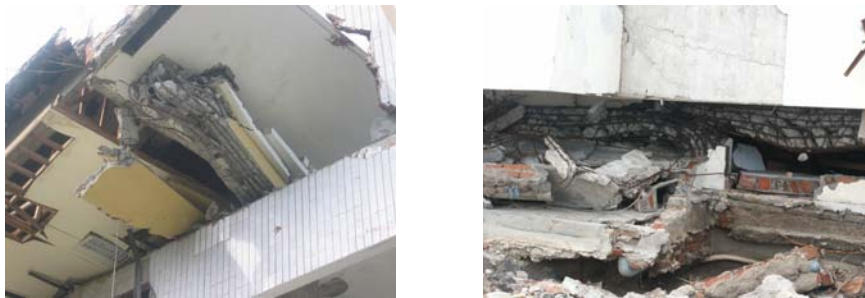
The investigation of damaged columns revealed lack of seismic design practices, including properly spaced and detailed hoops. This resulted in column flexural failures, especially in soft stories and where strong-column weak-beam design philosophy had not been implemented. While non-engineered building columns had definite lack of required volumetric ratio, as well as the spacing and detailing of column ties, engineered building columns did not contain sufficient transverse reinforcement either. Column failures and resulting building collapses associated with the lack of transverse reinforcement are illustrated in Figure 29.

(a) Column failure in Tax Office (b) Column failure in Customs Building

Fig. 29 Lack of concrete confinement and resulting failures in Banda Aceh

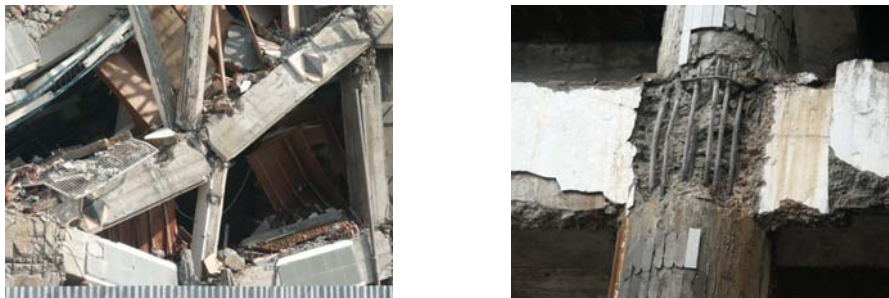
Many failures were attributed to lack of transverse reinforcement in beam-column connections. Furthermore, lack of transverse reinforcement in column splice regions, coupled with inadequate splice lengths resulted in additional column failures. Lack of shear reinforcement, aggravated by short column effects, resulted in column shear failures. Figures 30 and 31 show additional examples of column failures in Banda Aceh.

(a) Failure of beam-column connections (b) Lack of joint reinforcement

Fig. 30 Lack of confinement and resulting failures in Banda Aceh

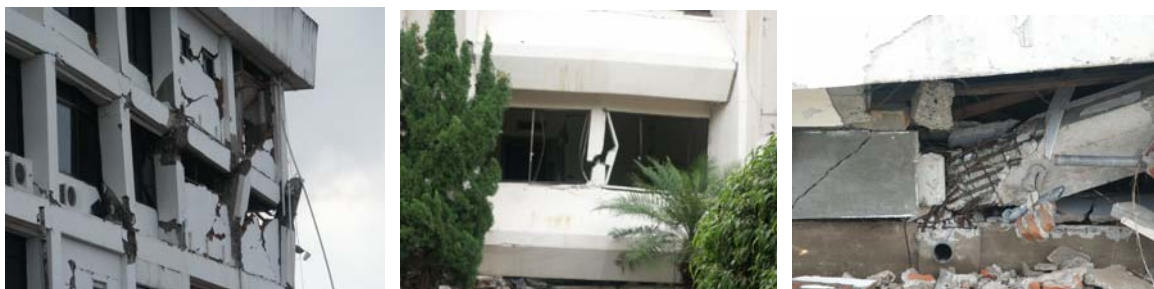
(a) Column shear failure (b) Column shear failure (c) Splice failure

Fig. 31 Column failures in Banda Aceh

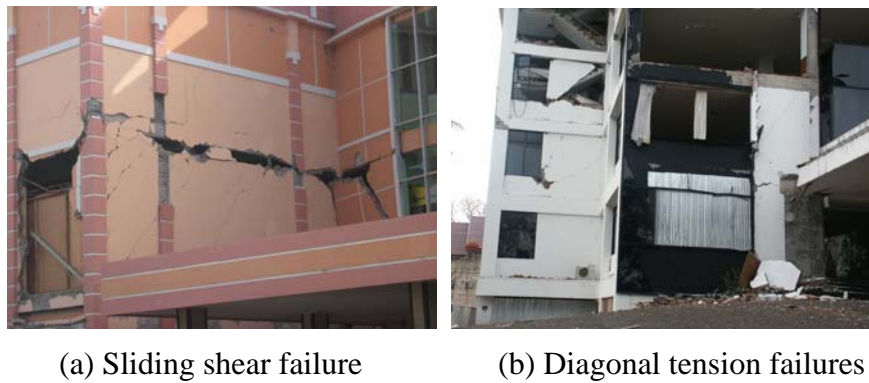
Unreinforced masonry walls were used extensively in all areas visited. Brick and block walls were used as exterior and interior infill walls, as well as partition walls. These walls increased the building mass and attracted seismic forces. They were able to brace buildings until their elastic limits were exceeded. When this happened, they developed either sliding shear failures or diagonal tension cracks followed by the crushing of diagonal compression struts. Figure 32 illustrates different types of damage inflicted on unreinforced masonry walls.

Fig. 32 Masonry damage in Banda Aceh

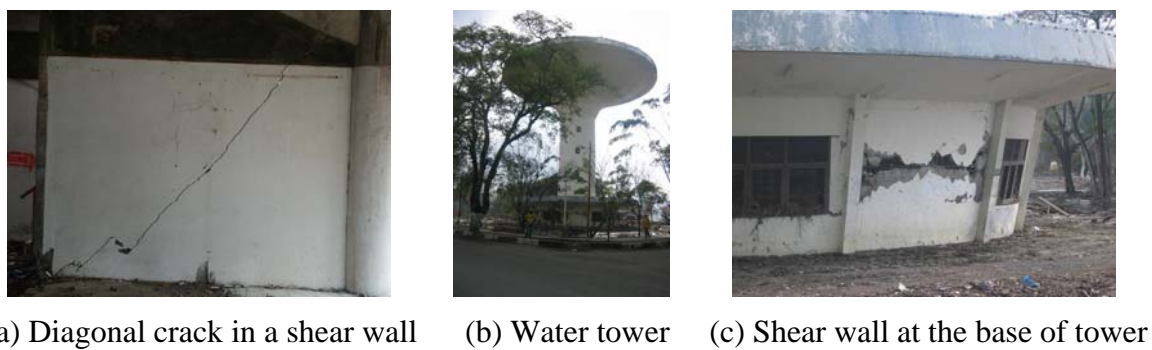
Very few structures had shear walls. A frame building, forming part of a shopping centre in Banda Aceh, had an inadequate shear wall which was not sufficient to provide lateral bracing, and developed a wide diagonal tension crack as shown in Figure 33(a). Similarly inadequate reinforced concrete shear walls were used at the base of a concrete water tower in central Banda Aceh. The walls suffered from extensive diagonal cracking. They also developed sliding shear failure due to the window openings within the walls. This is illustrated in Figures 33(b) and 33(c). Some of the masonry walls behaved as shear walls in terms of providing lateral bracing. However, if and when their elastic limit was exceeded, they developed diagonal tension cracks and diagonal compression crushing.

Fig. 33 Performance of concrete shear walls in Banda Aceh
