STUDY OF DAMAGES AND THROWS IN KOYNA EARTHQUAKE*

R. N. Joshi, Chartered Engineer

Synopsis

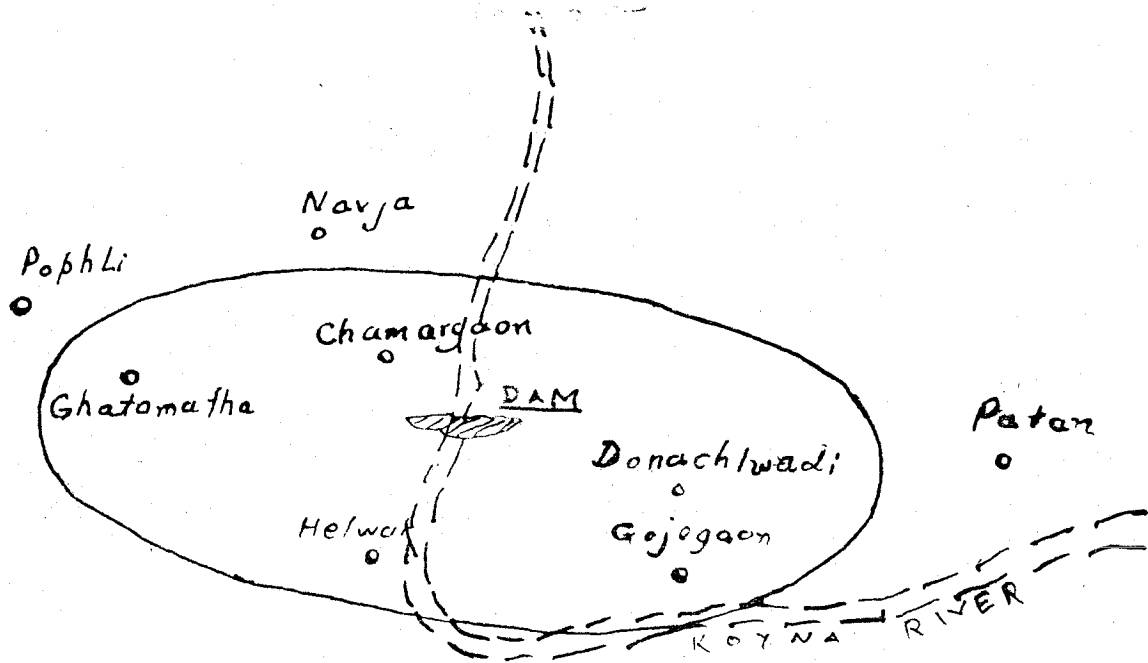
Fig. 1. Meizoseismic Area

Fig. 1. shows the heavily damaged area based on the observations of the author and a team of accompanying engineers which included Sarvashri M.N. Kulkarni, N.V. Joshi and Professrs. A.G. Patwardhan, Bapat and L.S. Sane. Damages to well-built structures in villeges were observed in particular and were taken as a measure rather than damages to poor type of construction or the rehabilitation activity. Buildings in many villeges which fetched useful information were the school building, the village panchayat office and a couple of houses and shops of leading merchants of the village. Damage to mud house of poor construction certainly aggravated the hardship of the villagers but such damage would not be a proper measure of the shock felt at the place.

Thus the zone of heavy damage looks to be an ellipse with major axis 20 km. in length mostly east-west and minor axis 6 km in length mostly north-south direction. Subsequent isosiesmals would be almost circular in shape touching Panchgani and Mahabaleshwar in the north. Nagthana and Karad in the east, and passing through Sangmeshwar Taluka in the south and Chiplun Taluka on the west. Damages at Panchgani and Mahabaleshwar may be due to being situated on high peaks and further might have received more publicity than the damages at other less known places.

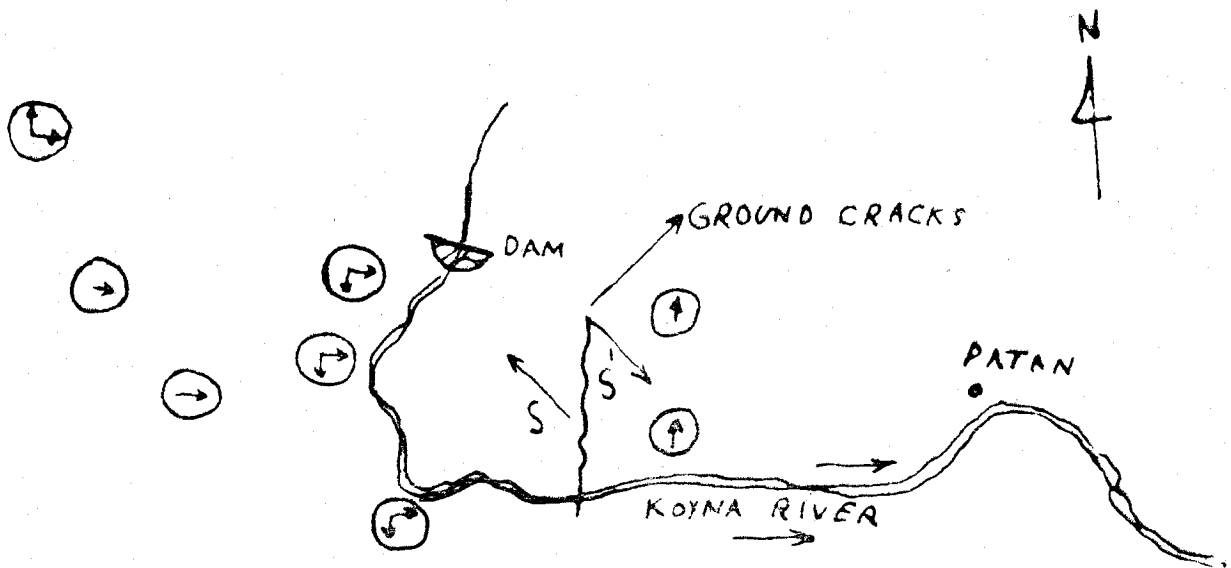
Fig. 2. Direction of Throws, Ground Cracks and Direction of Likely Tectonic Shear

It appears the ground disturbance is more exhibited along a more or less north south strip shown in Fig. 2 along Nanel and Donachi Wadi. This is confirmed by the observations of a team of Professors of Geology from Poona and Bombay.

Ground disturbances of significance are cracks across the slopes. Such cracks mostly running north-south are clearly exhibited across the hill slopes and across the Koyna river along the line indicated in Fig. 2. The ground disturbance has resulted in cracks across the road to Patan. There also appears a system of radial cracks on the road in the said region. This is indicated by a sketch in Fig. 3. The exact implication if any of radial pattern of cracks is not understood. Any way the observation in this respect is recorded here. The team of Geologists mentioned above have reported cracks in the ground in a width of 100 ft, the cracks being in a parallel system running N 15°W—S 15°E. The implication of the ground disturbance in relation to the direction is discussed later along with the throws of free objects.

The team of geologists from Poona and Bombay who surveyed a lot of damaged area find that the throws and damages is generally towards south in the area from Baja. Nanel and Donchi Wadi extending east (Fig. 2).

All these observations put together suggests that the tectonic shearing might have taken place in the NW-SE direction at about Donachi Wadi, with the seismic wave travelling SW therefrom with an initial oscillation of the ground in NW direction causing throws and failures in the southernly and easternly direction in the zone extending westwards, while the seismic wave might have travelled eastwards from Donachiwadi with the initial oscillation in the SE direction with the resulting throws and failures in the northernly and westernly directions (Fig. 2).

The system of shear might be in the direction NW to the west of tectonic disruption and SE to the east. Such system would induce diagonal tension in the east-west direction. It might also induce cracks in the ground in NS direction. A system of parallel cracks observed by the team of Geologists from Poona and Bombay appears somewhat in conformity with this direction.

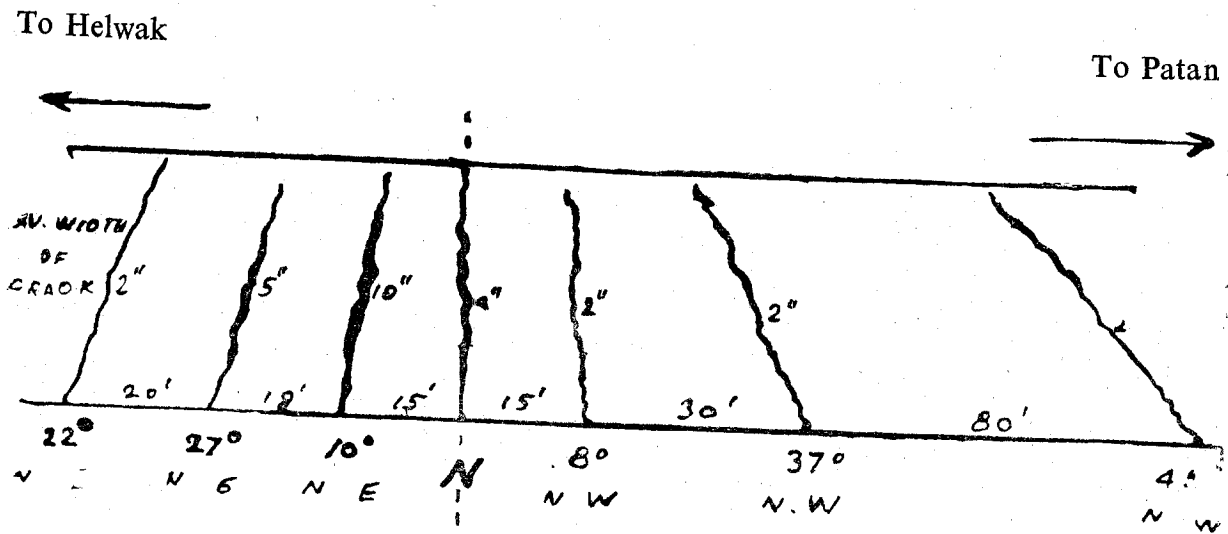
Fig. 3 : Radial Cracks on Guhagar Karad Road at Mile 55/1.

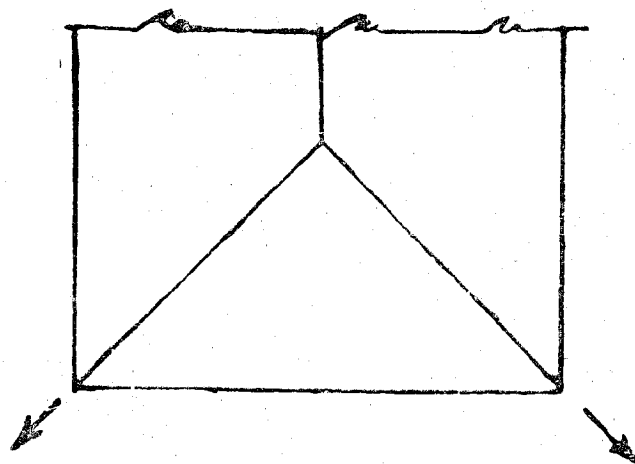
Fig. 4. Hip Rafters

(a) Hip rafters and valley rafters-Hip rafters resting on walls

in an inclined position create horizontal thrust in the diagonal direction on the corner joint of two walls. Under seismic loads condition is worsened and hip rafters create a severe thrust on the corners under which the corners are very much prone to being thrown out (Fig. 4). Several cases of such failures were noticed. Valley rafters also create similar conditions.

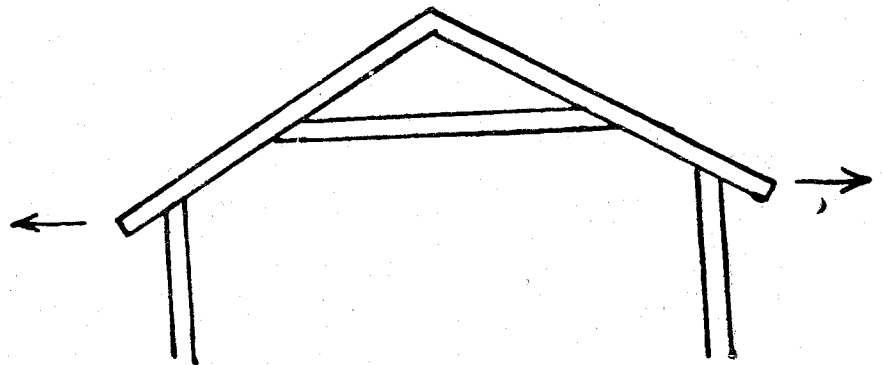
Fig. 5. Coller Beam Truss

(b) Collar beam trusses—Collar beam trusses are frequently used in buildings either to save cost or to increase the head room. In the absence of a regular tie beam the principal rafter exert a push on the supporting walls. The situation is worsened with horizontal seismic loads on the truss and the roof, with the result that the walls supporting the trusses are thrown out (Fig. 5).

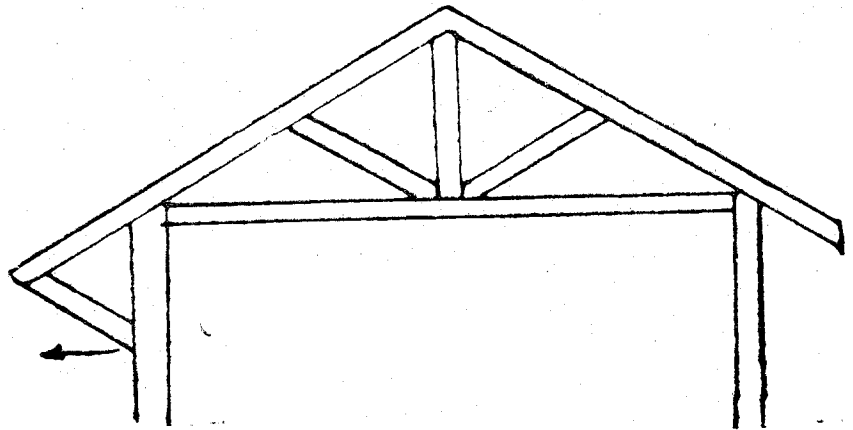
Fig. 6. Knee Brace

(c) Knee braces or knee struts—Sometimes knee struts are provided to support the overhanging portion of the roof, all the more in rainy areas to protect from the weather. The struts are embedded in masonry at the lower end. While acting as a strut it causes a horizontal thrust on the wall. Under seismic loads the condition is worsened causing failure of masonry at the stem of the supports. The vibrations and the push on the roof are transferred to the strut which may either push the masonry at the root of the strut inside or pull it out. (Fig. 6). There are many failures of the latter type at Koynanagar.

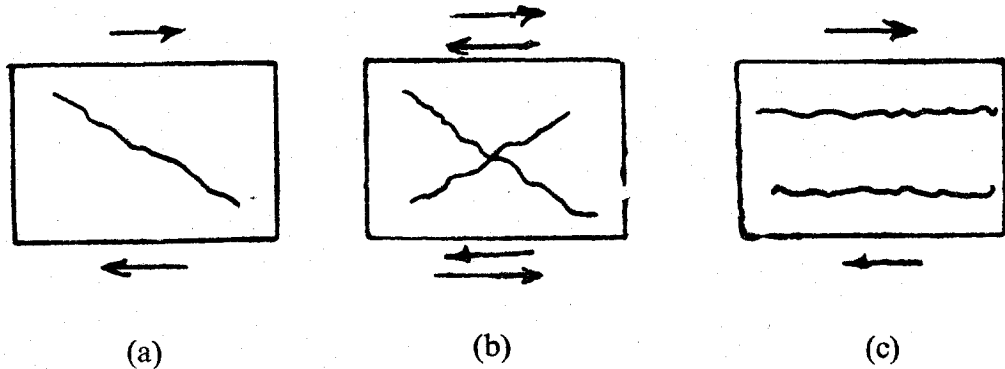
Fig. 8. Crack of Walls in Shear

Under the action of the forces as indicated the long walls would come under shear and should produce cracks of the pattern shown in Fig. 8.

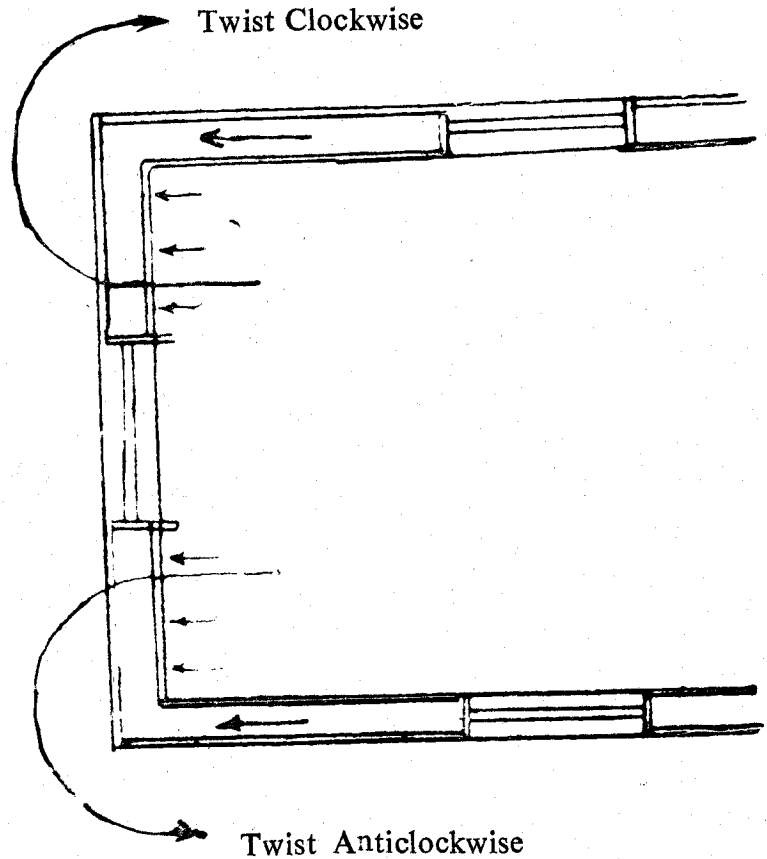
Fig. 9-A. Twisting of Corners

With the direction of oscillation along long walls putting them in shear and putting the cross wall in side thrust acting as in Fig. 9A, the system produces a twist in the two corners. The junction of walls because of its partial rigidity transfers the twist to some extent to the long walls. This produces a clockwise rotation in one corner and an anticlockwise rotation in the other. Such rotation is observed at several corners. Sometimes an entire object is seen to have rotated. This is due to the formation of a couple of the seismic force on the object with some point acting as pivot. The direction of rotation merely depends upon which point acts as pivot. At times the motion can be combined one of rotation and translation.

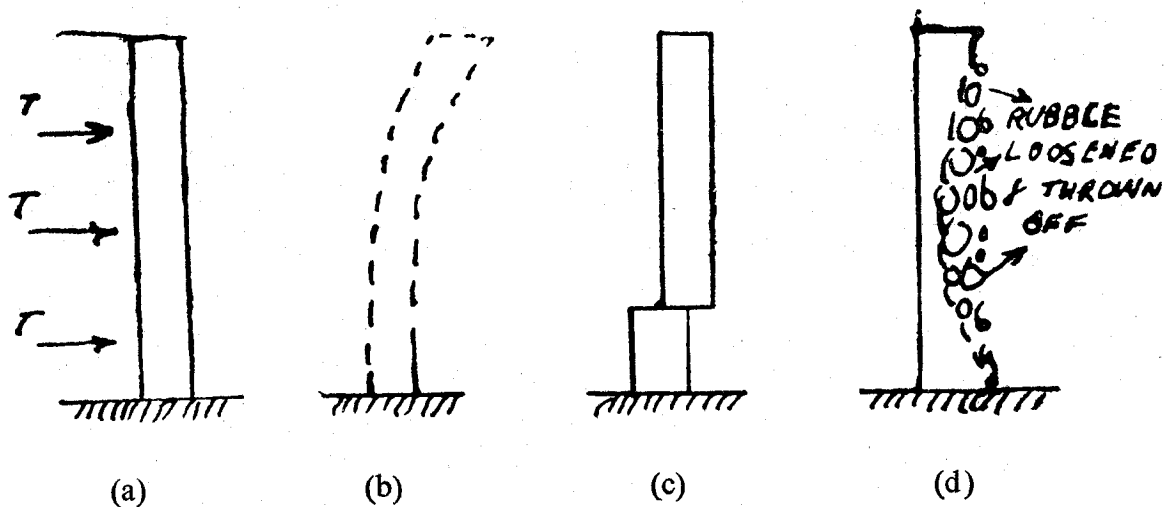
Fig. 10. Effect of Side Thrust on Farthest External Wall

In the case of wall BC in Fig. 7, the side support would be from portions of long walls BF and CH, which come in tension. Under these conditions the cross walls may tear off from the long walls, may bend out in the vertical plane or may slide horizontally at any level as shown in Fig. 10 a, b and c.

In the case of Fig. 10 c the upper portion of the wall has slid on the lower portion. There are some failures of this type.

In the case of Fig. 10 d the wall bulges out due to the side thrust T, which produces sagging in the wall with compressive stresses on the inner face of the masonry and tension on the outside face. The outside face may not be able to withstand the tension with the result that the stones would get loosened and fall down. At Koyna there are hundreds of failures of this type where stones on one face have fallen while stones on the other face standing intact. At first sight this is taken by many an onlooker as being due to bad workmanship, poor mortar and non use of bond stones. It appears that even with adequate bond stones, stones on the outside may still get loosened and fall down.

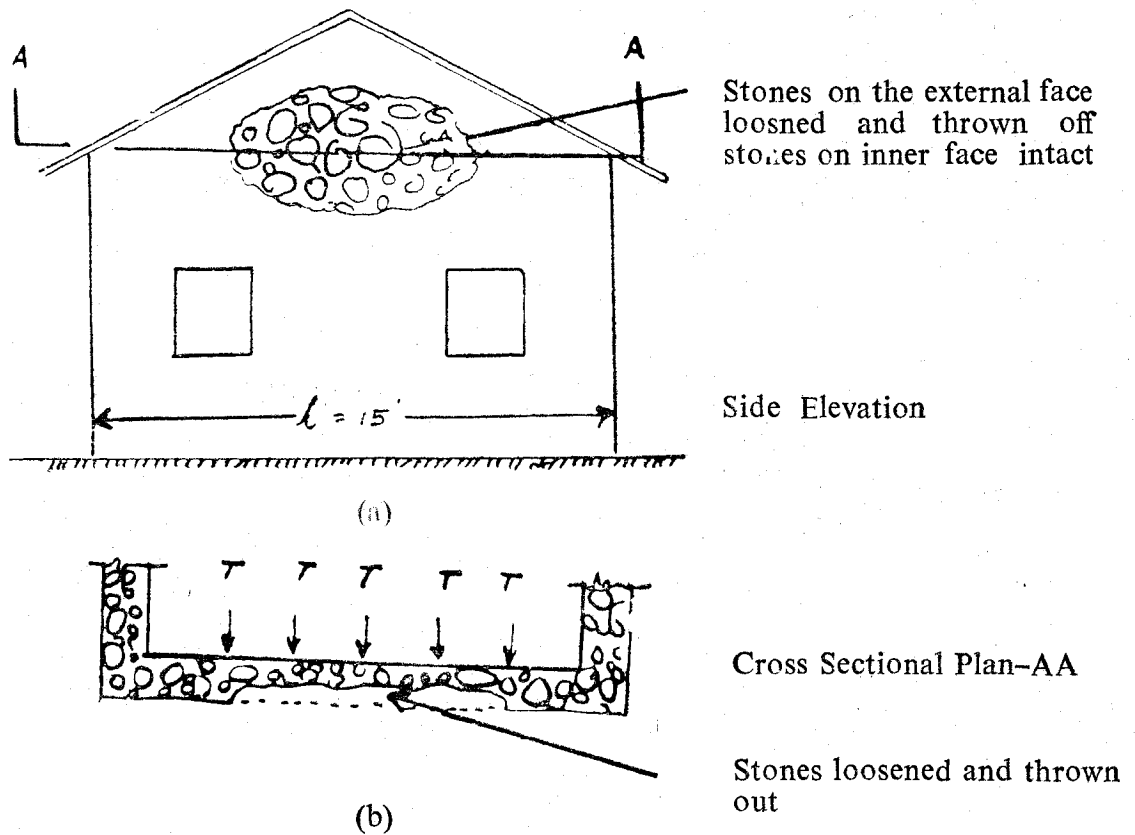
Fig. 11. Effect of Side Thrust on Gable wall

In several cases face stones in masonry gables have been thrown off (Fig. 11). At that level there is hardly any supporting reaction from the top or the bottom. The side thrust $T = a \cdot W$ on the wall at that level produces bending moment with l as span. Let the effective seismic coefficient be equal to a , Seismic thrust per sft. = $\frac{1.25 \times 120}{2240} \cdot a$
 $= .067 a$ tons/sft.

Under the assumptions made the fall of stones on the face of a wall indicates a horizontal seismic acceleration of 0.125 g.

In certain situations face stones on both the faces crumble and a big hole in the masonry is the result. Such occurrence is quite common.

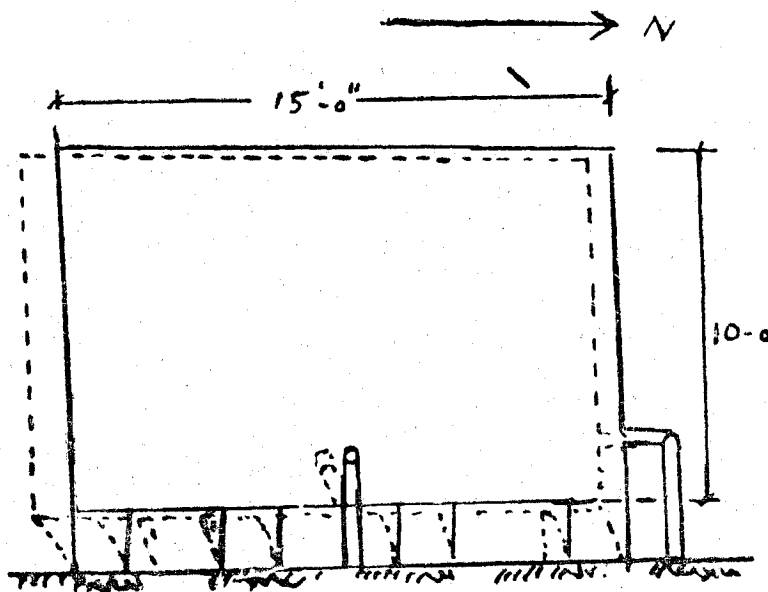
Fig. 12. Throw of Water Storage Tank

Movement of water storage tank of about 7500 gallon capacity situated on a hill near the A-type quarters fetches some useful information. The tank is 15' in length 10' in width and 10' in height. It was supported on dwarf masonry plinth walls 4 nos. $\times 16' \times 1'-6''$, the height of plinth walls being about 1'-6'' (Fig. 12).

The plinth walls have been bent southwards opening up the northern portions and crushing the southern portions. The tank bottom remains attached to the southern wall but has slid on northern walls. A $2\frac{1}{2}$ " dia. G.I. pipe is connected to the tank from the front face. The pipe has been twisted during the movement. In a height of 2', it has shifted 6" along the S 40° W long face of the tank and 4" along E 40° S at right angles to the face of the tank. The resultant shift of the tank is mostly due south.

Another pipe connection to the cross face shows a rotation in plan confirming the shift as above.

Thus on the presumption made, the least horizontal acceleration imparted to the tank during the shock must have been 0.23 g.

The net movement of the tank $= \sqrt{6^2 + 4^2} = 7.2"$ due south is indicative of the actual movement of soil particles on the surface of the ground. This inference is on the lines of the inference by Oldham regarding the movement of soil particles based on his classic study of tombs at Cherapunji in the earthquake of 1897, in which case the movement was as much as 12".
