EFFECTS OF THE DECEMBER 26, 2004 SUMATRA EARTHQUAKE AND TSUNAMI ON PHYSICAL INFRASTRUCTURE

Murat Saatcioglu*, Ahmed Ghobarah** and Ioan Nistor*

ABSTRACT

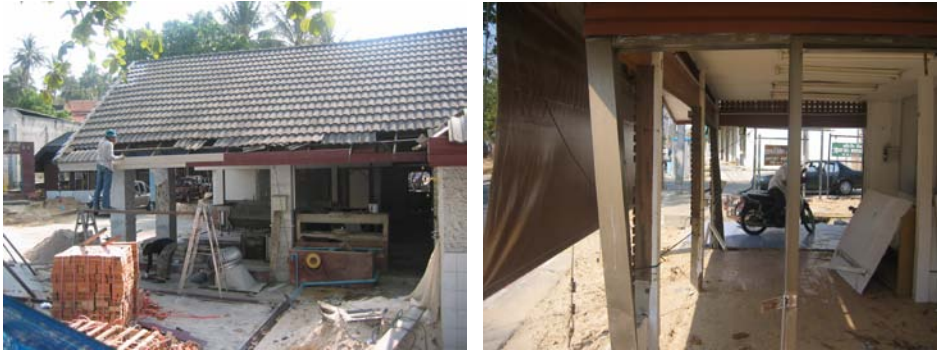
Damage along southern Phuket beaches was limited to coastal erosion and partial failures of non-engineered reinforced concrete and timber frame structures along the coast. The term non-engineered implies structures built without engineering design. The measured water height was approximately 4.0 m from the ground in Kata Beach, causing damage to low-rise buildings, including roof tiles, as illustrated in Figure 4. The most populated beach town along the west coast of Phuket was Patong Beach, which suffered extensive damage to low-rise buildings. The measured water mark on buildings was found to

Fig. 4 Damage to single story non-engineered buildings in Kata Beach

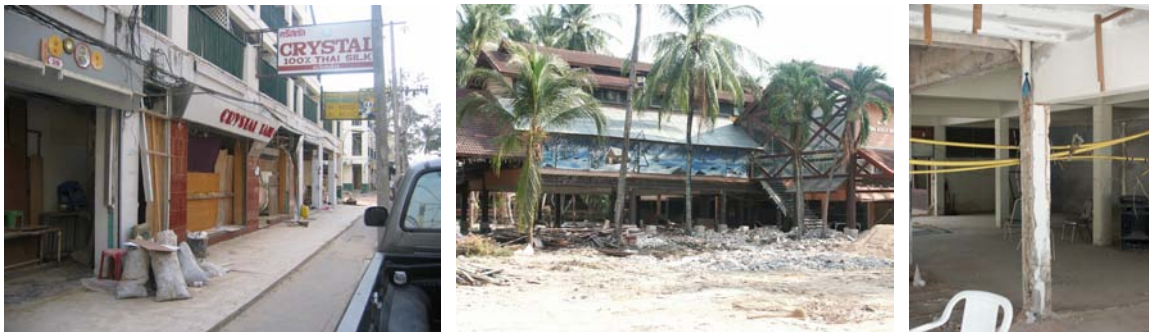
vary between 2.0 m to 4.0 m from the ground. The building inventory in Patong Beach consisted of a large number of non-engineered one to two story reinforced concrete and timber frame shops and hotels. There were also a number of multistory engineered reinforced concrete hotels. Extensive damage to masonry infill walls was observed. Limited damage occurred in reinforced concrete structural elements, though significant damage was seen in timber structural elements. The entire shopping district of Patong Beach was destroyed within an area extending approximately two kilometers inland from the shore, as illustrated in Figure 5.

Fig. 5 Damage in Patong Beach

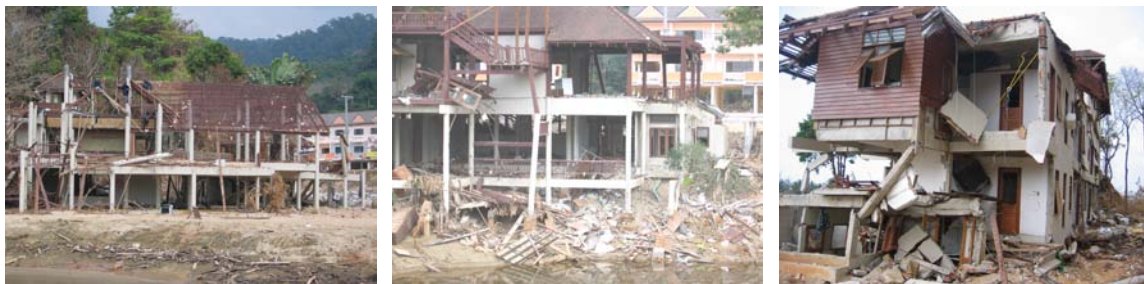
Nai Thon Beach, further north of Patong Beach on the island of Phuket, suffered extensive structural and non-structural damage to reinforced concrete frame buildings. The water height, relative to ground, was in excess of 10 m, especially in areas between the shore and the nearby hilly terrains, which led to water run-ups. Figure 6 illustrates the extent of structural damage observed in this area.

Fig. 6 Structural damage in Nai Thon Beach due to tsunami waves

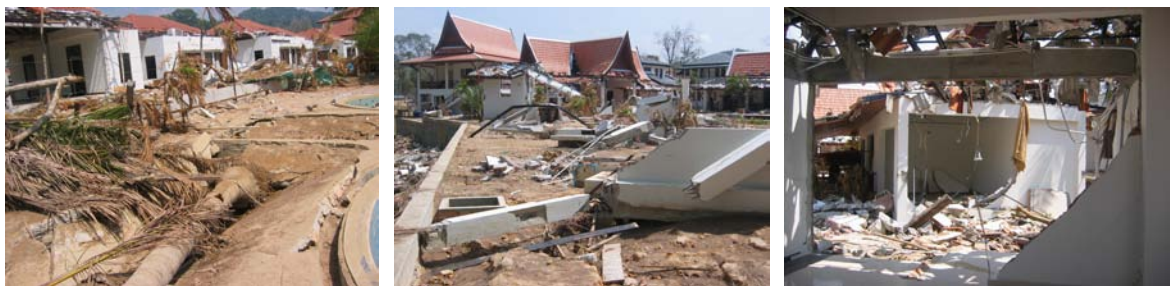
failure of first-story masonry infill walls and structural collapse of low-rise reinforced concrete frame buildings are shown in Figure 7. Many resort hotels were completely destroyed. Some multistory reinforced concrete hotels survived the tsunami pressure, with damage limited to the first-story infill walls.

Fig. 7 Structural and nonstructural damage in Khao Lak Beach

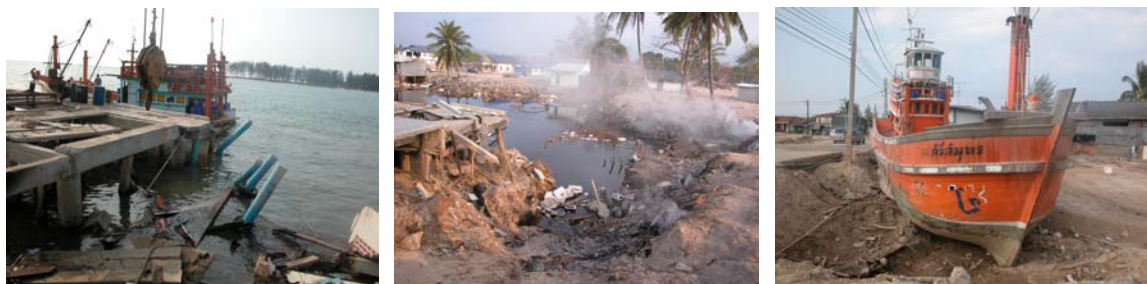
Further north of Khao Lak Beach is the harbor. This area was also hard hit by the tsunami, destroying the harbor and floating boats inland. The town near the harbor was devastated as shown in Figure 8.

Fig. 8 Damage to Khao Lak harbor town

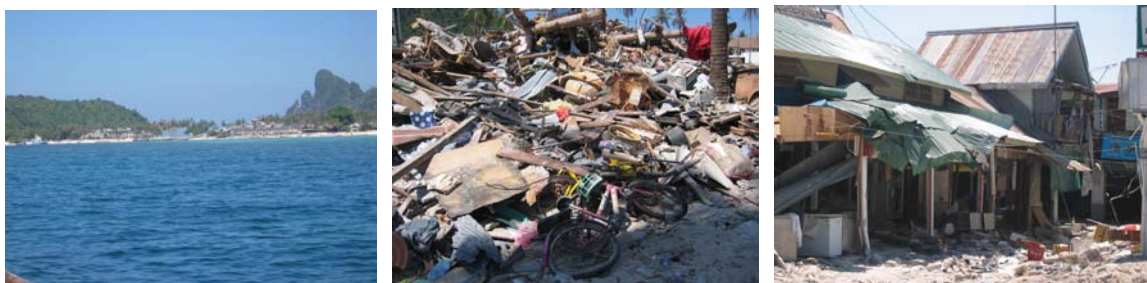
Phi Phi Island is a small island located about 48 km south east of Phuket. The topography of the island is such that east and west sides are entirely covered with steep hills, with a low laying area between the two, where most of the island’s inhabitants live (Figure 9, left). This area is only a few meters above the sea level and was hit by the tsunami from both sides. Most structures on the island were destroyed, with the exception of a few well built reinforced concrete frame buildings, a steel frame building and some non-engineered construction. Many of the one and two story non-engineered reinforced concrete and timber frame buildings of the island collapsed entirely due to tsunami wave pressures. Figure 9 illustrates the extent of damage on the island.

Fig. 9 Damage to Phi Phi island, Thailand

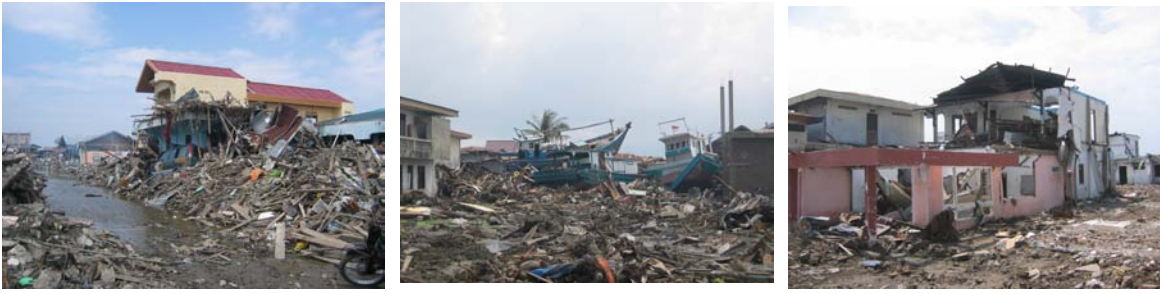
Banda Aceh, Indonesia is a city with a population of about 300,000 inhabitants before the tsunami. It was subjected to damaging forces of not only the tsunami but also the earthquake. The majority of casualties were in this city. Coastal areas were entirely swept away by tsunami waves, leaving piles of timber as the remains of building infrastructure. A large number of non-engineered reinforced concrete buildings suffered structural damage, especially in their first floor columns. Multi-story engineered reinforced concrete government buildings suffered seismic damage due to poor seismic design and

Fig. 10 Tsunami damage in Banda Aceh, Indonesia

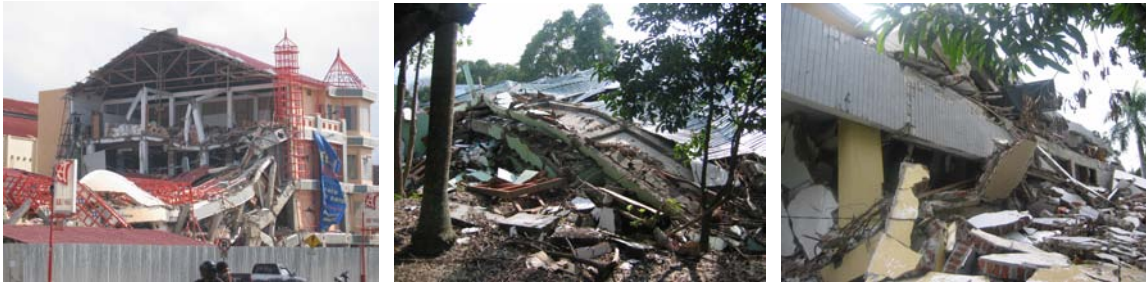
detailing practices. A large number of mosques survived the disaster, though they also suffered damage to masonry walls. Figures 10 and 11 illustrate the extent of damage observed in Banda Aceh.

Fig. 11 Earthquake damage in Banda Aceh, Indonesia

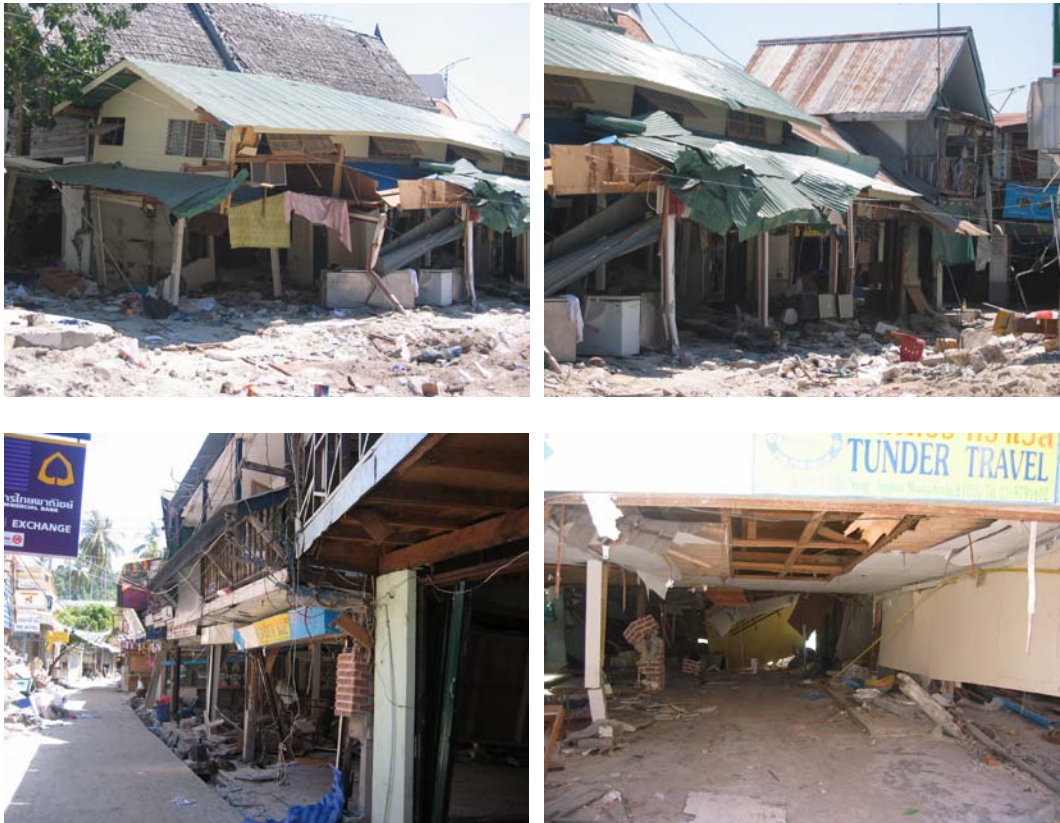
Both Thailand and Indonesia coastal towns had a large number of low-rise timber frame buildings. These buildings had timber columns and beams, supporting timber joist floor systems. The roofs either had light corrugated tin coverage or clay roofing tiles. Figure 14 illustrates the framing system used and the types of damage observed.

Fig. 14 Damage to timber frame buildings in Phi Phi Island, Thailand

- Light timber frame buildings are extremely vulnerable to tsunami wave pressures. Many residential districts with timber residential buildings in Banda Aceh were entirely wiped out by tsunami waves.

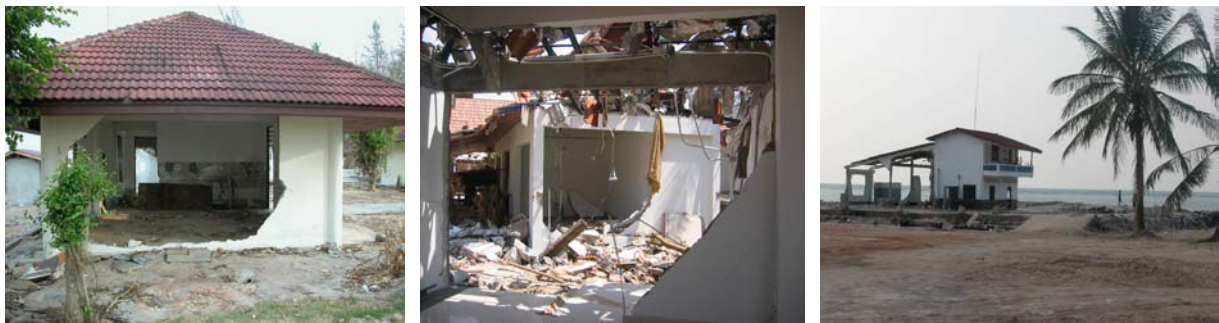
(a) Kamala Beach (b) Khao Lak Beach (c) Banda Aceh

The majority of buildings in Thailand and Indonesia had frames infilled with unreinforced masonry walls. The masonry units used were consistently of the same type, with 50 mm thickness. Both hollow clay bricks and concrete masonry blocks of the same thickness were used, as illustrated in Figure 15. These walls suffered punching shear failures due to the tsunami wave pressure applied perpendicular to the wall plane. These resulted in large holes in walls, sometimes removing the masonry almost entirely. The remaining walls around the frames did not show any sign of diagonal tension cracks, contrary to expectations, unless the failure was caused by seismic excitations, which was limited to Banda Aceh only. Figure 16 shows the type of punching failures observed in masonry infill walls.

Fig. 16 Punching failure of masonry infill walls caused by tsunami wave pressure

- Lateral forces generated by tsunami wave pressure can be significantly higher than typical design wind pressures, generating out of plane forces high enough to damage unreinforced masonry walls within the wave height. The observations indicated widespread failure of masonry infill

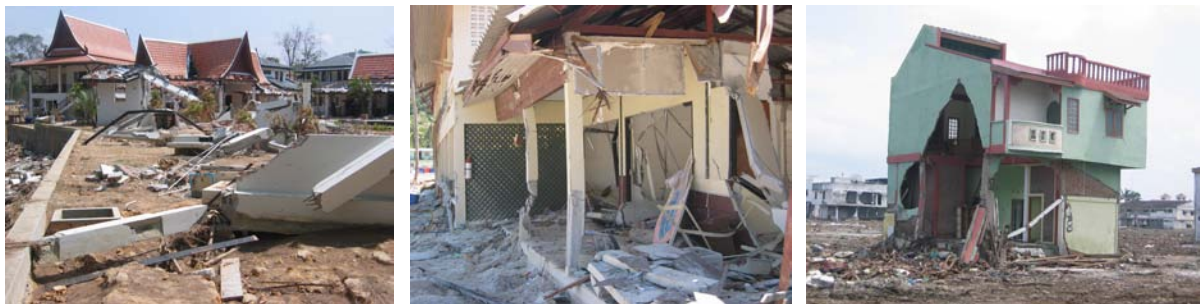
(a) Khao Lak Beach (b) Phi Phi Island (c) Banda Aceh

Fig. 17 Column failures in non-engineered reinforced concrete constructions

The majority of one to two story low-rise buildings were constructed using site-cast concrete, without much evidence of engineering design. The columns were of very small cross-section (about 200 mm square), containing 4 smooth or deformed corner bars with 8 mm diameter, resulting in approximately 0.5% reinforcement ratio. Their flexural capacity, based on 4 columns per frame providing resistance, was computed to be significantly below the moments imposed by tsunami waves as computed by Equation (2) and water height of 3.0 m (assumed tributary area of 4.5 m²). The column flexural capacity was slightly below the moments imposed by hydrostatic pressure of 3.0 m water height. Figure 17 illustrates column failures in non-engineered reinforced concrete frame buildings due to the tsunami wave pressure.

- Non-engineered low-rise reinforced concrete frame buildings, with small size structural elements, are vulnerable to partial or full collapse due to lateral tsunami pressures. Columns of such buildings are further vulnerable to impact forces generated by floating debris caused by tsunami, often leading to flexural failures of columns within their mid-heights.

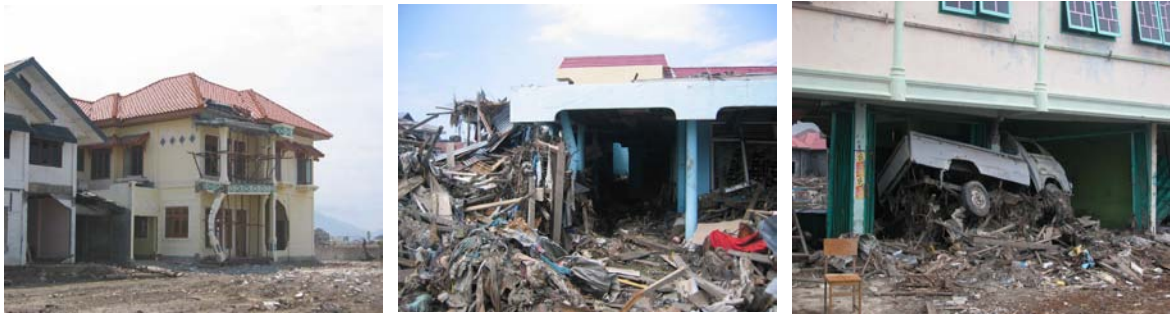
Observations on column behavior indicated that many failures occurred at mid-height, especially in Banda Aceh. This was attributed to the effects of debris impact, over and above the tsunami wave pressure. Indeed, floating building remains, as well as floating large objects like fishing boats and cars impacted on the columns, causing column failures near their mid-heights. This is illustrated in Figure 18.

Fig. 18 Column failures due to debris impact in Banda Aceh

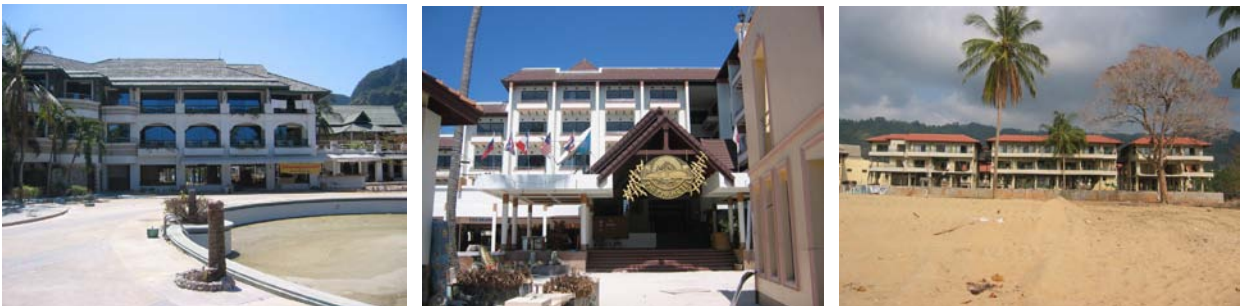
(a) Hotel on Phi Phi Island (b) Hotel on Phi Phi Island (c) Hotel in Nai Thon

There were many low to mid-rise reinforced concrete frame buildings which appeared to have been engineered in the visited areas of Thailand and Indonesia. These frame buildings survived the tsunami pressure without structural damage, though they suffered damage to non-structural elements, especially the first story masonry walls. Figure 19 shows reinforced concrete hotel buildings in Thailand that survived the tsunami without any sign of structural damage, although nearby non-engineered buildings were either partially or fully collapsed. There were some exceptions to this observation in Nai Thon Beach, where water run-up affected slender reinforced concrete columns of a shopping centre, causing a partial collapse.

Fig. 19 Engineered concrete buildings survived tsunami forces without structural damage

- Engineered reinforced concrete frames appear to have sufficient strength against tsunami forces. There was very little damage observed in structural components of engineered concrete buildings. Often, nonstructural elements failed before the effects of tsunami pressure reached a critical level for structural components of such buildings, relieving pressure on structural elements. There was one steel frame building investigated, which survived the tsunami pressure without any sign of distress.

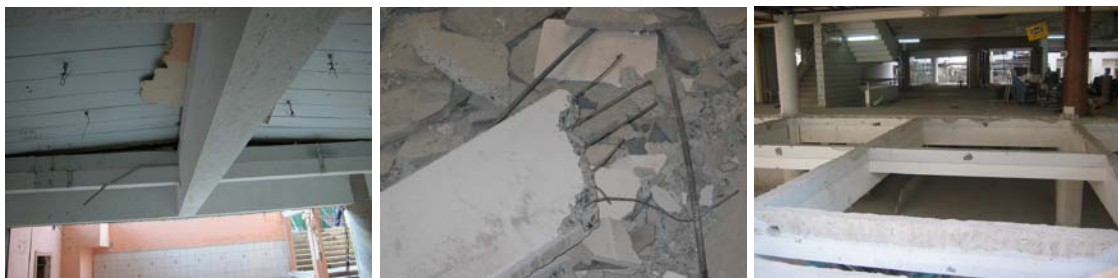
A common precast slab system that was used in Thailand consisted of prefabricated reinforced concrete strips, supported by cast-in-place beams. These strips had 50 mm thickness, 300 mm width and 2.0 m length, reinforced with 4-6 mm diameter smooth wires, equally spaced in the centre of the section. Figure 20 shows the specifics of the slab system. Because of lack of proper connection to the supporting beams, these strips lifted up due to water pressure, causing slab failures. One good example was a shopping centre in Patong Beach on Phuket Island, Thailand, where the lower level below grade was filled up with water, lifting and destroying the first floor slab panels, as illustrated in Figure 20. A similar type of slab failure was also observed in the concrete dock of the Kao Lak Harbor, as shown in Figure 21, though the strips used in the harbor dock were slightly thicker.

Fig. 20 Failure of precast slab strips in Patong Beach

- Prefabricated reinforced concrete slab strips, commonly used in the area, suffered from uplift forces caused by hydrostatic pressures. Lack of proper anchorage to the supporting beams was blamed for the failure of these slab systems.

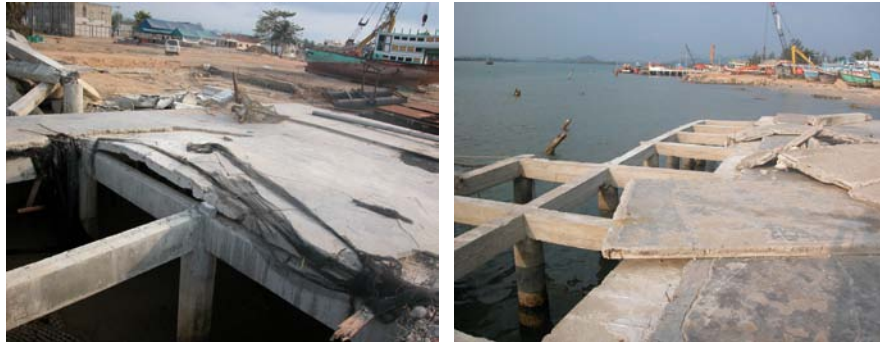
Fig. 21 Failure of Kao Lak Harbor dock

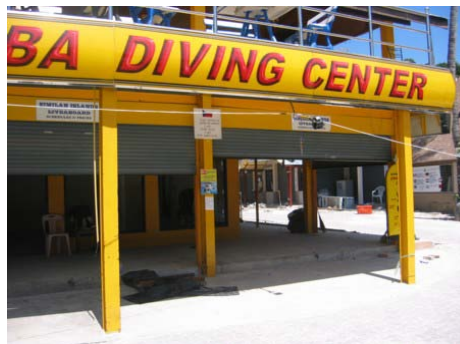
There was only one steel frame building that was investigated during the visit. The structure was located in Phi Phi Island in an area that was totally devastated by tsunami pressures. The frame consisted of steel “I” sections as illustrated in Figure 22. The building was not affected by tsunami forces and survived the disaster without any sign of structural damage.

Fig. 22 Steel frame structure in Phi Phi Island

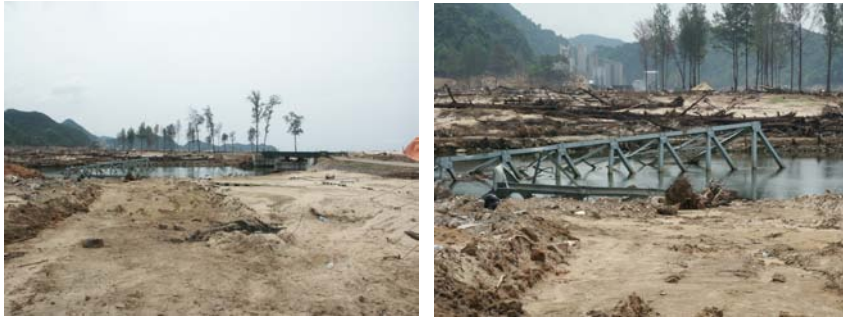
There was extensive damage to bridges in the Aceh province of Indonesia caused by tsunami wave forces, causing many to collapse and jeopardizing relief efforts. Figure 23 shows a two-span steel truss bridge in western Banda Aceh that failed and displaced approximately 50 m from its piers and abutments which were not damaged. The Indonesian army constructed a Bailey bridge on the same supports to maintain access to the nearby cement plant. Similarly, in eastern Banda Aceh a two-lane, multi-span reinforced concrete bridge was swept off its piers, as illustrated in Figure 24(a). Two of the bridge piers were also destroyed while the others remained in place. Another multi-span, reinforced concrete bridge, over the same river further away from the ocean, survived the tsunami wave pressure as shown in Figure 24(b). This bridge is likely to be of the same type as that collapsed (shown in Figure 24(a)), judging by the spans and the piers, though this point could not be confirmed.

Fig. 23 The failure of steel truss bridge in eastern Banda Aceh

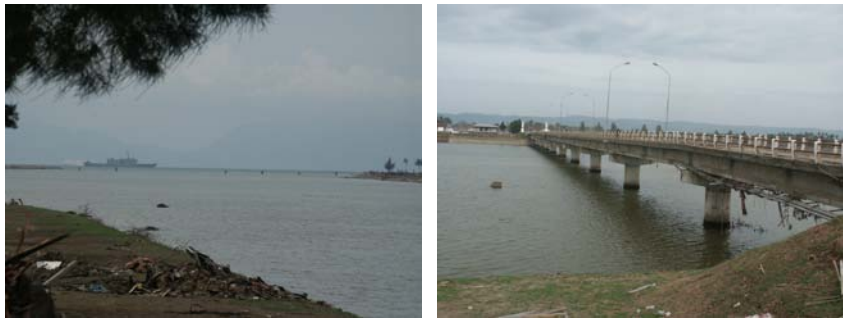
Fig. 24 Multi-span reinforced concrete bridges in eastern Banda Aceh: (a) bridge completely swept off by tsunami; (b) bridge that survived the tsunami

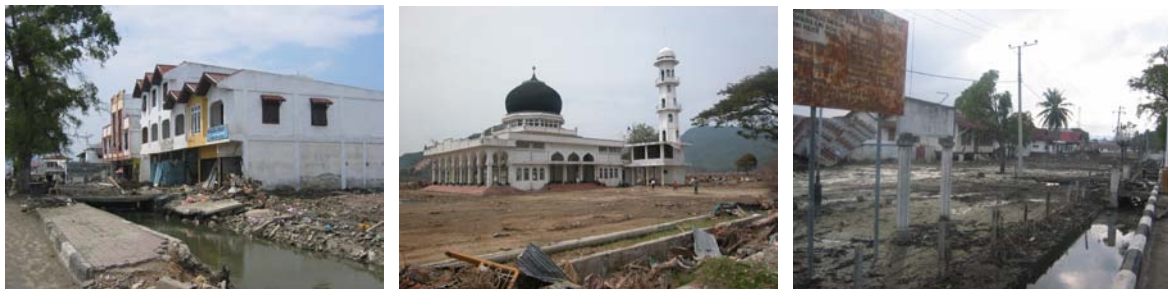
The storm drainage system in Banda Aceh, as well as in Medan, Indonesia consists of concrete open channels located along main streets. These channels are sometimes covered with prefabricated concrete slabs, especially in populated regions. This drainage system suffered extensive damage in Banda Aceh. Cover slabs were broken and displaced and the channels were blocked by mud and debris, further contributing to flooding. A major part of the clean-up operation was to clean the drainage channels to make them functional again, as illustrated in Figure 25.

Fig. 25 Open channel drainage system in Banda Aceh

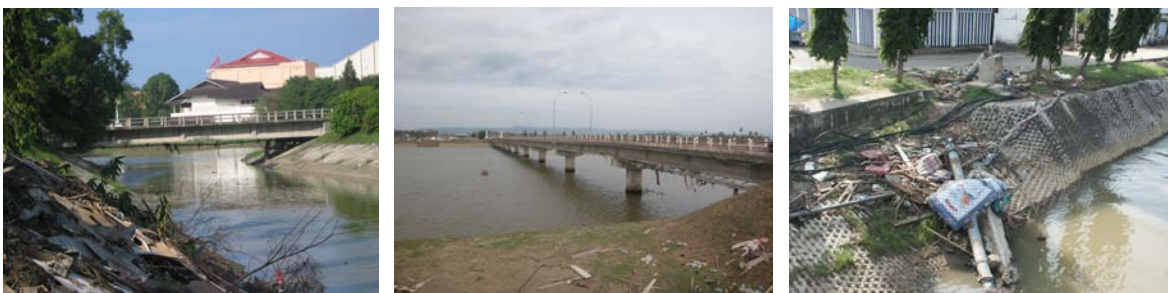
Fig. 26 Damage to pipeline attached to the underside of bridge girders in Banda Aceh

Water supply in Banda Aceh was disrupted due to the failure of water mains. A number of main pipelines were broken as they were attached to bridges to cross the rivers that pass through the city. These pipes were damaged either by the floating debris or collapsed bridge components. Figure 26 illustrates damaged pipelines attached to bridges.

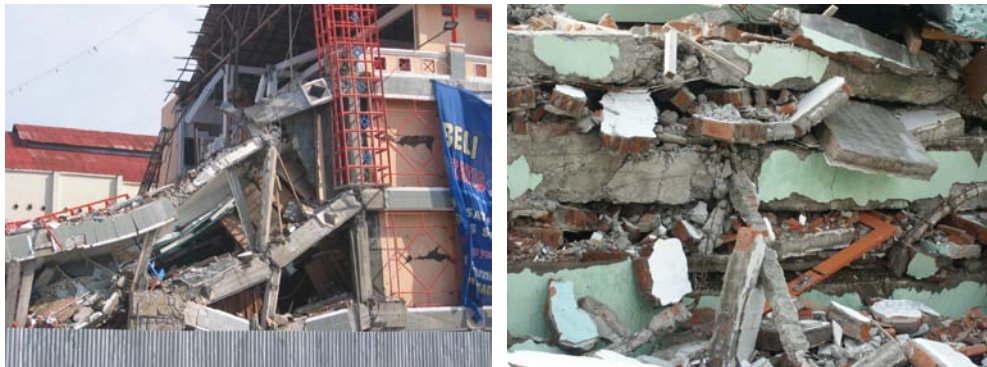
(a) Shopping centre in Banda Aceh (b) Office building in Banda Aceh

Most of the reinforced concrete frame buildings, which appeared to have been engineered, had strong and relatively deep beams supported by smaller-size columns. Therefore, hinging of columns was widespread throughout the area while the majority of the beams remained elastic until the collapse of the structure, triggering overall stability failures of frames. Figure 27(a) shows an example of this type of failure of a shopping centre located in downtown Banda Aceh, although this building also suffered from an additional problem of lack of joint reinforcement. Hinging of weak columns relative to beams also resulted in the pancaking of slabs, as illustrated in Figure 27(b).

Fig. 27 Deep and strong beams supported by smaller-size and weak columns

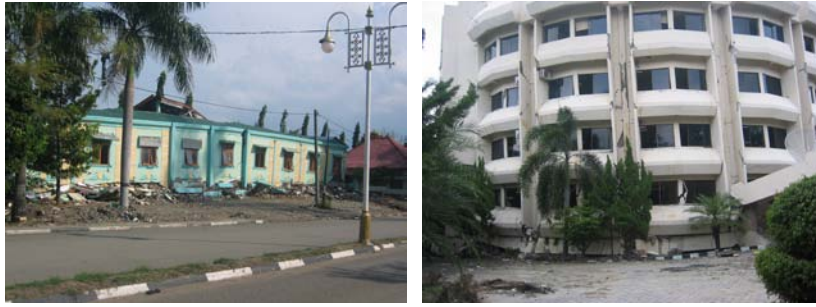
Open spaces at entrance levels resulted in soft stories in most commercial buildings. Increased deformation demands on the first story columns of these buildings, coupled with lack of confinement and column deformability, resulted in column failures. The failure of first story columns triggered the collapse of entire story. Older and newer buildings alike suffered from soft story failures as illustrated in Figure 28 (left and right, respectively).

Fig. 28 Soft story failures in Banda Aceh

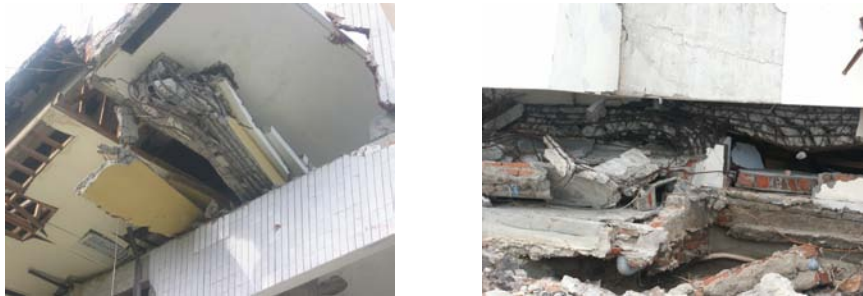
(a) Column failure in Tax Office (b) Column failure in Customs Building

The investigation of damaged columns revealed lack of seismic design practices, including properly spaced and detailed hoops. This resulted in column flexural failures, especially in soft stories and where strong-column weak-beam design philosophy had not been implemented. While non-engineered building columns had definite lack of required volumetric ratio, as well as the spacing and detailing of column ties, engineered building columns did not contain sufficient transverse reinforcement either. Column failures and resulting building collapses associated with the lack of transverse reinforcement are illustrated in Figure 29.

Fig. 29 Lack of concrete confinement and resulting failures in Banda Aceh

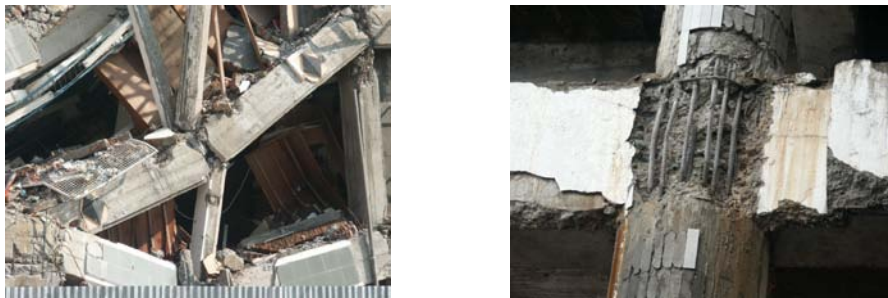
(a) Failure of beam-column connections (b) Lack of joint reinforcement

Many failures were attributed to lack of transverse reinforcement in beam-column connections. Furthermore, lack of transverse reinforcement in column splice regions, coupled with inadequate splice lengths resulted in additional column failures. Lack of shear reinforcement, aggravated by short column effects, resulted in column shear failures. Figures 30 and 31 show additional examples of column failures in Banda Aceh.

Fig. 30 Lack of confinement and resulting failures in Banda Aceh

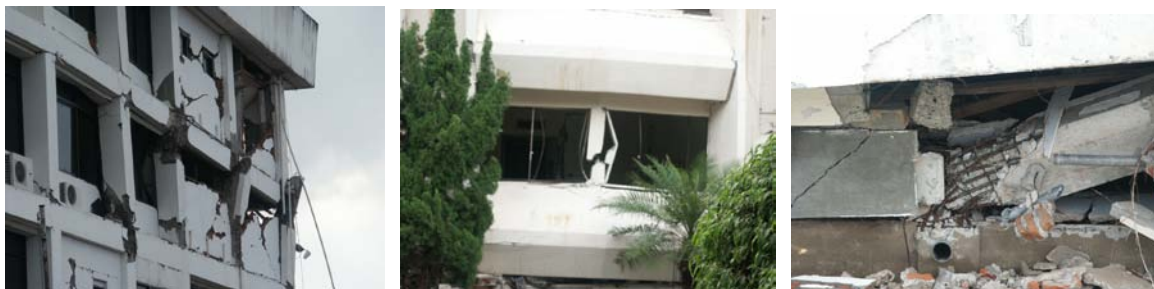
(a) Column shear failure (b) Column shear failure (c) Splice failure

Fig. 31 Column failures in Banda Aceh

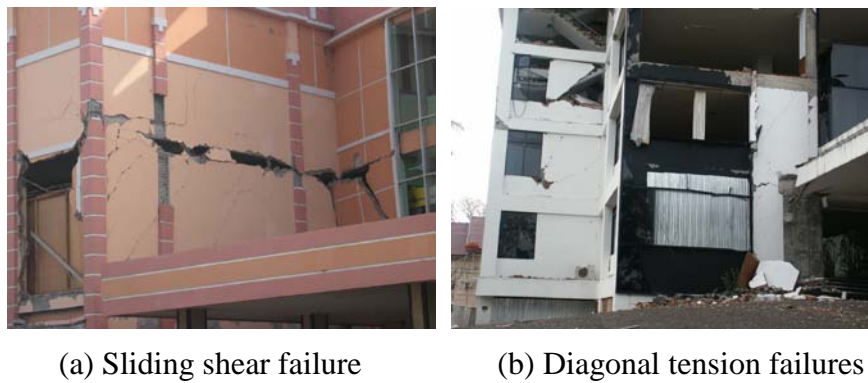
Unreinforced masonry walls were used extensively in all areas visited. Brick and block walls were used as exterior and interior infill walls, as well as partition walls. These walls increased the building mass and attracted seismic forces. They were able to brace buildings until their elastic limits were exceeded. When this happened, they developed either sliding shear failures or diagonal tension cracks followed by the crushing of diagonal compression struts. Figure 32 illustrates different types of damage inflicted on unreinforced masonry walls.

Fig. 32 Masonry damage in Banda Aceh

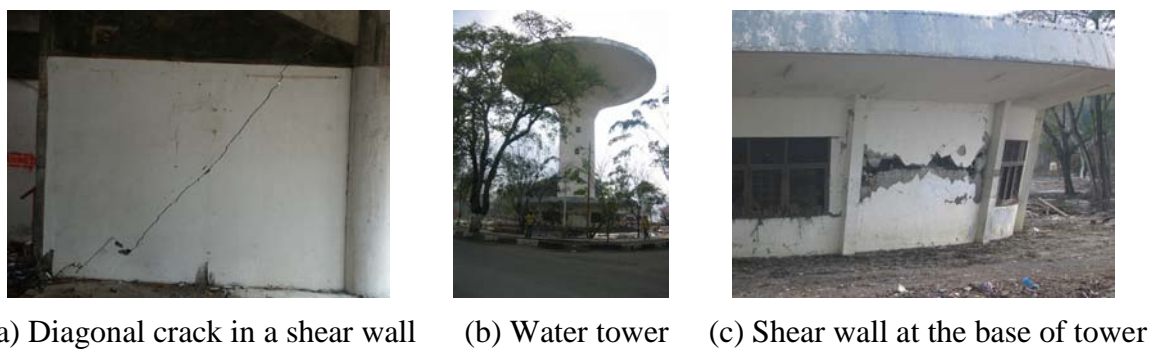
Very few structures had shear walls. A frame building, forming part of a shopping centre in Banda Aceh, had an inadequate shear wall which was not sufficient to provide lateral bracing, and developed a wide diagonal tension crack as shown in Figure 33(a). Similarly inadequate reinforced concrete shear walls were used at the base of a concrete water tower in central Banda Aceh. The walls suffered from extensive diagonal cracking. They also developed sliding shear failure due to the window openings within the walls. This is illustrated in Figures 33(b) and 33(c). Some of the masonry walls behaved as shear walls in terms of providing lateral bracing. However, if and when their elastic limit was exceeded, they developed diagonal tension cracks and diagonal compression crushing.

Fig. 33 Performance of concrete shear walls in Banda Aceh
