## **DAMAGES DURING DHAMAR EARTHQUAKE OF DECEMBER 13, 1982 IN YEMEN ARAB REPUBLIC**

**A.S. ARYA, L.S. SRIVASTAVA AND SATYENDRA P. GUPTA\***

The Dhamar province of Yemen Arab Republic was shaken on December 13, 1982 by a moderate earthquake. The earthquake caused considerable loss of life and different degrees of damage to the traditional houses in the area. The most prevalent form of construction consisting of stone masonry and adobe suffered very extensive damage. The destruction of houses was mainly due to failure of superstructure and none due to movement of foundations. Ground ruptures, failure of dry packed stone retaining walls, rock fall and rupture of stone on hill sides were also observed. An above ground reinforced concrete water tank also collapsed. An isocismal map of the earthquake damaged area has also been presented.

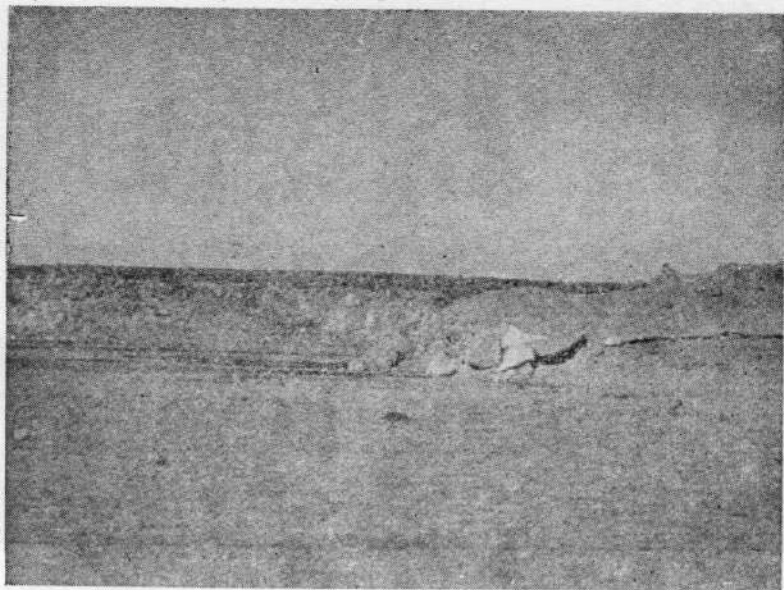
Sliding and overturning of utensils, furnitures and other loose objects was reported in the region and at Dawran a 3 m × 3 m × 2.5 m iron sheet box grocery shop facing S60°W direction and supported on 30 cm long, 7.5 cm wide angle iron legs was overturned as its front legs were bent. A similar shop resting on rock boulder platform did not undergo any movement. Photo 1 shows rupture of stone on a hill and photo 2 shows rock fall on a mountain and dislodging of boulders.

Photo 1. Rupture of stone on a hill due to force of Earthquake near village Qubatil.

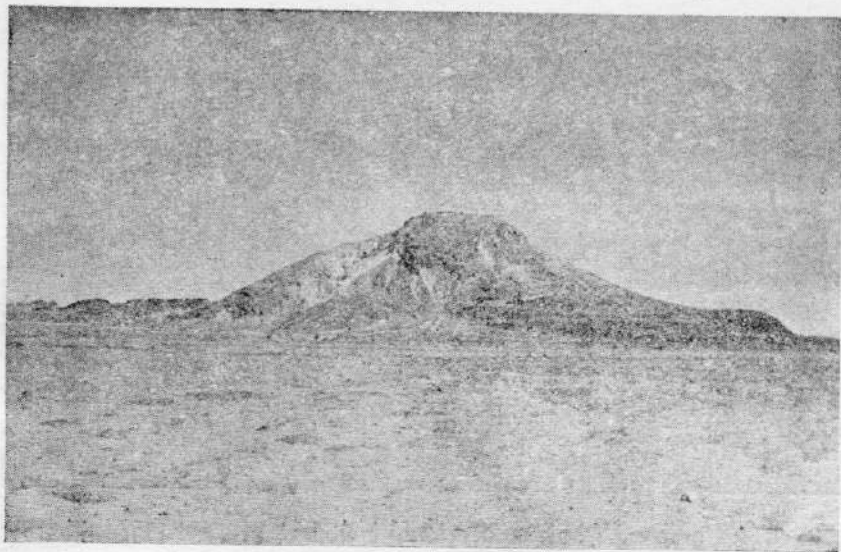
Photo 2. Rock fall and slide on the mountain near village Alisi.

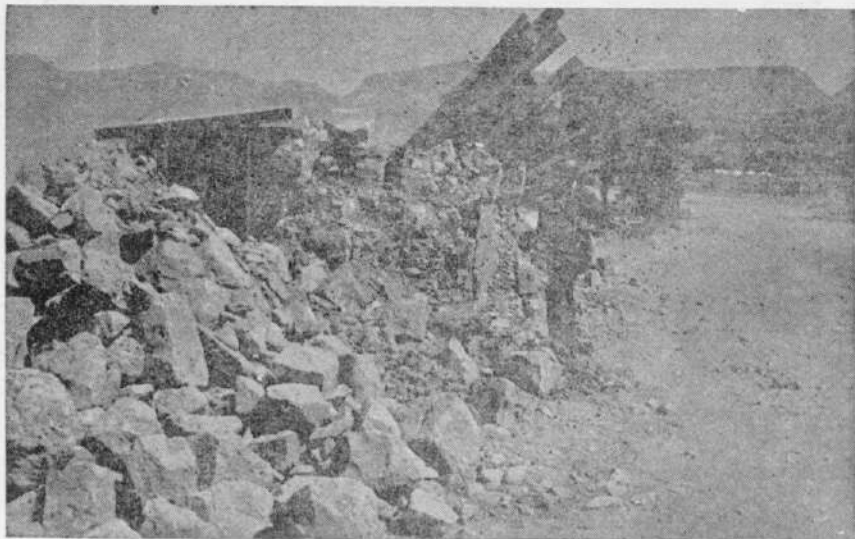
Photo 3. Complete Collapse of a single storied dwelling of random stone construction near Dohran.

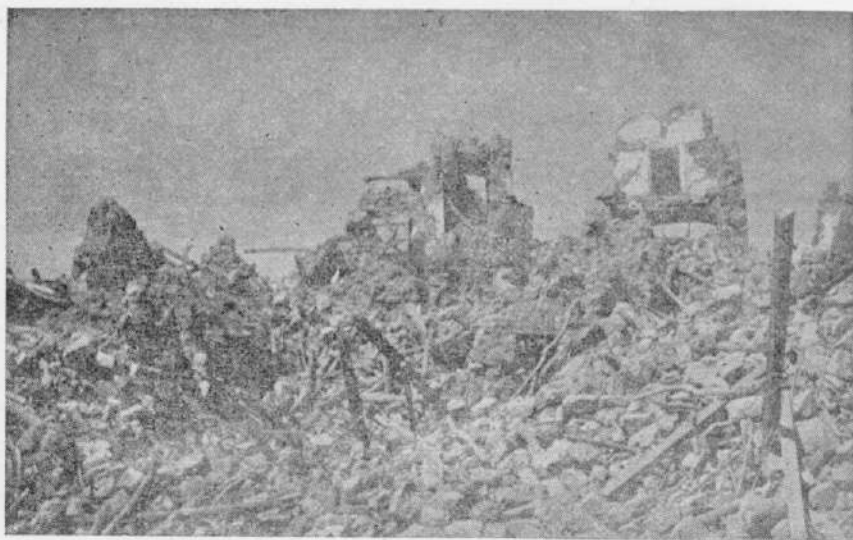
(a) *Stone Masonry Walls*—The wall thickness of this construction as seen in photo 4 and 13 varies from 60 to 90 cm. Heavy stones are provided on outside and on the inside faces of the walls and any space or gap left in between the two leaf of stones are filled with loosely broken stone or simply mud, and it could be easily seen in Photo 13 that there is generally no inter-connection between these stone widths provided in the innerside and outside of a wall.

Photo 4. Complete Collapse of random stone house in village Dohran.

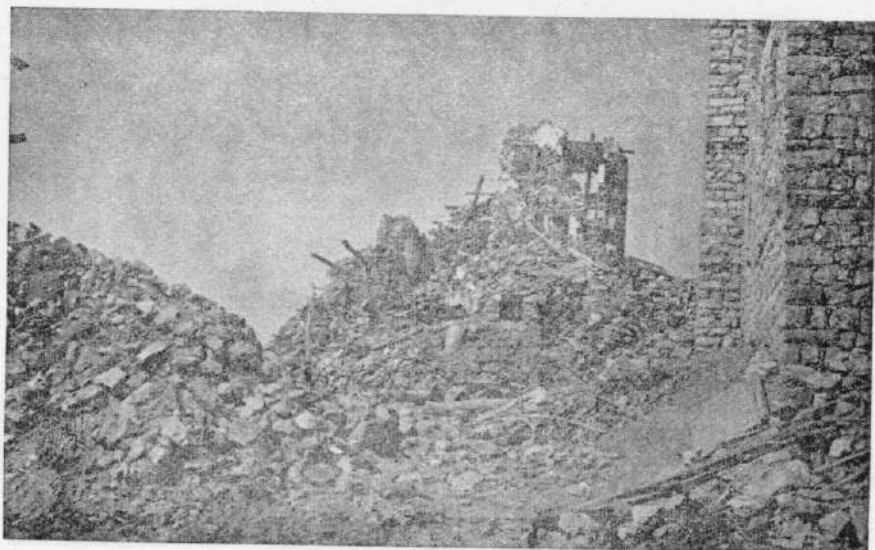
Photo 5. Collapse of houses built of random rubble stone in village Dohran.

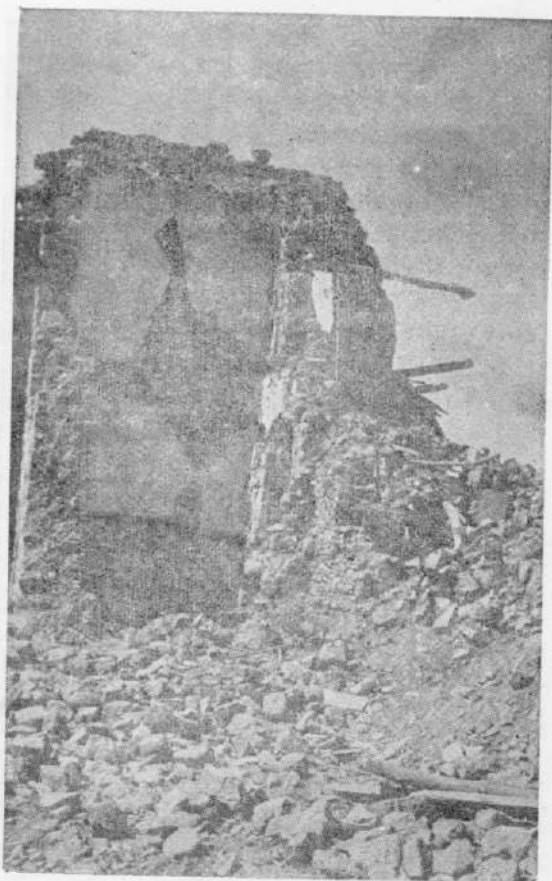
Photo 6. Complete Collapse of a house of random stone construction with muck filling in the hearting of walls at village Dohran.

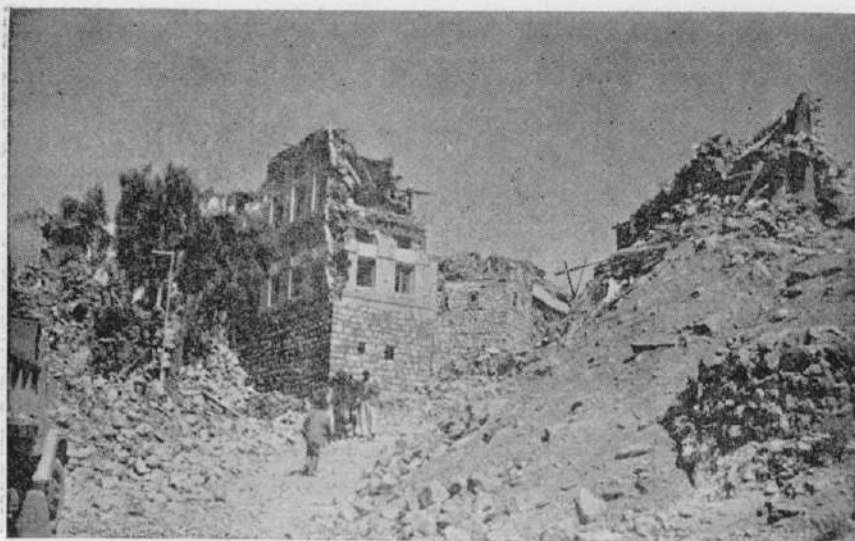
Photo 7. Collapse of stone built dwellings in village Dohran.

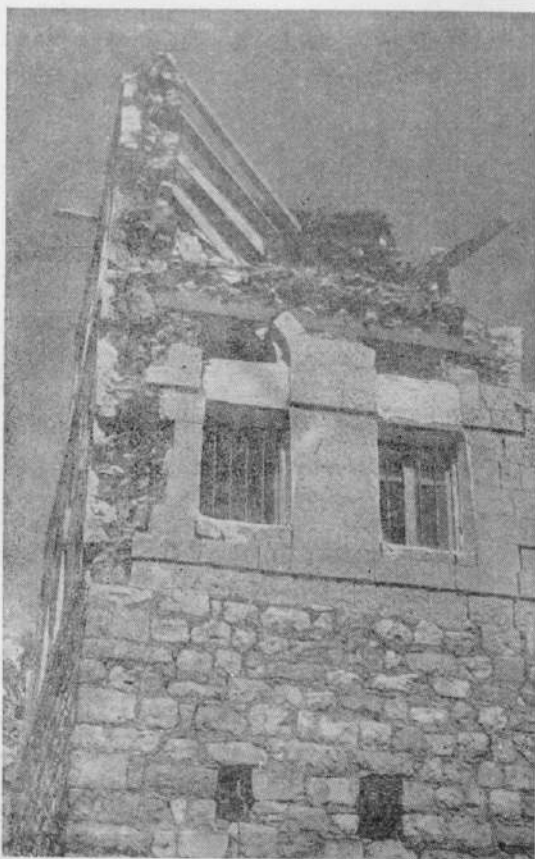
Photo 8. Collapse of third storey and cracks in lower storey walls, very heavy floors in houses seen in village Dohran.

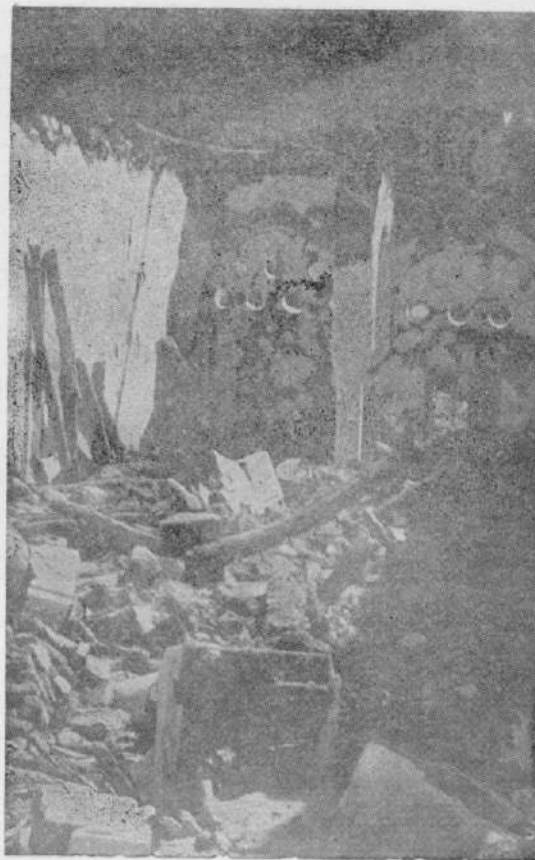
Photo 9. Collapse of Dohran Mādarsa-cum-Mosque, some Arches and posts still standing.

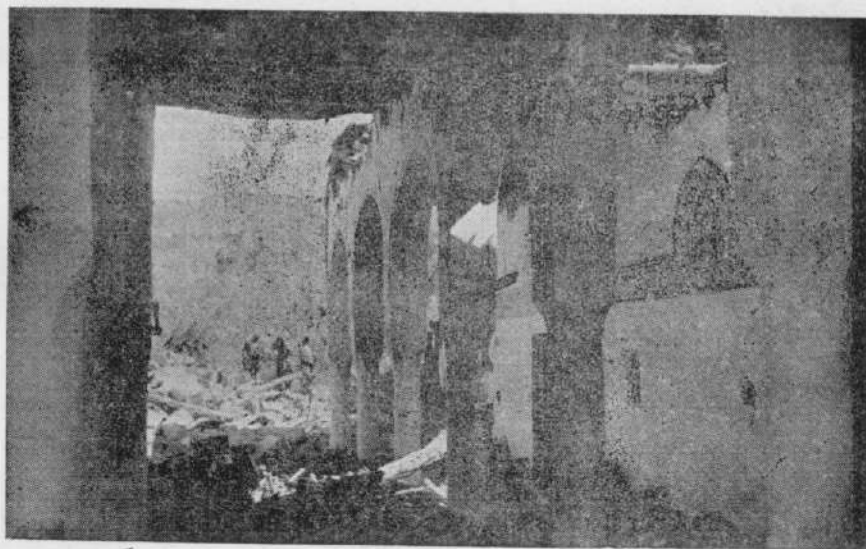
Photo 10. Undamaged portion of Dohran Madarsa-cum-Mosque, standing posts, arches and damage in the roof.

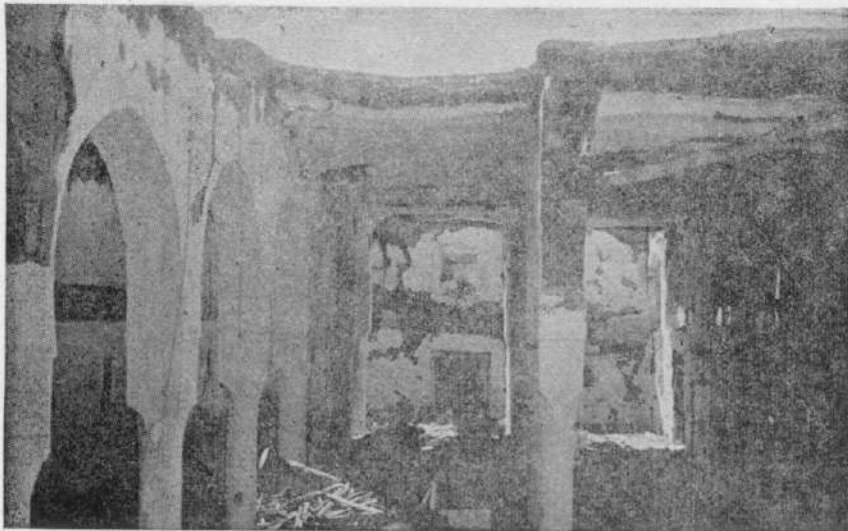
Photo 11. Damages to the Dohran Madarsa-cum-Mosque, fallen wood pieces from roof, cracked and peeled off plaster on walls and pillars.

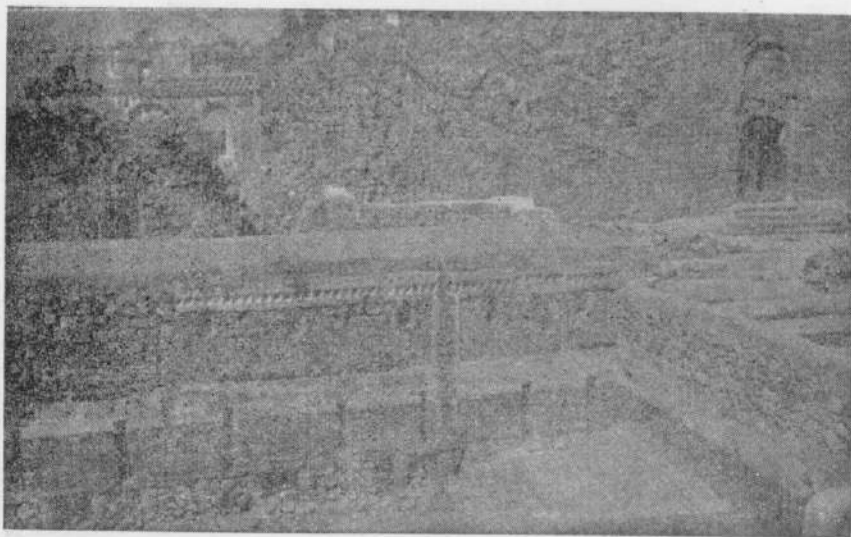
- (ii) Bulging of the wall masonry outward or inward and falling away of half the wall-thickness eitherway as shown in photo 12 and 15 was also a common sight. The outer wythe consisting of stones with outer face roughly dressed separated from the hearting of the wall and fell out at innumerable places exposing the inner muck-filling of the wall. The exposed cross-sections of masonry walls clearly showed the separate building up of the two wythes of the wall with small stone and earth filling in between them, without practically any mechanical connection which could be achieved by the use of "through" stones. At many places this must have led to the complete shattering of the wall resulting in only a heap of rubble as shown in photo 3, 4, 5, 6, 7 and 9 and falling of the roof along with it as shown in photo 8. Another adverse effect seen in the old masonry walls was that of washing away of the mud mortar from the joints leaving gaps between the stones so that their relative movement became easier leading to destruction of the walls.

Photo 12. Back portion of Dohran Madarsa-cum-Mosque wall, one leaf of stone fallen, random combination of stone and brick wall construction may be seen in the foreground.

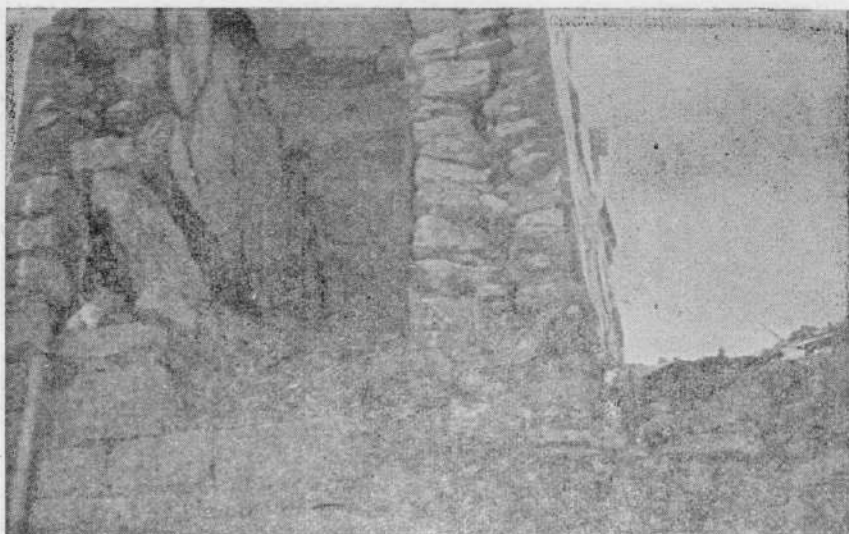
Photo 13. Random rubble stone wall, no interlocking between inner outer faces of stones at Village Hizrat Mangada.

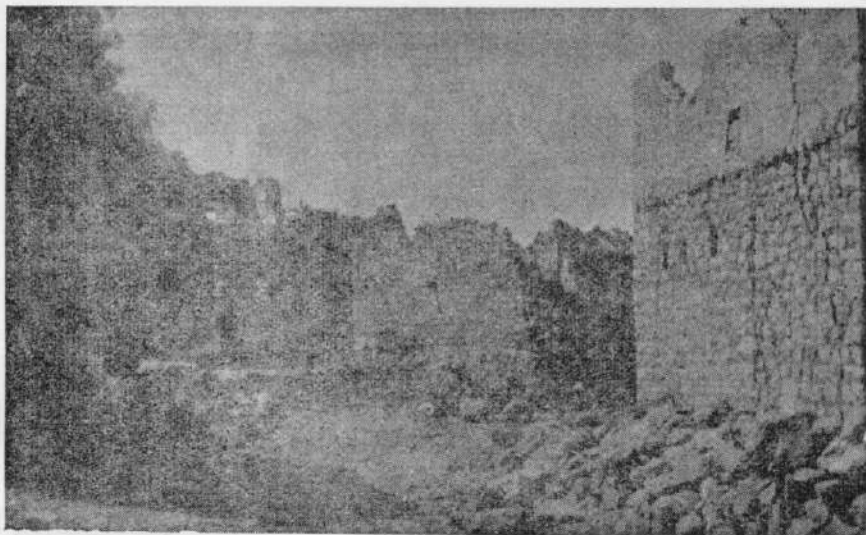
Photo 14. Construction using random stone in lower floor and adobe on upper floor in village Dohran, cracks and collapse of wall.

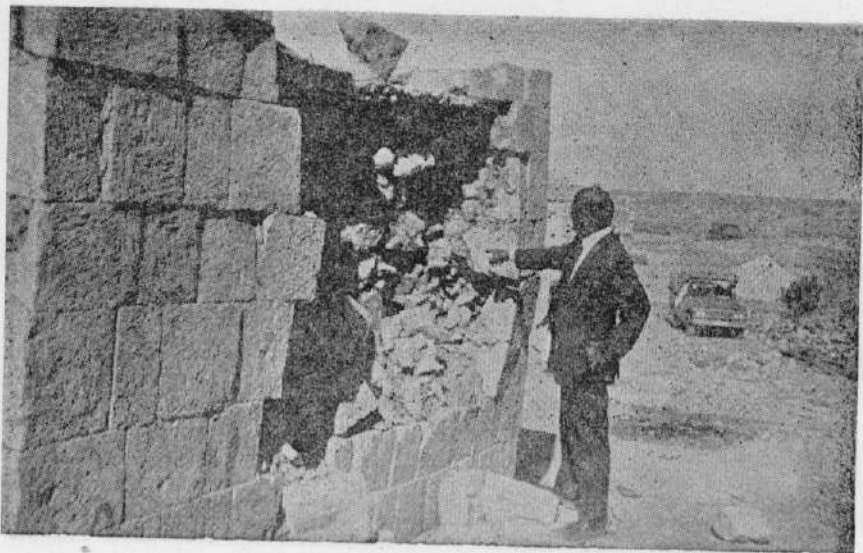
Photo 15. Outside dressed stone wall and inside small random stone and muck filling at Village Qubatil. Collapse of outer leaf of dressed stone.

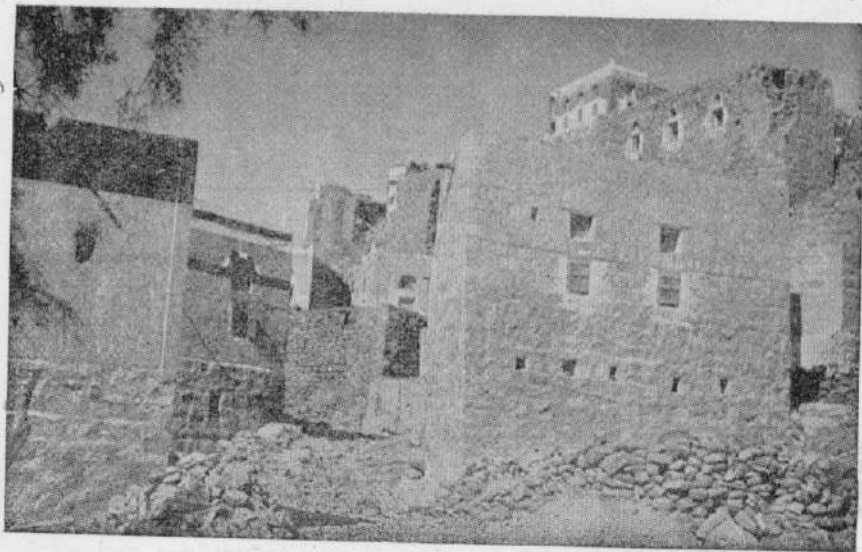
Photo 16. Damage to corners and walls in upper floors of dwellings, random provision of wood pieces over window in village Dhi-Hawlan.

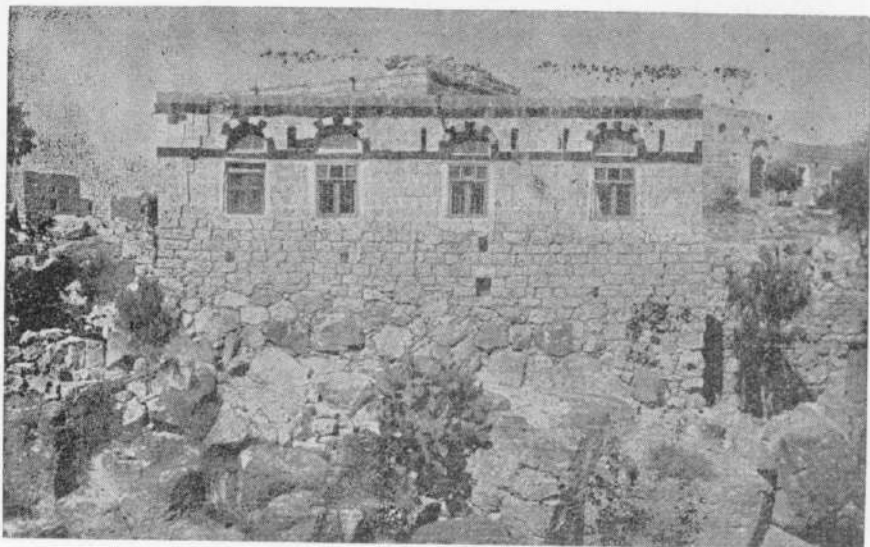
Photo 17. Random stone and coursed stone construction, cracks and separation at corner of wall at Village Hizrat Mangada.

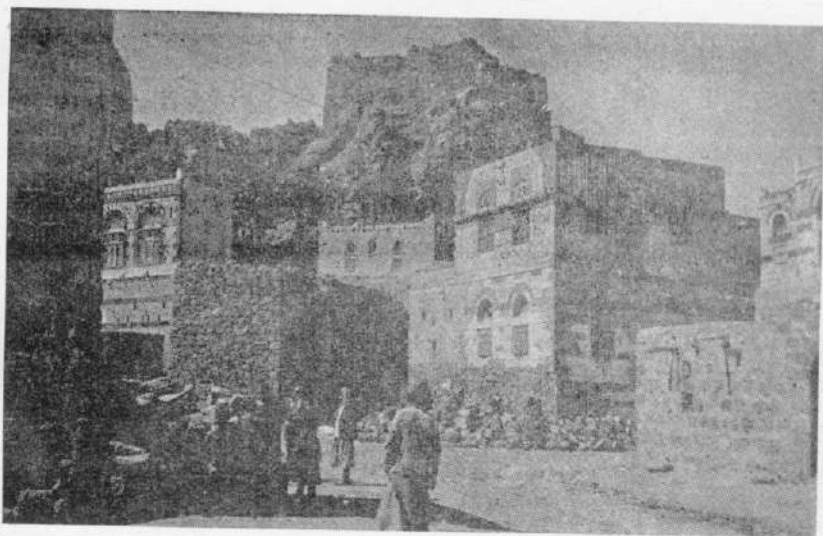
Photo 18. Collapse of upper floor of a house on hill top. Other houses cracked but not collapsed in village Warakah. Separation of walls seen at their intersections.

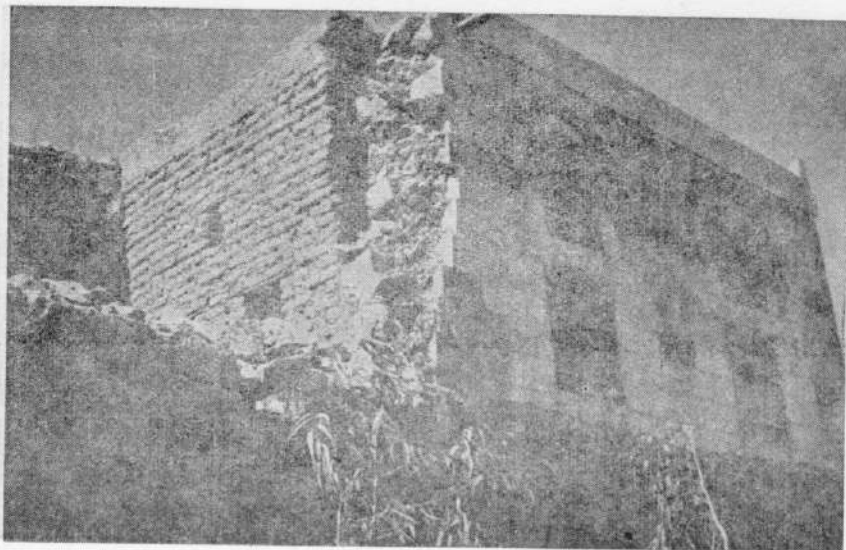
The hammer dressed stone which is used for outside walls in village houses is also mostly decorative as shown in photo 19 and these stones are also not connected with the inside face stones as described above. There is no interlocking at the corners or at T-junctions of walls.

Photo 19. One face dressed coursed stone and another face random stone in front wall and adobe construction along side wall of a house, no interlocking at corner of wall and damage at corner in Village Warakah.

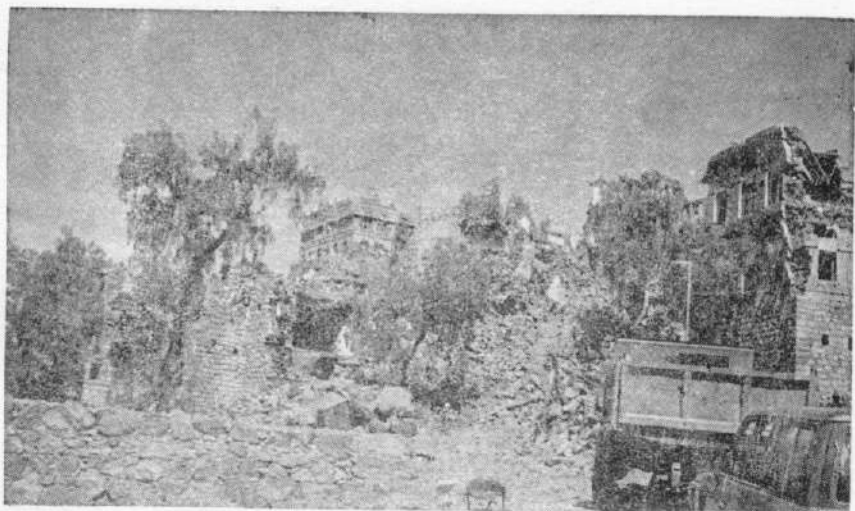
Photo 22. Destruction of houses in village Dohran.

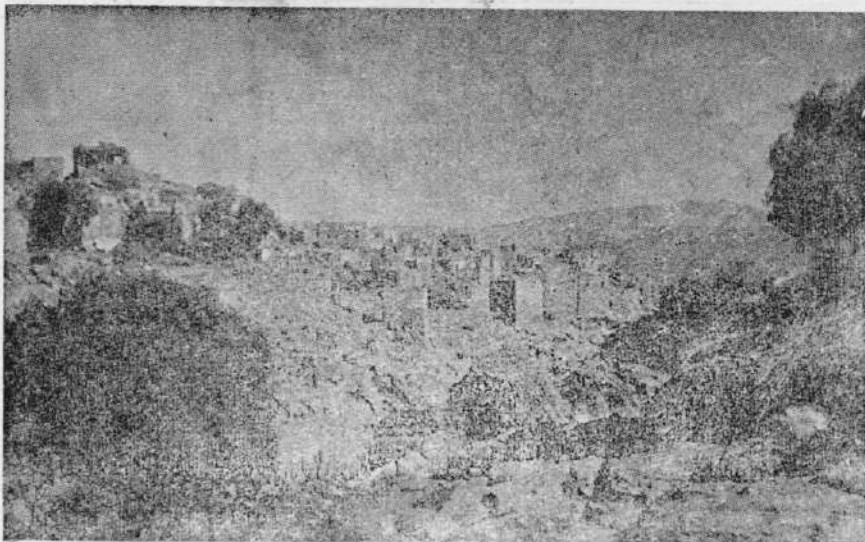
Photo 23. General view of severe damages of houses on a hill top near Hizarat Mangada.

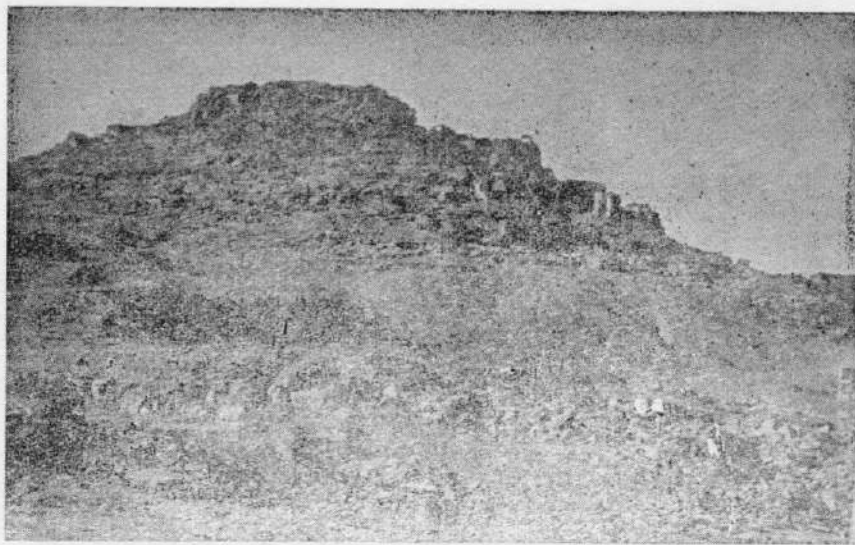
Photo 24. Complete destruction of all houses situated on hill top in Qubatil. The random stones littered all over the hill slopes.

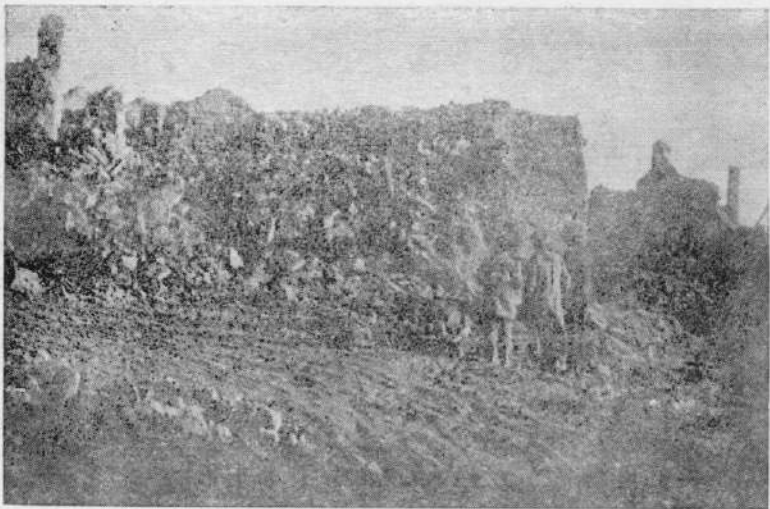
at corners and junction takes place easily under ground shaking, the cracks passing through the blocks themselves. Afterwards the walls fails either due to bending or shearing combined with the compressive loads, the whole house crashing down. Adobe walls do not on the other hand, have the bulging tendency as in masonry walls since they have flat courses and bonding between outer and inner faces. The effect of roof and intermediate floors is similar to that stated above for masonry buildings. A number of single storeyed clay-block houses showed practically no damage at all in the same areas where collapse of two or three storey houses had occurred. Photo 27, 28 and 29 shows the damages to the adobe and mud houses.

Photo 27. Destruction of adobe Houses at village Al-Olayb.

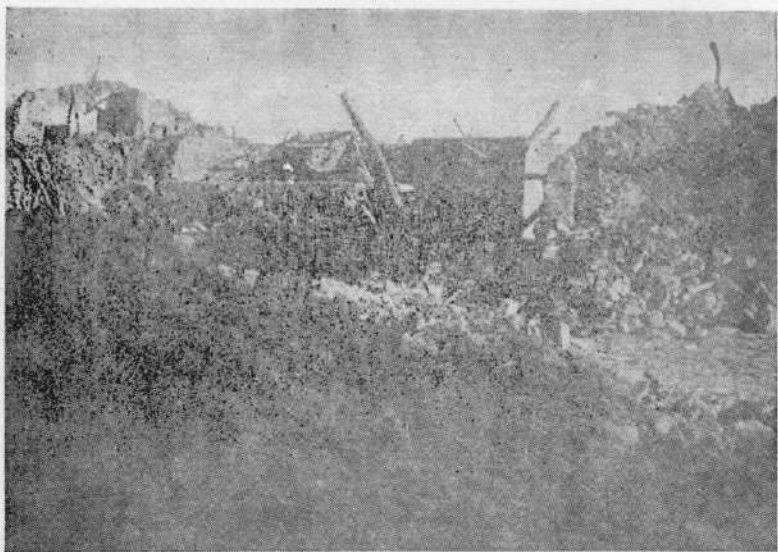
Photo 28. Destruction of adobe Houses in village Al-Olayb. See choking of streets.

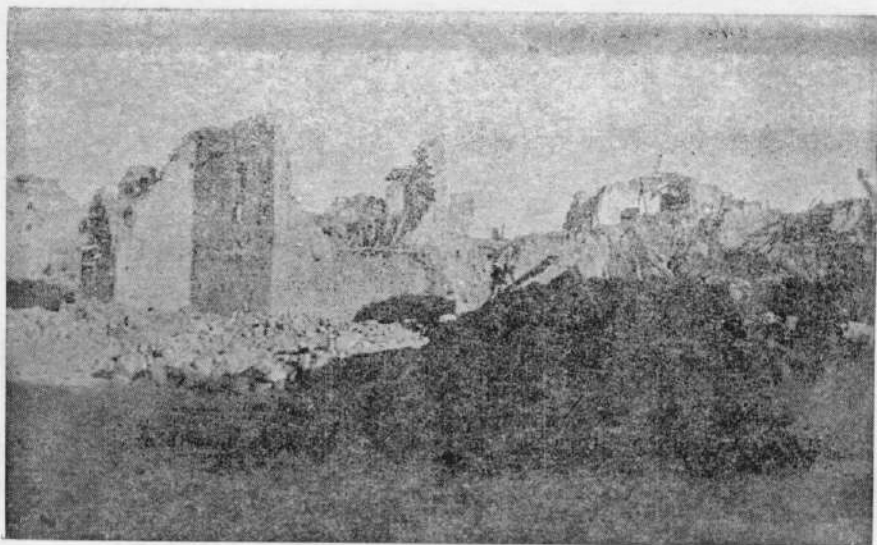
Photo 29. Damages to adobe construction in village Al-Olayb.

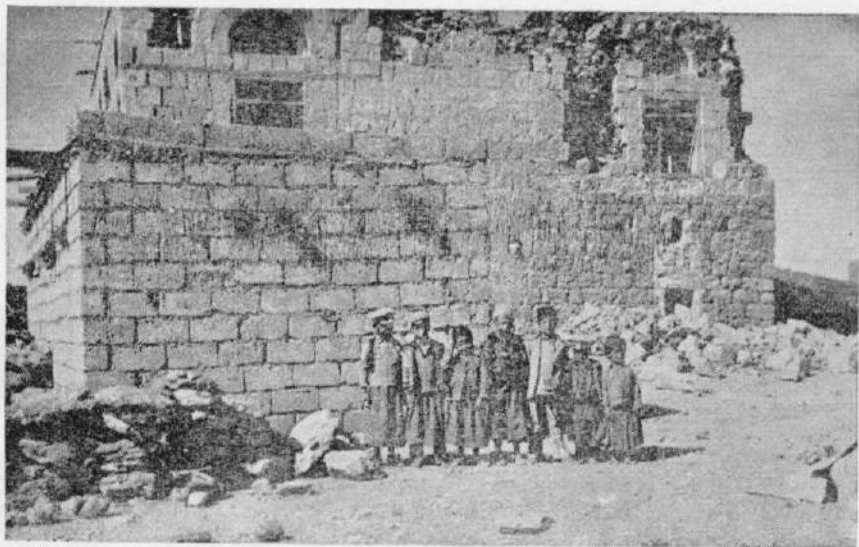
Photo 30. A single storeyed house built from solid concrete blocks in gypsum mortar remains undamaged and a two storeyed stone house badly damaged with collapse of corners in village Hizarat Mangada (See discontinuous use of wood pieces).

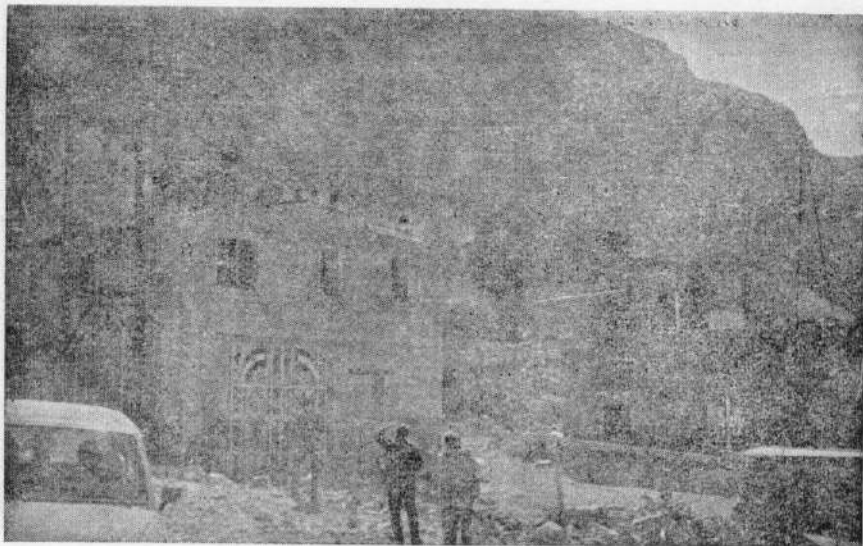
Photo 31. Electrical substation building, minor crack in wall in village Dohran (Dressed stone masonry in cement mortar).

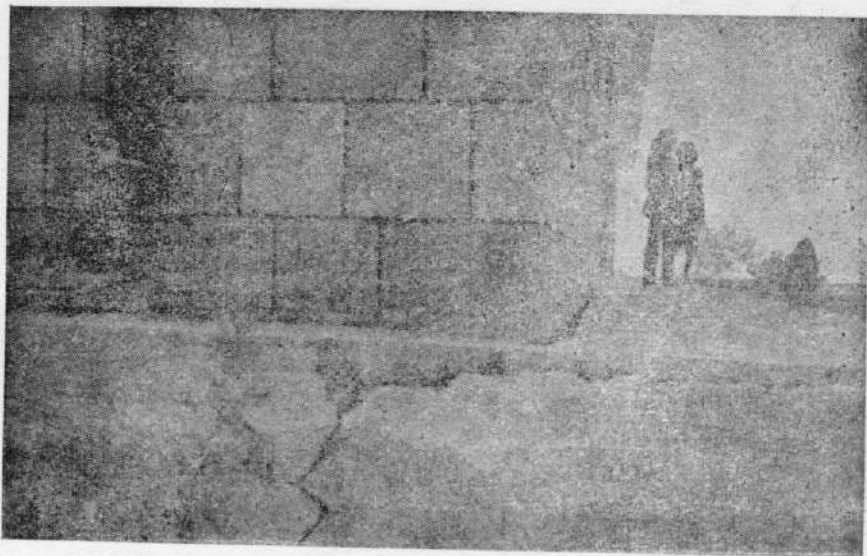
Photo 33. Cracks and separation on the North-East corner of the foundation and wall of the Dohran Dispensary. Sinking of outside passage.

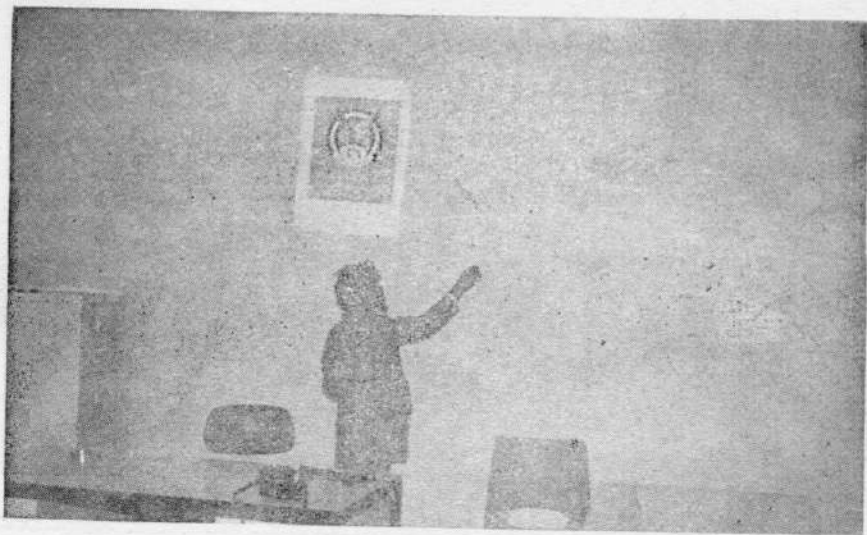
Photo 34. Diagonal cracks in the wall (inside view) in a room of the Dohran Dispensary, stone masonry consisting of half-dressed stones built in gypsum mortar.

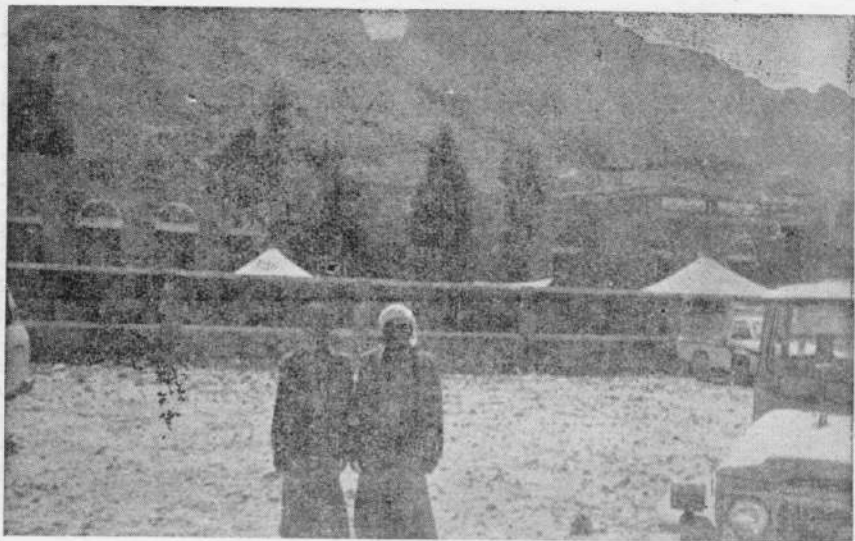
Photo 35. No damage, only minor cracks in the Dohran Madarsa (Masonry as in Dohran Dispensary.)

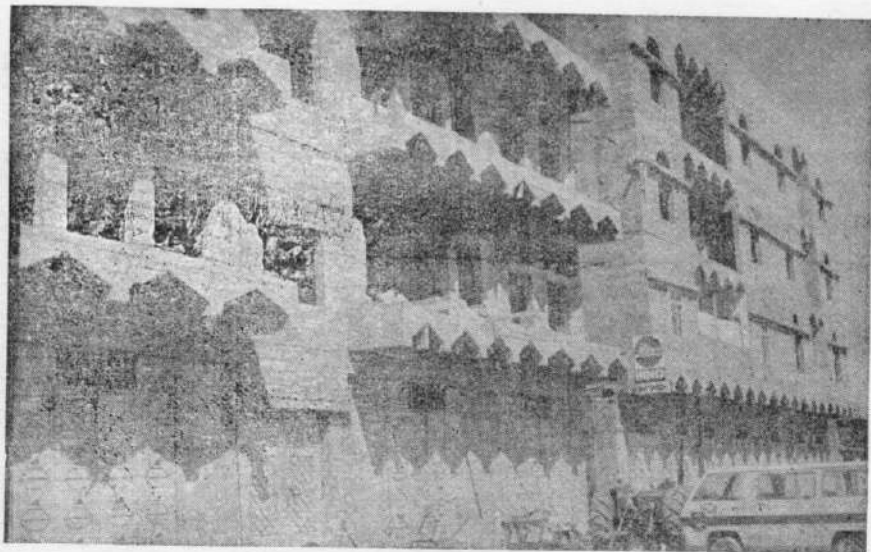
Photo 36. Reinforced concrete framed structures with concrete block wall filling in Dhamar, no damage reported. (Balcony wall filled with concrete block may fall in severe shaking, proper bonding and strength required.)

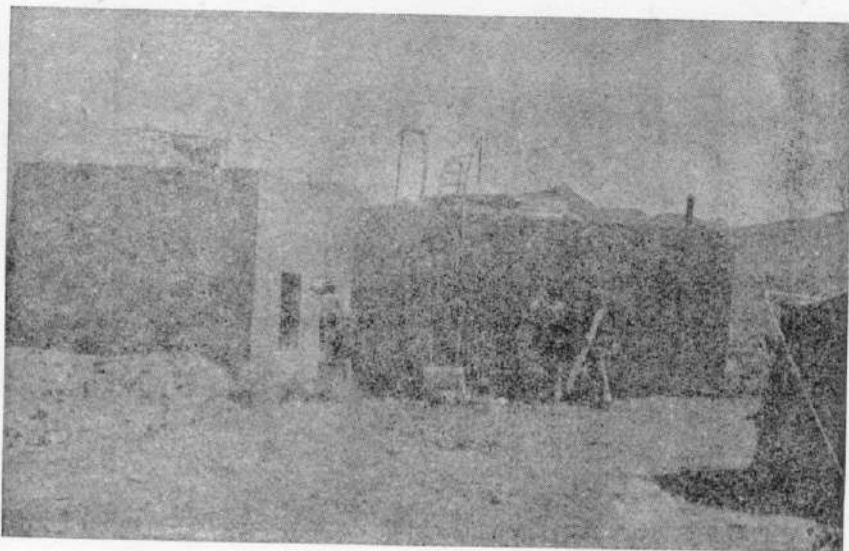
A concrete water tank of rectangular section measuring 7.5 m × 6.5 m × 3.1 m and supported by seven reinforced concrete columns 3 m tall and 25 × 30 cm in cross-section crashed to the ground due to the collapse of the columns. Calculations indicated that the columns were too weak to take the horizontal accelerations in MM VIII area since their ultimate moment capacity would be exhausted at only 6 percent of gravity acceleration and hence the failure of columns is not surprising. Photo 37 shows the water tank on the ground and photo 38 and 39 shows the column failure with exposed reinforcement. A serious weakness of the reinforced concrete columns was lack of lateral ties which are required at closer spacing of about 7.5 cm near the column ends so as to confine the concrete and impart ductility to the columns.

Photo 37. Collapse of a reinforced concrete water tank near village Dohran, the adjoining pump house suffered cracks in the walls.

For safeguarding other tanks of similar types, it is recommended that stone block masonry or brick walls in 1 : 6 cement-sand mortar should be tightly infilled between the column on the periphery so as to increase the stiffness as well as the lateral strength of the supporting structure.

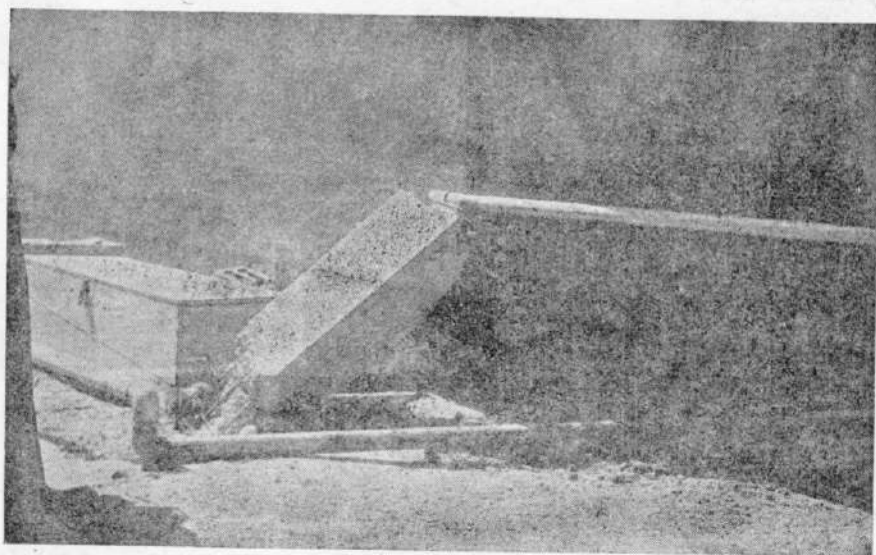
Photo 38. Damage to reinforced water tank columns, inadequate reinforcement and ties.

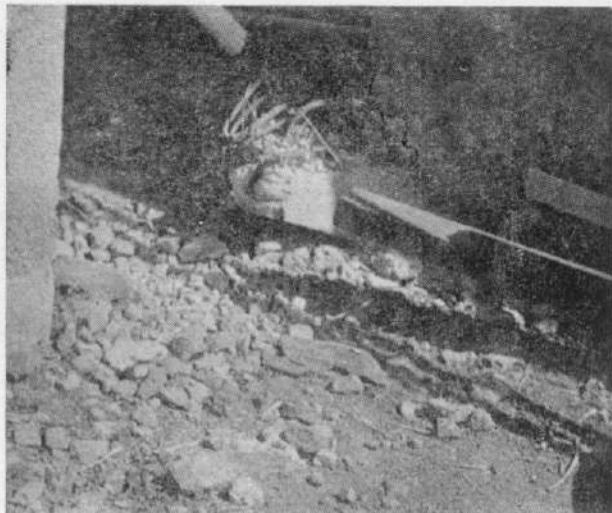
Photo 39. Buckling of reinforcements in the columns of water tank, badly mixed concrete and few reinforcements.
