REMEDIAL MEASURES FOR THE FOUNDATION OF A DIESEL GENERATOR

A. S. ARYA* AND M. K. GUPTA**

INTRODUCTION

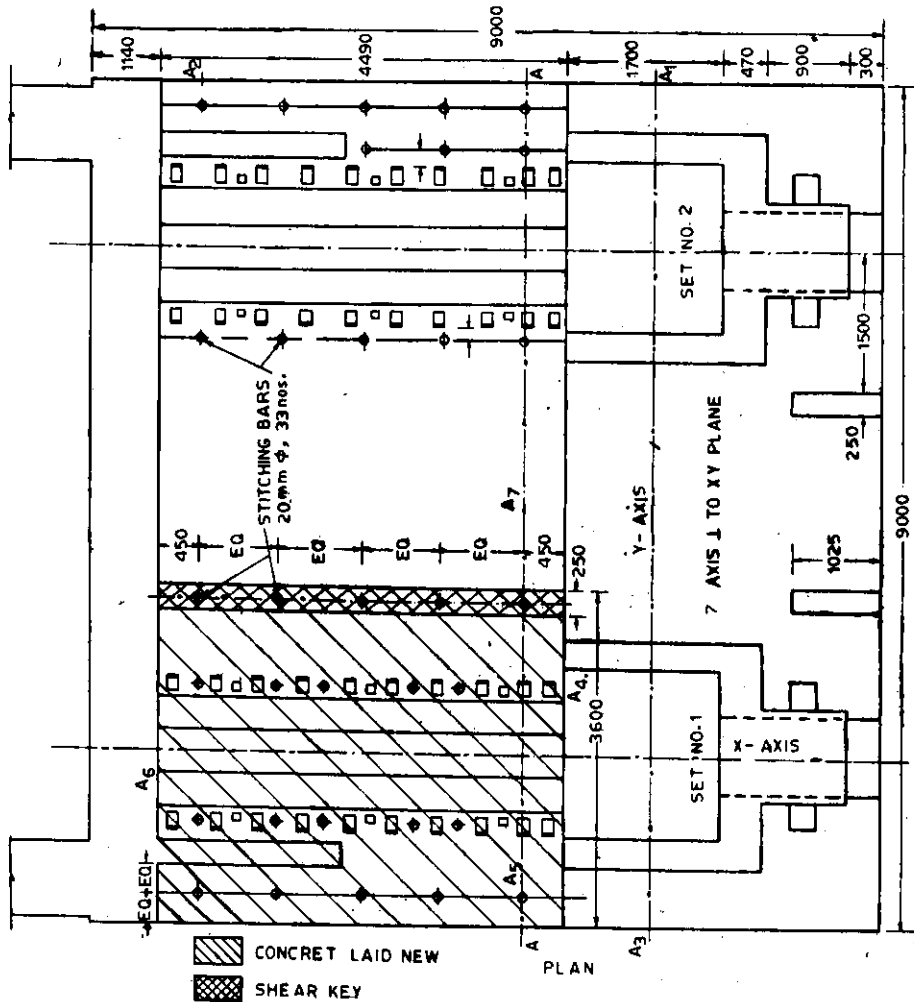
Fig. 1. Plan of generator foundations

After removing the engine the foundation was examined and a cold joint was suspected at a depth of 800 mm from the top of the foundation. Unfortunately without conducting tests to confirm it, a portion of block $4.49 \text{ m} \times 3.6 \text{ m} \times 0.8 \text{ m}$ deep was removed as shown hatched in Fig. 1. The problem was referred to the authors at this stage for checking how significant was the cold joint, if any, in the dynamic behaviour of the foundation and what remedial measures could be adopted to restore the footing to near original characteristics before installing the engine again. The observations taken and remedies suggested are described herein.

When the second engine (Set No. 2) was running on load, the acceleration measurements on block were taken with the help of Millar acceleration pickup, Brush Amplifier and Brush Ink writing oscillograph. The acceleration was measured at 4 locations, A_1 to A_4 as shown in Fig. 1, below and above the suspected horizontal cold joint at a depth of 800 mm from top of the block in the three directions X, Y, Z perpendicular to each other. Table 1 shows the acceleration amplitudes at these locations in various directions before the repair work was carried out.

From Table 1, it is observed that there is no marked difference between the accelerations below and above the suspected cold joint at any location in any direction. This indicates that the block was infact behaving as one unit and the cold joint suspected was not really 'cold'.

(e) A similar scheme of bolts was suggested for the second engine also in view of the suspected cold joint as discussed earlier. Since the second engine was in position and a channel 800mm deep also existed, it permitted only 3 bolts to be provided in one of the rows. Five bolts were also provided in the shear key shown cross hatched in Fig. 1. Thus 33 stitching bolts were suggested in all at locations shown in Fig. 1.
