BUILDING PRACTICES IN SEISMIC ZONES OF NORTH BIHAR, NORTH BENGAL AND ASSAM

N. Gosain*

Buildings which were damaged and which survived the past earthquakes in North Bihar, North Bengal and Assam, along with the recommendations made for improving their aseismicity are described briefly in this paper.

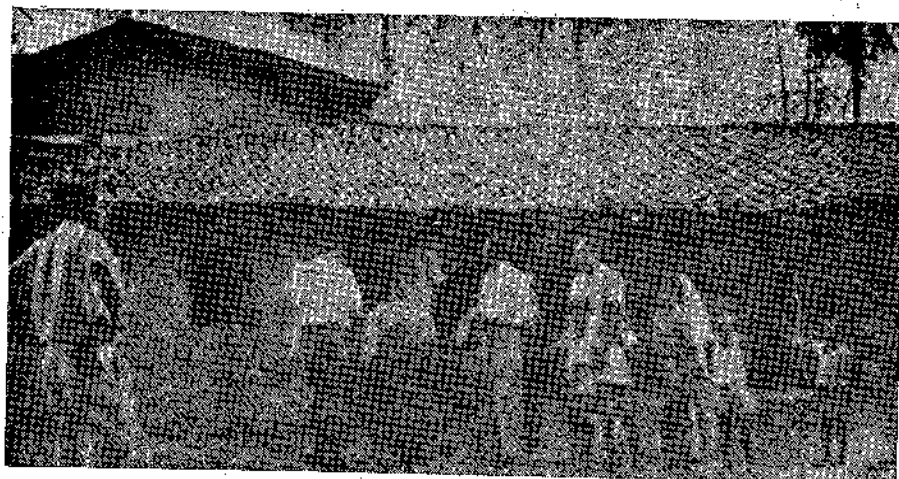
This has been in the lot of the Indian villager for many centuries and still continues to be the main form of residence. In Bihar, the hut is usually constructed of mud walls. No proper foundation is made and the plinth is raised from the ground level to about 1 ft. in mud itself. Normal practice is to make the walls varying uniformly from about 4 ft. thick at the base to about 2 ft. thick at the roof level. The clayey mud is mixed with local species of straw, ("dhabi", "khar"), wheat or rice husk and pounded well to a paste. Rough prismatic blocks 9"x6"x6" are made by hand, and when still moist, laid one above the other with no set pattern. The walls are then smeared with the same mud-plaster on both the sides. Roof is pitched, consisting of timber ridge and eaves made usually from trunks of palm trees. Bamboo and twig matting is then provided and the roof covered by either thatch or Nurria tiles. Since the walls are often eroded by the weathering action of the rains, villagers who can afford, build in third or fourth class brick masonry in mud mortar upto the plinth level. Village huts get easily damaged during earthquakes of moderate and even low intensity. It was observed in the 1934 earthquake that collapse of tiled roof huts was larger than thatched roof huts (1). Fig. 1 shows a typical village hut near Muzaffarpur. It will be interesting to note that in the 1934 earthquake this was the only hut that was undamaged in the village and it still stands today.

Fig. 1. Village Hut in Bihar.

Noting the wide-spread damage to these "Kutchha" buildings it was suggested by Nasu that walls of mud houses should be thick at the base and thin at the top, the inner and outer surfaces having parabolic cross-section (1). The author had an opportunity of visiting some villages around Muzaffarpur and it was found that this has not been adopted and the walls are of the traditional form. Another method which is suggested for strengthening the mud walls against weathering effect and earthquakes is by the provision of bamboo "jaffri" or bamboo-wattle placed at the centre (2).

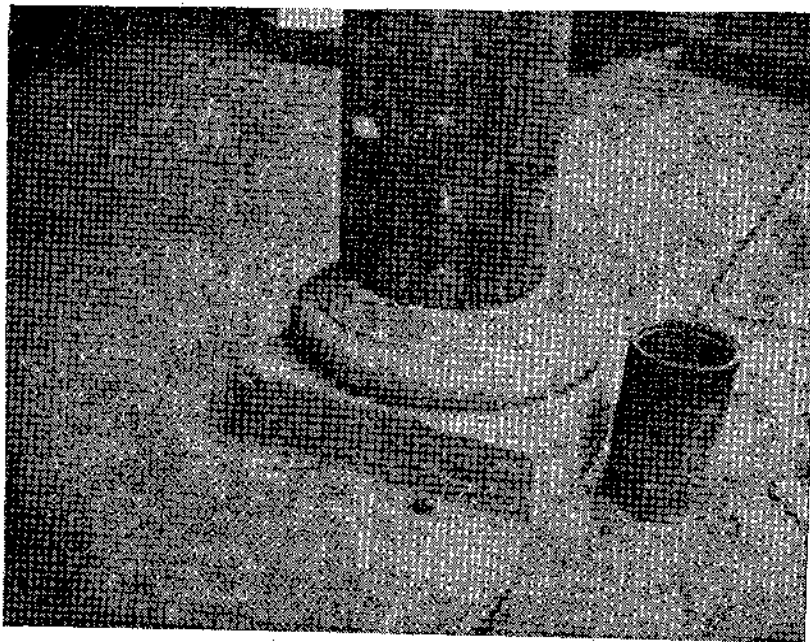
A two storeyed "kutchha-pucca" house at Muzaffarpur which suffered very minor damage during earthquake whereas hundreds around it collapsed, has outer walls made of

second class brick masonry (English bond) in poor lime-sand mortar, 20" thick throughout. Interior walls are of poor quality bricks in mud-mortar. The verandah roof is supported by slender sal timber columns which merely rest on sandstone soling in both the storeys. Top storey columns shifted 3/4" at the base during the earthquake (Fig. 2). The roof is flat and made of sal timber joists covered with brick tiles and earth.

Figure 2 Timber Column on Sandstone Soling.

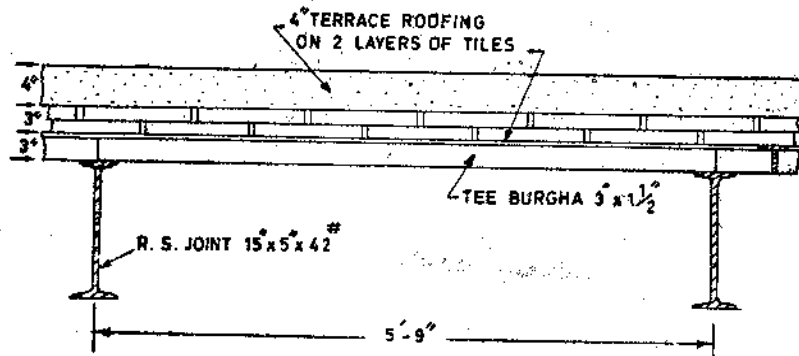
The earthquake cracked the main portico of the building and the N.E. corner of the eastern first floor wing crashed and fell outwards. Roofs of the building proved very susceptible to the shock; they either collapsed or were badly cracked. The verandahs also collapsed and fell outwards.

Fig. 3 A. Roof of Court Room, First Floor, Civil Court, Laheria Serai.

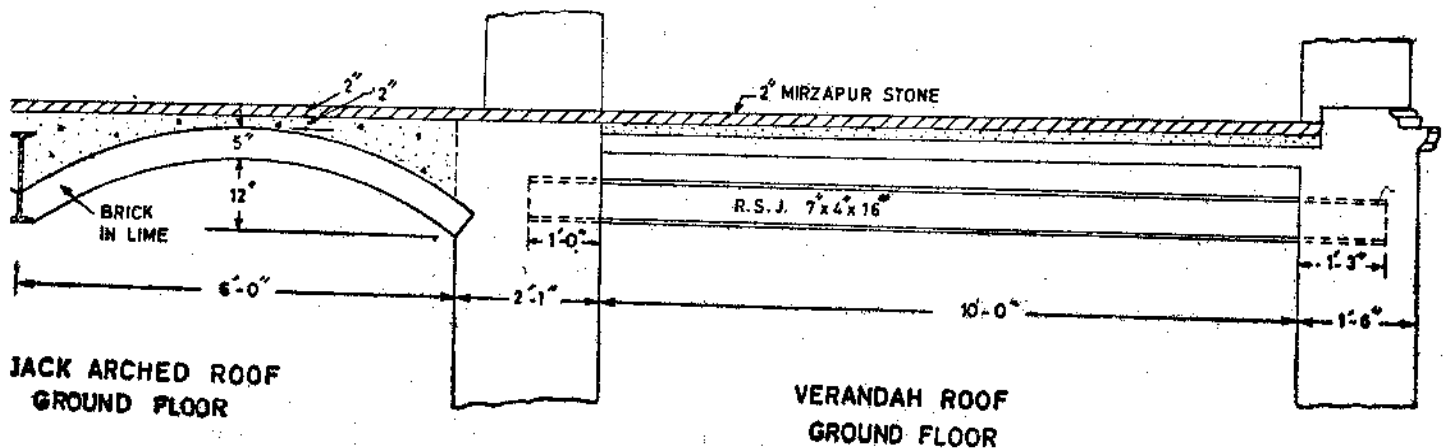
Fig. 3 B. Ground Floor Roof, Civil Court, Laheria Serai.

1. Not to be used in North Bihar except for replacement of damaged roofs.
2. Cement mortar (1:3) to be used around supporting R.S. Joists.
3. Jack arches should be sprung from the top flange whenever possible.
4. Arches to be in first class bricks, 5" thick set in fine lime mortar (1 lime : 3 Surkhi)
5. Rise = 1" per foot of span.

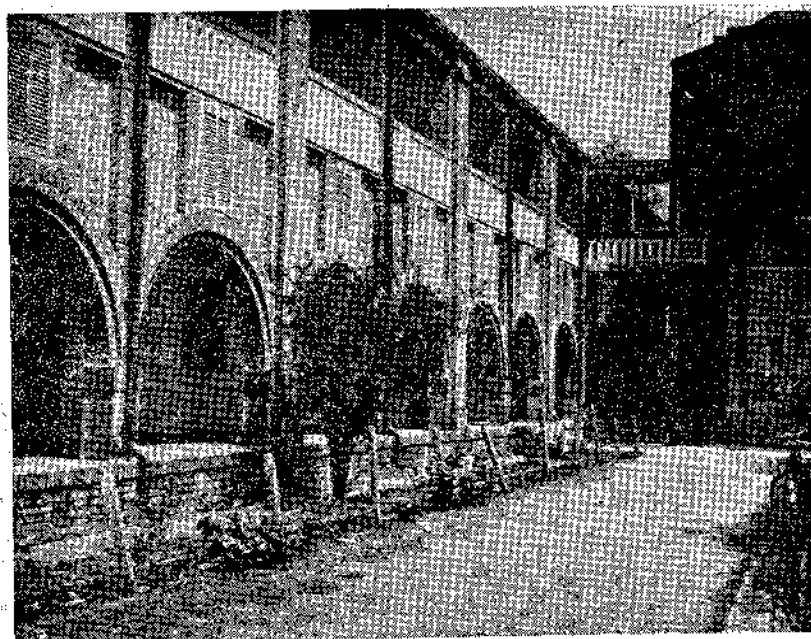
The two storeyed "pucca" brick masonry Zilla School building constructed in 1910 as per the specifications of the P.W.D, North Bihar Circle, presents an interesting study. Ground floor of the two storeyed class room block has an arcuated facade with excellent herring bond (dove-tailed) brick masonry filling over the arches. First floor has a trabeated facade with an R.S. joist running right along the length of the building over brick masonry piers supporting the roof over an arched corridor. Walls are of first class brick masonry 30" thick in lime-sand mortar (1:2). The hall is situated centrally and at right angles to this block. It has a narrow gallery at the first floor level supported by a collonade of circular brick columns. Roofs over both the blocks are pitched and covered by Nurria tiles. The passage (Fig. 4) between the two blocks at the first storey level collapsed during the earthquake. Besides some minor cracks in the wall and slippage of tiles from the roof, this building did not suffer appreciably. The two blocks, because of their dissimilarity, had different periods of vibration but the damage was safely concentrated in the passage, a lighter and more fragile structure. Rear view of the building (Fig 5)

Fig. 4 Passage between Classroom Block and Hall, Zilla School, Muzaffarpur.

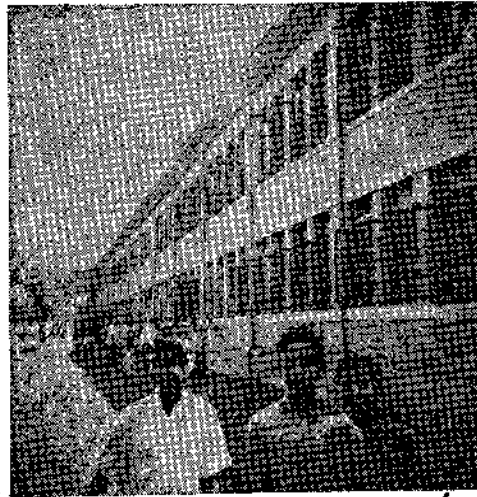
shows the exposed R.S. joists at the roof level of the ground floor. Specifications of N. Bihar Circle, 1935, however, indicate that a 3" cut-brick in cement mortar is to be provided beyond the 3/4" expansion gap at the end of R.S. joist resting on bed stone or R.B. lintel at the top of wall (4).

Fig. 5 Rear View of Zilla School, Muzaffarpur: Note the exposed steel joists.

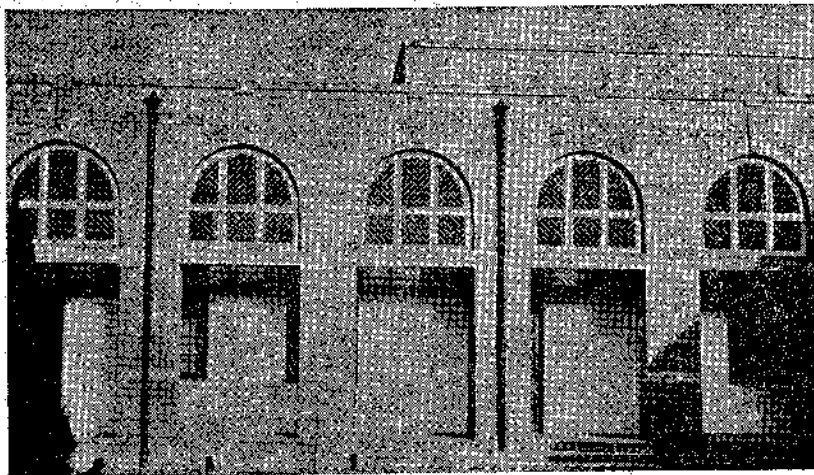
Muzaffarpur was not affected at all. Another instance of the survival of "Jali-work" in lime-mortar can be found in the Muzaffarpur Club Swimming Pool (Fig. 7) constructed in 1885. This is 90'x30' structure, 30' high with a 20 gauge G.I. roof supported on M.S. russes. Joints are bolted and ends anchored to the walls in the usual manner.

Fig. 6 Brick "Jali-work" in L.S. College, Muzaffarpur.

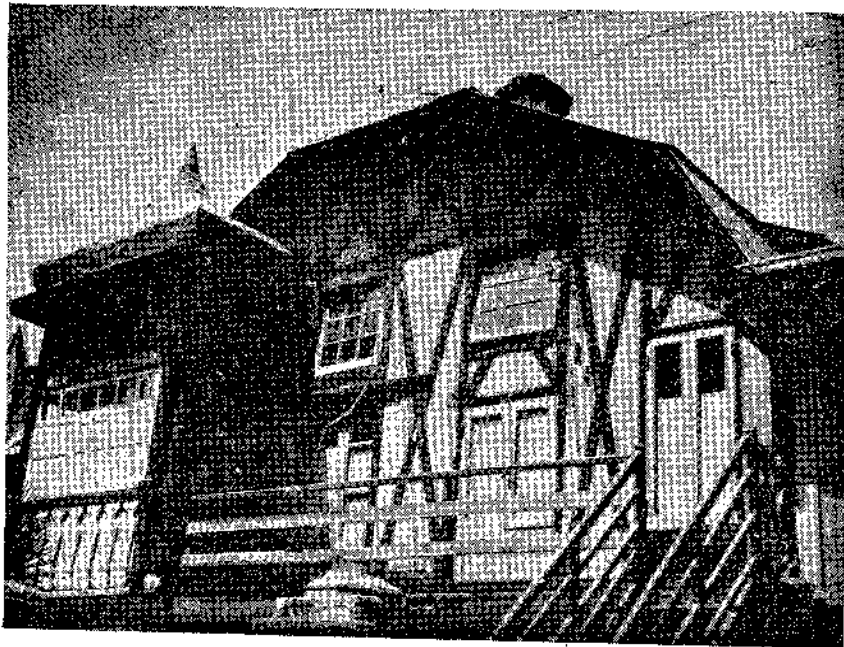
but thatch roofing is more common. Due to availability of bamboo in large quantities, bamboo-wattles plastered with a thin layer of mud are often used as walls. These are usually very thin and light. In higher altitudes where timber is abundant, log cabins are also constructed. These have walls made of timber planks. Roof usually consists of ridge and eave pieces covered with G.I. sheeting or thatch. A bricknogged building of the type shown in Fig. 8 (Darjeeling) could be classified as "kutch-pucca" construction.

Fig. 8 Brick-nogged Building in Darjeeling.

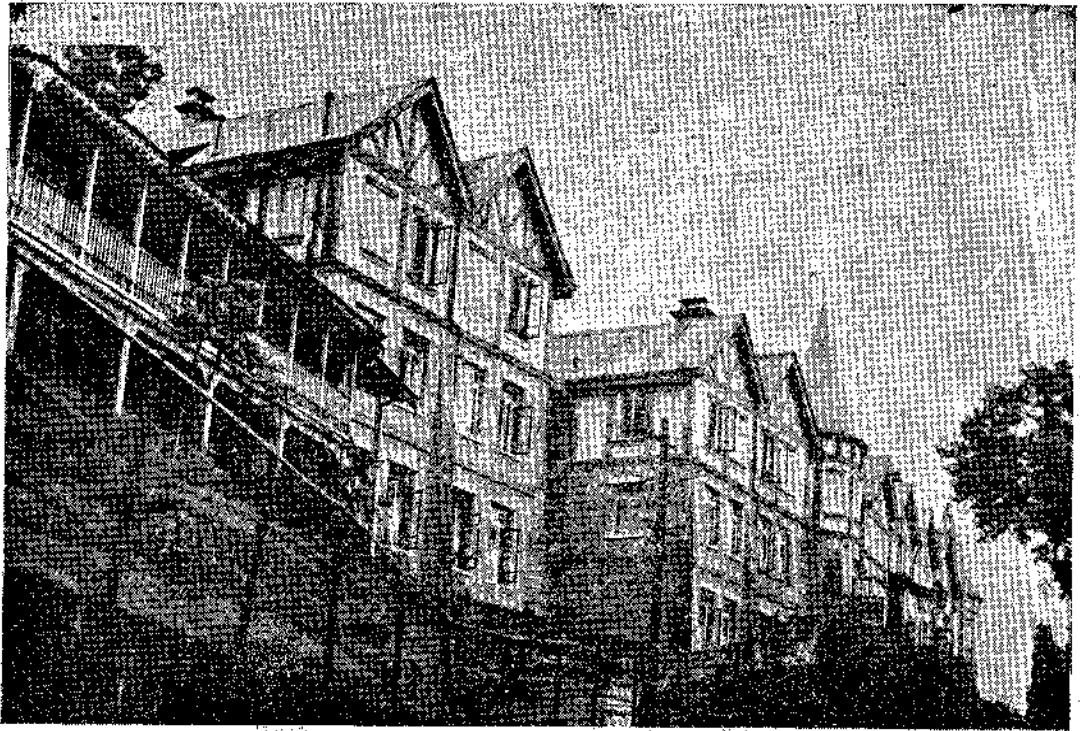
Stone being available locally, stone masonry buildings are very common in Darjeeling, Kurseong and Kalimpong. Some of the structures which suffered badly during the 1934 Bihar earthquake were rather old and constructed of heavy undressed stone masonry, set in mud or poor quality mortar, with foundations on loosely aggregated subsoils. Oberoi Hotel Mt. Everest with its heavily buttressed walls (Fig. 9) and light top floor suffered very little damage. Fig. 10 shows a three storeyed house, bottom two storeys are in rubble masonry and top floor is of metal lath-plaster with steel bracings. (Metal lath sheeting is usually from coal-tar drums. Holes are perforated in the sheets and placed within timber or steel framework. These are then plastered on both the sides giving a wall about 2" thick).

Fig. 9 Stone Masonry Buttressed Walls of Mt. Everest Hotel, Darjeeling

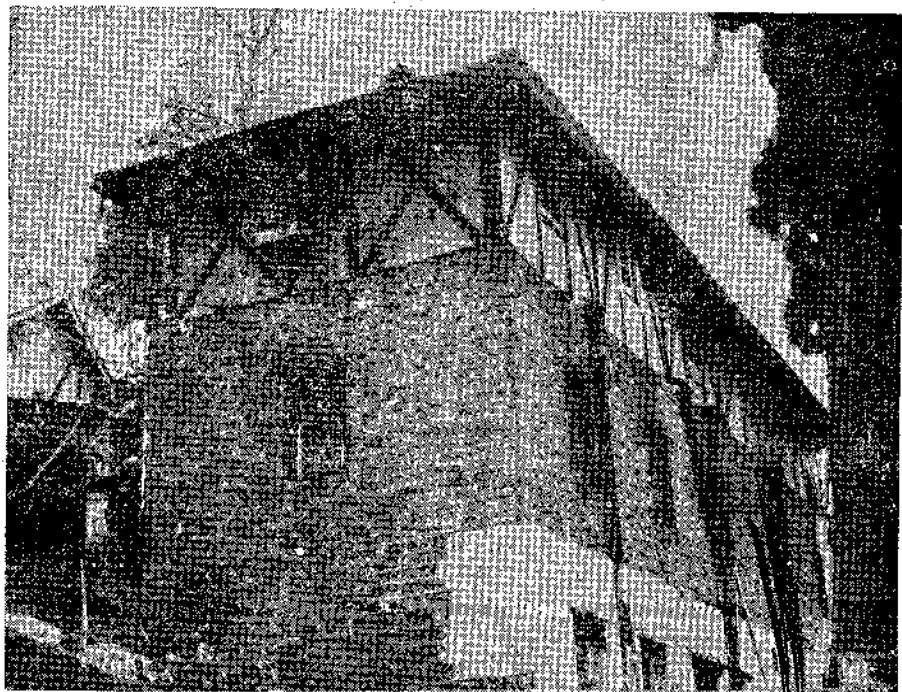
Fig. 10 Stone Masonry and Metal Lath-Plaster Construction, Darjeeling.

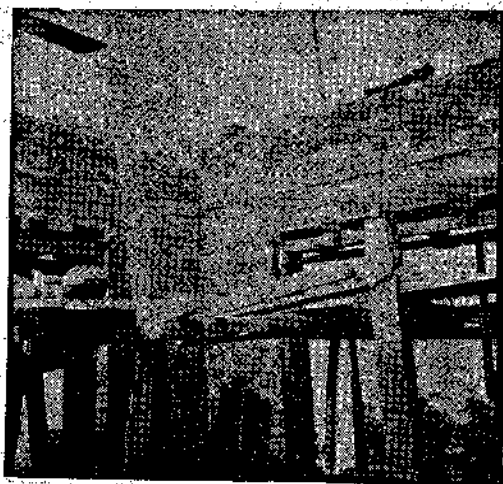
Lessons learnt from past damages appear to have been applied to some extent in Darjeeling. The new Office and Suptd. Quarter in the Himalayan Zoological Park is a two storey coursed rubble masonry building with R.C.C. roof slab. The coursed rubble masonry walls, in cement mortar (1:3), are 15" thick in both the storeys. Size of stone is 10" x 7" x 5". A continuous lintel band (Fig. 11), 9" thick above openings and 6" thick in wall is provided in both the storeys. Walls have the usual wall type step foundation, 3'—3" deep with 1:3:6 c.c. (6" thick) over 6" thick rubble soking 3'—6" wide. Floor surface will comprise of wooden planks over 3" x 3" timber joists placed on cement floors.

Fig. 11 Continuous Lintel Band in Stone Masonry Wall.

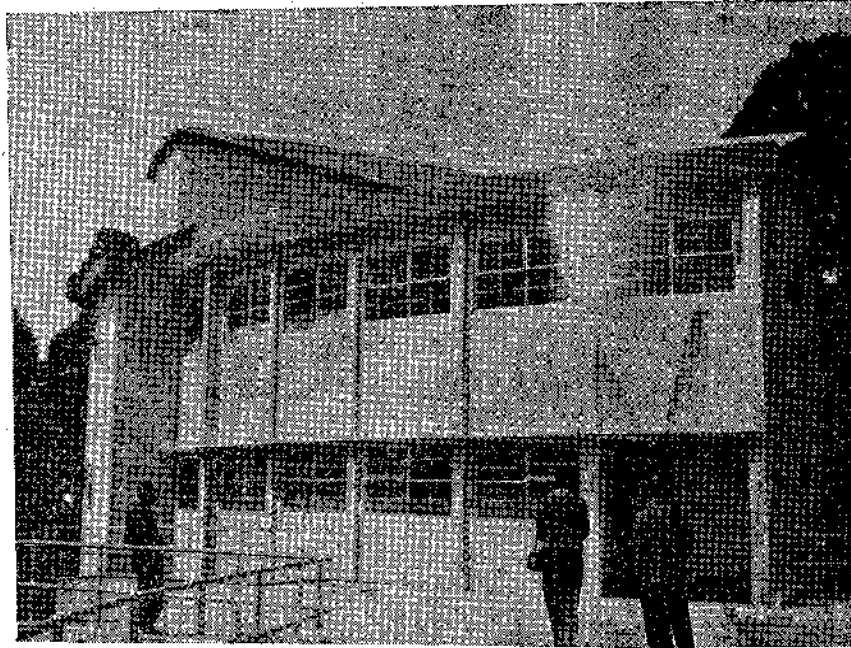
The new Tourists Lodge opened in April 1966 is a three storeyed reinforced concrete framed structure (Fig. 12) on R.C. raft foundation. R.C. walls are 4" thick throughout with horizontal reinforcement $\frac{1}{4}"\phi$ bars at 9" c.c. and vertical reinforcement $\frac{3}{8}"\phi$ bars at 6" c.c. Roof is a sloping R.C. slab with edge beams.

Fig. 12 Tourist's Lodge, Darjeeling, R.C.C. Framed Structure with R.C.C. Walls

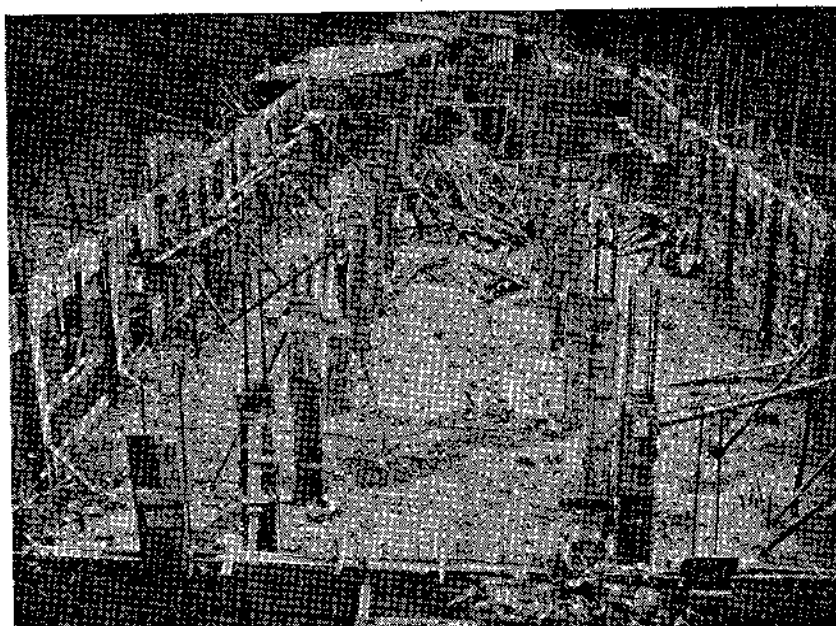
A private two-storeyed Buddhist School Building under construction is also of reinforced concrete (Fig. 13). On account of heavy rains and winter snow, pitched roof with G.I. sheets is very common. These are normally carried in timber trusses, the common timbers being bola (kimbu), suji (dhupei) and champ (champa).

Fig. 13. Buddhist School Building under Construction, Darjeeling.

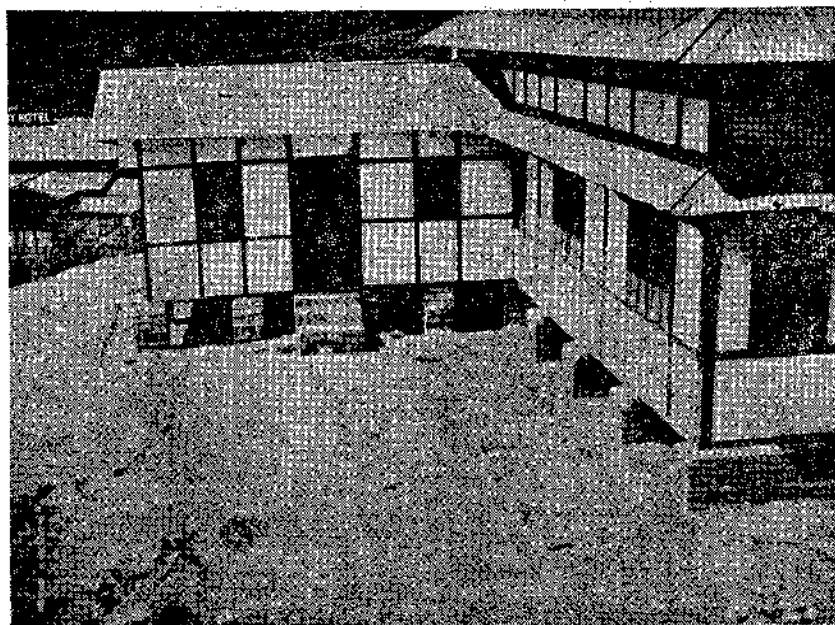
Type (c) proved to be the best. This was demonstrated by the American Mission Buildings at Tura(6). These light superstructures, of a pattern similar to the badly affected Government buildings (of "ikra", split-bamboo, wood etc.) are mainly supported 3 to 4 ft. above the ground on large blocks of stone placed on thick wooden posts. The earthquake shock (Dhubri 1930) was fortunately of insufficient intensity to throw the buildings bodily off these boulder supports, though in one or two instances, they moved to the extent of several inches. The superstructures thus vibrated as a whole irrespective of the oscillation of the ground below, and as a result comparatively little damage was caused. The Forest Department Bungalows being fixed to the ground by supporting piles and situated on the same valley were, however, seriously affected.

Fig. 15 Shillong Pattern Building

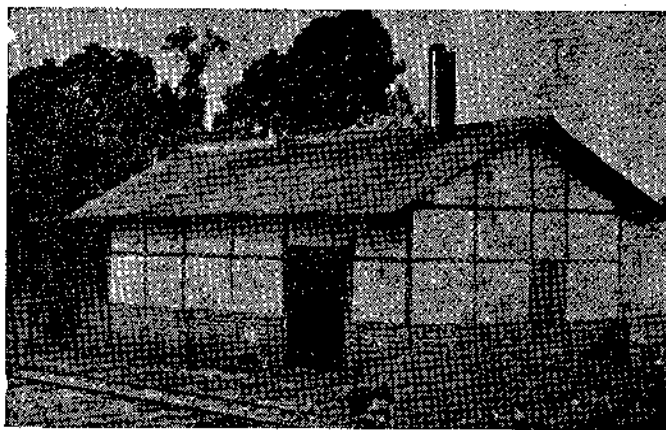
portion of plastered "ikra" or bamboo within timber panels. Roof covering is again of light G.I. sheeting. They either have the conventional foundation or the "Shillong-pattern" supporting system. In the earthquakes of 1930 and 1950, a number of these were more or less severely damaged.

Fig. 16 "Semi-Pucca" Construction, Assam.

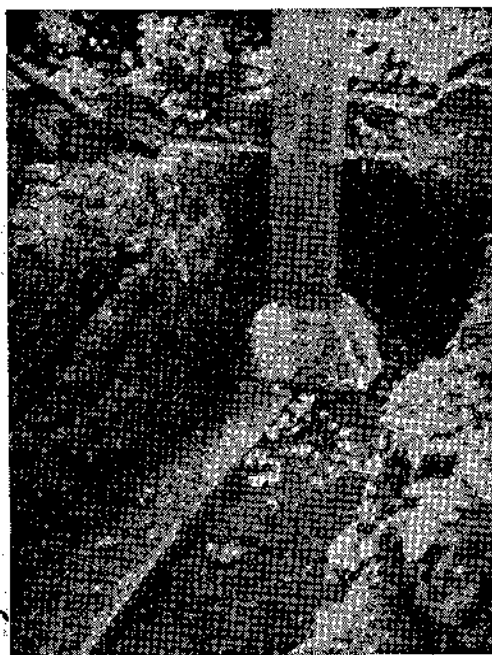
are tied to each other by tie beams. Fig. 20 shows the tie beam in the foundation of the Additional Secretariat, Shillong. Similar tie beams have also been provided in the four storeyed R.C.C. Constables Quarters under construction at Dhubri.

Fig. 20 Foundation Tie-Beam.
