## DAMAGE DURING NOVEMBER 27, 1971 ROCKBURSTS IN NUNDYDROOG MINE IN KOLAR GOLD FIELDS

A. S. ARYA\* AND L. S. SRIVASTAVA\*\*

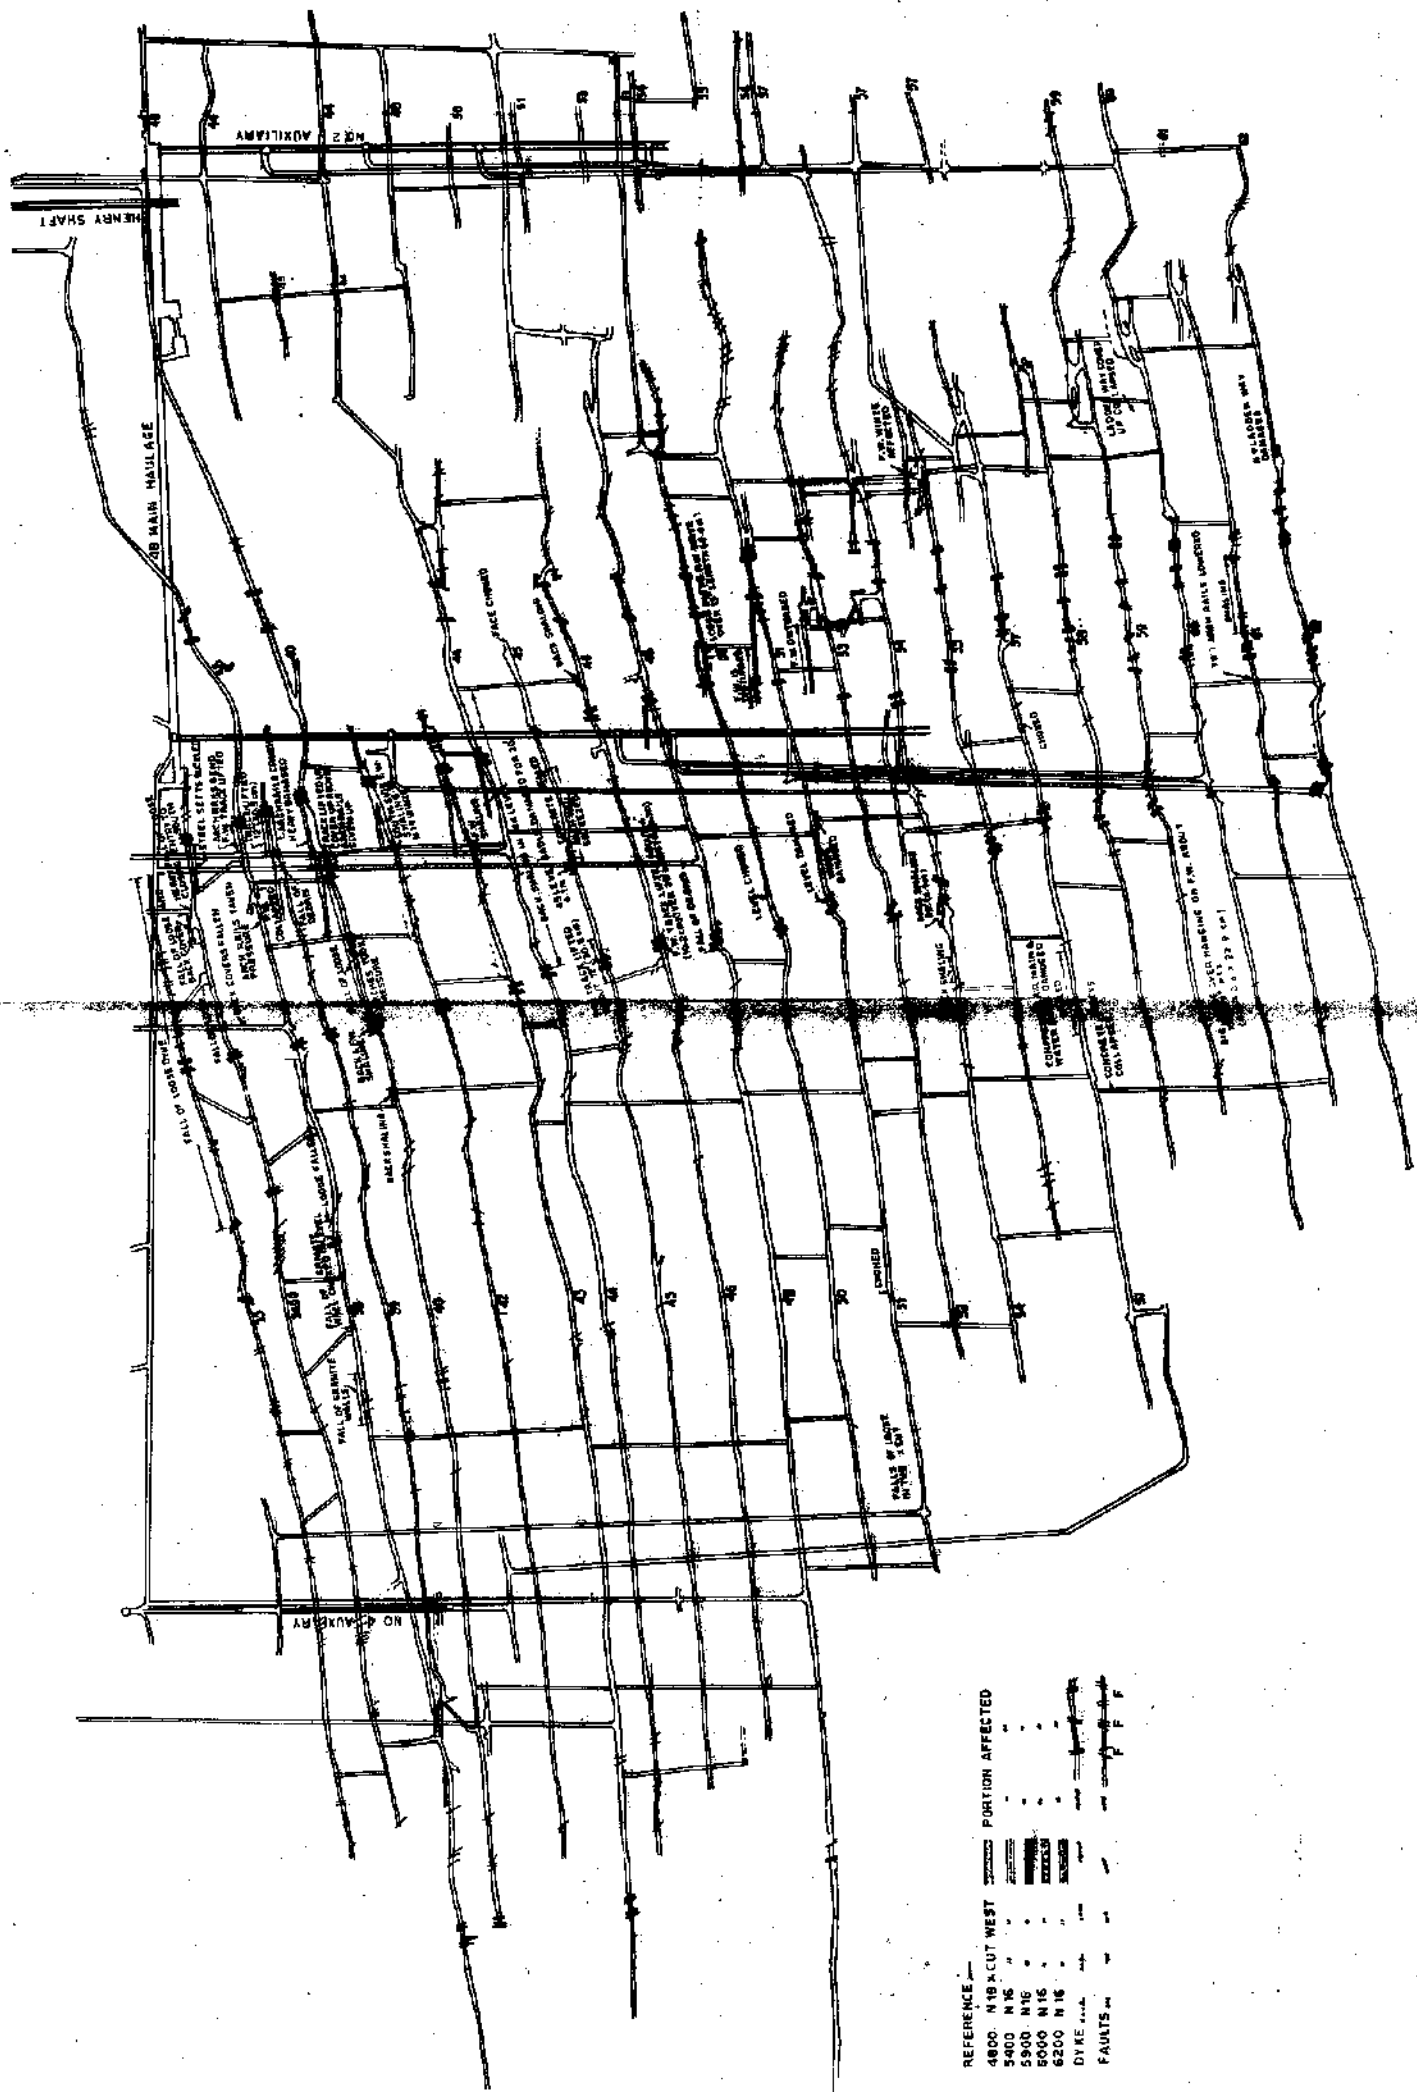
Considerable damage occurred underground between 3400 and 6200 levels (ft below ground level), with fall of loose rocks, debris and granite walls, shaling of back and front walls, lifting of the haulage tracks, buckling of the steel sets and collapse and closure at different points. Figures 1 and 2 shows the general location of the underground damages. Greater damage was noted in between the dykes which traverse the reef. There was more crushing of the country rock at the contact of the porphyritic dolerite dyke in the north and the dolerite dyke about 240 m (800 ft) towards south, and the dyke rock itself was fractured and developed cracks from 3600 to 4500 levels. The width of the damage along the levels was about 300 m (1000 ft) and in the cross cuts the damage was mostly confined to the region within the porphyritic dolerite dyke and dolerite dyke towards its south. The damage from 3600 to 4500 level thus appears to be directly related with the zone of rupture during the rockburst, and the damage at other levels was a result of the dynamic forces due to the stress wave propagating from this rupture zone.

Fig. 1. Staggered plan of Nanshydroog mine (100 ft. apart 3500 to 6200 Level) showing the locations affected due to rock burst on 27.11.71 at 2.16 hours.

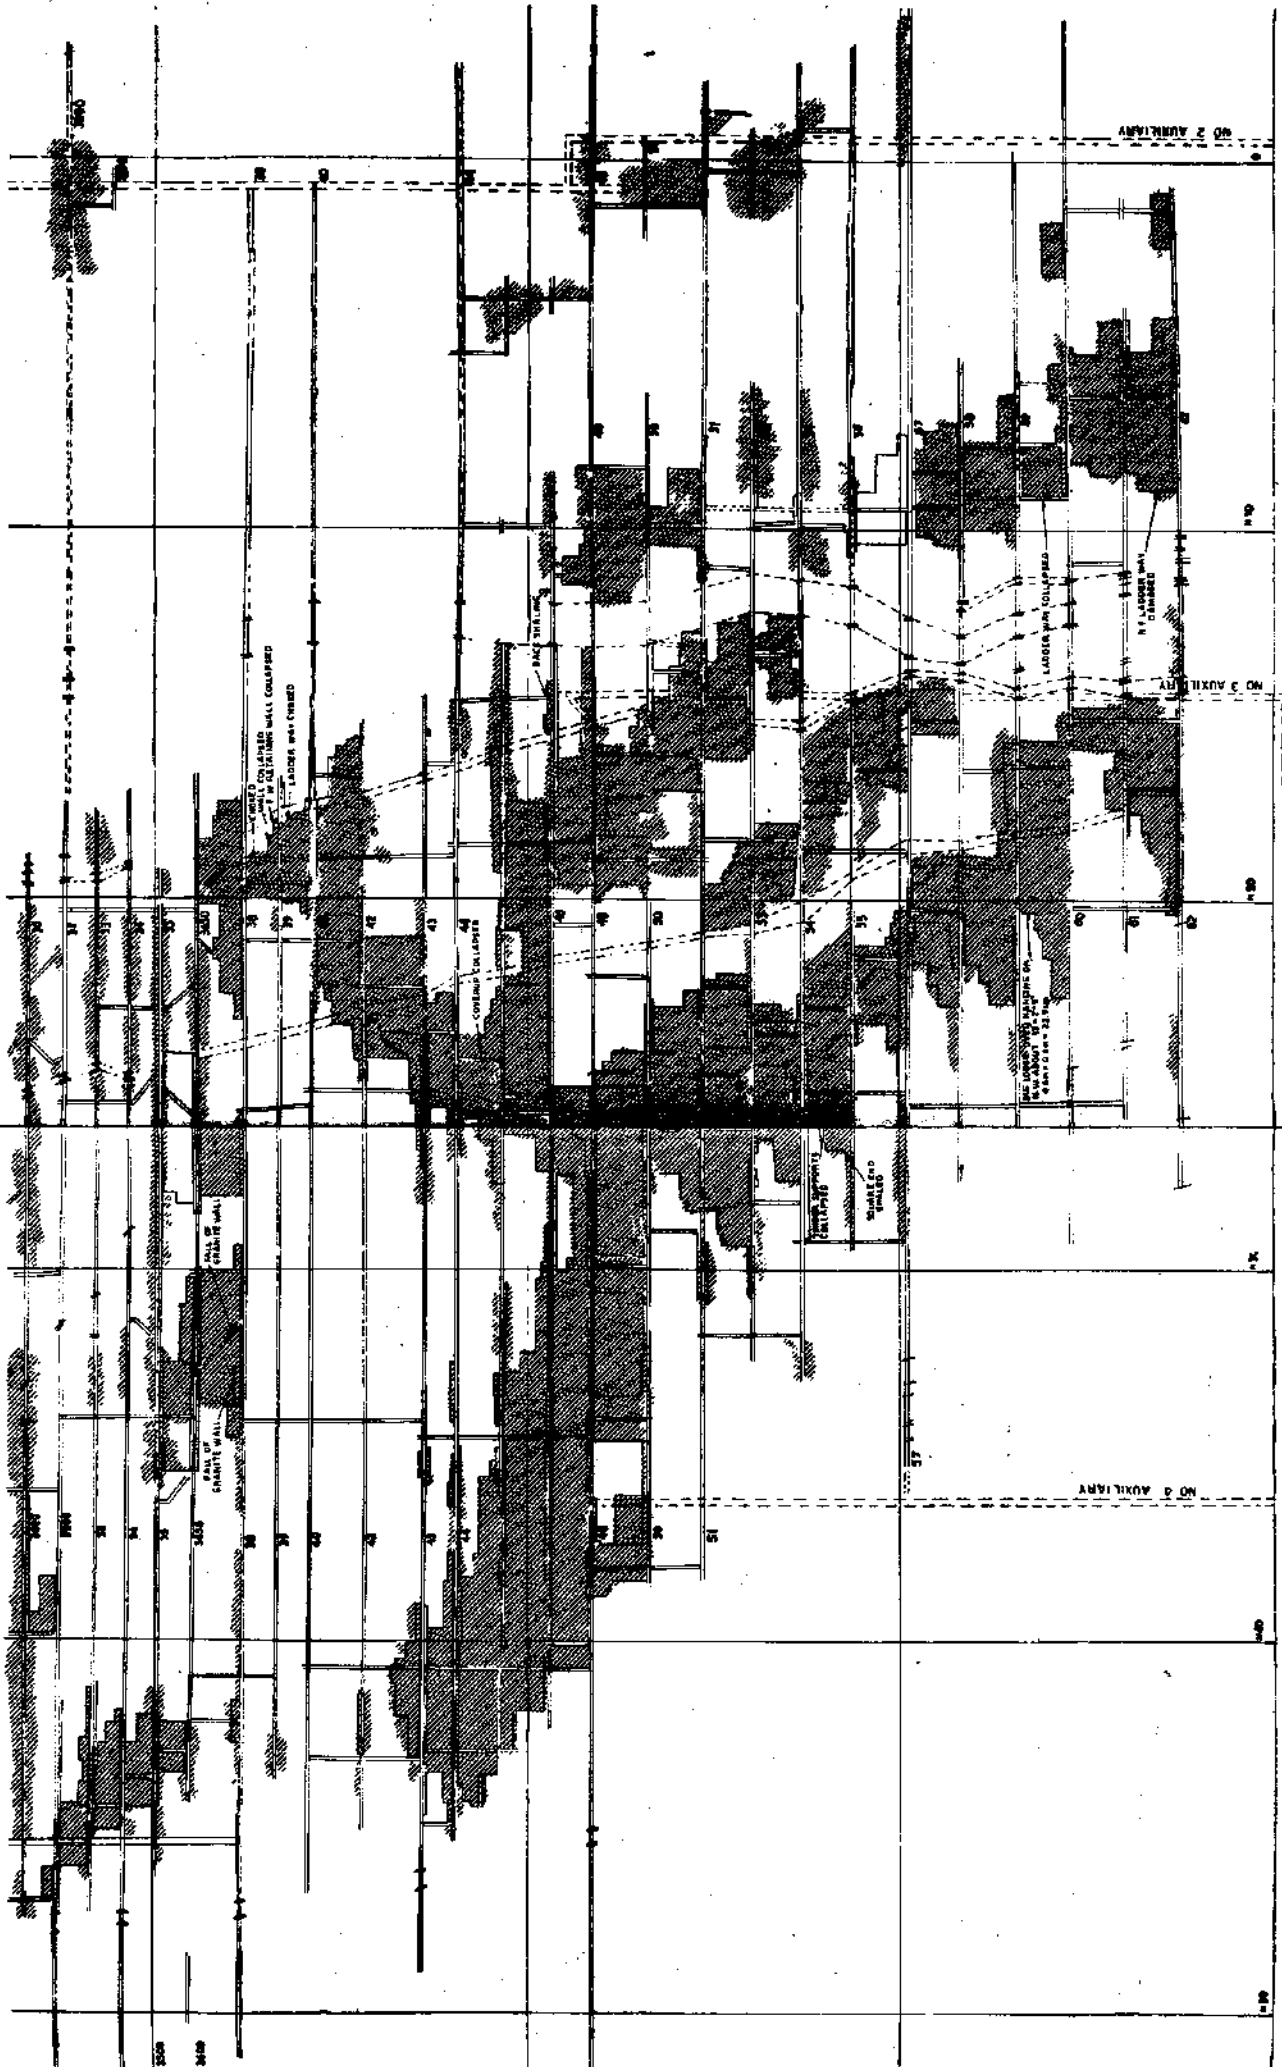
Fig. 2. Vertical section showing locations affected in the slopes of Niandhydroog mine due to rockburst on 27.11.17 at 2.10 hours.

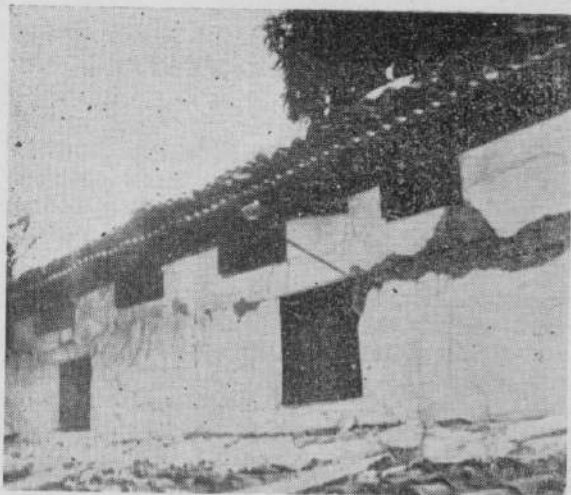
Almost all the bungalows suffered damage. Dressed stone masonry developed cracks from window and door opening (Fig. 3) whereas random rubble masonry suffered greater damage, often with bulging and partial fall of masonry (Fig. 4). The damage in brick masonry in cement mortar in general was less as compared to stone masonry construction. The most common type of damage was the development of vertical and inclined cracks from the top of the gable to the corner of openings, horizontal cracks at lintel levels between openings and branching towards roofs and sides, inclined and vertical cracks from window sill levels towards foundations (Fig. 5), vertical and branching cracks at junctions of main walls and cross walls (Fig. 6) and cross fractures and radial cracks in solid masonry walls (Fig. 5). Development of cracks and fall of plaster in the walls at roof level and above the ventilators (Fig. 3 and 4), and shattering of plaster and exposing the masonry indicating relative movement between the heavy tile covered roof and walls was also very common. Brick filler walls and "Dhajji Divari" partition walls developed cracks along its margins and shifting of bricks occurred at few places. Such filler walls and partition walls were not tied with the columns or walls or timber framework to resist their movement. Diagonal timber strips (Fig. 7) covering the brick filling in "Dhajji Divari" construction prevented their collapse. Timber units behaved better and resisted the rockburst with only movement of filler material along the margins.

Fig. 3. Cracks in western wall near roof level, extending from window and ventilator openings at Shri A. C. Hiriannah's residence.

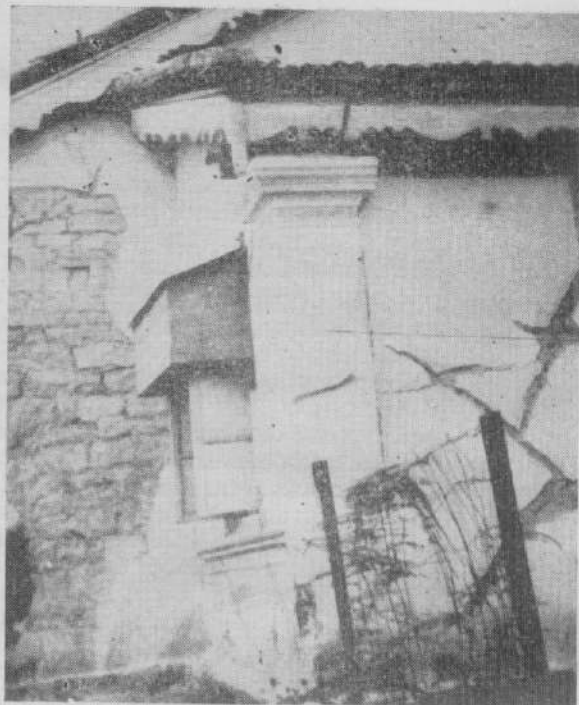
Brick pillars supporting the roof in verandahs developed horizontal cracks at different heights (Fig. 5) from the base with slight lateral shift towards or away from the rockburst centre. Timber posts supporting such roofs showed similar shifts at the base. Parapet walls in verandahs developed cracks and showed similar lateral shifts.

Fig. 5. Development of cross fracture and radial cracks in the wall and rupture of the masonry pillar on the east gable end side of Shri M. C. Ramasamy's residence. Cracks from window sill level extend down towards foundation.

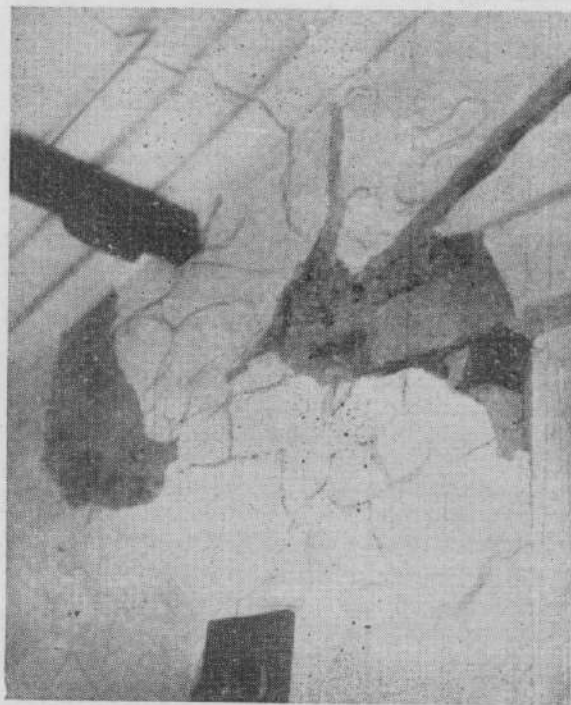
Fig. 4. Bulging and damage of random rubble masonry wall at Shri V. R. Vinayagan's residence.

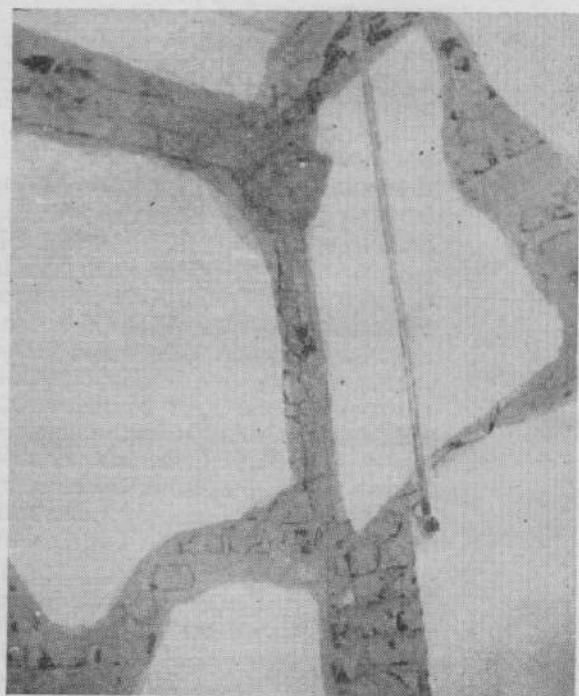
Fig. 6. Development of cracks in stone masonry walls at junction of walls, at roof level and along the door openings at Shri H. C. Ramasamy's residence.

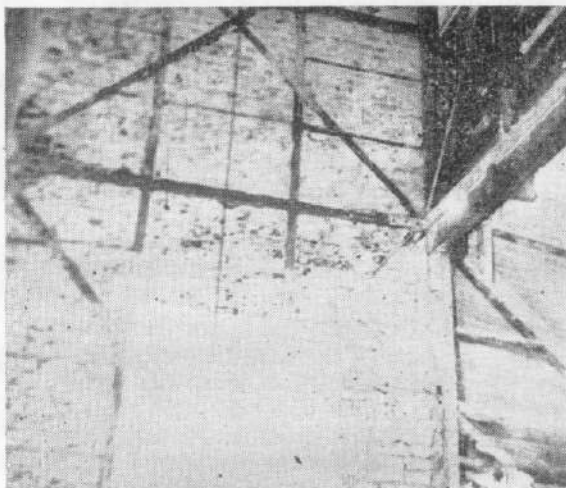
Fig. 7. Brick panels in timber frame (Kashmir type-Dhajji-Diwari construction) forming partition walls in second storey level at Shri M. H. R. Rao's residence, which developed extensive cracks with displacement of bricks, necessitating their dismantling.

- (iii) Masonry filler walls in timber or concrete framework should be tied with the frame by providing some form of hold-fasts. In timber frame wire nails projecting out by 10 cm from the framework and embedded along mortar joints can be adopted. Projecting reinforcement bars from the concrete columns and beams could be utilised for tying the walls in concrete frames.

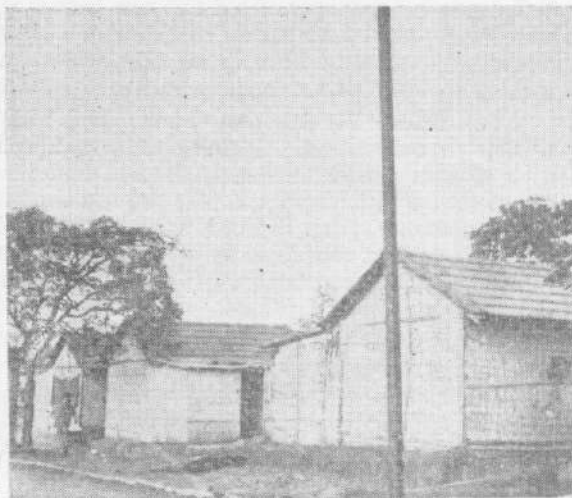
Fig. 9. Tatty houses, with walls of split bamboo mats nailed on timber posts, supporting the tiled roofs, which did not suffer any damage.

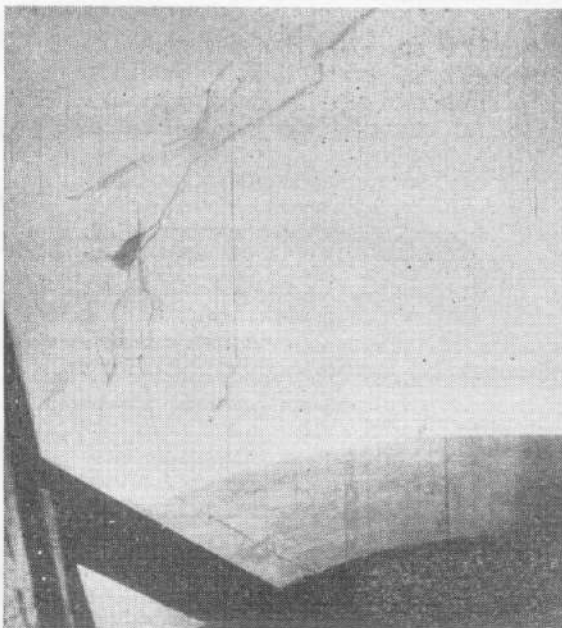
Almost all unsupported arches developed cracks (Fig. 8) along key stones as well as neighbouring stones. These had suffered damage in earlier rockbursts and many of the arches had been strengthened with steel arches to conform to their intrados. The sides of the arch were either taken to the foundation or tied together with steel rods at the top. Such supports prevented further damage to the arches in the present rockburst.

Fig. 8. Development of cracks in masonry arch in Shri A. C. Hiriyaniah's residence.

- (ii) Masonry arches existing over large openings should either be supported on the inside curvature as used heretofore or suitably tied by providing tie bars.

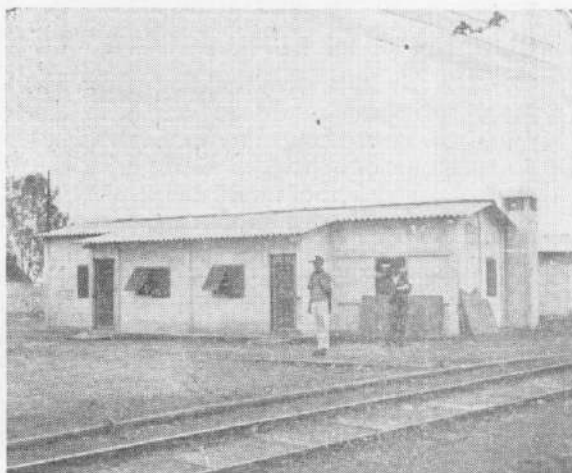
Fig. 10. A prefabricated post panel reinforced concrete house which did not suffer any damage due to rock burst.

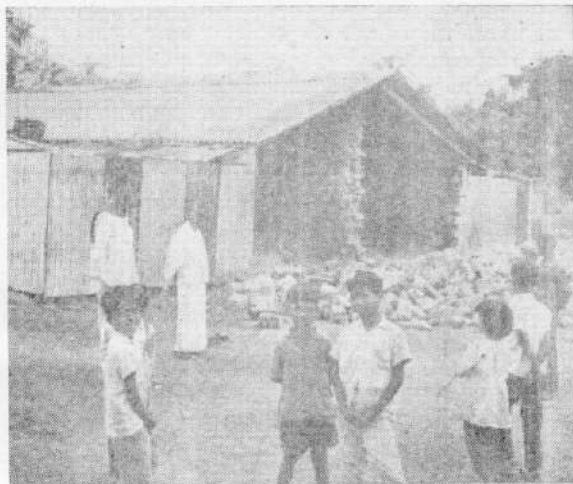
Old stone masonry houses in mud and cinder mortar suffered the maximum damage (Fig. 11 and 12). The walls at the gable ends developed major cracks, with fall of plaster and necessitating their demolition (Fig. 11) and rebuilding, and partial collapse of walls in some cases (Fig. 13). Cracks in the walls and along junctions with cross walls and partition walls, corners of windows (Fig. 13) and door (Fig. 14) and along arches (Fig. 15) were developed extensively. Old construction in brick masonry suffered similar damage,

Fig. 11. Stone masonry wall at gable end which suffered extensive damage necessitating its dismantling.

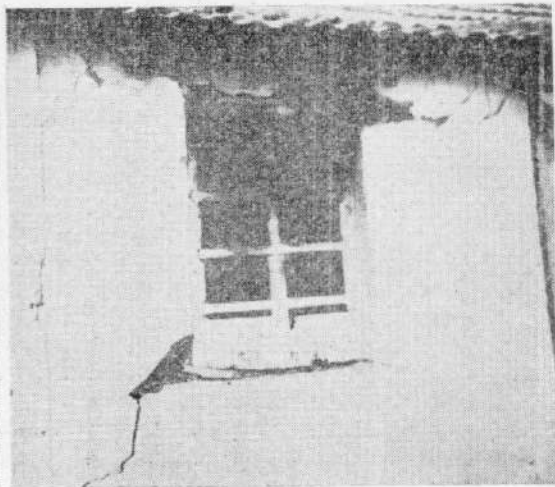
Fig. 13. Extensive cracks from window and door opening propagating towards roof and foundation in masonry wall in House No. 6 in Henry's Masonry block No. 8,

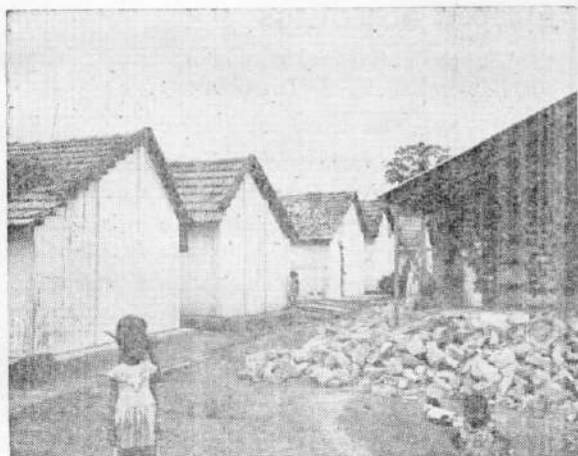
Fig. 12. End wall of stone masonry row house which suffered extensive damage with partial collapse of masonry, necessitating dismantling part of the wall, whereas prefabricated reinforced concrete houses in the left did not suffer any damage.

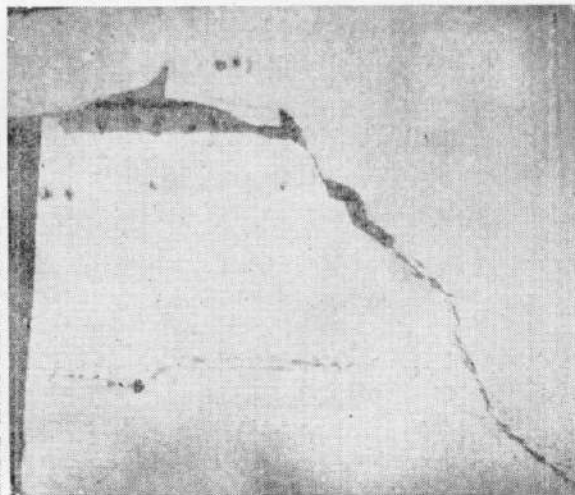
Fig. 14. Damage in the interior wall with cracks propagating from door opening in Kennedy's Muslim lines.

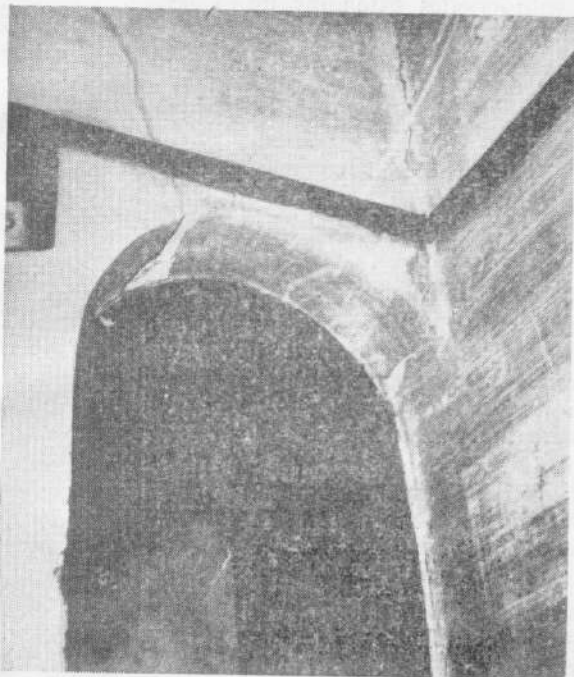
Fig. 15. Damage of masonry arch in cross wall in Henry's masonry Block No. 4, with development of crack along the junction of the main wall.

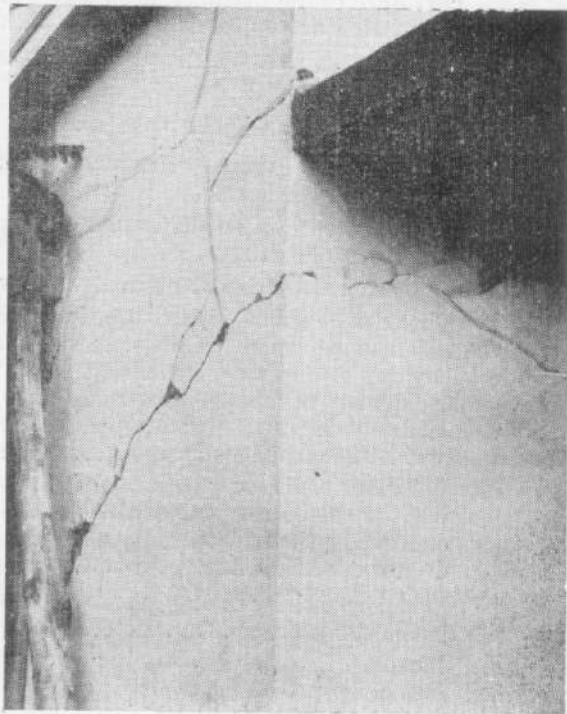
Fig. 17. Development of cracks in brick masonry walls of Gate Clerk Room at Henry's Shaft Gate, which suffered extensive damage. The photograph shows northwest corner of the room from outside.

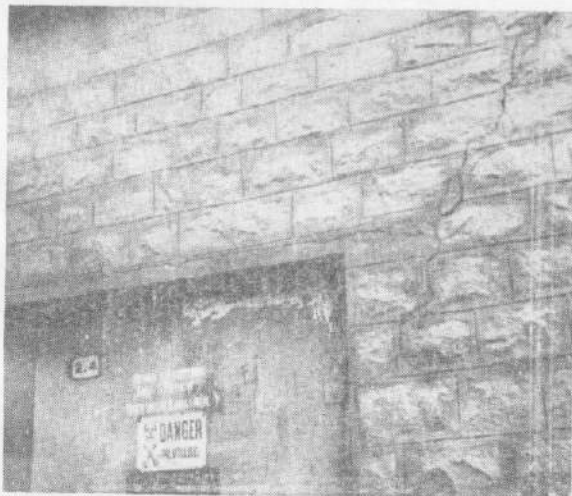
Fig. 16. Development of cracks in stone masonry north wall of the Lighting Sub-Station in Henry shaft area. Similar cracks developed in other walls of the structure.

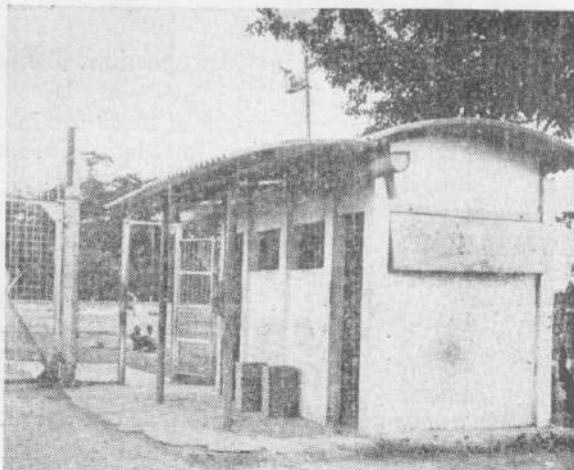
Fig. 18. The Watch and Ward Post, at Henry's Shaft Gate in prefabricated reinforced concrete construction, which did not suffer any damage.

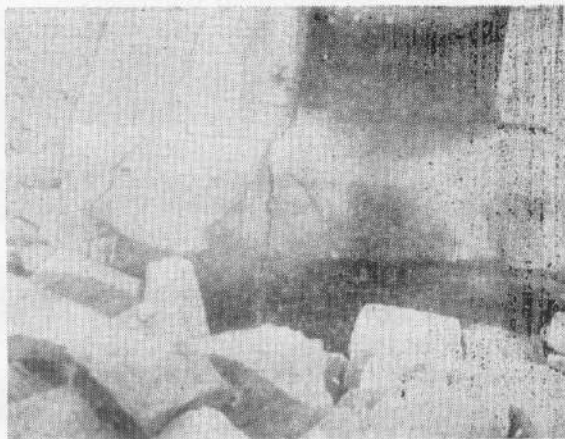
Fig. 19. The concrete foundation of the back brace of the head frame of the Henry's shaft which developed extensive cracks.

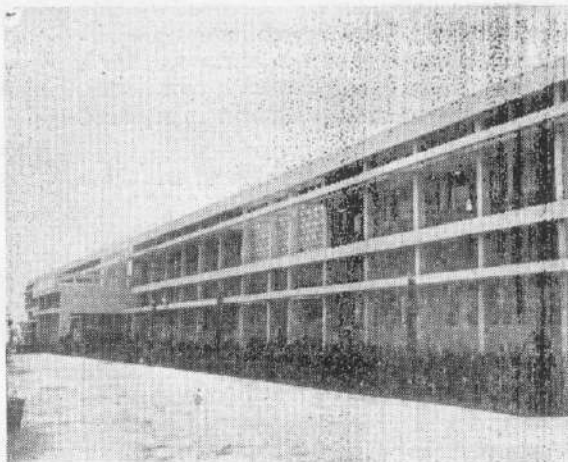
The administrative Building of the Bharat Earth Movers Ltd., a two storeyed R.C.C. frame structure developed cracks in almost all the brick panels (Fig. 20) along their margins with the concrete columns and beams, the horizontal and inclined cracks starting from corners of openings. Some brick columns along door openings were sheared at the top. Diagonal cracks were noted along north-south panel walls. The western end wall moved towards west producing a separation of about 2.5 cms at the second storey (Fig. 21).

Fig. 20. Administrative building of the Bharat Earth Movers Ltd., a two storeyed reinforced concrete frame structure which suffered damage in the interior brick panel walls.

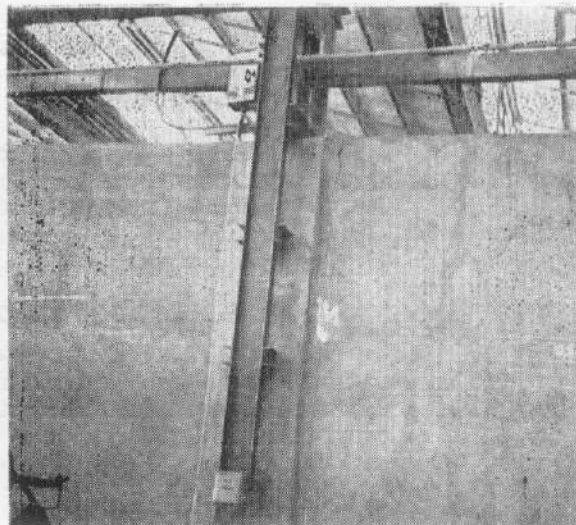
Fig. 22. Brick masonry wall in the Wheeled Equipment Assembly Shop showing vertical cracks near the Junction of brick columns.

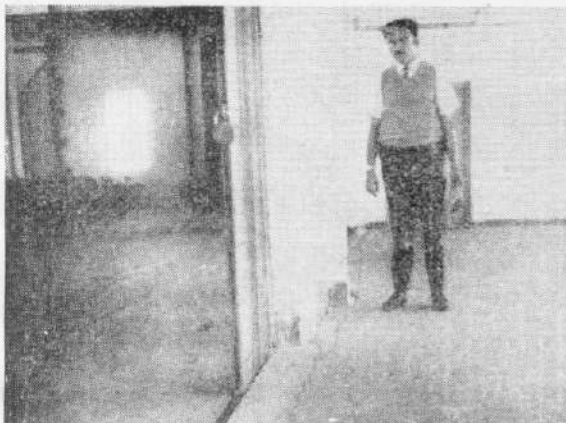
Room and Gear Shop appears to have suffered a slight movement and tilt towards south, as a result of which a continuous crack developed parallel to the wall throughout the length of the wall at the entrance as well as in all the rooms (Fig. 23). Similar damage was noted along the west gable end wall of Personnel Office. Cracks also developed near junction of walls of the shed where these were interlinked with office spaces and other annexes in most of the shops. In general brick wall standing over thick stone masonry walls developed cracks.

Fig. 23. Development of a crack in the floor near the 10.5 m high southern wall of the Tool Room Shop of Bharat Earth Movers Ltd. which propagated parallel to the length to the wall in all the rooms.

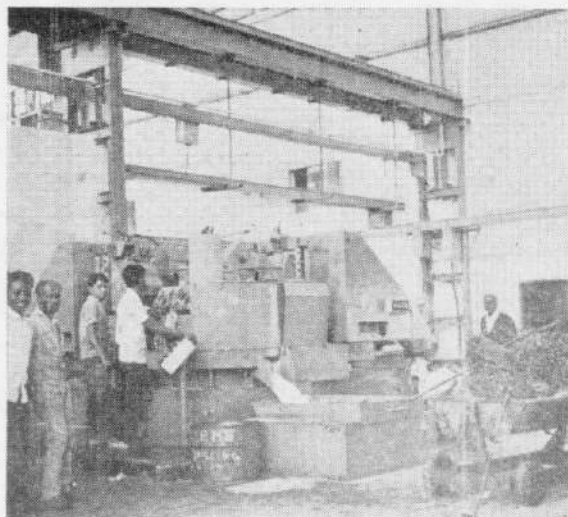
In factory area overtoppling and sliding of loose objects was reported. Several heavy machines were laterally moved to the extent of 5 to 10 mm (Fig. 25) towards N 195° to N 210°. Link Boring Machine, weighing about 20 tons resting on twenty 15 cm diameter circular steel pads moved through a distance of 1 cm (Fig. 26) towards N 195°. Multi-spindle Drilling Machine, weighing about 10 tons, resting on twelve similar steel pads moved through a distance of 6 mm toward N 210°. In many machines which were grouted the bolts got loosened, however, no bolt was sheared. Planer Milling Machines weighing 60 and 75 tons which were grouted and leveled over pads were moved towards south by 3 mm and 2 mm respectively and all the foundation bolts got loosened. The friction between the steel pads and the concrete was determined by test at site, and the coefficient of friction was noted to be 0.5. This indicates that the peak ground acceleration during the tremor exceeded 0.5 g.

Fig. 25. Link Boring Machine, 20 tons in weight, which was moved by 1 cm. towards south.

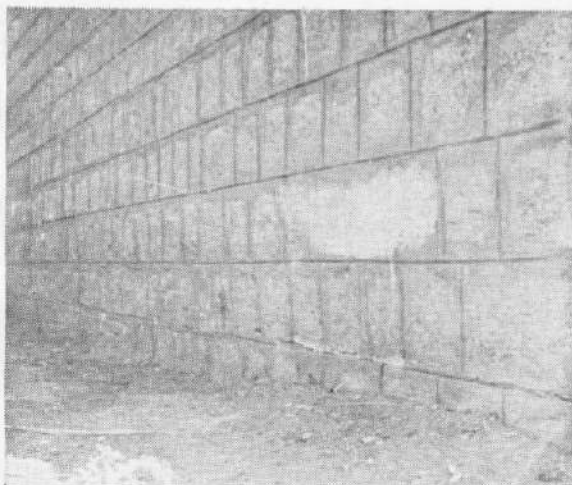
Fig. 24. Separation of end wall of a Type I quarter in Bharat Earth Movers Limited township, which produced a horizontal crack at the plinth level.

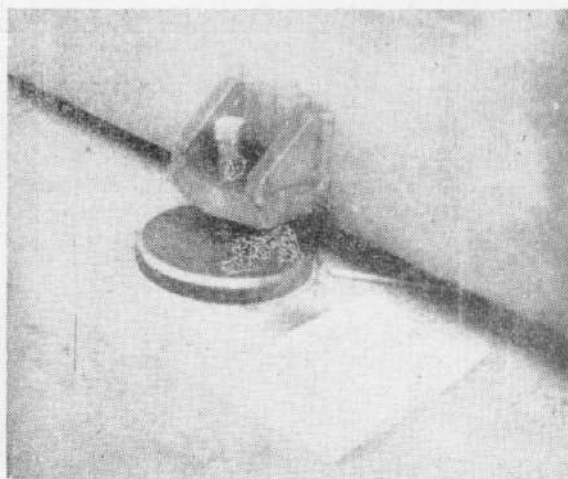
Fig. 26. Displacement of one of the steel pads supporting Link Boring Machine shown in figure 43. Shaded area shown was exposed after resetting of the pads.
