BIGGEST EARTHQUAKE IN JAPAN

DR. M. HOSHIYA¹, PROF. T. CHIBA², DR. T. KATADA³, MR. E. SAITO⁴,
 PROF. H. OHNO⁵, DR. J. N. MANDAL⁶ AND MR. K. YAMAMOTO⁷

The investigation team, composed of the writers, with the first name designed as the Team Leader, rushed to the distress spot immediately after the earthquake occurred. It is the nation's worst earthquake in 35 years in Akita.

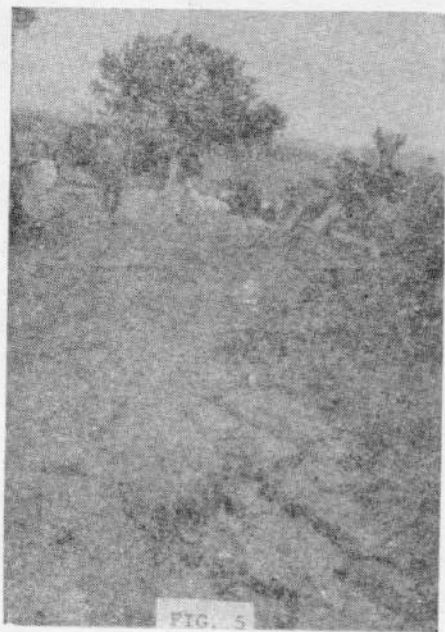
FIG. 5

From the Fig. 32, it is interesting to note that the pole of power supply lines are inclined towards the opposite direction as shown by small arrows along the Oga Road (Fig. 6). The inclination of the concrete fencing of the road are also in opposite direction as shown by large arrows. No other residential buildings on the surrounding areas damaged but the residential building of Figs. 3 and 4 (Same building) was damaged due to earthquake. It is further to note that the ground surfaces show the shear crack patterns as shown in Fig. 5.

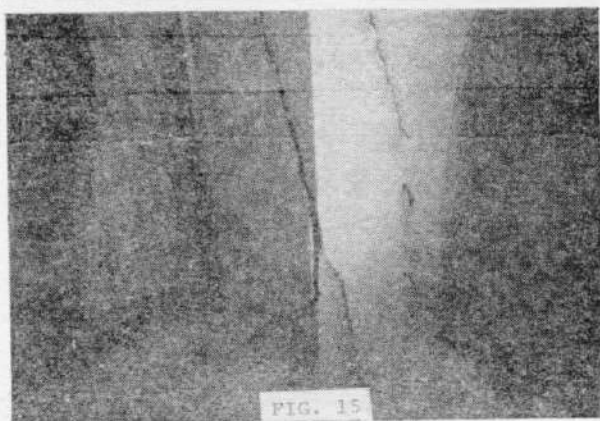
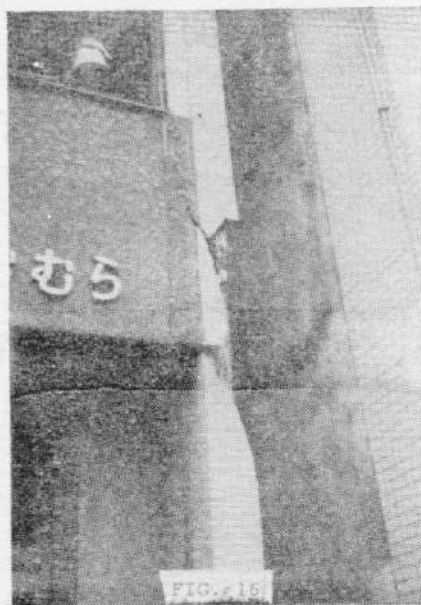
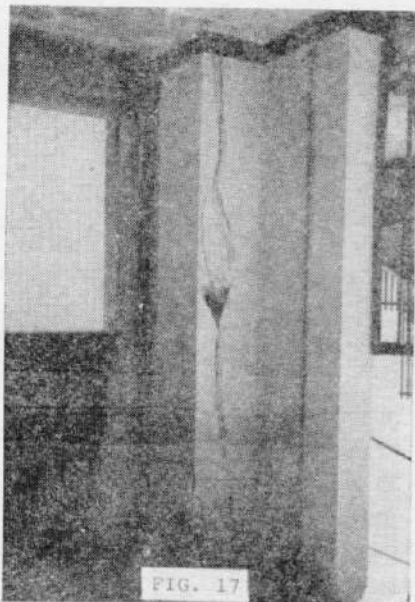
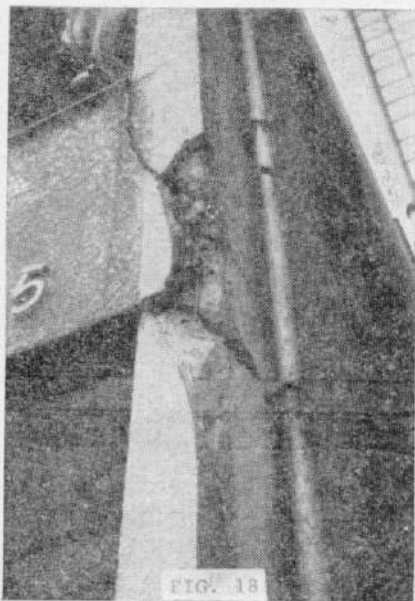
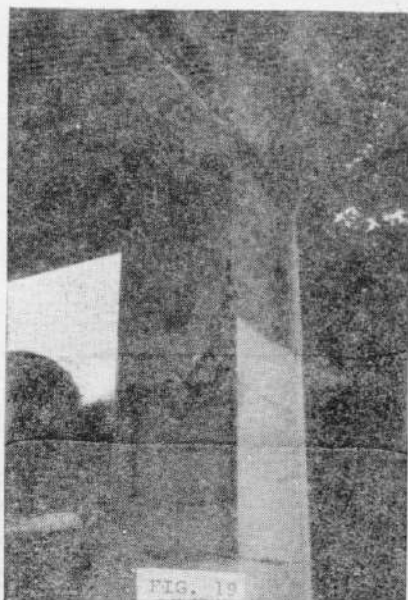
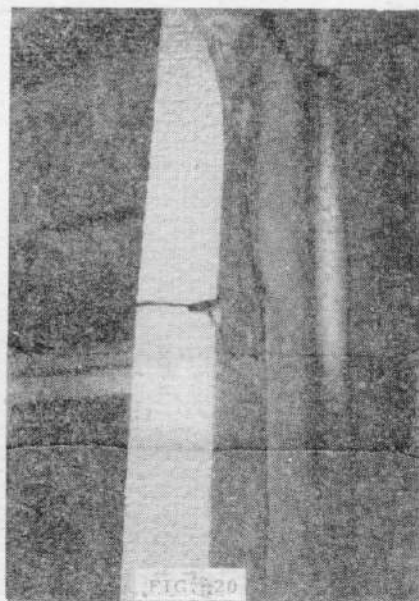
The columns of the building have been damaged (See Figs. 15 to 20). Liquefactions have also been observed in some places of Akita and the pattern of

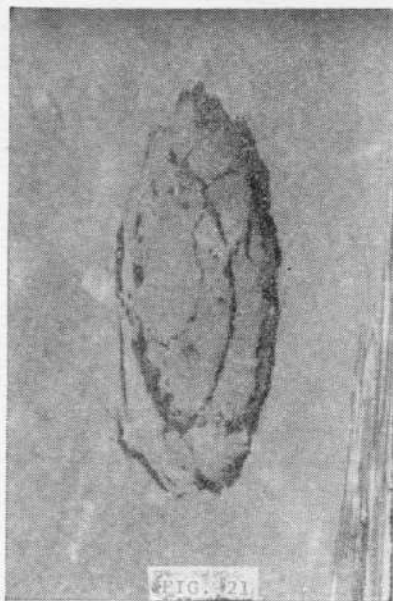
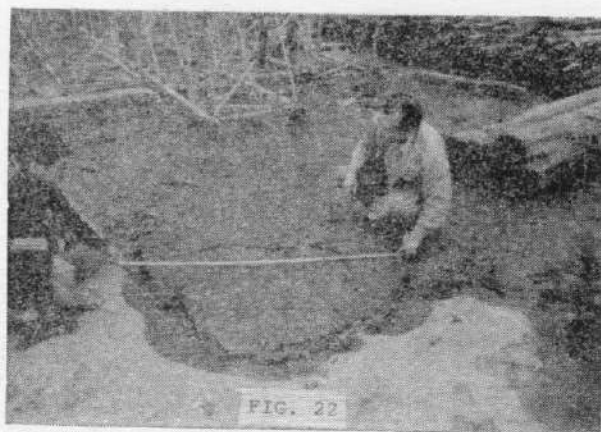
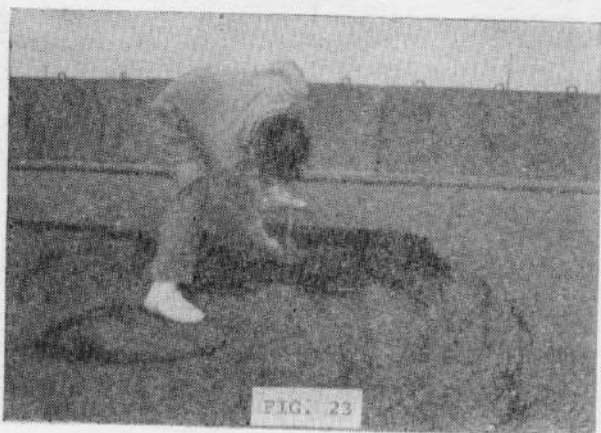
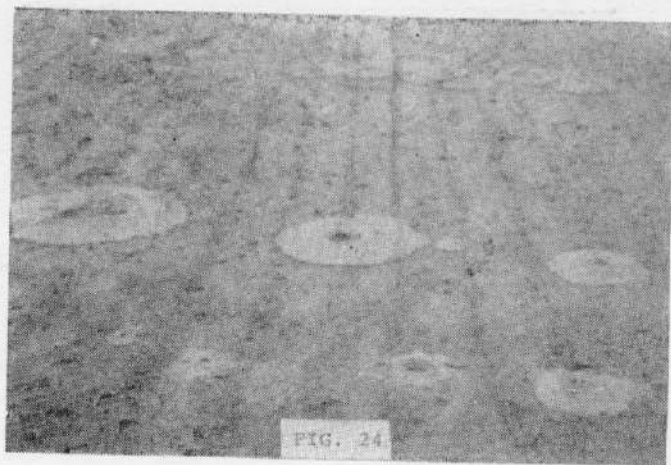
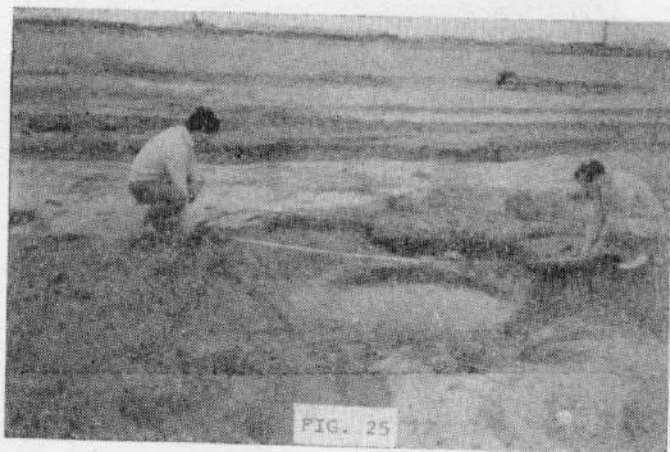
liquefactions are shown in Figs. 21 to 25. The railing of the road has been shifted due to earthquake (See Figs. 26 and 27). The pipe line, the sea port and the crane have also been damaged as shown in Figs. 28 to 31 due to recent severe earthquake in Japan.
