THE GREAT HANSHIN EARTHQUAKE OF JANUARY 17, 1995

G.R.Reddy, H.S.Kushwaha, S.C.Mahajan
Reactor Engineering Division
Bhabha Atomic Research Center
Bombay-400085, India

Abstract

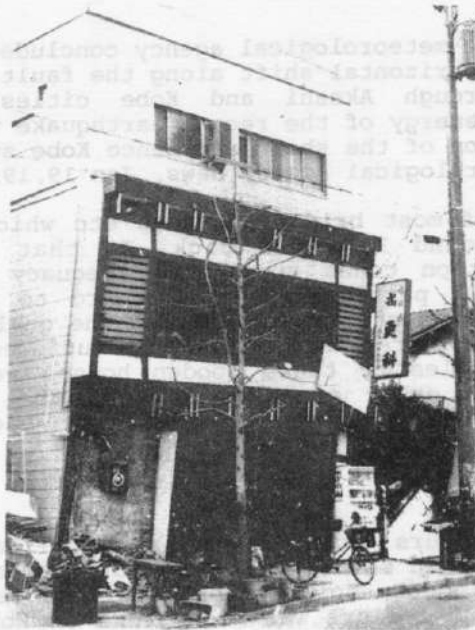
(i) In Kobe a large number of buildings were structures with first floor used for commercial operations ranging from retail or restaurants to light industrial use and upper floors used for living space. However this construction creates a soft first storey (Hresh Shah, Jan 29, 1995). The residential building shown in Fig.3, though not completely collapsed has been severely damaged. This building may have failed because of weak first floor.

Fig.3 Typical wood house failure

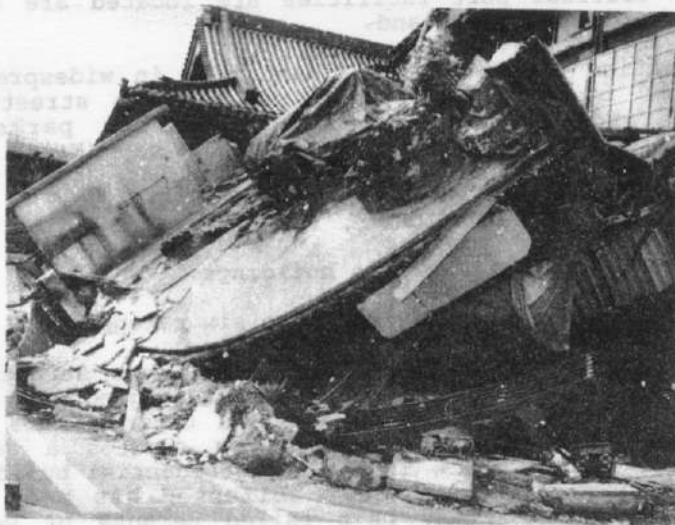
(ii) Some buildings failed due to a heavy roof. Heavy roofs were used in Kobe city to avoid wind problems, as explained earlier. Fig.4 shows a typical residential building which failed due to a heavy roof.

Fig.4 House failure due to heavy roof

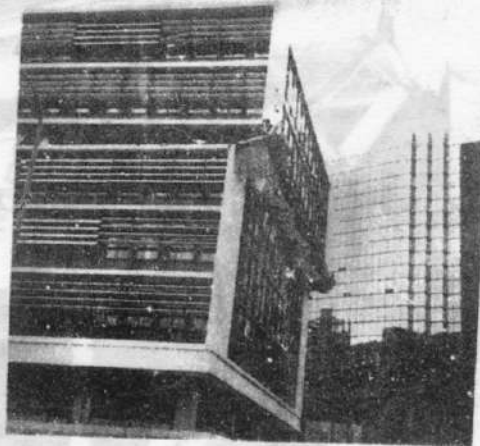
(iii) Some buildings got damaged due to the failure of intermediate storeys. They were of medium height with about 10 stories. Damage was concentrated around 4th to 6th storey (INCEDE news letter, Jan, 1995). The reason could be high ground acceleration, reduced density of walls in a particular floor due to office space use and higher mode of structural vibration. Some experts suspect that this type of damage may take place as a result of clash effects of vertical shock waves. Fig.5 shows failure of middle floor of an office building (Haresh Shah, Jan 29, 1995).

Fig.5 Failure of office building due to discontinuity in fifth floor

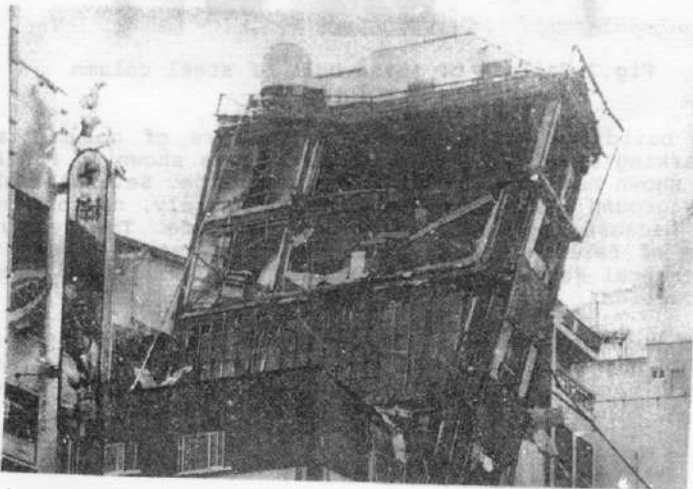
Fig.6 Failure of steel frame structure due to large ductile deformation

(iv) One type of steel structure failure was because of large ductile deformation due to severe ground motion and is shown in Fig.6. Another type of failure was due to shearing of bolts at joints of concrete and steel column. This failure may be due to large ground shaking or due to degrading of bolts. This type of failure is shown in Fig 7.

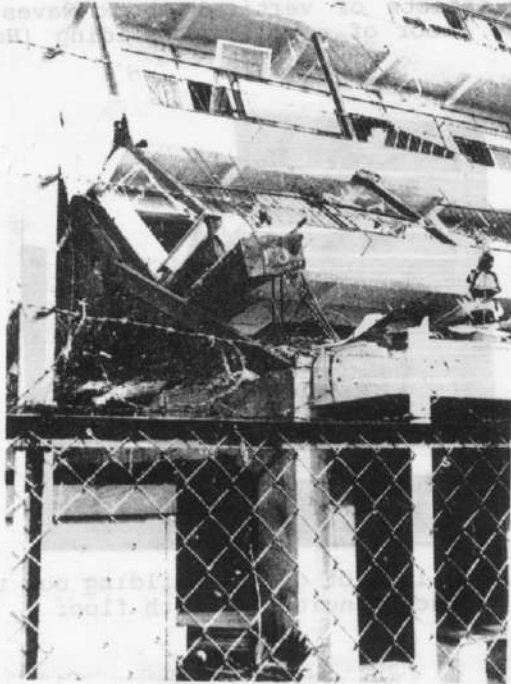
Fig.7 Failure of joint bolt of steel column and concrete column

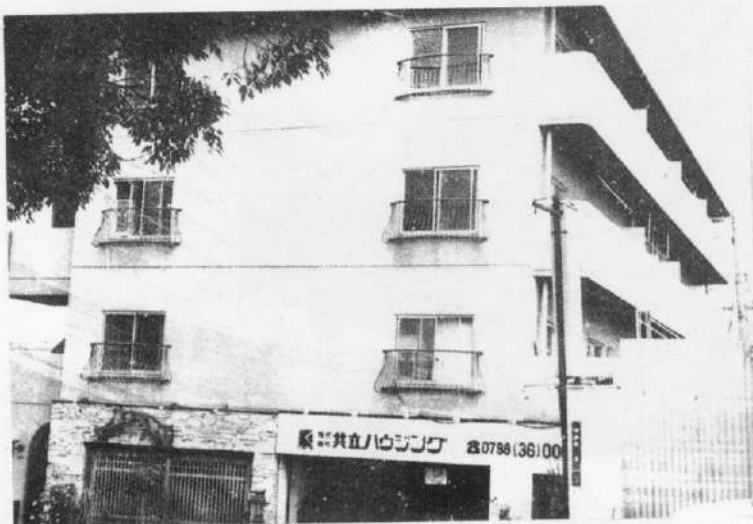
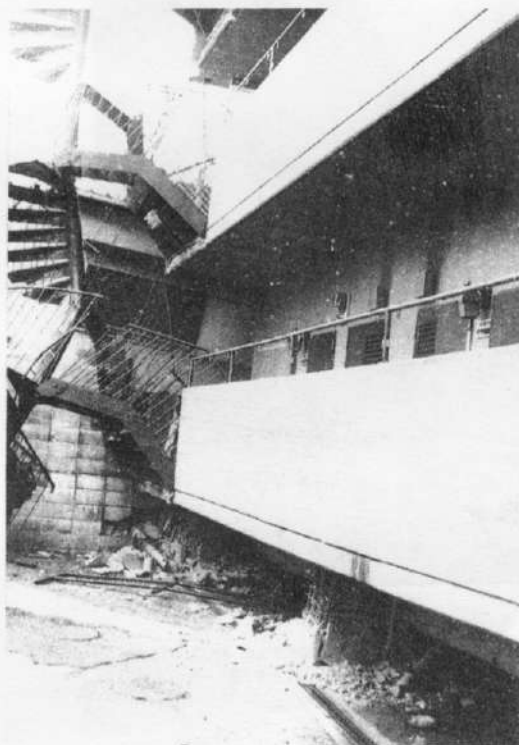
(v) Some buildings collapsed due to failure of columns at the ground/parking area. This type of damage is shown in Fig.8. The building shown had moved about 60 cm downwards. Several vehicles parked at ground level were damaged. Fortunately, no loss of life occurred because the super structure was safe. The reasons for this type of failure appear to be due to a heavy, strong floor, strong vertical acceleration and uneven settlement of columns due to liquefaction.

Fig.8 Failure of building due to weak columns
(a) super structure (b) failure of columns

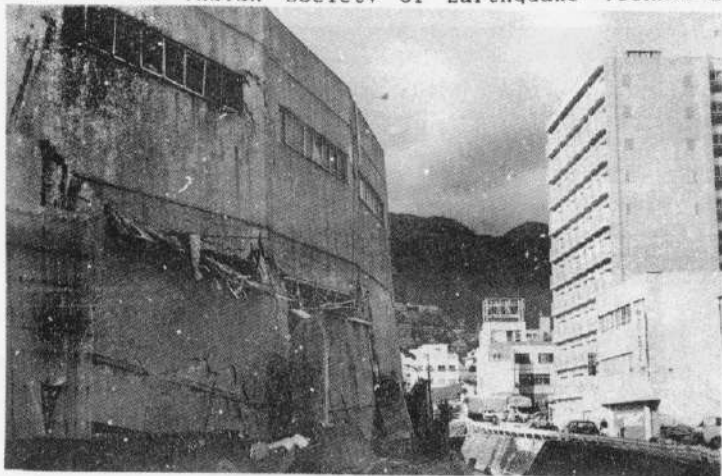
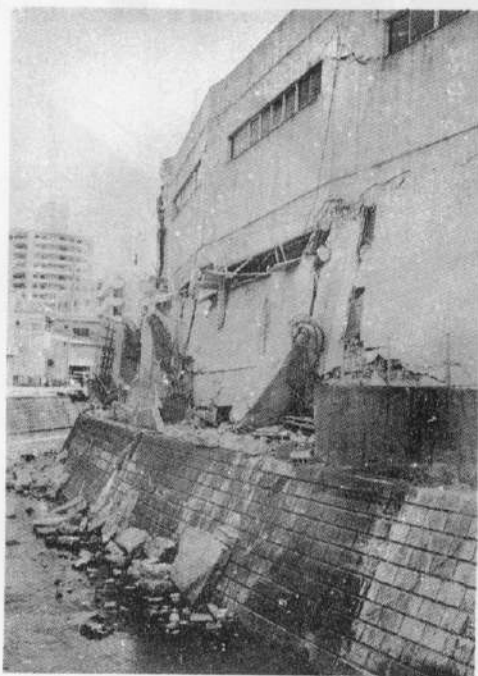
(vi) Some buildings failed due to asymmetry as shown in Fig.9. This might have failed due to strong ground acceleration and to some extent torsional ground motion. Torsional motion and rocking movement of monument is shown in Fig.10.

Fig.9 Failure of asymmetric building
(a) view.1 (b) view.2

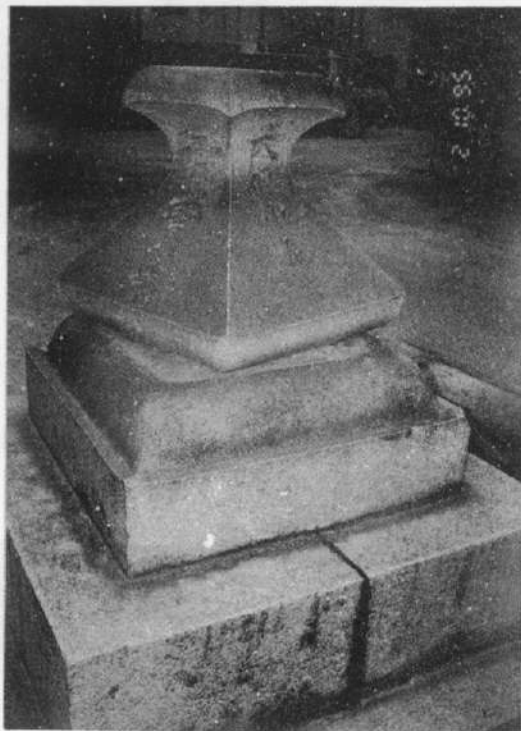
Fig.10 Rocking movement of a typical monument

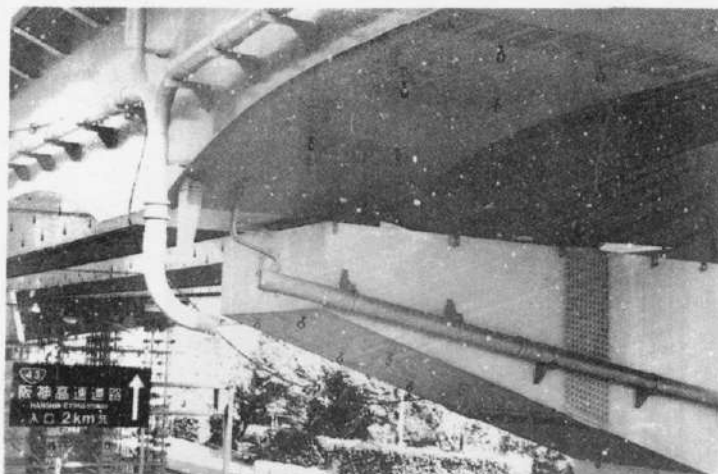
One of the surprising failures due to the earthquake was the collapse of Hanshin expressway. This was the main link between Osaka and Kobe cities. This portion of the expressway in Kobe was built about 30 years back. It is a mixture of two types of construction explained above. There were different modes of damage of the expressway. In the first type steel girders moved and slid (Fig.11) and in other places it fell down (Fig.12). There was local damage of girders at supporting points. In this situation concrete columns were generally safe. In another type the girder transmitted total load to the column with out falling/sliding and the resultant column failure is shown in Fig.12.

Fig.11 Slided girder of Hanshin highway

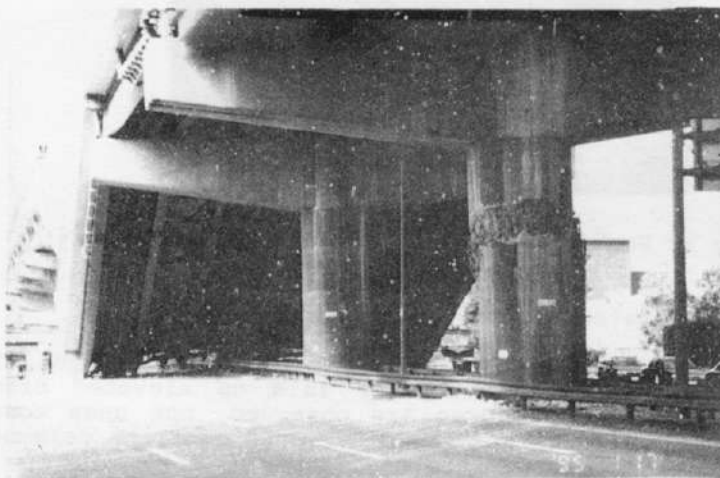
Fig.12 Collapsed bridge girder and typical column failure of Hanshin highway

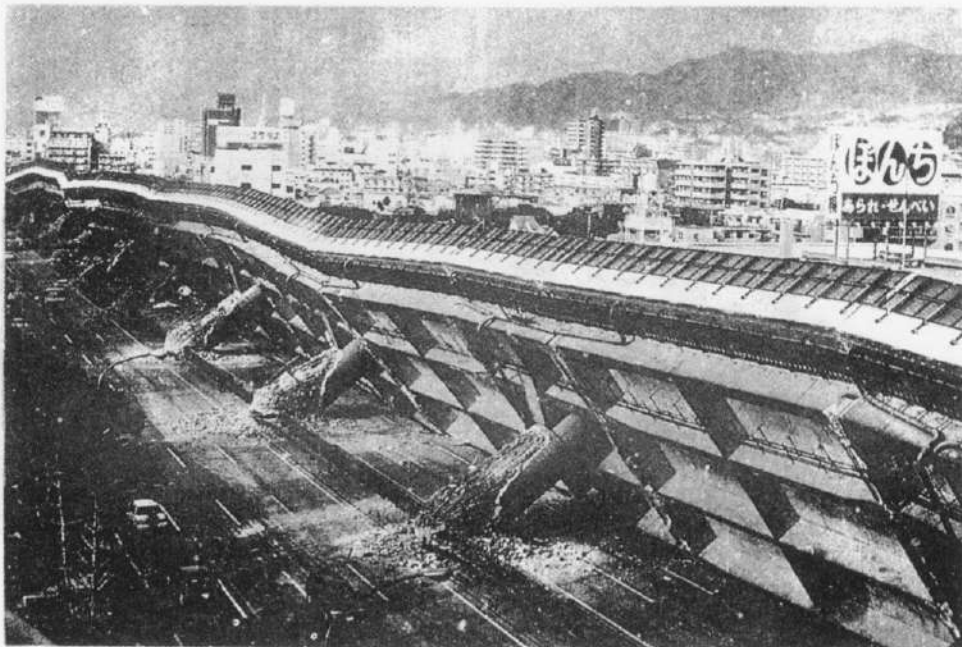
In Hagishinada ward of Kobe city about 500 m span portion of the expressway toppled down as shown in Fig.13. In another place columns were damaged badly as shown in Fig.14 (INCEDE news letter, Jan, 1995). This may be due to weak columns and strong girders, strong ground shaking or uneven settlement of columns due to liquefaction.

Fig.13 Toppled Hanshin highway (Kobe city, Higashinada ward)

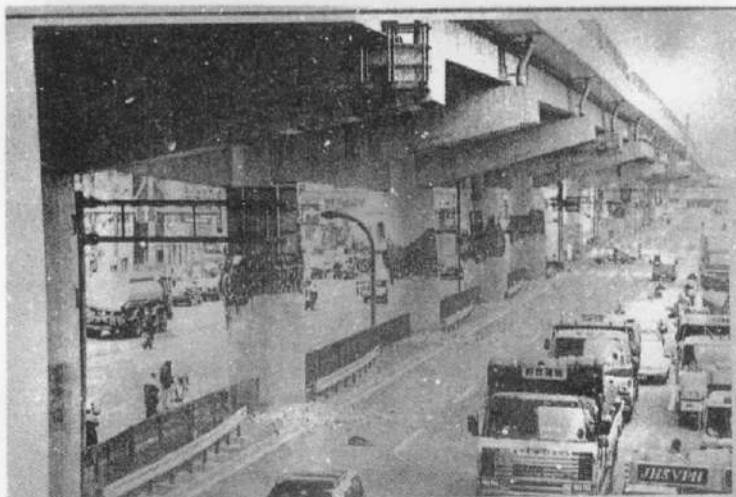
Fig.14 Failure of columns of highway due to compression

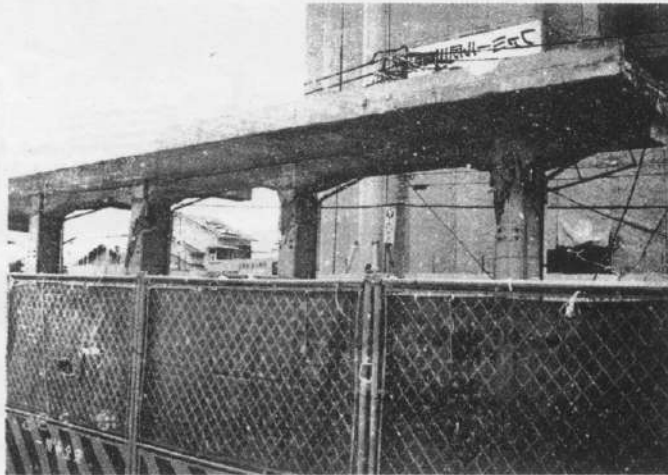
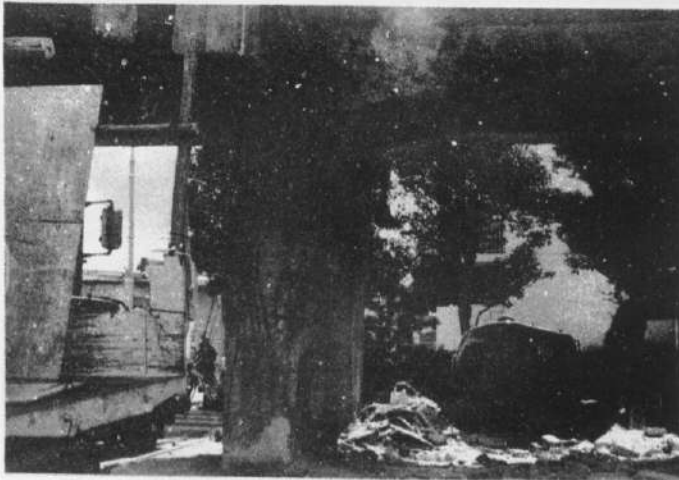
Similar types of failures were observed in the case of elevated railway lines including the famous Shinkansen line, shown in Fig.15.

Fig.15 Failure of columns in Hankyu-Kobe railway line
(a) shear failure (b) compression failure

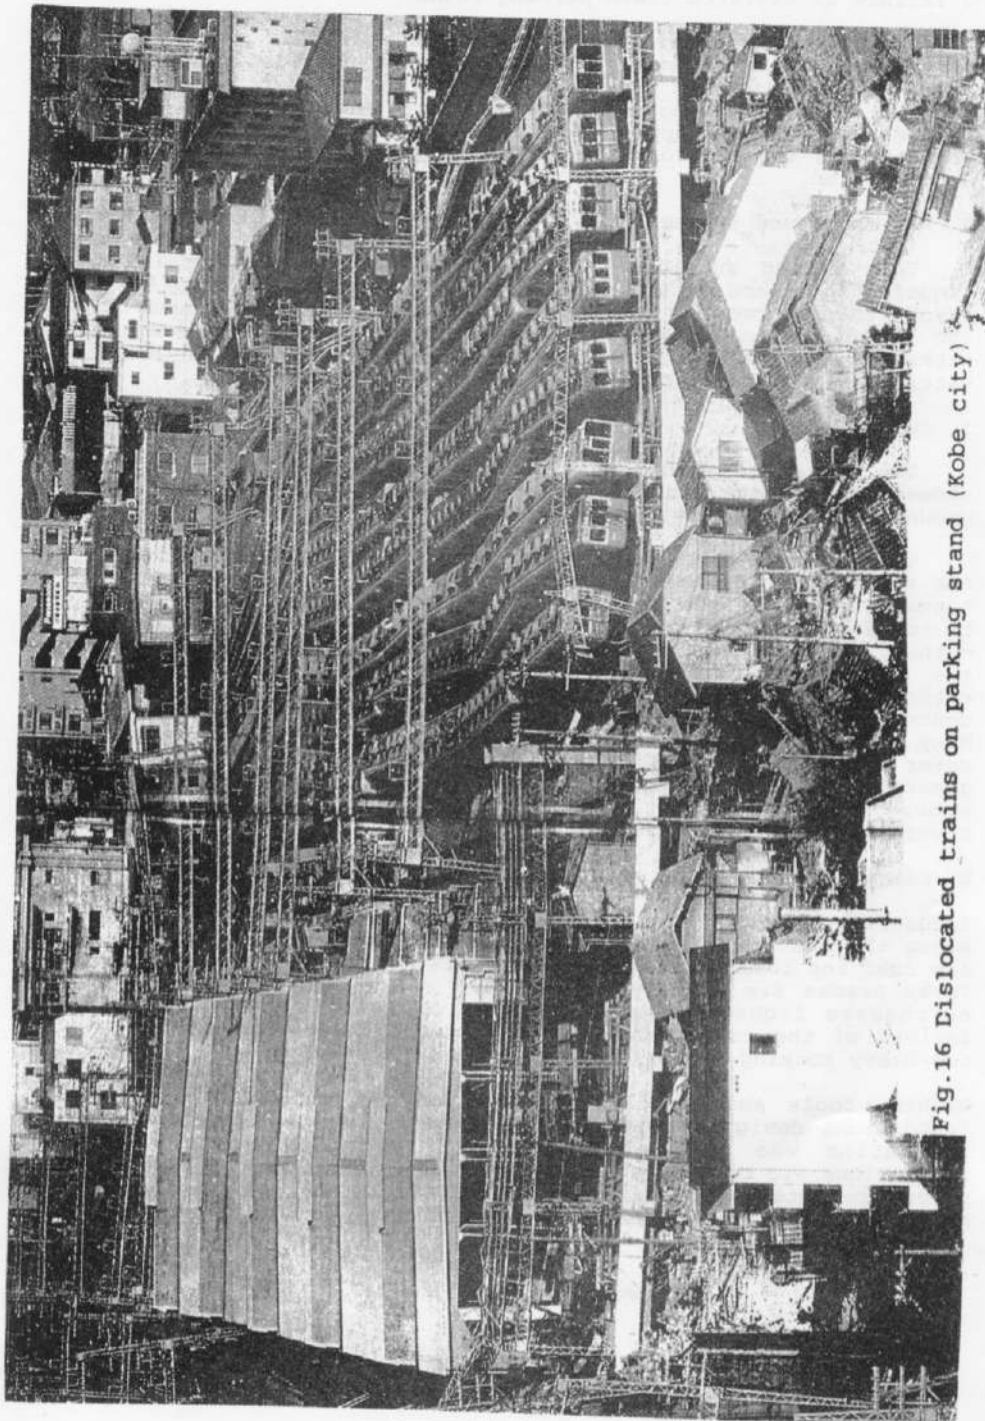
Fig.16 Dislocated trains on parking stand (Kobe city)

To save space, train parking area was provided on elevated platforms. The area under the platform was provided for shops. Dislocated trains in the parking area are shown in Fig.16. Failure of the parking stand columns are shown in Fig.17. The reasons for failure appear to be a strong floor weak column, asymmetry of the platform and uneven settlement of columns due to liquefaction.

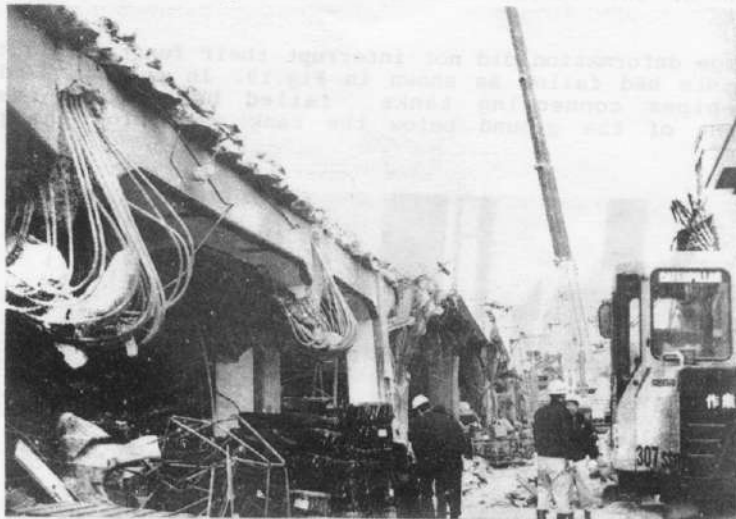
Fig.17 Failure of columns of train parking stand due to compression (Kobe city)

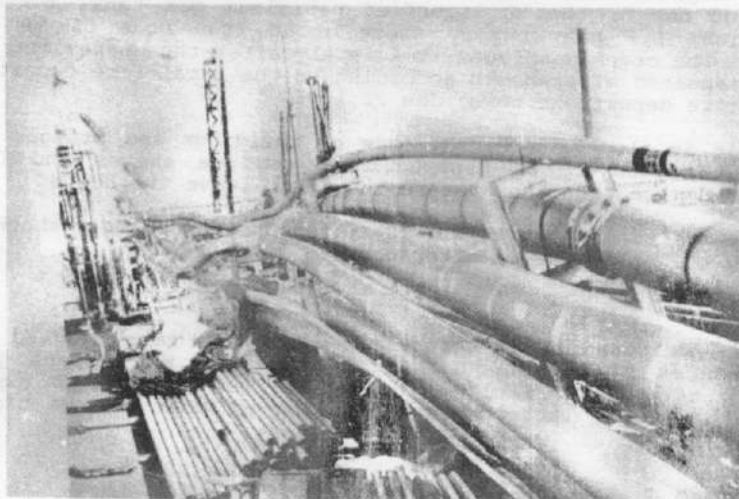
Failure of industrial pipelines: Pipe line supports failed causing large ductile deformation in the pipe lines (Fig.18).

Fig.18 Large ductile deformation of pipes due to failure of supports

This large deformation did not interrupt their function. Brittle pipe joints had failed as shown in Fig.19. In another kind of system pipes connecting tanks failed because of uneven settlement of the ground below the tank and below the pipe supports.

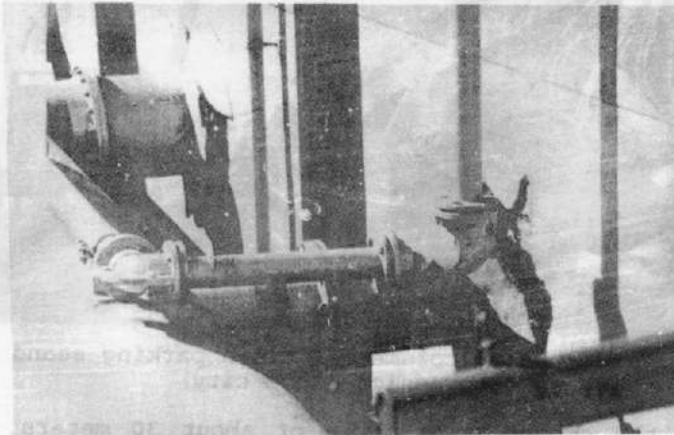
Fig 19 Brittle failure of pipe bends

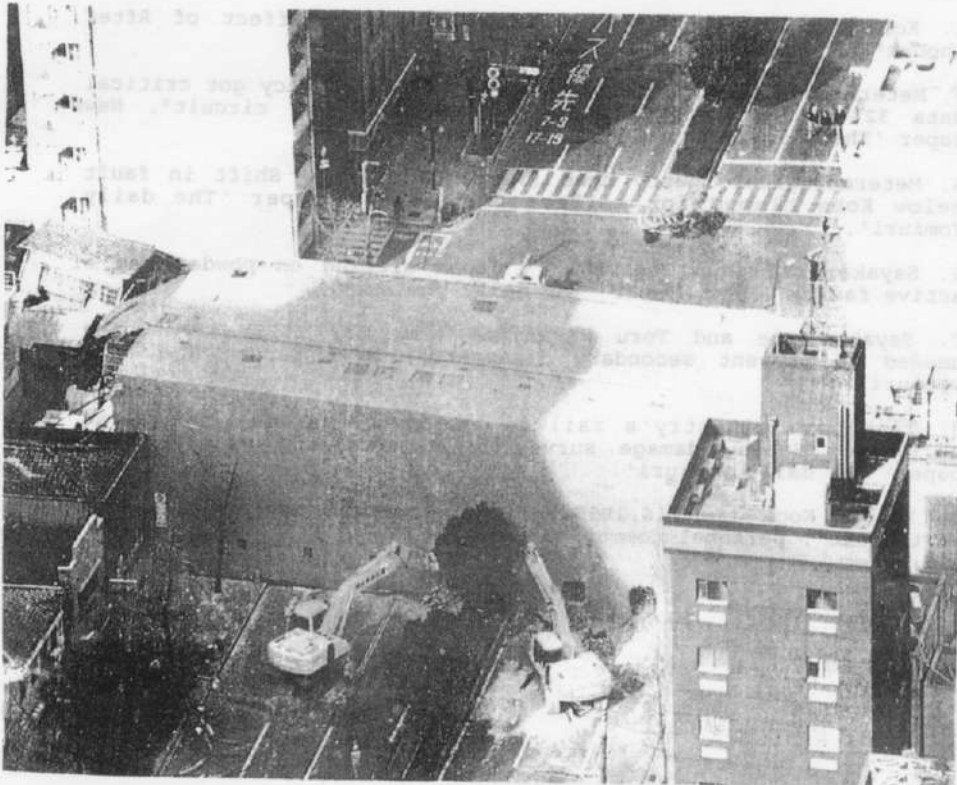
The building shown in Fig.20 tilted due to the main shock and totally collapsed due to aftershocks.

Fig.20 Collapsed building due to aftershocks
