RESPONSE OF STRUCTURES IN BROACH EARTHQUAKE †

B.S. Bulsari* and M.C. Thakkar*

† Presented at the Fourth Symposium on Earthquake Engineering, Koorkee, November 1970.

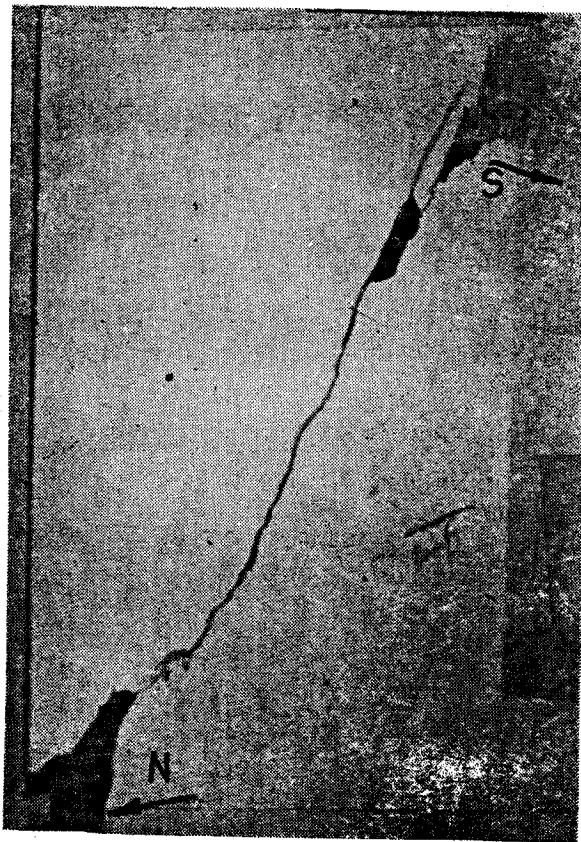
The major component of earthquake acceleration is N-S. This is very clear from the diagonal cracks on N-S walls. These cracks on larger panels are running from top at north to bottom at south, indicating the seismic force from north to south (Fig. 3). This direction is also very clear from fallouts of E-W walls. The photograph (Fig. 4) shows the shift of bench seat to south from the seat rests. Cracks produced by the earthquake at the surface of the ground at Kasia and Borbhata are approximately E-W, clearly indicating the N-S direction of seismic force (Fig. 5)

Figure 3. Diagonal Cracks bearing wall at Broach

This building is a two storeyed structure with one and half brick bearing wall in cement mortar construction on fairly level ground. Ground floor walls have cracked very heavily with the cracking pattern of Jayendrapuri Arts and Science College building. Photograph (Fig. 3) shows one of the typical cracks in this building. Western side (one and half) brick wall of the big prayer hall, of length 12 to 15 metres and height of about 8 metres, had cracked very badly. It has partially survived because of its N-S direction. Had it been E-W, the failure would have caused a major disaster.

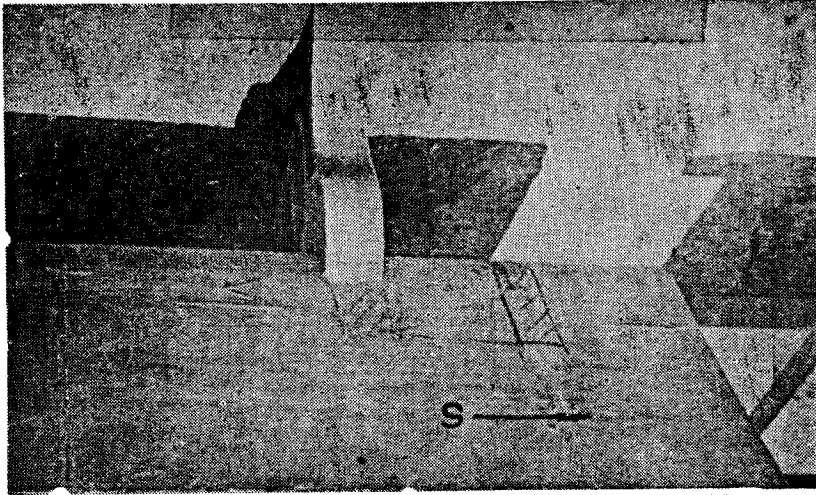
Figure 4. Shift of concrete bench seat at Broach.

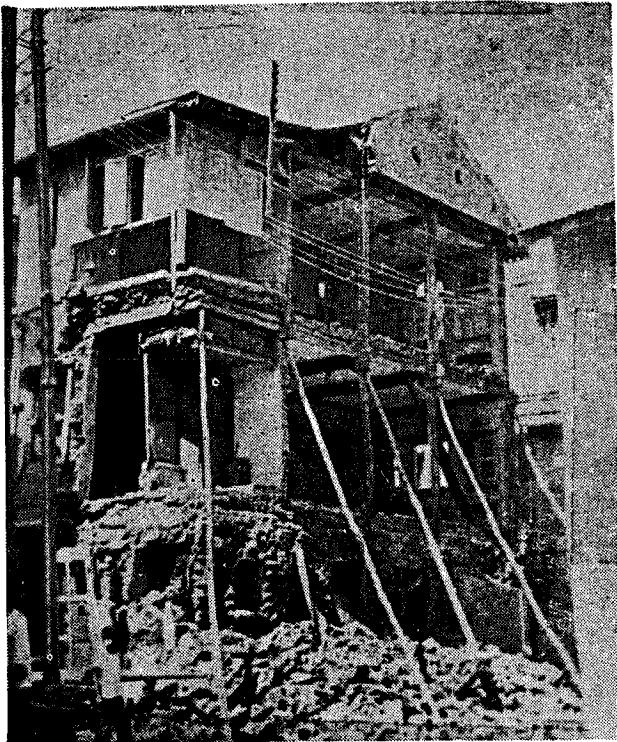
When the walls are not effectively anchored to the framework of either timber or RCC, then due to excessively different deformations of a wall and members of a frame, at the common surfaces, walls are practically separated and behave independently as an individual structural unit. Such a wall may be either parallel or normal to the direction of the principal component of the earthquake. It is quite obvious that the walls parallel to the principal component absorb the energy extensively and forms either X cracks or cracks inclined in one direction only, depending upon strong motion, panel size and constrained conditions.

Figure 6. Failure of filler walls due to improper connections at Worwad, Broach.

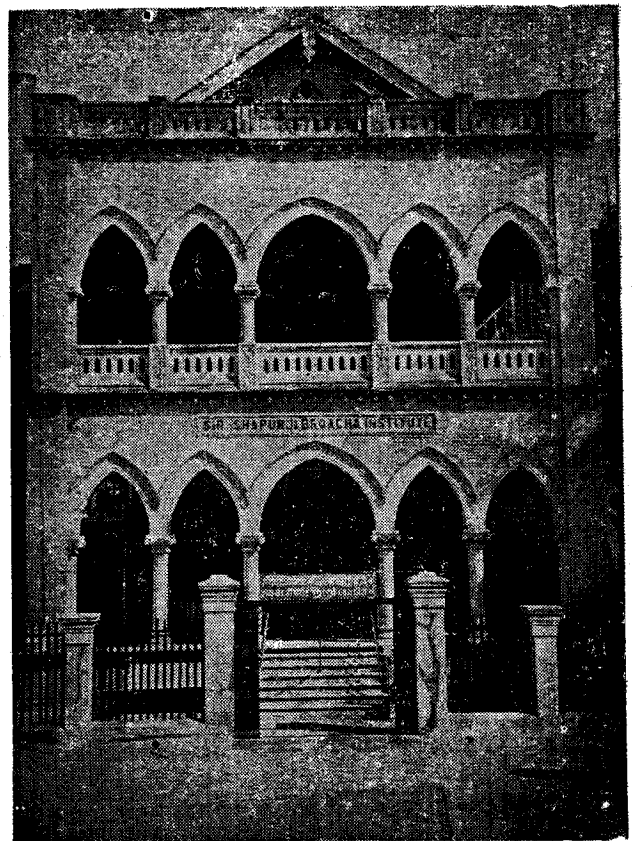
Figure 7. Bharucha Town Hall, Broach. Southern view before earthquake.

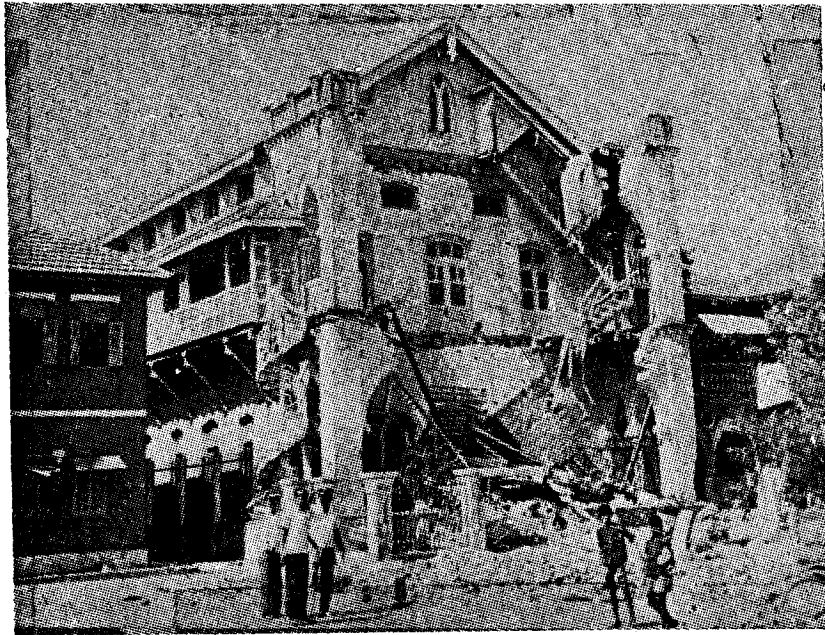
This structure located near Victoria Memorial Clock Tower, was built some 50 years ago, with load bearing masonry walls and brick arches over openings, with a pitched roof on steel trusses. The ground floor houses one of the oldest and best libraries of Gujarat and the first floor is utilized as a town hall. The southern side of the building had stone pillars and brick arches over which the floor was resting. This side is almost destroyed. The photographs Fig. 7 and 8 show that part before and after the earthquake. This collapse was primarily due to high arches, with stone pillars as supporting structural elements. The floor was transferring its loads on this system by N-S timber runners. These timber runners, as can be seen from the photograph (Fig. 8) were supporting only for gravity loads and were anchored poorly even for a small amount of horizontal pull. Moreover, the rotation was allowed to arches and pillars by spherical stone hinges at the capitals and pedestals. This, with no constraints on the sides had allowed for more deformations which caused the collapse.

Figure 8. Bharucha Town Hall, Broach, southern view after earthquake.

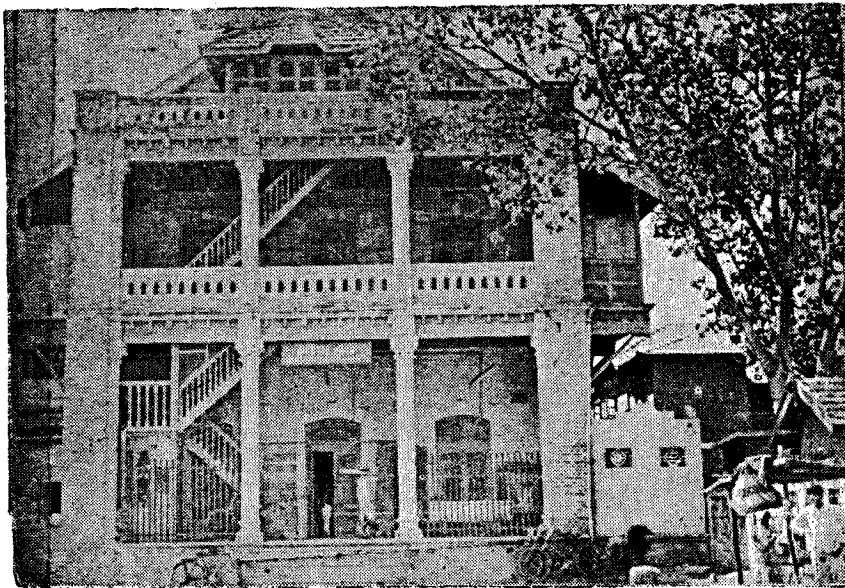
The northern side of the structure is absolutely different from the southern side (Fig. 9). Light construction by timber beams spanning over stone pillars is the root cause of its survival, as compared with heavy arches on stone pillars on the southern side.

Figure 9. Bharucha Town Hall, Broach, northern view after earthquake.

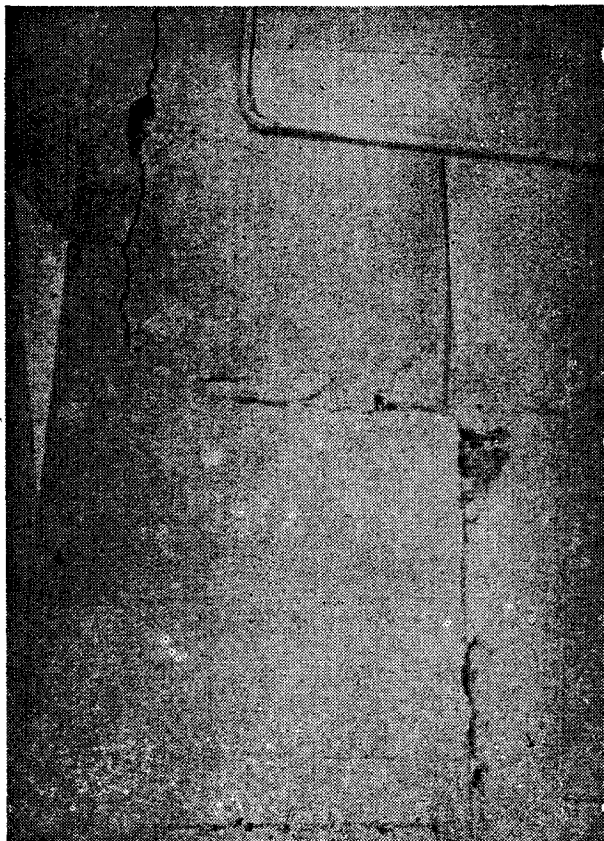
This is one of the very few RCC framed structures in the town. This is located near the railway station. Infilled walls are one-brick walls in cement mortar 1 : 6. Part of the structure is exploited for a mezzanine floor. RCC columns are finished with excessively thick terrazo. The photograph Fig. 10 shows the typical crack at the junction of the beam and the column. This crack is horizontal initially at the soffit of the mezzanine beam and it extends thereafter vertically in the column. Horizontal part of the crack seems to be due to the lack of proper construction joint between the column and the mezzanine beam soffit. Vertical part of the crack is due to excessive terrazo finish to cover up the plumb discrepancies.

Figure 10. State Transport Bus Stand. Broach - Cracking at mezzanine level in Beam-Column joints,

When Broach was revisited after a month, to inspect the progressive cracking in any of the structures, the diagonal cracks at quarter span in the terrace level beams were observed in this structure.
