A REPORT ON ANANTNAG EARTHQUAKE OF FEBRUARY 20, 1967

N. Gosain* and A. S. Arya**

Abstract

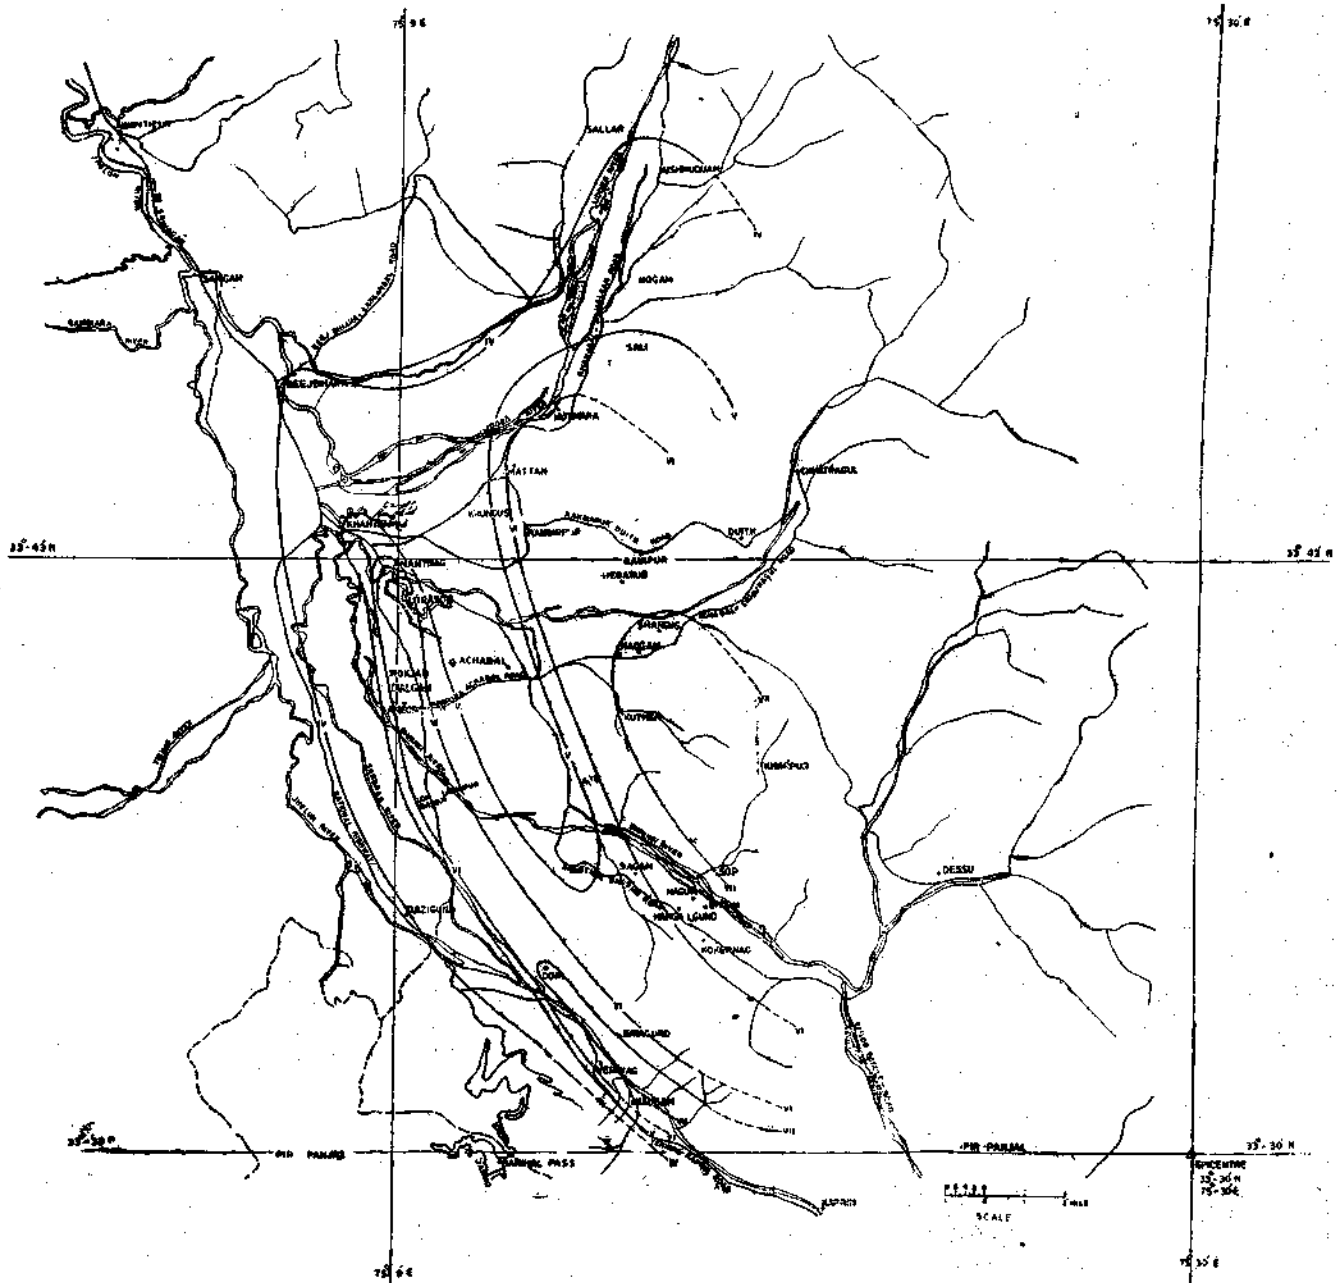
Fig. 2: Isoseismals of the Anantnag Earthquake of February 20, 1967.

The plot of the isoseismals as shown in Fig. 2 is based on field data and on the spot questioning of the local people after the earthquake. Out of the worst affected places, Shangus, Hutmara and Mattan lie close to the left bank of the Lidder River; Sop lies on the right bank of the Bringi River and Doru on the right bank of the River Sandran, a few kilometres east of the confluence of this river and River Jhelum. Anantnag itself is just a few kilometres away from the right bank of River Jhelum. The damage in these places may be due to their situation on alluvium beds. Achabal, though it is situated within the triangle formed by joining Sop, Doru and Anantnag, and is only 34.1 Km. from the Epicentre, escaped vigorous shaking and had very minor damage. The Modified Mercalli Intensity value that could be assigned to this place is V. It is thus seen that the isoseismals plotted are neither circular nor elliptical—they appear to have been greatly influenced by the geological and soil conditions. Moreover, the instrumental epicentre, 33.5°N, 75.5°E (approximately 41 Km. S.E. from Anantnag town) being near the Marbul Pass in the Pir Panjal Range of mountains, is a very sparsely populated area with practically no habitation. The absence of dwelling houses and buildings in the epicentral region thus leaves a void in the isoseismal study. It was fortunate that the epicentral tract was in the desolate mountains otherwise the damage would have been more intense and the toll of life would have been larger. This earthquake and the Badgam earthquake of 1962 both were of magnitude 5.5. Anantnag shock had a focal depth of 44 Km. However, larger number of lives were lost then—only one death (in Sop) has been confirmed for this earthquake. Reports of large scale slumping and fissuring of the earth have not been received, nor were such phenomena observed in the villages (and their neighbourhood) which suffered the maximum damage. There was, however, one instance in which an almost spherical boulder, 2.0 metres in diameter, rolled down a hillside in the precincts of the temple at Mattan. The boulder crashed into the rear wall of the temple "dharamshala" (Fig. 3) from a point on a hillside about 15 metres away inclined at about 20° to the horizontal (Fig. 4).

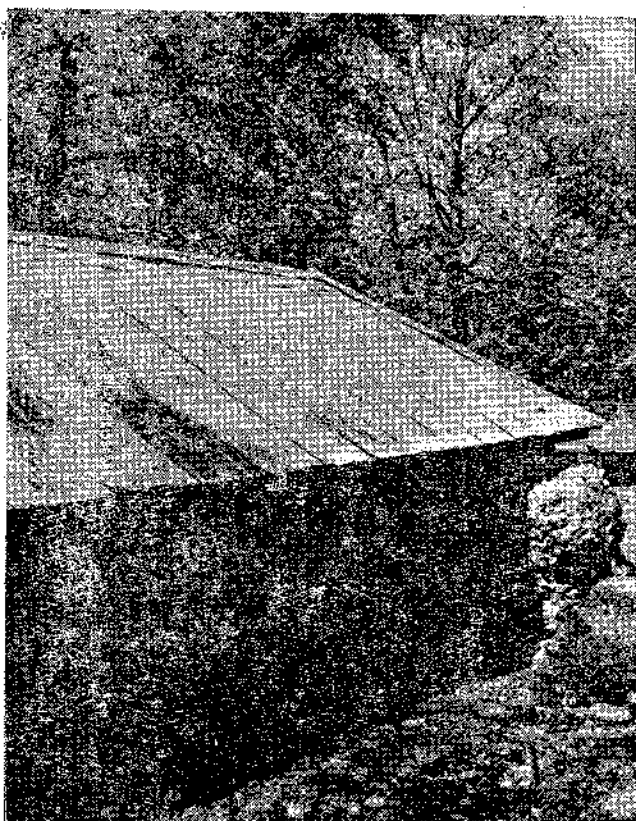
Fig. 3 Rolled Boulder which crashed into Dharam Shala in Mattan.

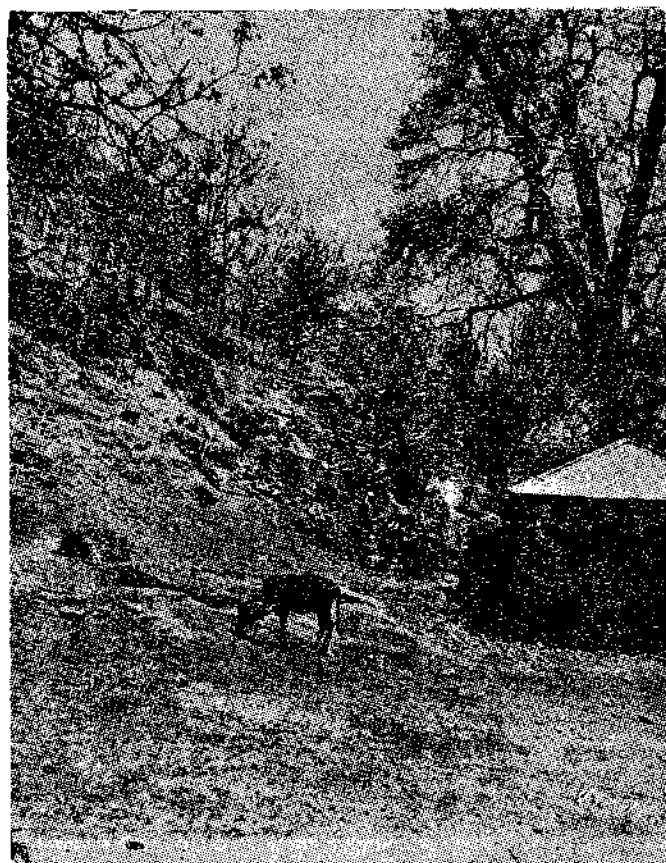
Fig. 4. View of the Hillside; from where Boulder Rolled Down.

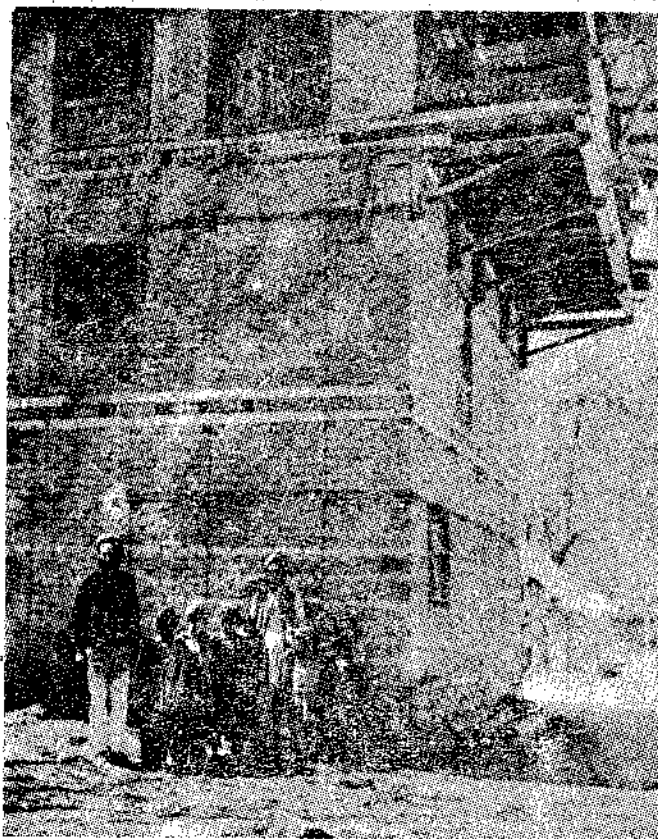
Fig. 5 "Dhaji-Diwari" Construction showing the Piers and the Infill. (Not the absence of bond between the two).

The most disappointing characteristic feature of such construction is that no attempt is made to have a bond between the pier and infill and both are entirely independent units. This is seen clearly in Fig. 5.

- (ii) Since the infills were observed to separate out during earthquakes, care should be taken in "tying" the piers to the infill between them.
- (iii) The usual English or Flemish bond may be introduced for brick masonry work instead of the bond comprising of stretchers only. This will ensure that there is proper keying of the facing and backing. To save the inmates from cold during winters, instead of constructing thicker walls by filling the space between facing and backing by brick-bats, stones, mud and rubbish, it will be desirable to construct cavity walls which will be light and more effective against cold.

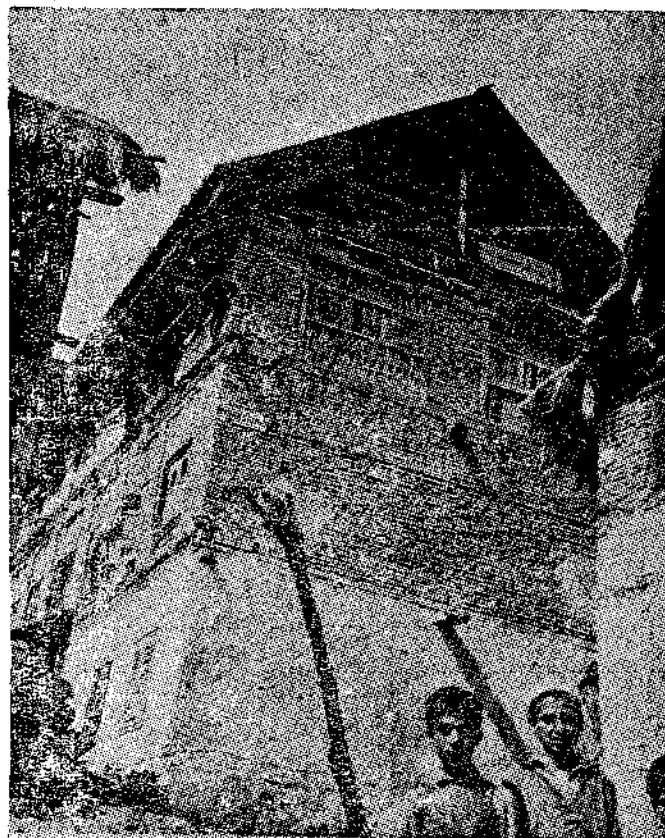
Fig. 6 Shoddy appearance of the Adobe Walls in Mud plaster

The thickness of the joint varies from 18 mm to 25 mm. In the course of time, the exposed mud gets washed away by the rain, and wall gives a shoddy appearance as in Fig. 6. The piers also have a similar construction.

- (i) The sun-dried bricks used in the traditional Kashmiri village hut needs to be replaced by burnt bricks. Instead of mud-mortar, better quality mortar such as lime mortar or 1 : 6 cement-mortar should be used. If it is not economically possible to adopt the better quality mortar for the entire construction, the corners and jambs must be bonded in better quality mortar and the rest of the masonry work may be in mud mortar. In such a composite construction, the more critical points in a building will be strengthened.

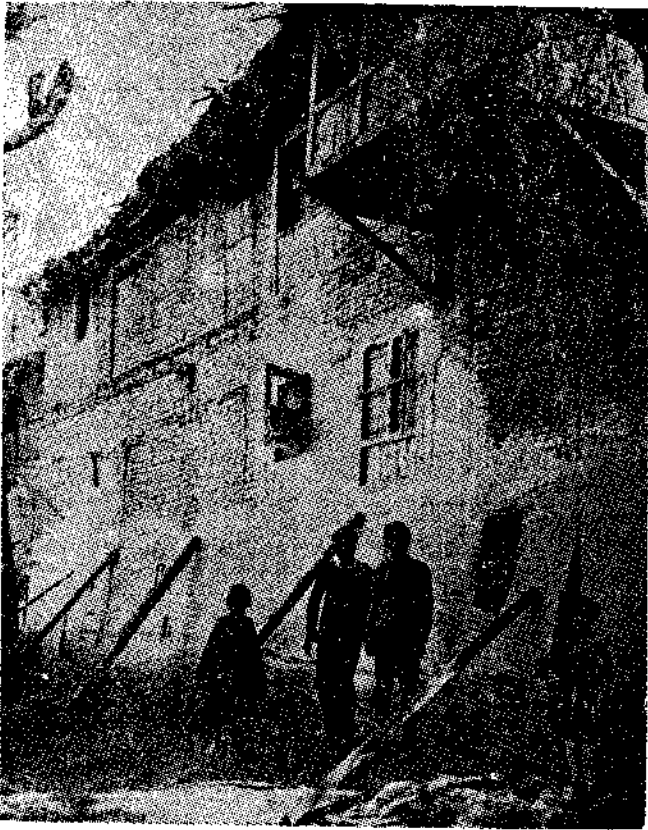
Fig. 7. Timber Rakers supporting out of Plumb Walls

Thus the construction appears to be such that a shock of intensity VI or even V (MMS) is sufficient to throw the wall out of plumb and even to cause damage beyond repair. Fig. 7 shows out-of-plumb walls supported by timber rakers. Fig. 8 is a close-up of the "dhajji-diwari" house shown in Fig. 7. The dressed exterior surface of the panel is separated both from the corner pier and remainder of the wall for lack of proper bond between themselves. The longitudinal section of an adobe pier is seen in Fig. 9. Absence of key stones is very conspicuous, both between the front and rear half of the pier and between the pier and the wall that has fallen apart altogether. Fig. 10 shows the damage of an upper storey wall and an adjacent pier. The mud-mortar which merely peeled off by the shock is seen lying on the floor. Fig. 11 shows the damage of a ground floor wall, and reveals the muck that is used for constructing such walls. Diagonal cracks may also develop in adobe walls bonded with mud mortar as in the case of the interior walls of the residence of the doctors of the Missionary Hospital in Anantnag (Fig. 12).

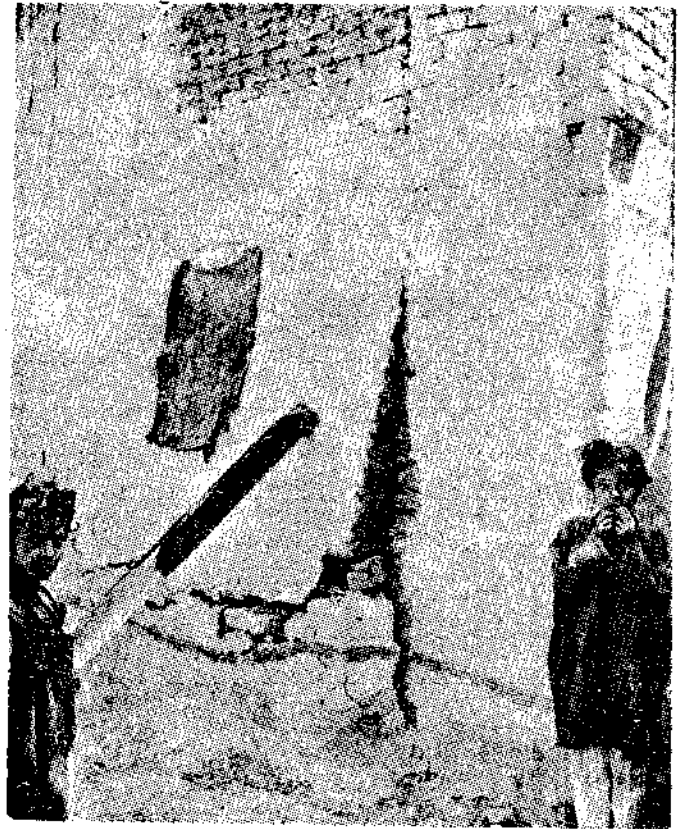
Fig. 8. Close-up of the Damaged Wall shown in Fig. 7

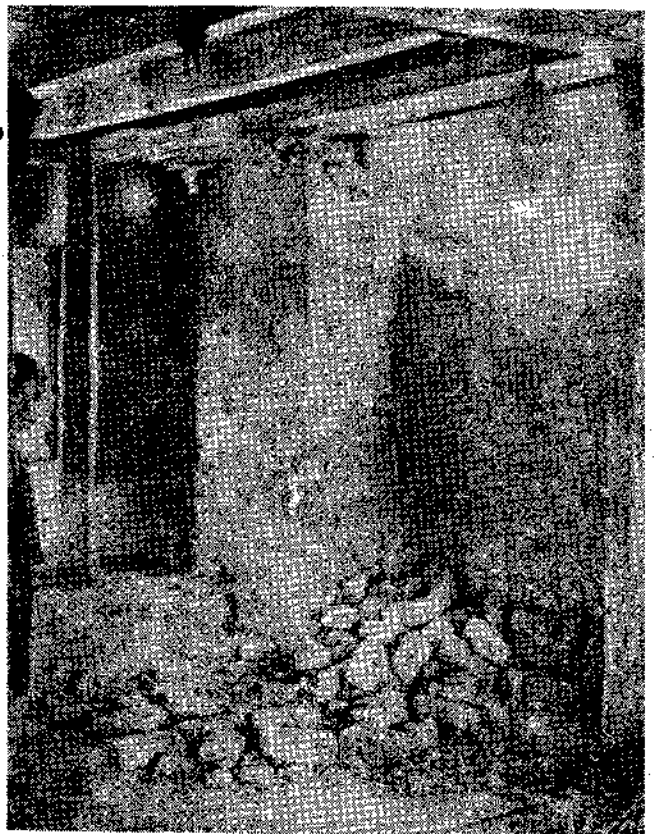
Fig. 10. Damage of Upper Storey Adobe Pier and Panel

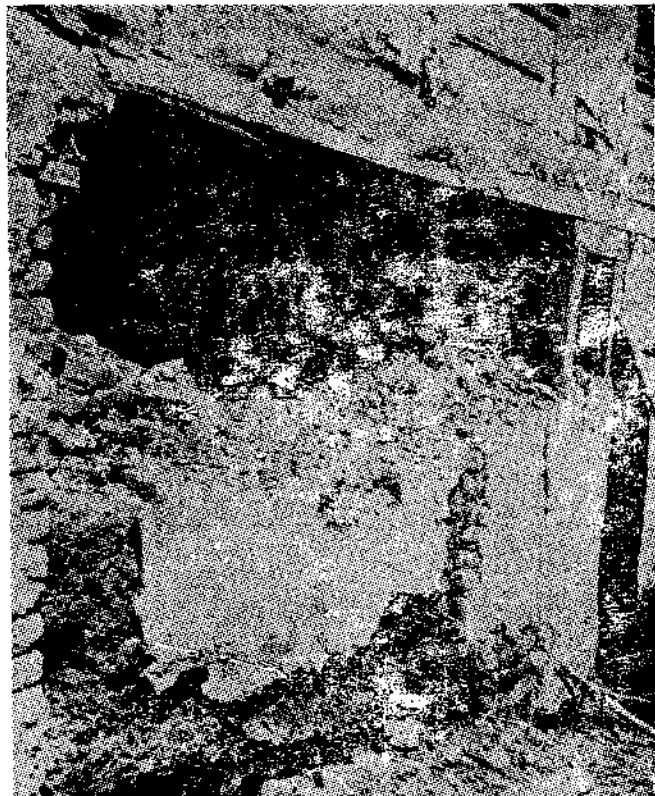
Fig. 11. Damage of Ground Floor Wall made of Adobe, Mud and Muck

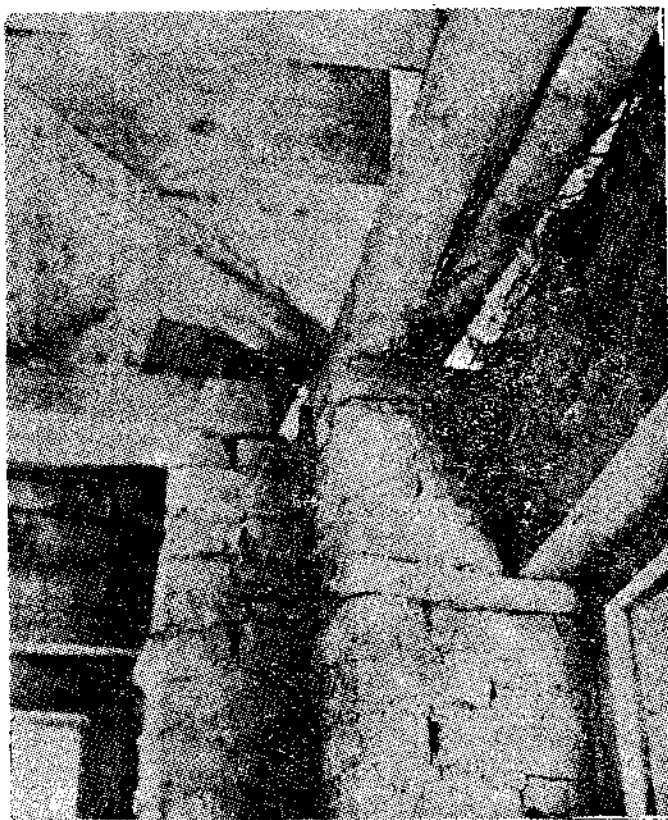
Fig. 21. Wall Plates of Short and Long Walls
(Note the absence of connection between the two)

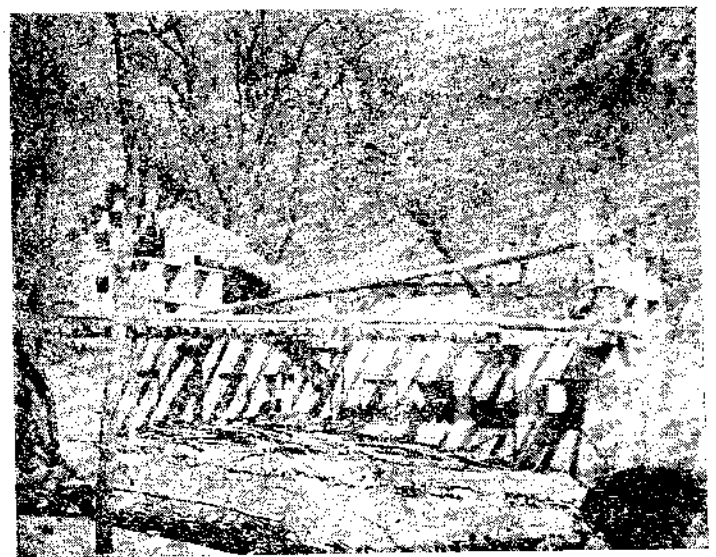
It was observed that "dhajji-diwaris" having roofing system of type (i) proved more hazardous than a trussed roof. This would appear to be obvious since the timber logs at ridge and eaves are supported on isolated adobe piers which experience vigorous shaking during earthquakes. Their strength in the lateral direction is almost negligible and these are liable to collapse first, bringing down the whole roof along with them. Fig. 23 shows the collapse of such a house in Batagund (Iseismic VI).

Fig. 22. Collapse of a "Dhajji-Diwari" in
Batagund with pigeonhole type Gable

- (v) Roofs with pigeon-hole type gables should be discouraged. The alternative would be a simple truss system with nailed, bolted or dowelled joints.

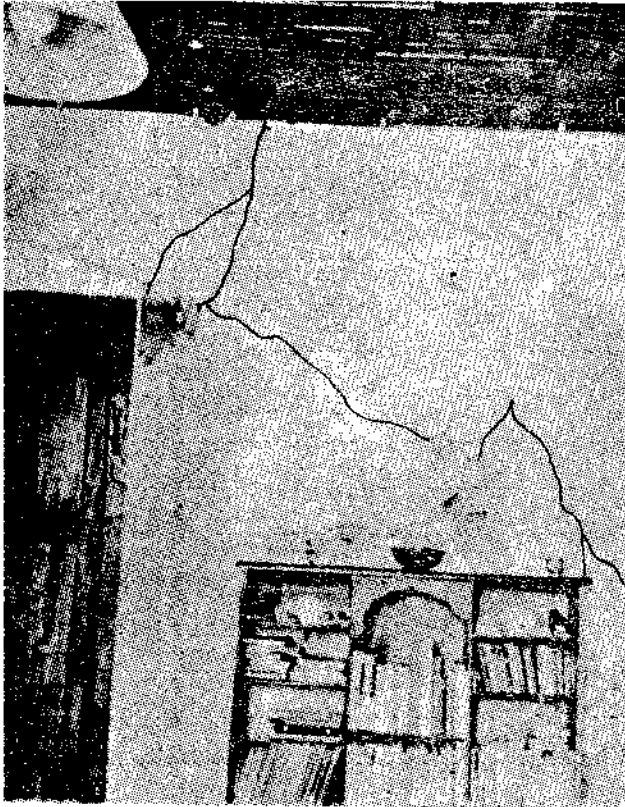
Fig. 27. Diagonal cracking of interior Sun Dried Brick Masonry Wall in Mission Hospital, Anantnag.

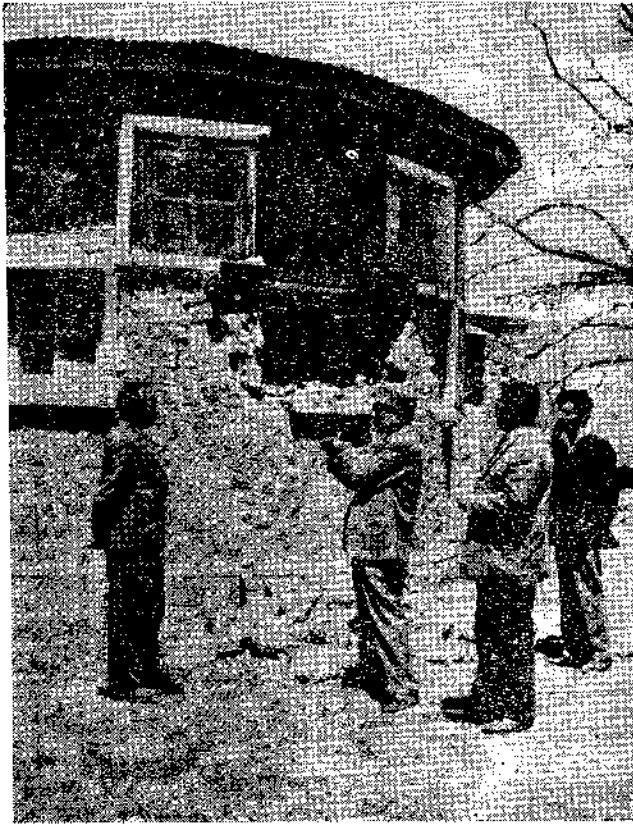
Fig. 31. Damage of Random Rubble Masonry Walls around Windows in B. D. O., Shangus.

The desirability of siting the window sufficiently away from the edge, the necessity of strengthening the wall around the opening and having a certain prescribed distance between two adjacent openings, and the indispensability of a lintel band to inhibit the development of diagonal cracks, may be seen rather clearly in the cracking pattern of a single storeyed random rubble masonry building in Mattan (Fig. 36). The separation of the brick masonry pier at the corner from the wall of the building (Fig. 37) of the Social Education Centre at Mattan, again emphasises the importance of having a bond or a tie between the various elements of a structure. In contradistinction, a coursed rubble masonry construction with a timber runner at a level slightly above the lintel level (Fig. 38) situated at Mir Maidan remained unscathed. The P. W. D. overseer's house at Verinag (Isoseismal VI) which is a random rubble masonry structure with a reinforced cement concrete lintel band (Fig. 39), sustained the shock admirably. However, the upper storey of the double storeyed Tourists' Department Dak Bungalow about 20 metres away was considerably damaged, so much so, that the gable end towards the staircase had to be rebuilt. The triangular space of the gable of the Government College building at Khanabal was also excessively damaged. The coursed rubble facing toppled down, exposing an interesting feature used in the construction of walls about sixty to seventy years back (Fig. 40). Horizontally laid timber boards about 20 mm thick can be seen after every course. The use of these boards in the construction of walls is not understandable since they apparently have no structural function for they cannot strengthen the walls if arranged as seen in the figure. Damage of the gables in this earthquake again affirmed their weakness in withstanding an earthquake shock. It was observed in this as well as in the past earthquakes that roofs with hipped ends were better and should be preferred over gable ends for houses in seismic zones⁽⁹⁾.

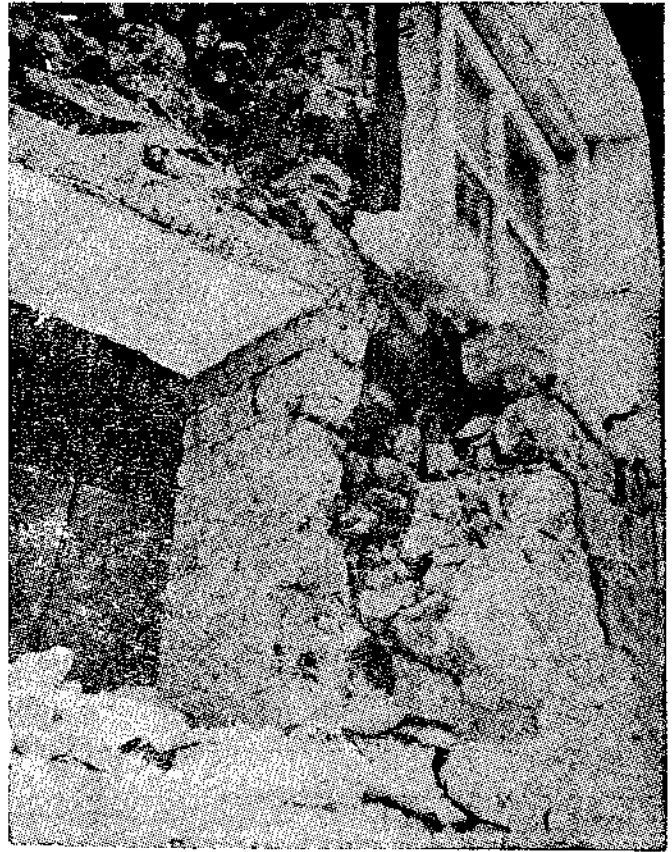
Fig. 32. Close-up of the Damaged Wall near Corner of Window seen in Fig. 31.

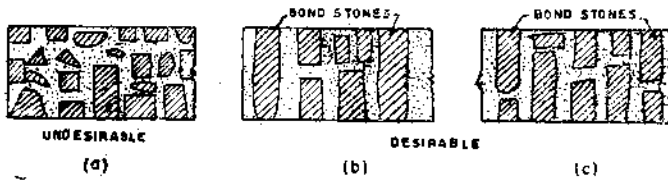
FIG. 33

CROSS SECTION OF DESIRABLE AND UNDESIRABLE RANDOM RUBBLE MASONRY WALLS

create a good bond between the facing, hearting and backing. Sketches giving the desirable and undesirable types of random rubble masonry work are given in Fig. 33.

- (i) Rubble masonry also requires better bonding material. Mud-mortar should be discarded and lime-mortar or cement mortar used.
- (ii) Cross-section of a rubble masonry wall as shown in Fig. 33 (a) is undesirable, and should be avoided. The desirable cross-section is as shown in Fig. 33 (b) in which bond stones are provided from facing to backing. If stones of length equal to the thickness of the walls are not available, then the bond stones may be two-thirds the thickness of the wall and a lap provided as shown in Fig. 33 (c). Such stones when provided every metre apart vertically and horizontally will ensure a good bond between the facing, hearting and backing.

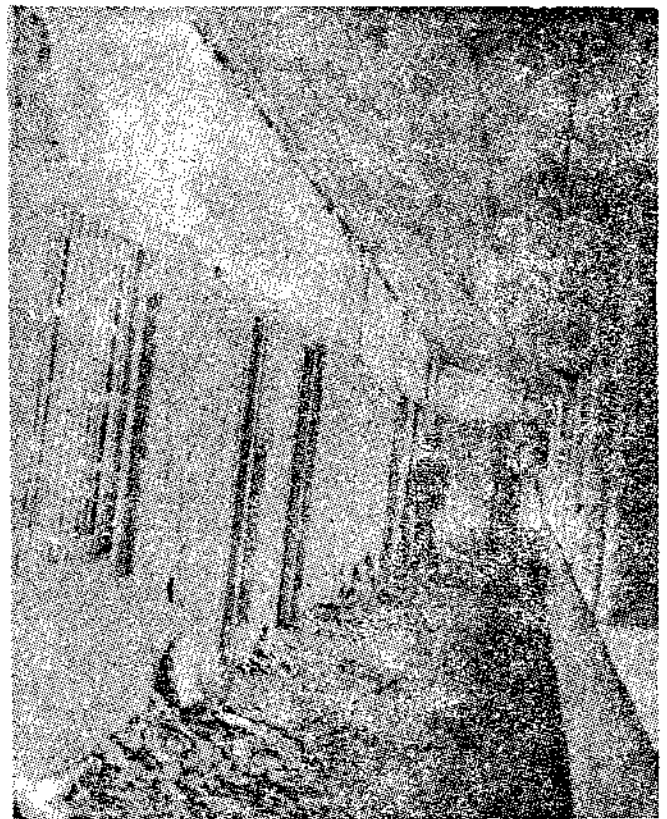
Fig. 34. Verandah of the B.D.O. at Shangus after the Earthquake.

The verandah and the interior walls were plastered by lime plaster about 25 mm thick. This peeled off almost completely in the entire building. Fig. 34 shows the condition of the verandah of the Shangus Block Development Office.

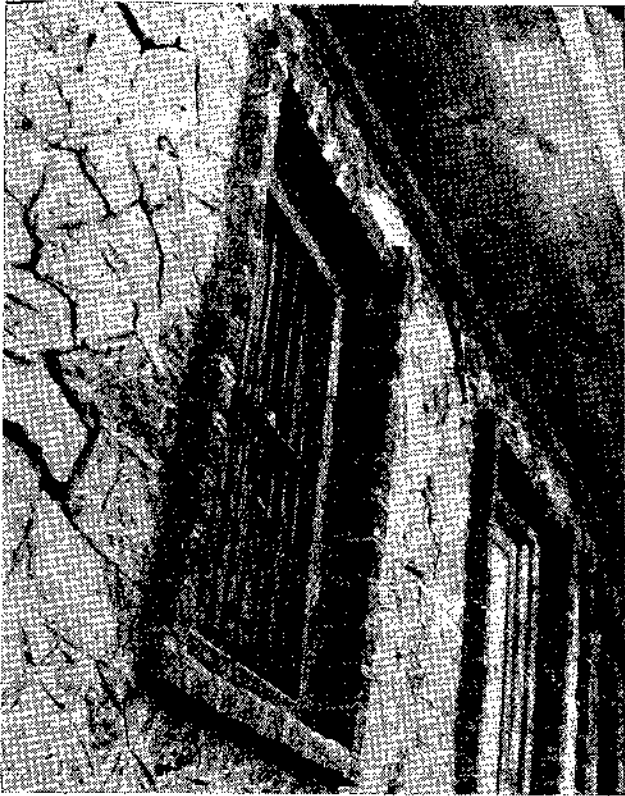
The office building of the Range Officer, Lower Range, at Mattan was also badly affected and declared unsafe. It has a random rubble construction similar to the masonry work of Block Development Offices. The walls in this structure also were shattered beyond repair. At many places they bulged out due to lack of bond between the facing, hearting and backing. From Fig. 35 it is to be noted that on account of bulging, there is a difference of about 25 mm between the jamb and the window frame.

Fig. 35. Bulging of Random Rubble Masonry Walls of the Office of the Range Officer, Mattan. (Note the difference between window frame and jamb).

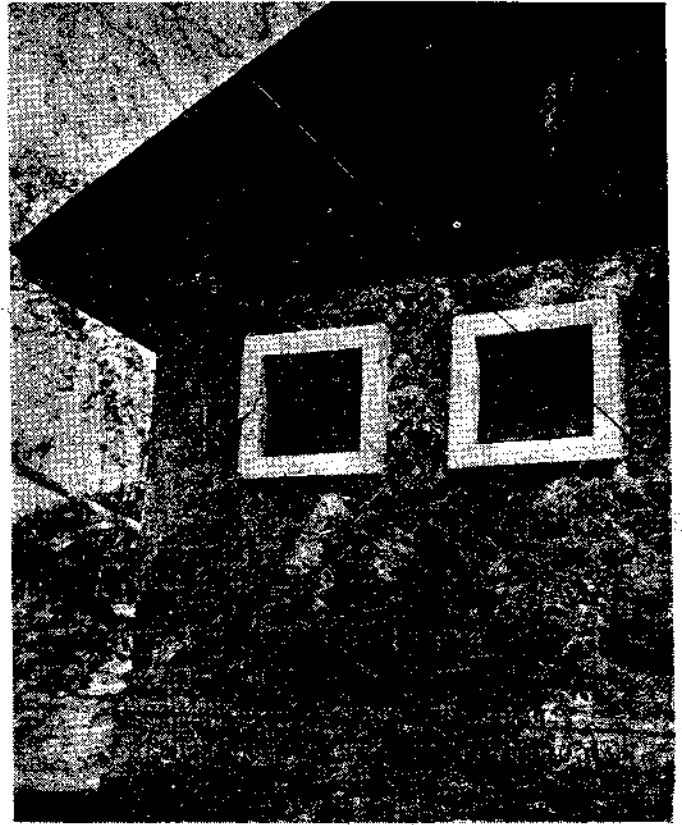
Fig. 36. Diagonal Cracking of Rubble Masonry Walls and Damage around Window opening of a House in Mattan.

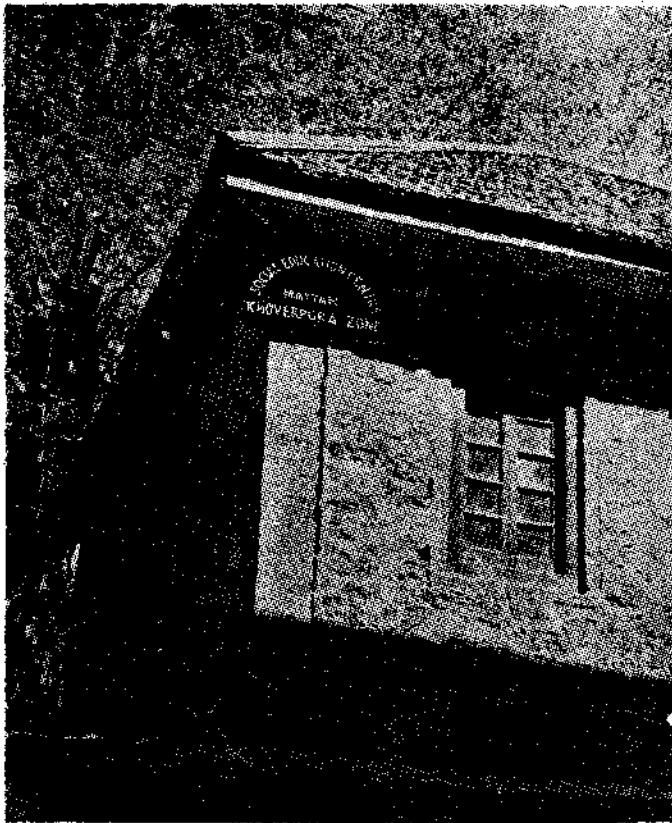
Fig. 37. Separation of the Brick Masonry Corner Pier from the Rubble wall.

- (iii) The long and cross walls should be "tied" together by interlacing the storeys at the corner. If there is a pier at the corner, the two walls should be tied to the pier to ensure integral action of long and cross walls. A band of reinforced cement concrete may be provided all around at the lintel level.

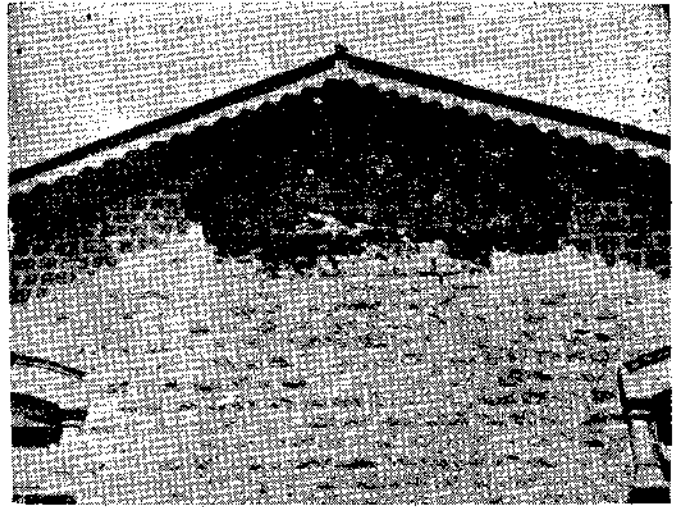
Fig. 40. Damaged Gable End of the Government College Building in Khanabal, showing the use of Horizontal Timber Planks in the Walls.

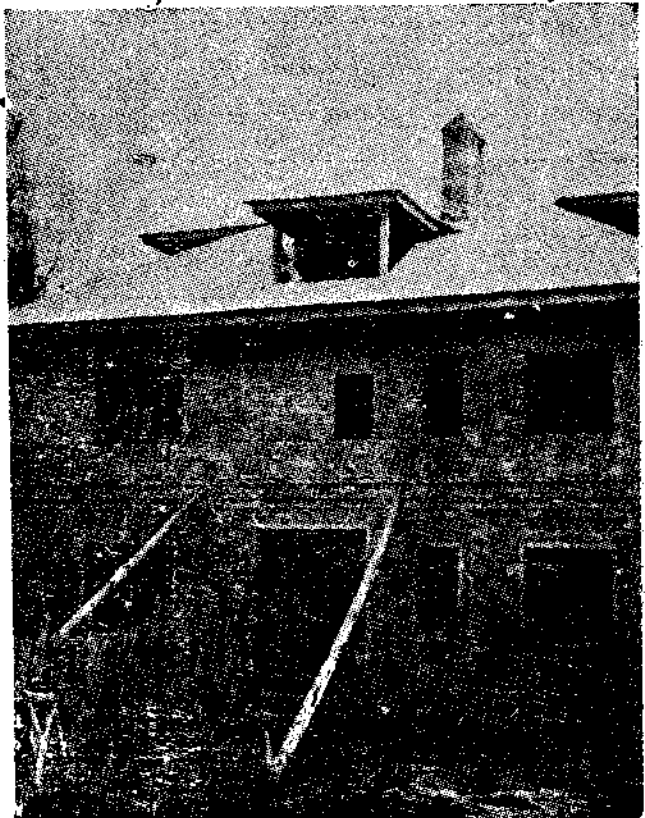
Fig. 50. Damage of a New Brick Masonry Building in Mir Maidan.

Absence of horizontal timber runners appears to be a serious omission in modern construction of burnt brick and rubble masonry. Such houses will have inadequate strength against earthquakes. Experimental studies and observed behaviour have shown that lintel bands of either timber or reinforced cement concrete add considerable strength to the buildings. If economically feasible, vertical steel may be introduced at the corners and junctions of load bearing walls.

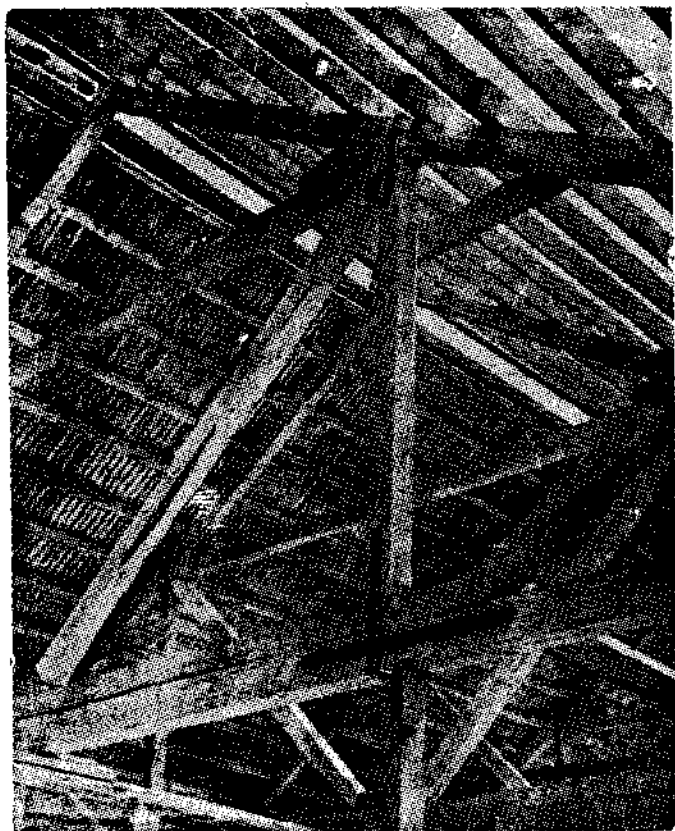
Fig. 51 shows a partially covered timber roof truss of a building under construction in the newly established Industrial Estate in Anantnag. This is a purlin-rafter construction in which the common rafter is omitted and the roof covering rests directly on the purlins. The bolted metal strip covers used in conjunction with the splayed joint strengthens the main tie beam considerably. U-shaped metal straps connect the lower end of the vertical strut to tie-beam and the upper end to the principal rafter. Such straps prevent the loosening of the joints and tie the various members efficiently. Joints and connections of this type, although reasonably good for timber trusses in seismic zones, are rather expensive and cannot be adopted by the majority of the private house builders of rural Kashmir. Under such circumstances, nailed, bolted, or disc-dowel joints may be employed effectively and economically⁽²²⁾.

Fig. 51. Timber Roof Truss showing Main Tie-beam, Diagonal and Vertical Struct.

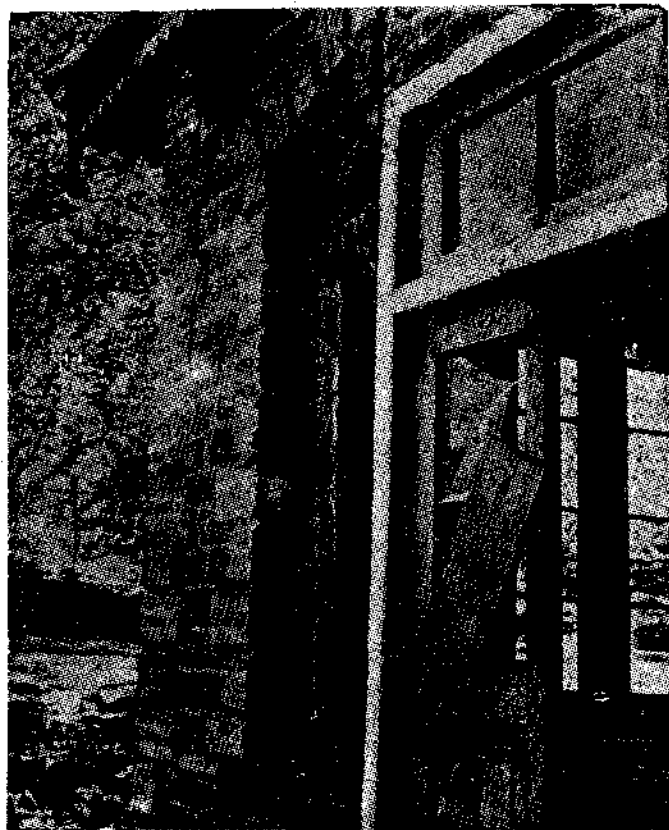
It is necessary that where some alterations have to be done in the existing structure, a proper bond should be provided between the old and new construction. This will ensure that the latter built up portion does not fall apart as it did in the altered arched opening in the High School building at Mattan (Fig. 52). An arched opening in the Mission Hospital at Anantnag which was subsequently provided with a lintel also suffered the same fate.

Fig. 52. Damage of the improperly bonded New and Old Construction
