REPAIR AND STRENGTHENING OF EARTHQUAKE DAMAGED HOUSES IN MAHARASHTRA

Central Building Research Institute, Roorkee (U.P.)

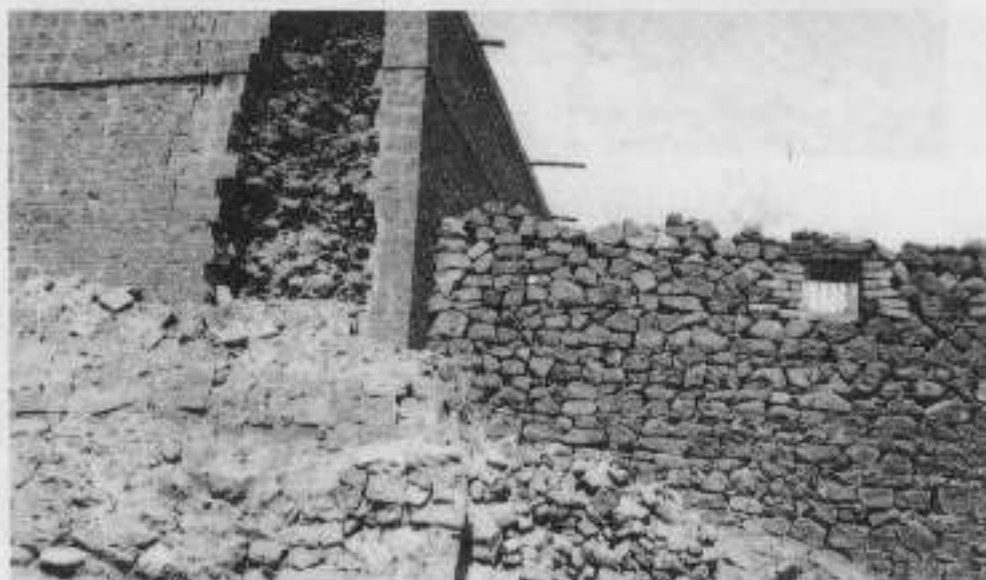
- * The most common distress observed was vertical cracks at the junctions of walls, specially at the corners of buildings. These cracks occur on the walls at a distance equal to the thickness of the wall, from outer edge of the corner.
- * In houses having RR masonry pilastrers, projecting out of wall, cracks occurred at the junction of pilaster and wall.
- * Inclined cracks in walls over openings were noticed in some of the damaged houses.
- * In severely damaged houses, in addition to development of cracks at corners, there was spalling of masonry (mainly outer wythe) at top of wall.
- * Collapse of outer wythe to the full height of wall and for a distance equal to thickness of the perpendicular wall joining at the corner (Fig.3) was also observed.

Fig.3 COLLAPSE OF OUTER WYTHE OF WALL TO FULL HEIGHT

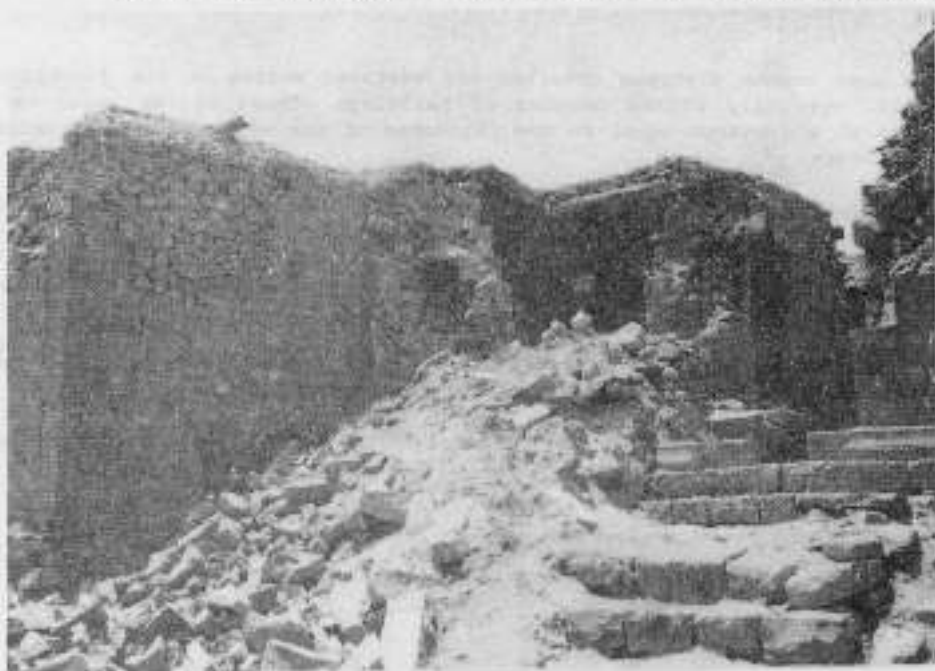
- * Collapse of masonry in 'V' shape at corners of walls near the top was another distress commonly noticed in severely damaged houses.
- * Further stage of damage was collapse of complete wall, which was more prevalent in the rear rooms of houses, where the roof was directly resting on walls, without the support of framework.
- * Complete collapse of outer wythe of wall was another stage of damage (Fig.4). In most cases, walls had completely collapsed with part of roof still resting on timber framework, which had swayed in one direction or the other. (Fig.5)

Fig.4 COMPLETE COLLAPSE OF OUTER MASONRY OF WALL

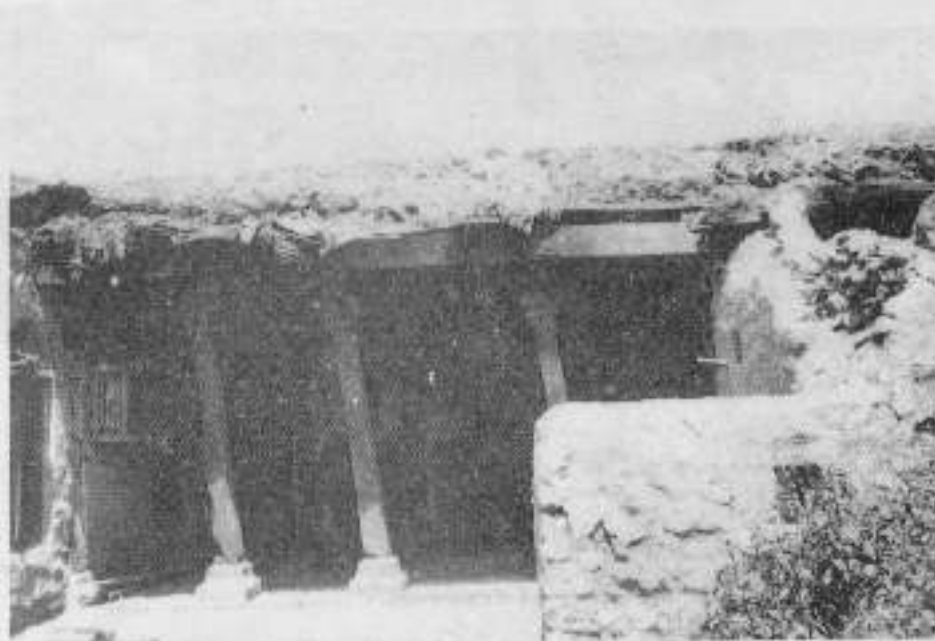
Fig.5 SWAY OF TIMBER FRAME WORK

- * In case of timber framework, the posts were resting freely on stone pedestals and beams at top were resting on the posts directly or through corbels, without much of fixity. These pin jointed connections resulted in sway of the frames during tremors in most cases and in collapse of frames and roofs in some cases.

To avoid sway of frames and their collapse, fixity should be provided to the joints between members of frames. Knee bracing at top of frame is one such measure.
