LESSONS FROM NIIGATA EARTHQUAKE

C.S. Jain*

SYNOPSIS

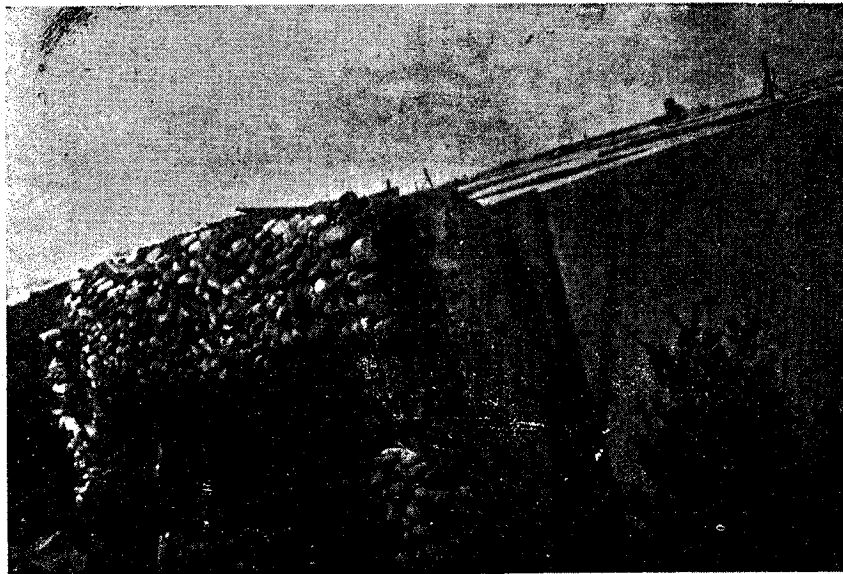
Therefore in the planning and design of earthquake resistant structures provision for basement and pile foundation should be given adequate consideration. Photo II shows a overturned apartment exposing the bottom stones of the foundation and indicating the inadequate depth of foundation.

Photo No. 2 Overturned Apartment at Niigata Showing the Foundation Stones
