PERFORMANCE OF KALIABHOMORA BRIDGE ON RIVER BRAHMAPUTRA DURING BURMA-INDIA BORDER REGION EARTHQUAKE OF AUGUST 6, 1988

G.I. Prajapati

Deptt. of Earthquake Engg., University of Roorkee, Roorkee

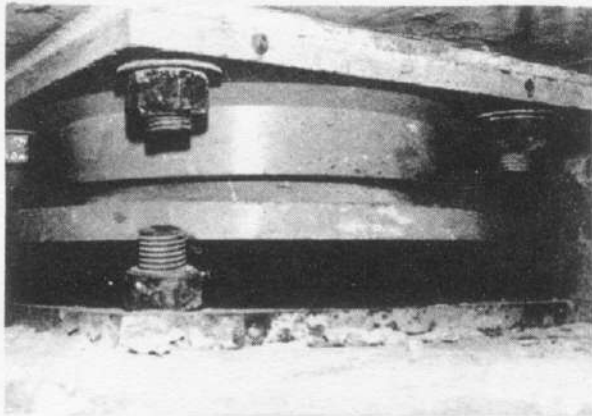
Fig. 6: Bending of Bolts Holding Bottom Steel Plate of Fixed Bearing

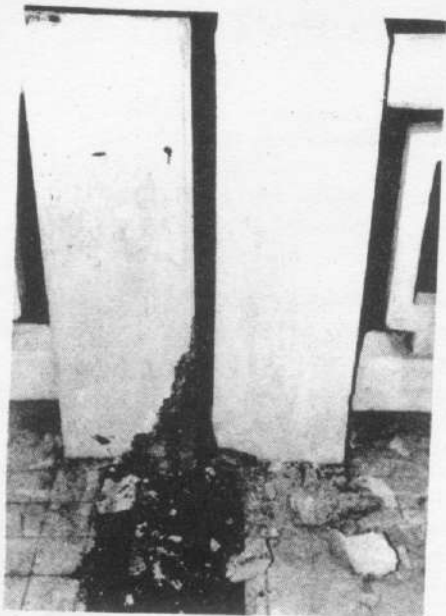
Fig. 7: Damage to Rail Post at Fixed End of Suspended Span

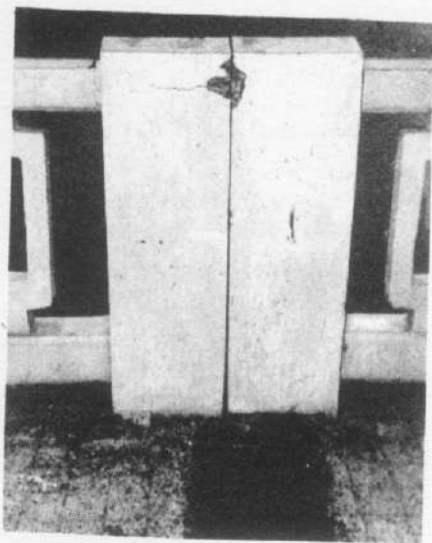
Fig. 8: Closure of Gap between Two Rail Posts at Fixed End of Suspended Span between Piers 14 and 15
