CASE STUDY OF KOYNA DAM*

J. KRISHNA¹

Introduction

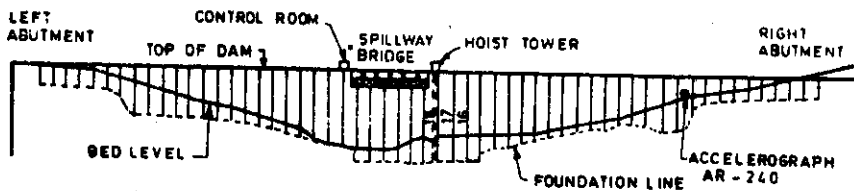
Fig. 12 Valley showing various monoliths of koyna dam

Fig. 12 shows the general elevation of the dam showing its monolith, position of gallery in which the accelerograph was installed. The dam was damaged by the earthquake and developed cracks and consequent leakage of water seen in the gallery and the downstream face. In order to determine the strengthening required, model tests and elastic analysis based on "Beam Method" and "Finite Element Technique" were carried out. The model studies and the analysis forecast the cracking at more or less the same levels as it occurred in practice.

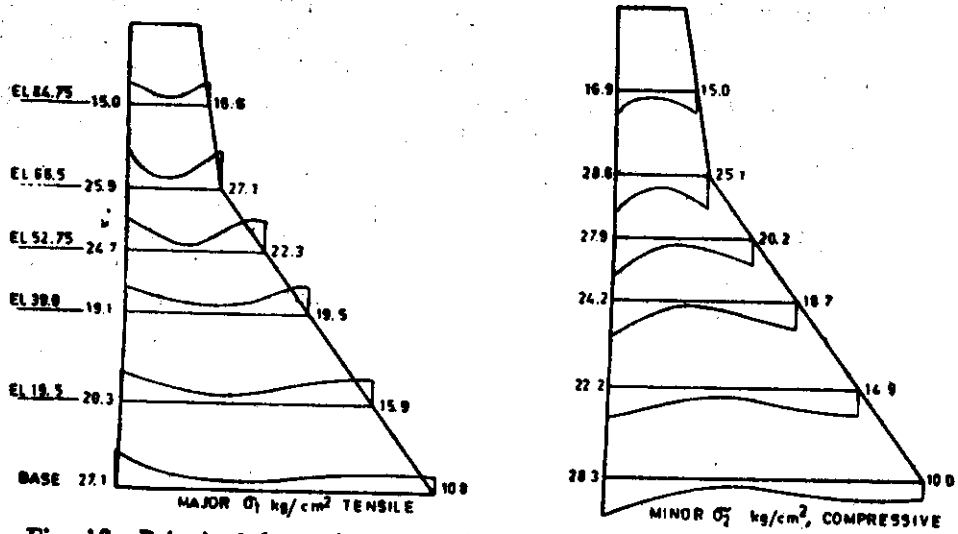
Fig. 13 Principal dynamic stresses due to horizontal ground motion without reservoir water (maximum during earthquake)

Figs. 13, 14, 15 and 16 indicate the variation of stresses due to the earthquake. Fig. 17 gives the total stresses static and dynamic due to horizontal ground motion. It will be seen

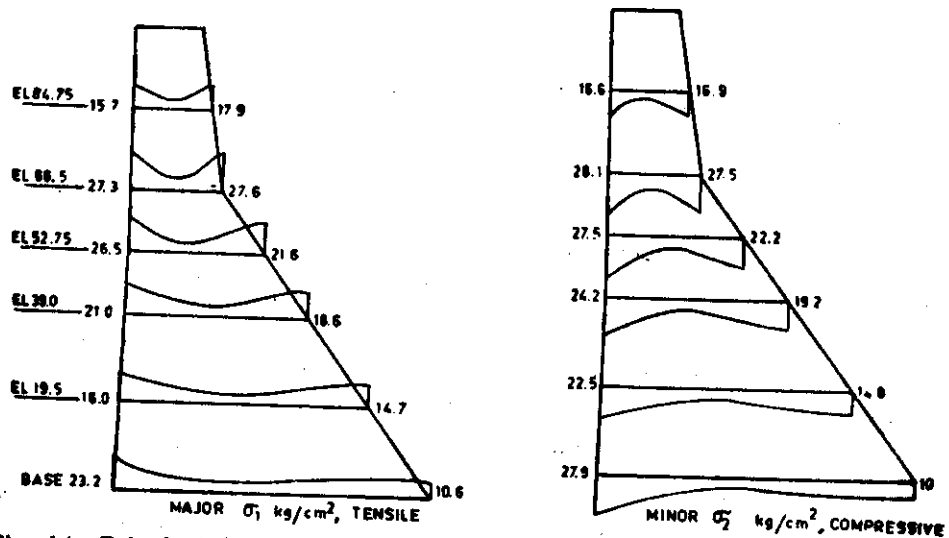
Fig. 14 Principal dynamic stresses due to horizontal and vertical ground motion without reservoir water (maximum during earthquake)

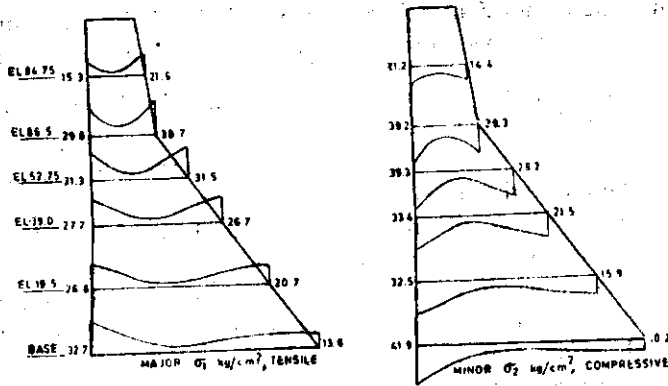
Fig. 15 Principal dynamic stresses due to horizontal ground motion with reservoir water as virtual mass (maximum during earthquake)

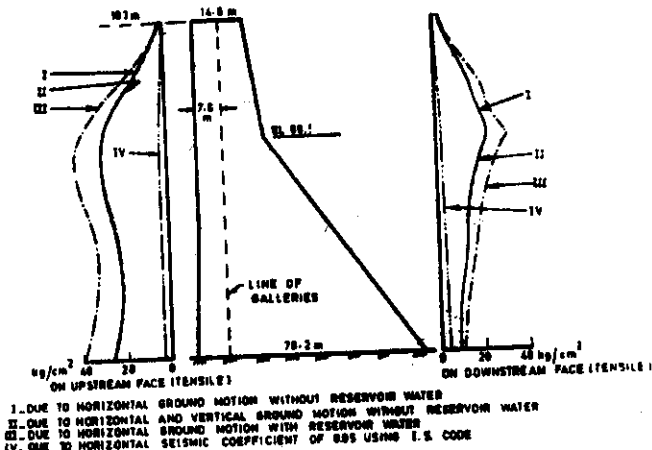
Fig. 16 Variation of vertical normal dynamic stress along upstream and downstream face of dam

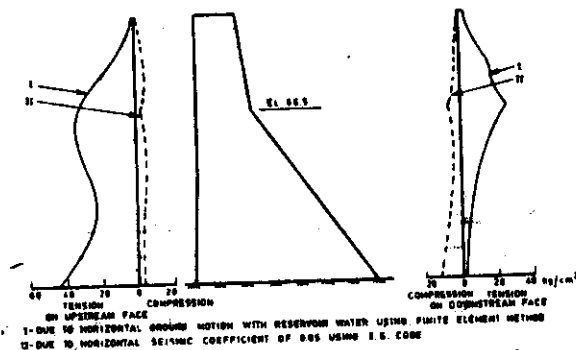
Fig. 17 Variation of vertical normal total stress along upstream and downstream face of dam

that a provision of 5%g as horizontal force as per code is wholly inadequate compared with the type of forces that actually develop in a dam during a strong earthquake.
