## DAMAGE REPORT OF THE LATUR - OSMANABAD EARTHQUAKE OF SEPTEMBER 30, 1993

A. Sinvhal, P.R. Bose and R.N. Dubey  
Department of Earthquake Engineering,  
University of Roorkee,  
Roorkee, U.P., India, 247667.

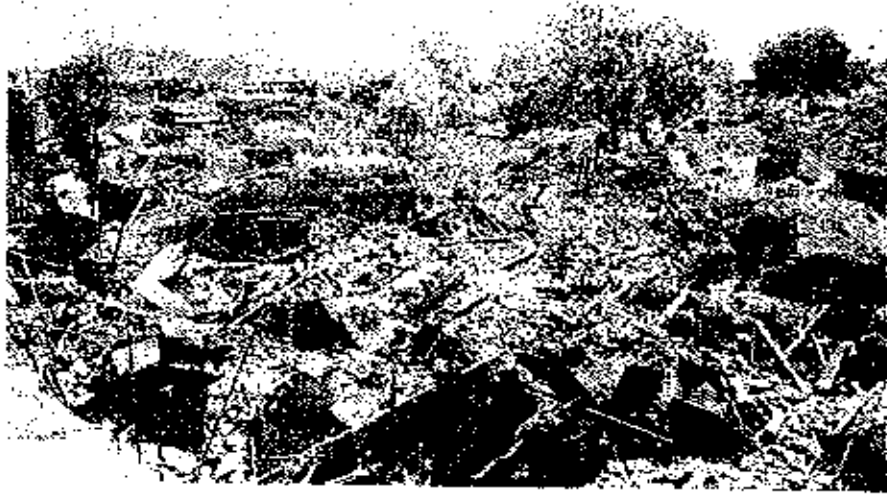
*Fig 2 View of the devastated Killari village.*

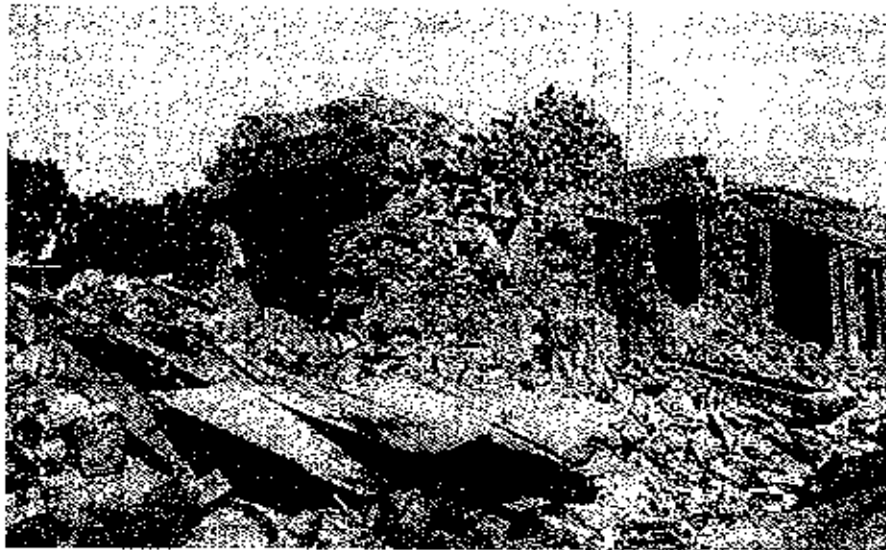
*Fig 3 This heap of stone rubble, timber and mud was street of stone houses at Killari before the earthquake.*

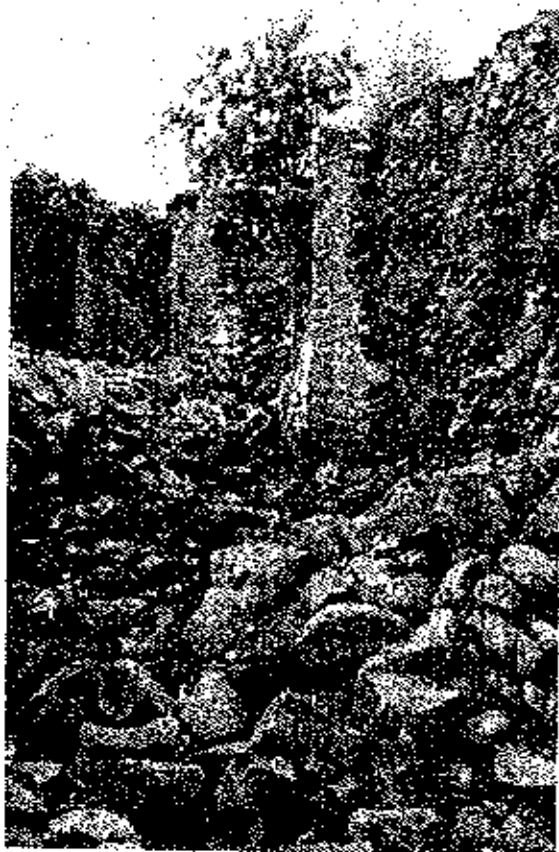
The walls are made of random rubble stone masonry laid in mud mortar with very few and small openings for doors and windows. The walls are usually 70 cm to 1.8 m thick, with 1 m being the norm. Such thick walls are popular as they provide thermal comfort and security. Everywhere typical wythe failure or delamination associated with stone walls is visible due to absence of bond stones, fig 4. The quake has demolished all such houses in the entire metzosalimal area.

*Fig 4 Failure of stone wall. The outer wythe bulged out and collapsed completely, Sastur.*

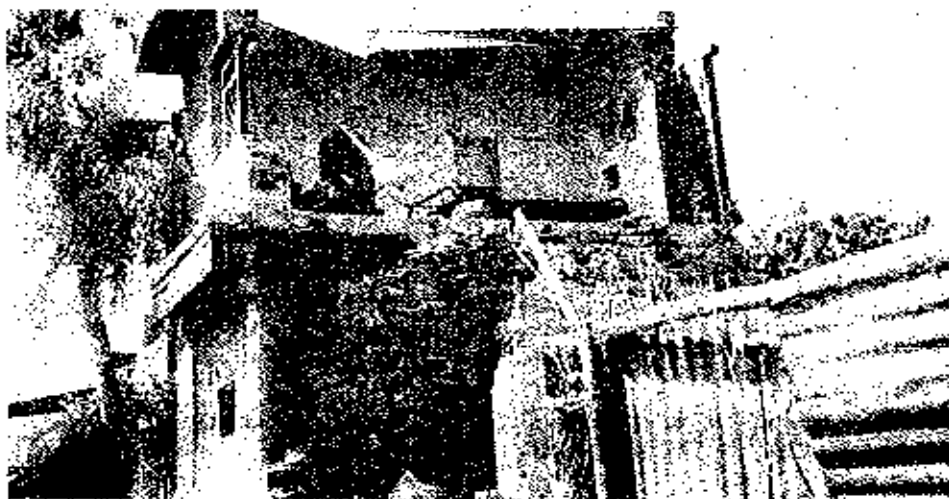
In bigger villages such as at Kilari, extensions are sometimes made in existing stone structures either in the front court yard, or when there is a shortage of open space another storey is added on to an existing stone house. The new storey is made of brick or stone blocks which are laid in cement mortar. Mixed construction of this type had very typical failure, fig 6.

*Fig 6 Failure in a construction of mixed type at Killari. Brick was laid in cement-sand mortar to make walls above a stone house. The brick wall slided and came down en masse as there was no connection between old and new type of construction.*

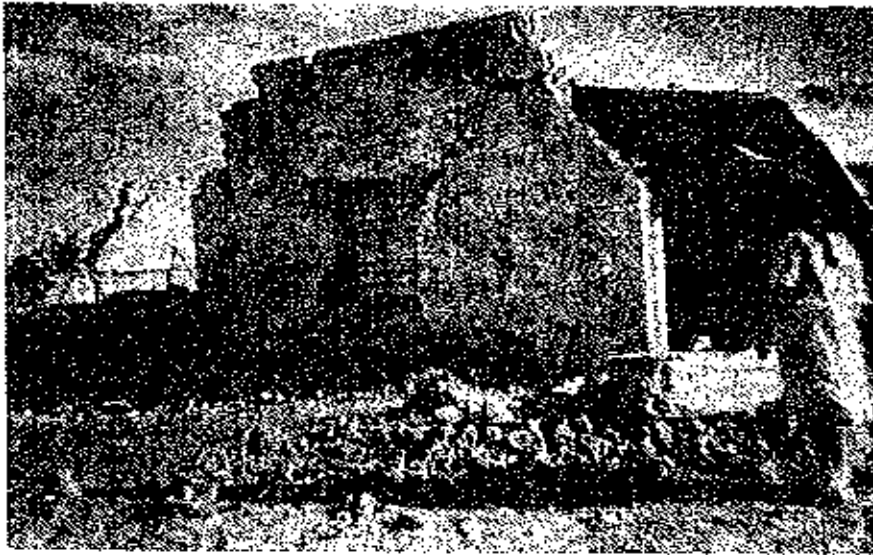
In most stone houses the roof in the verandah is made of CGI sheets. The shaking caused by the earthquake separated the walls at corners, the walls moved outwards and the roof collapsed. School buildings in the melzosalem area were usually made of brick with CGI roof. Damage to such a school building is shown in fig 8.

*Fig 8 Collapsed CGI roof of Government School at Mangrul.*

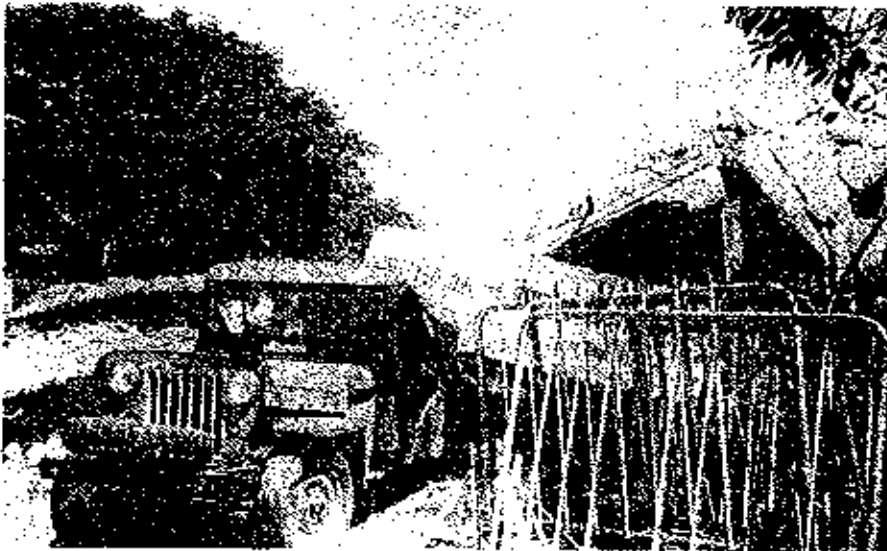
In some buildings the roof is made of an RCC slab which is supported on stone walls where the stone is laid in mud mortar. The earthquake caused failure of stone walls in such buildings, which caused the concrete slab to come down like a sheet, and this proved to be an unmitigated earthquake disaster on September 30, 1993, as shown in fig 9.

*Fig 9 A jeep trapped under the collapsed RCC roof of District Cooperative Bank at Killari. The RCC roof rested on stone walls before the earthquake.*

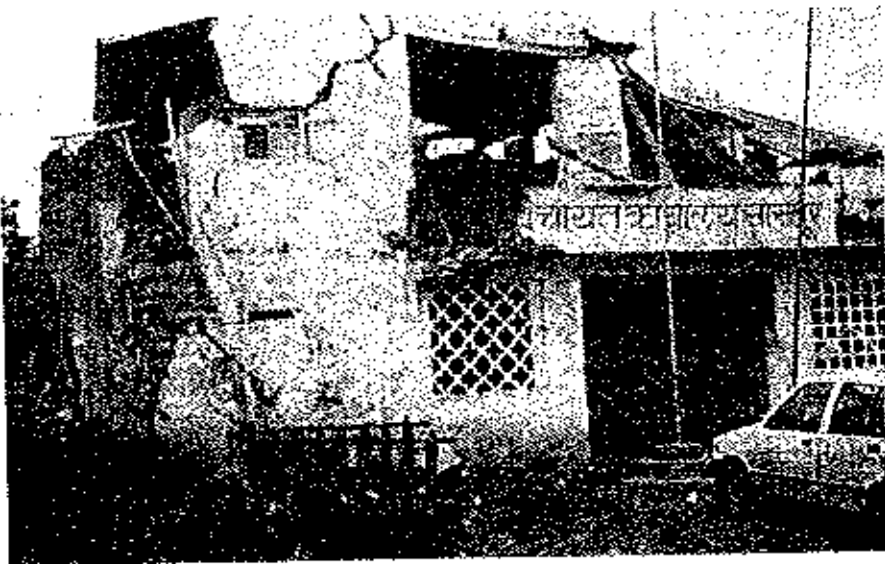
As the local soil is not conducive for manufacture of good quality bricks therefore it is not a common building material. Where bricks were used they were mostly laid in cement - sand mortar and only sometimes in mud mortar. The latter have very thick walls. The police station, the post office, the society building and the Bank of Maharashtra, all at Kilan, showed horizontal, vertical and diagonal cracks in walls. Several shops made in this way at Sastur showed partial damage. Damage to the Panchayat Office at Sastur is shown in fig 10.

*Fig 10* Brick building of Panchayat office at Sastur showed extensive damage to the first floor. This was because the tin roof rested on iron rafters and did not have a roof band.

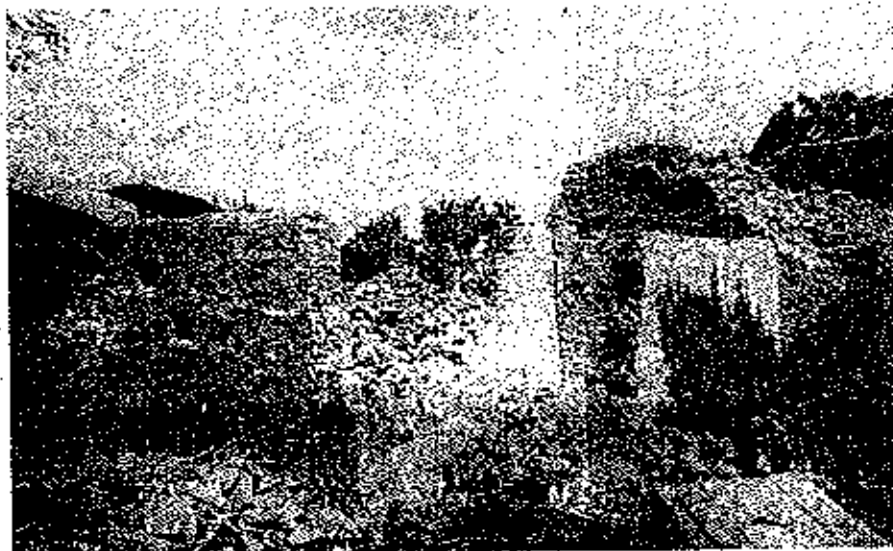
*Fig 12 Collapsed adobe house at Killari.*

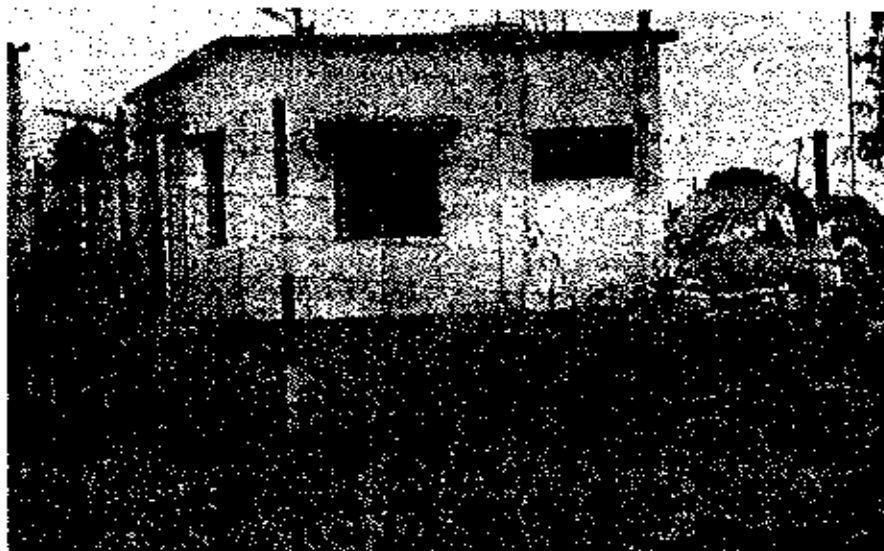
*Fig 16 The well engineered brick masonry building of Electricity Board survived with cracks, at Sastur.*

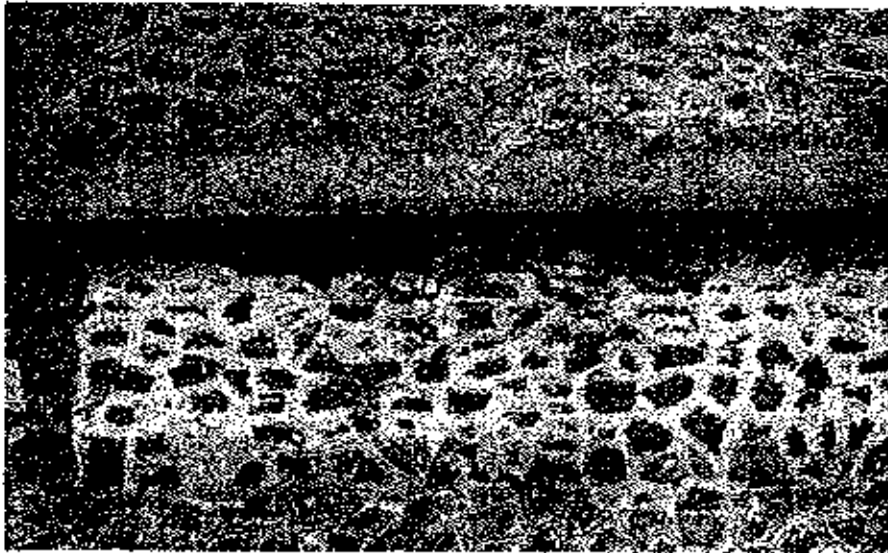
A well engineered structure, the sugar mill at Killari has very heavy machinery installed inside. Damage to this large mill was minimal, fall of plaster was observed at one place only. A portion of the infilled stone masonry fell off, fig 20. Slight damage to the huge chimney was observed at the top in the form of vertical cracks. This sugar mill served as a local centre for collection of relief material in post earthquake operations.

*Fig 20*      *Damaged stone masonry infilled panel in sugar mill at Killari.*

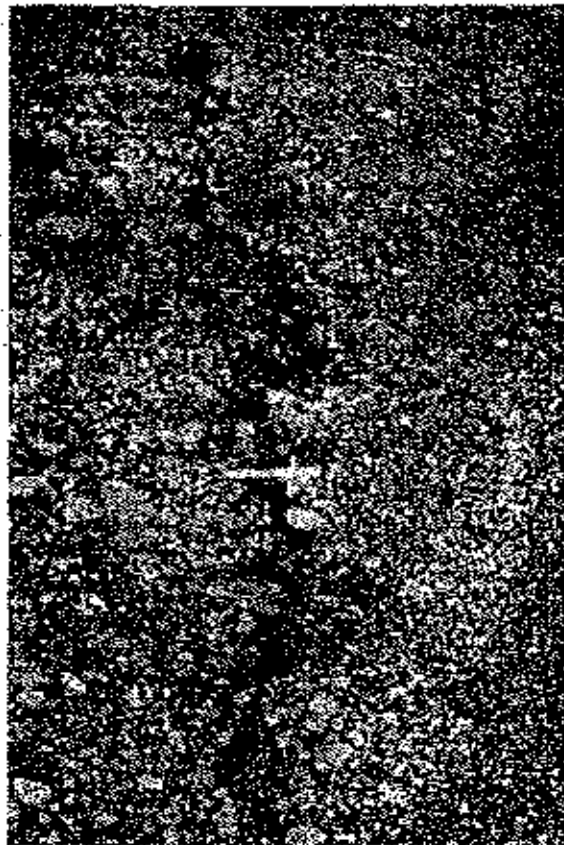
At Ganjankheda a long fissure developed in the left embankment of the canal due to slope failure of loose material, figs 21 and 22. The surface opening was more than 2 cm wide at places, the slope settled about 10 cm. A diagonal fissure in the canal covered 3/4th of the width of the right embankment, in north south direction. It was 4 - 5 cm wide and 12.5 - 25 cm deep at places. A newly constructed aqueduct showed non-structural minor cracking in the railing of the bridge at several places.

*Fig 21*      *Fissure in left embankment of canal near Ganjankheda.*

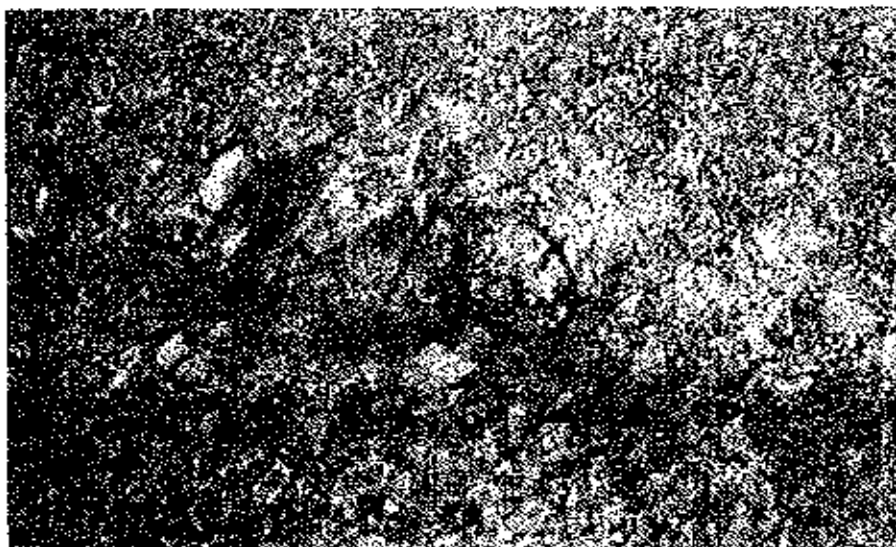
*Fig 22 Slope failure of canal embankment at Ganjankheda.*

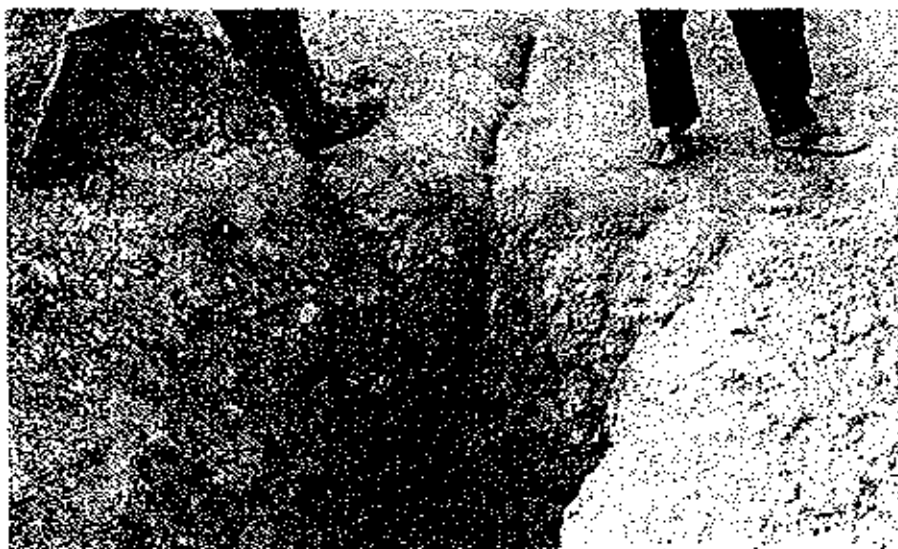
At Makni a 15.4 meter high earth dam consists of a reinforced concrete spillway in the middle and earthen embankments on both sides. A 400 m long fissure was observed in the left embankment which was one meter deep as confirmed by pit opening, fig 23. The embankment partially settled down which was clear from the side of the spillway bridge, fig 24. However, the fissure developed 130 m away from the bridge where anchoring effects of the spillway were lost. A similar failure but of lesser extent occurred on the right embankment also. This type of failure confirms dominance of vertical motion. This kind of typical damage indicates that since an earth dam dampens the vibrations therefore it offers an inherent resistance against earthquakes, the damping being proportional to the deformation. As reported by the dam engineers all gates of the dam leaked after the earthquake and healed on their own 24 hours later.

*Fig 23 One meter deep fissure in left embankment of lower Terna dam, as confirmed by pit opening.*

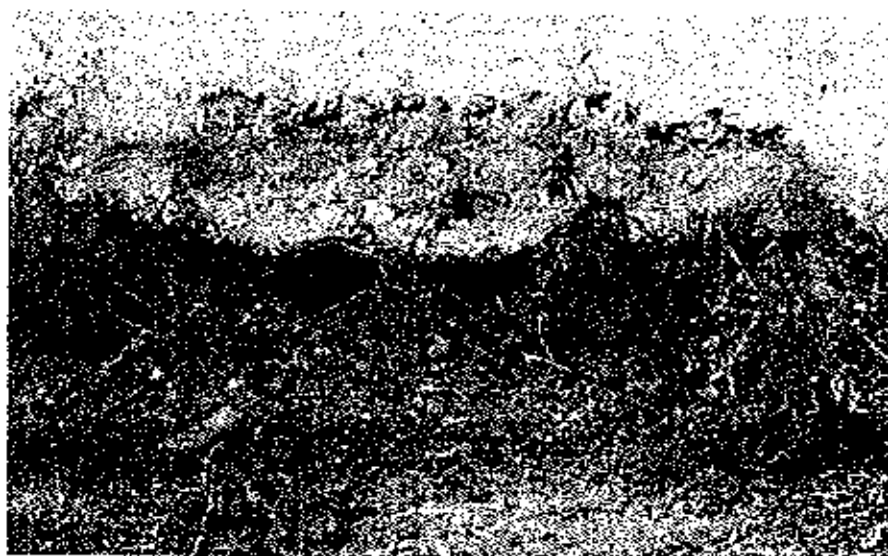
*Fig 24 Settlement on left embankment in spillway bridge, Terna Dam.*

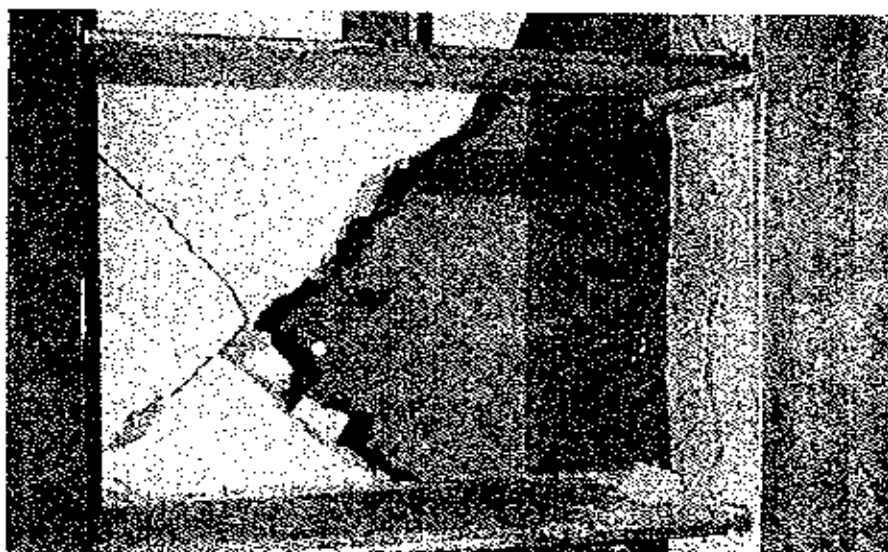
Damage to the rest house for this dam is shown in fig 25. The doors were jammed at the time of the earthquake and inmates had problems in escaping.

*Fig 25 In the brick masonry building of rest house of Lower Terna Dam Project at Makni, walls cracked, plaster fell off from walls and part of a half brick thick wall collapsed. Fig shows a portion of the collapsed partition wall between bedroom and washroom.*

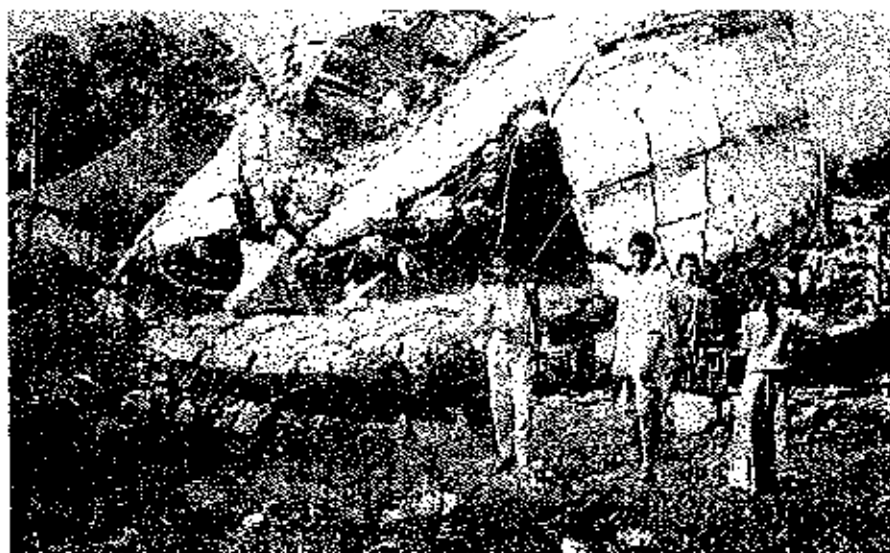
An overhead water tank, fig 26, of 100 kilo liter capacity, full at the time of the earthquake, collapsed completely. The possible reasons of failure could be a combination of one or more of the following factors

1. Torsional component of ground motion
2. The stair case tower was connected with the tank, which increased torsion in the eccentric structure, fig 27.
3. Presence of water at the time of the earthquake generated heavy inertia forces.
4. Inadequate transverse reinforcement was used near joints in columns, fig 28.
5. P - effect, i.e. vertical load vs horizontal displacement effect.

*Fig 26 Failed overhead water tank with domical base at Kawtha.*

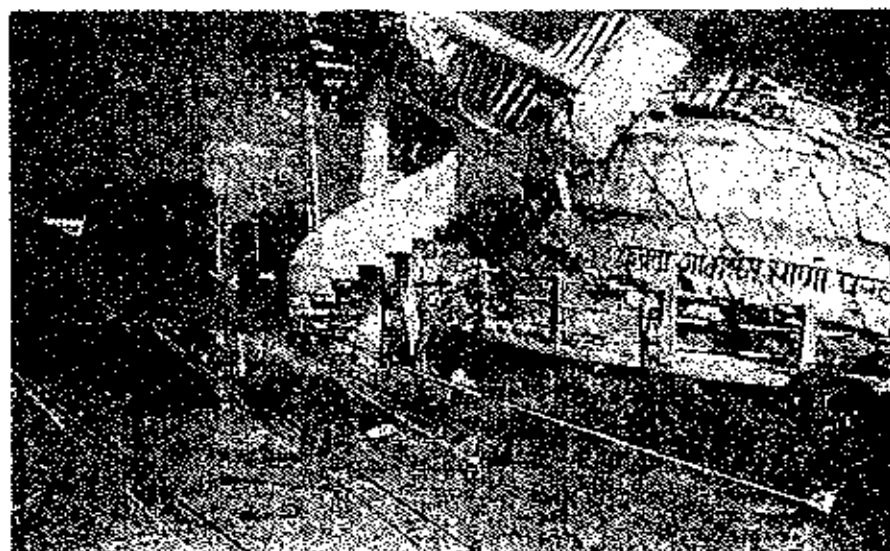
*Fig 27 Failed staircase unit of overhead water tank, Kawtha.*

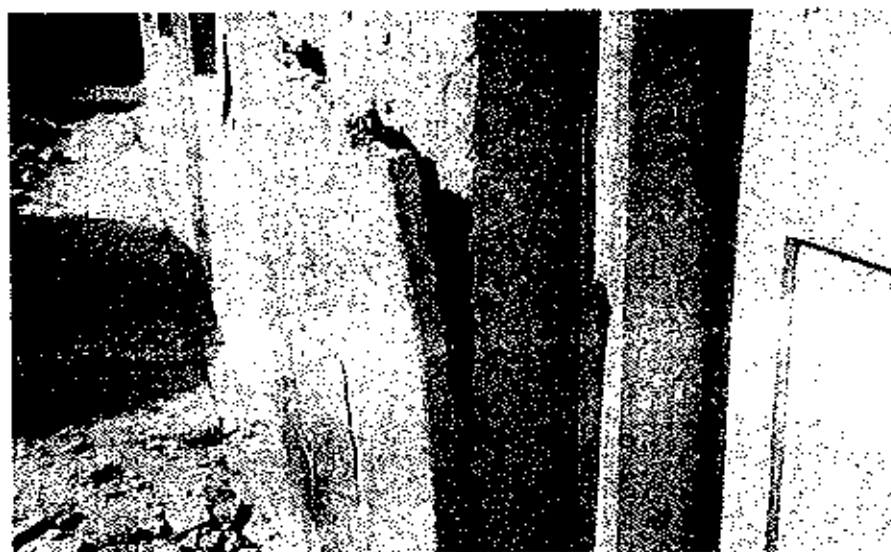
*Fig 31 Thick plaster bulged out at Dr. Bhujbal's clinic, Killari.*

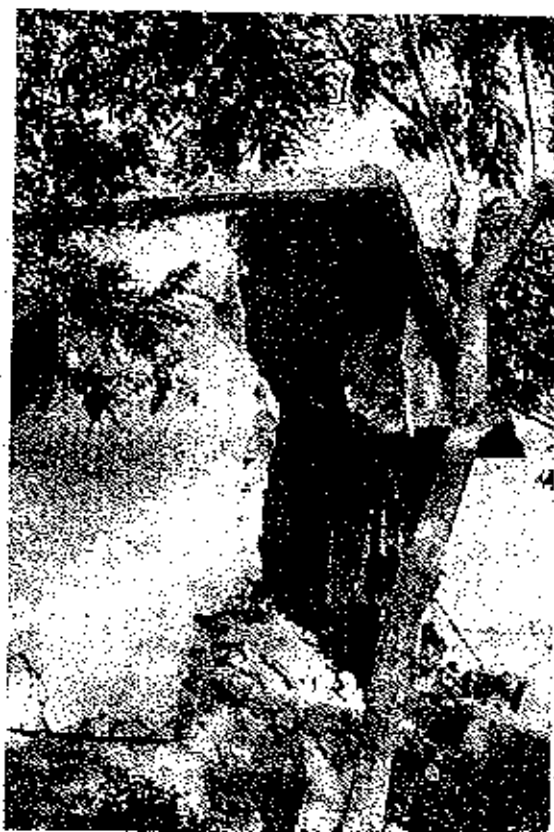
*Fig 32* Brick masonry building of leprosy centre at Mangrul developed large and deep cracks.

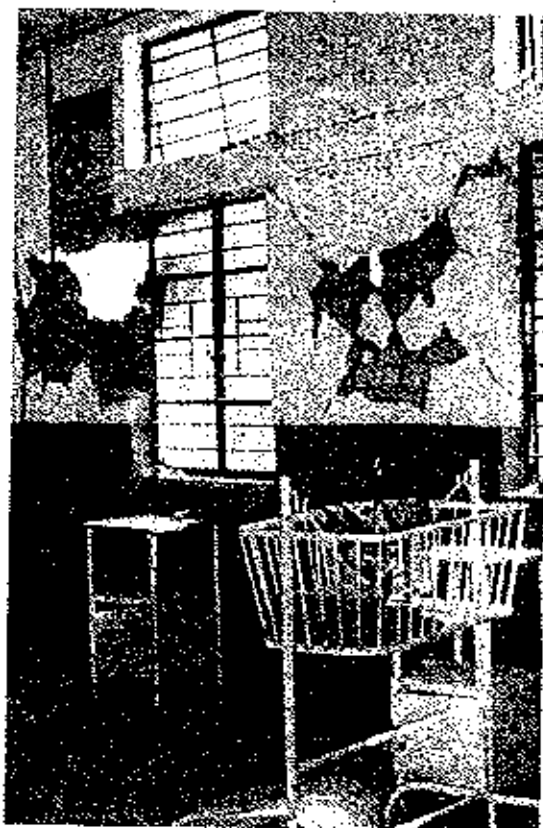
The Rural Hospital at Kilarī is made of brick masonry in cement - sand mortar. The earthquake caused wide, deep, diagonal and horizontal cracks in walls, fig 33, and some portions of the wall fell off. The doctors showed the authors portions of the walls where cracks had developed due to a previous tremor which occurred on October 18, 1992. These were subsequently repaired, fig 34. Extensive damage was observed to non structural elements like tiles, wash basins, electric fittings etc, fig 35. Several doors of the hospital were jammed. Seven resident patients (2 for tubectomy, 4 for gastro enteritis and one for delivery) escaped after the earthquake. Several houses on the hospital campus developed cracks and roof of the garage and boundary wall of the post mortem room collapsed. An hour after the earthquake the dead and the injured were brought into the hospital premises.

*Fig 33* Portions of wall fell off in the gynecological ward, Rural hospital, Killari.

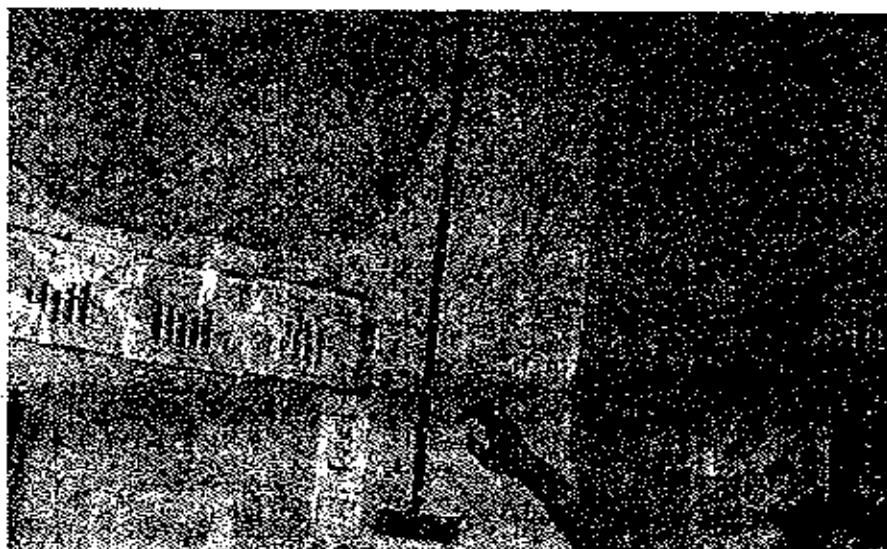
*Fig 34* Doctors showing portion of a wall which developed cracks one year earlier, in the tremor of October 18, 1992. These were plastered subsequently, Rural Hospital at Killari.

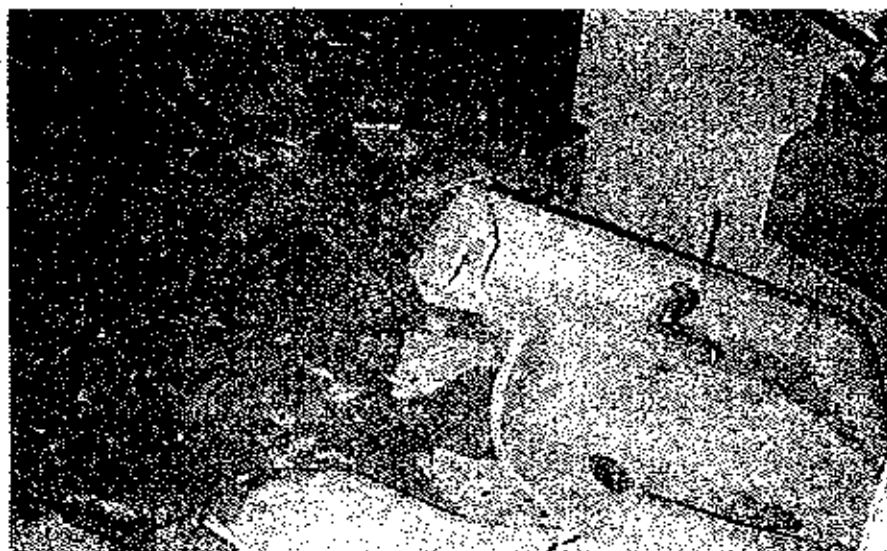
*Fig 35* Dislodged electric fittings and wash basin inside the operation theatre at Rural hospital, Killari.

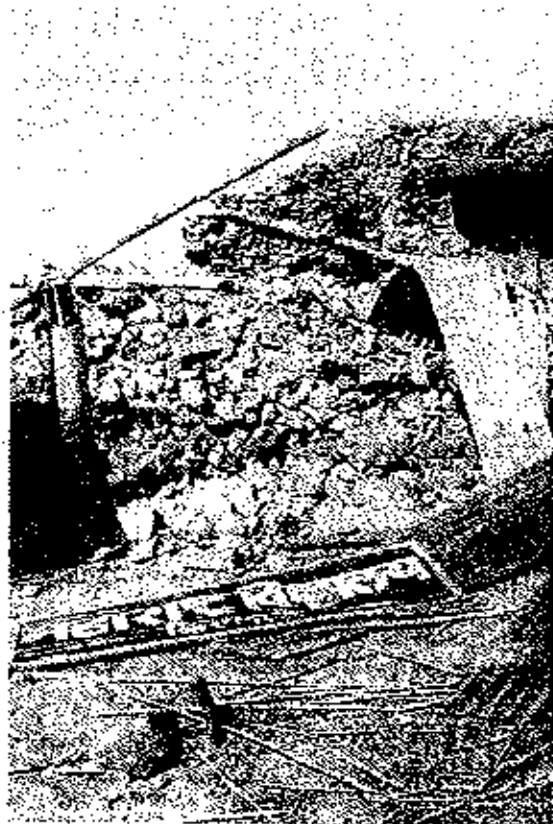
Fig 36 Collapsed building  
of Maharashtra  
Vidyalyaya at  
Killari.

Schools made of random rubble stone masonry collapsed in the quake affected area, such as the Maharashtra Vidyalyaya, fig 36, and Shishu Vihar at Kilarī. However, since the Dayanand Vidyalyaya at Kawtha was made of dressed stone it sustained the shock. The Zila Parishad Basal School at Limbada is made of brick masonry with a tin roof inclined at a very low angle. Damage to this school was in the form of huge gaps in wall. A small building of a government school at Mangrul, made with one and a half thick brick wall with cement mortar and a tin roof showed huge diagonal cracks. The roof of one room collapsed because of outward movement of wall. Fig 37 shows the damaged school at Sastur which had a tin roof and very thick brick walls laid in poor quality mortar.

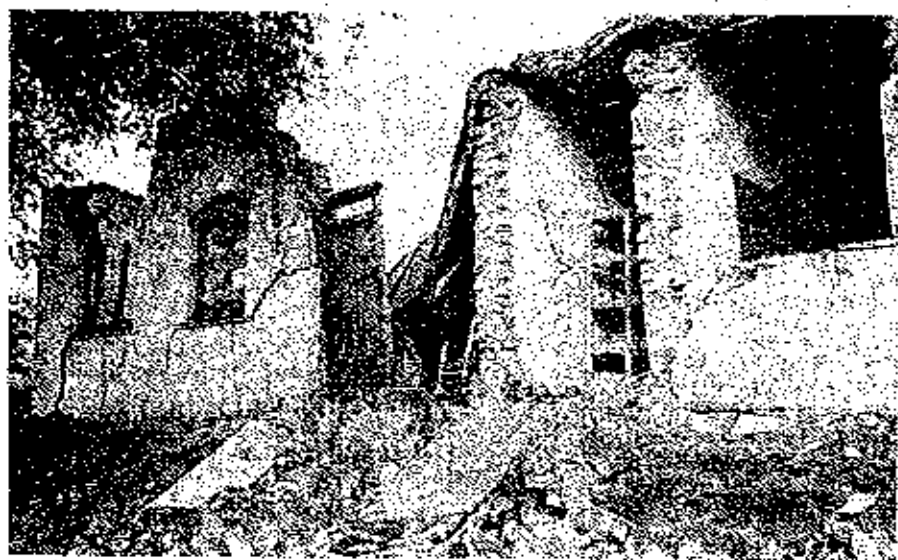
Fig 37 Collapsed school at Sastur.

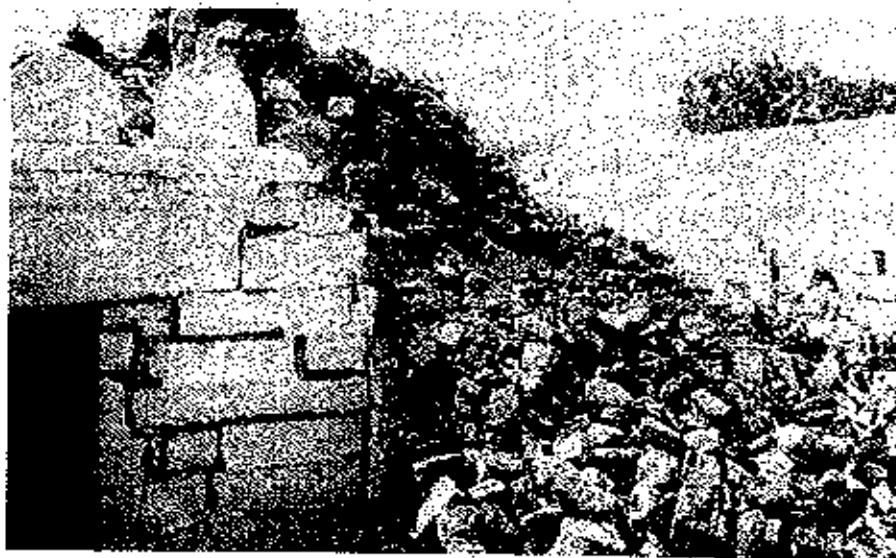
Fig 39 Collapsed dome of Neel Kantheshwar temple at Killari.

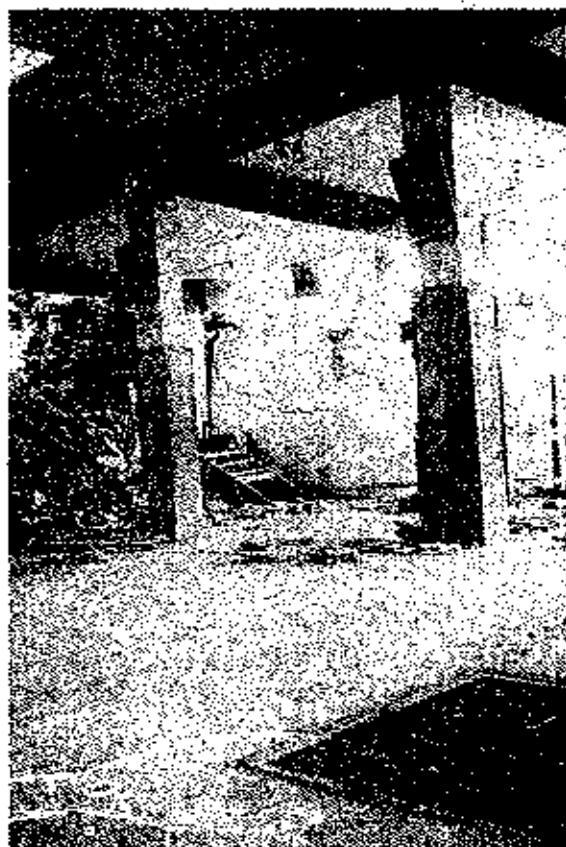
*Fig 41*      *Undamaged RCC frame at Neelkantheshwar temple, Killari. Tiles fixed on RCC column fell off.*

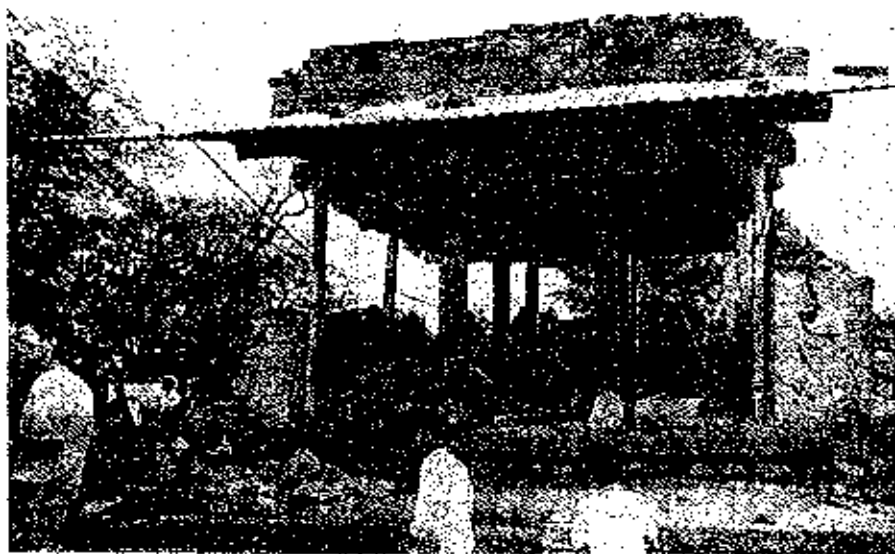
*Fig 42 Ganesh temple at Sastur. Walls around the timber frame collapsed outwards while the roof is intact.*

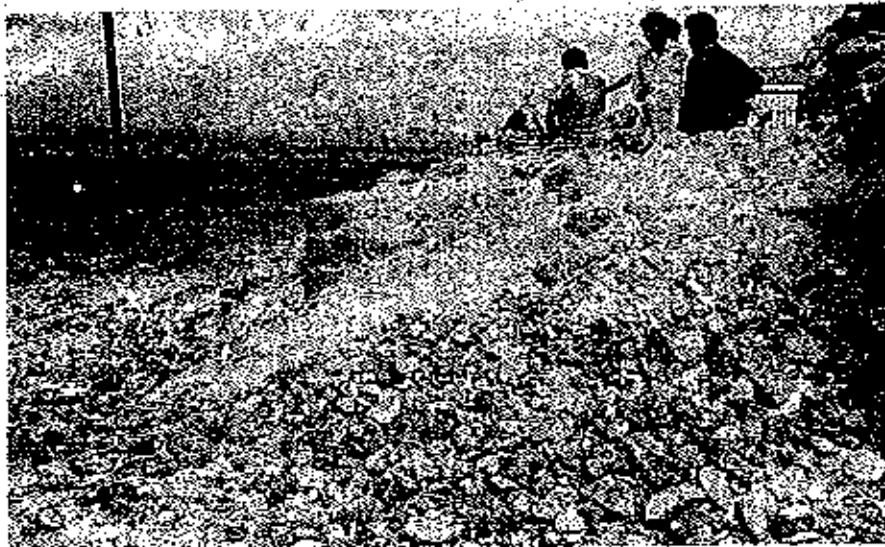
The central column of the Prakash Stambh outside the Renuka Devi temple and the sancum sancorum of this ancient temple collapsed completely, fig 45. A new idol has since been installed in the place of the old one. A heavy Kalash, (brass pot) almost 75 kg in weight, fig 46, fell off at a horizontal distance of about 8.25 m from a height of 10 m. The mosque and mazar complex is of a later date and 2 minarets partially collapsed due to the earthquake, fig 47. Plaster fell off the dome and vertical hair line cracks appeared in the mazar of Peer Pasha. The wireless station is a well engineered structure, fig 48 and remained intact in wake of the earthquake.

Fig 45 Completely collapsed sanctum sanctorum of Renuka Devi Temple at Kharosa.

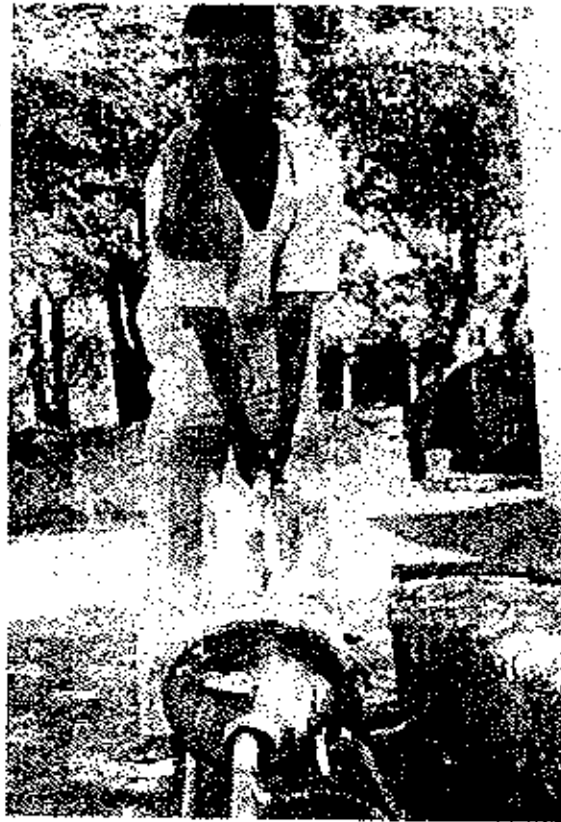
*Fig 46* Heavy kalash which fell off the spire of Renuka Devi temple.

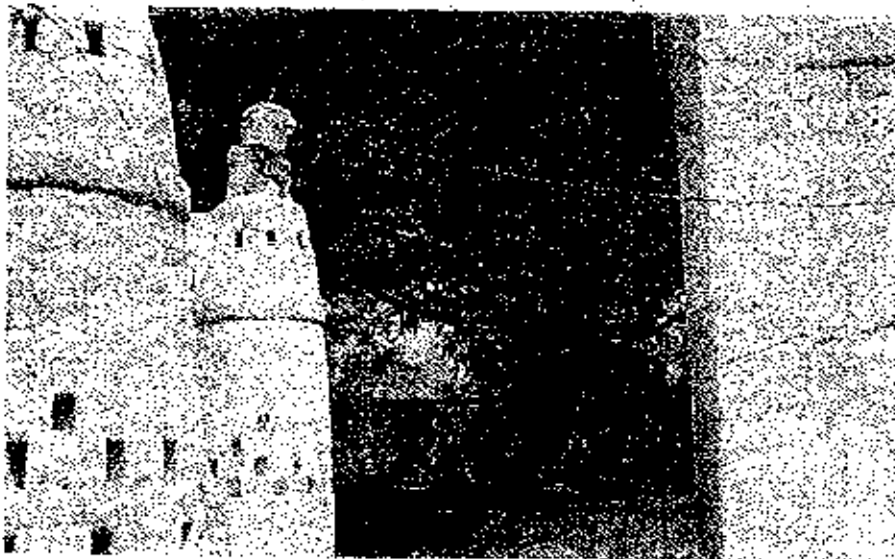
*Fig 47* Damaged minaret of mosque at Kharosa.

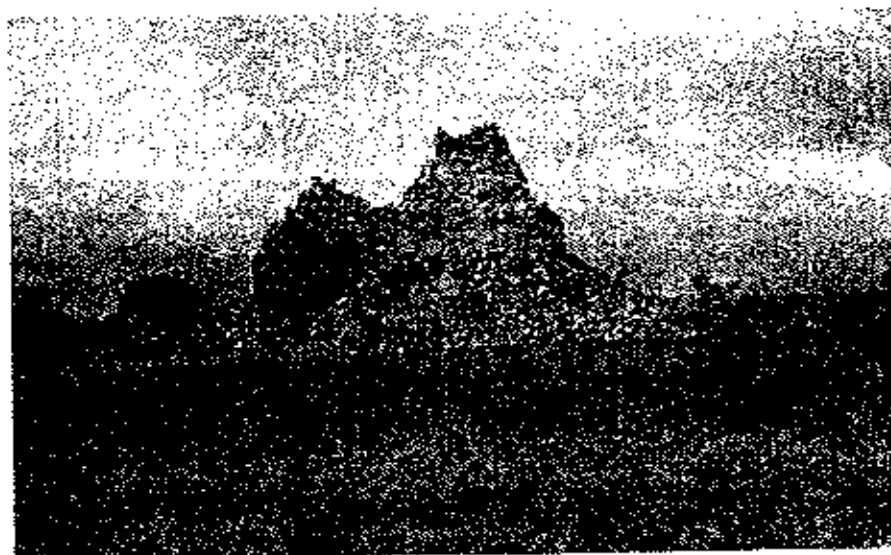
*Fig 49 Collapsed Mughal dome near Sastur.*

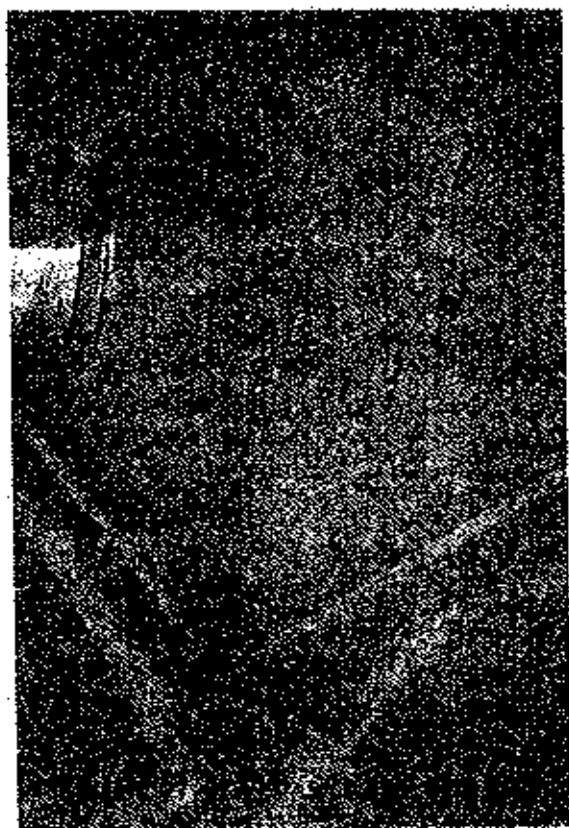
*Fig 51*    *Cracks inside the Bijapur dome.*

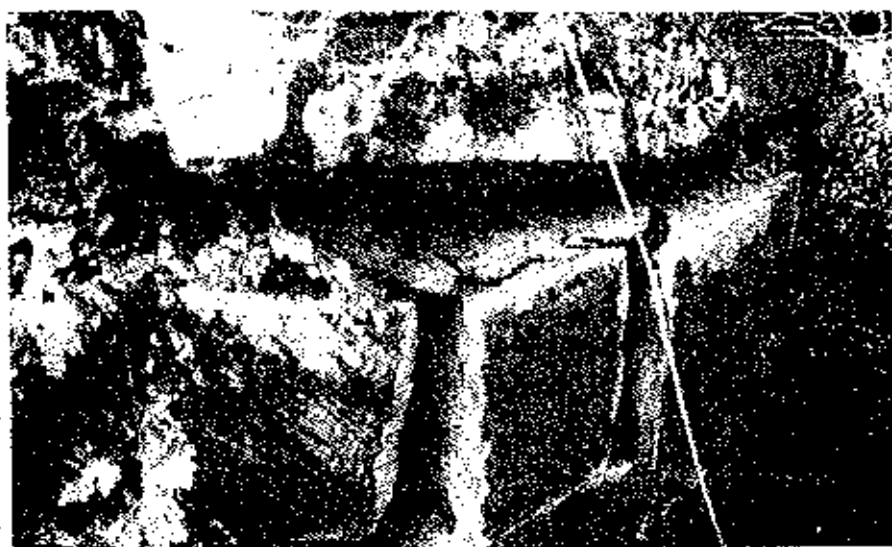
*Fig 53* At Maharashtra Vidyalyaya in Killari stones were displaced in pillars towards the north by about 4 - 6 cm. The circular pillar was made of 5 layers of hewn stones. One stone was displaced by a lift of 8 cm in 12 cm showing presence of vertical motion.

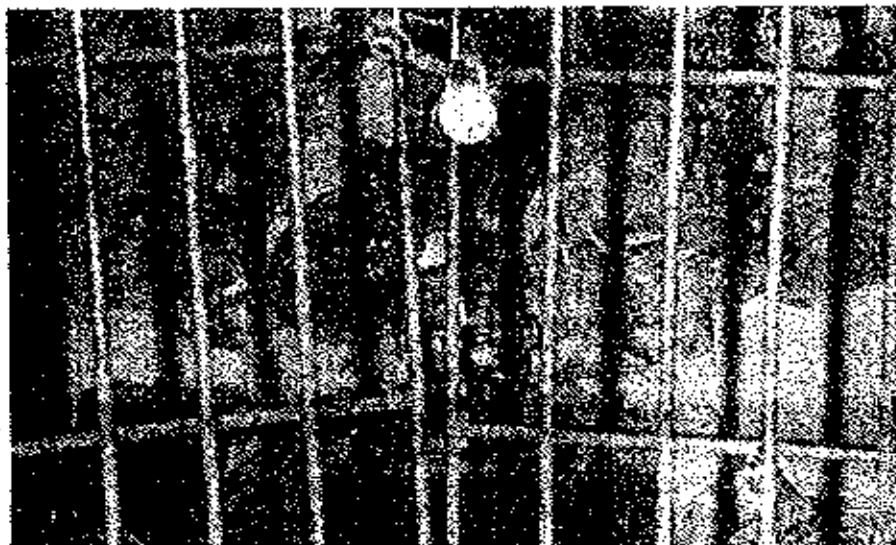
At Limbada torsional motion in north east direction is evident from the rotated statue of Lord Shiva, fig 54. This is also confirmed by deflection of four piers around the temple, the two piers in the east are tilted towards the north while those in the west are tilted towards the south. In Umarga the motion came from north west.

*Fig 54 Twisted statue of Lord Shiva at Limbada.*
