## **SEISMIC RESPONSE OF A TWICE-RETROFITTED BUILDING**

### **ABSTRACT**

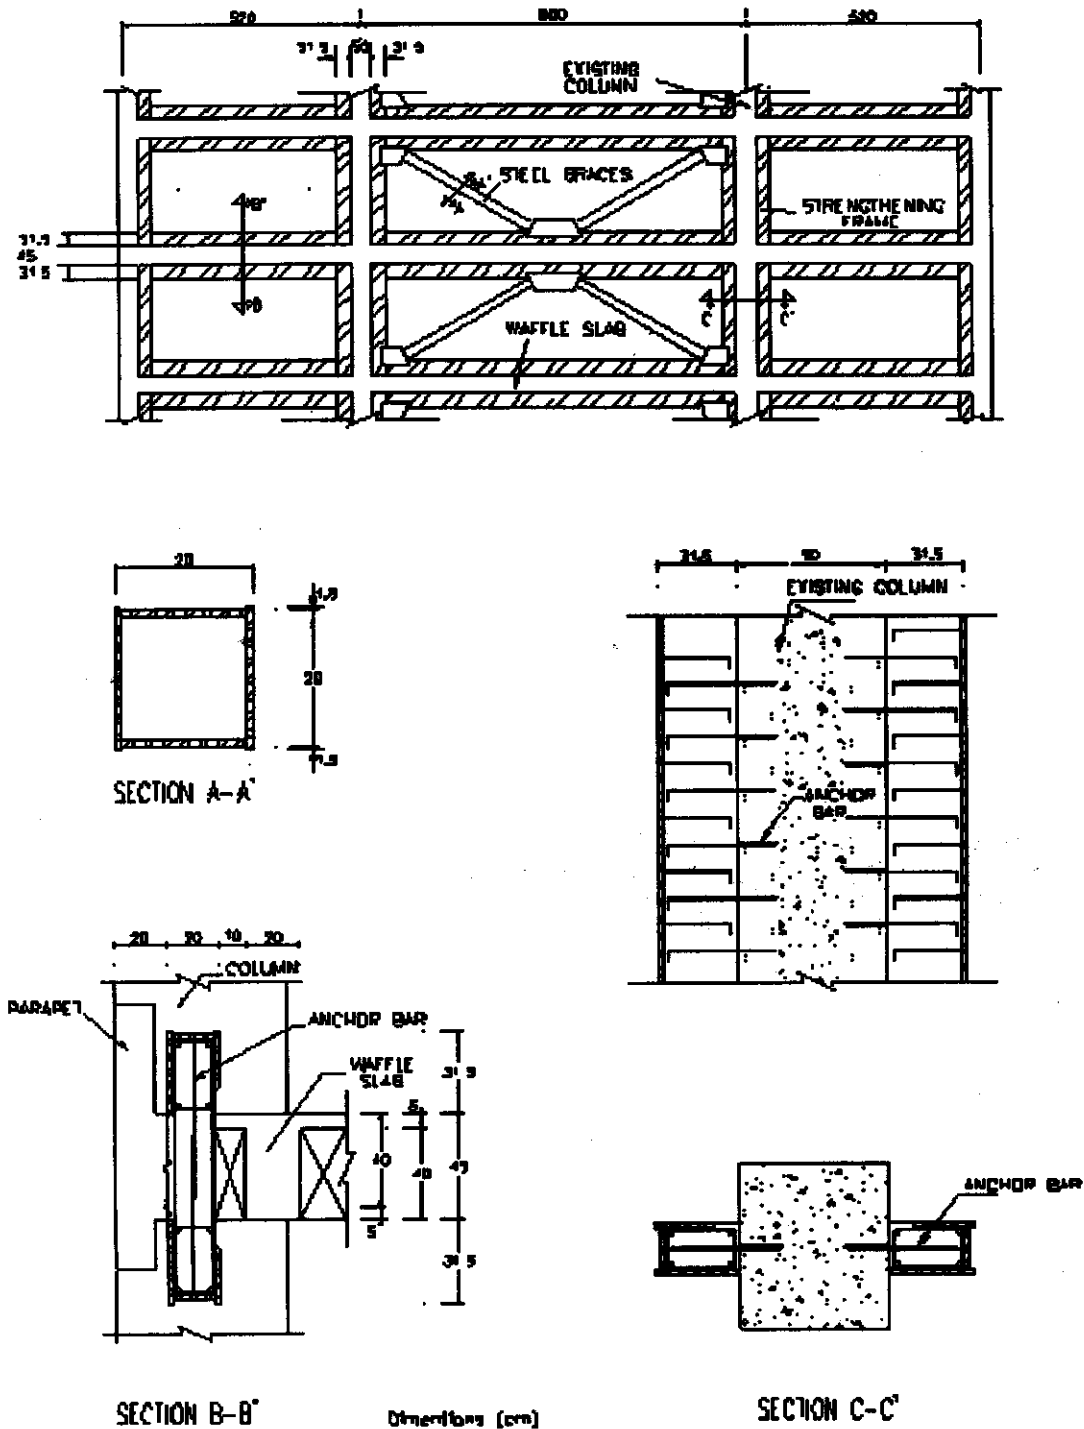
Fig. 4 Details of second rehabilitation

The December 10, 1994 earthquake (event 94-3) produced moderate damages in non-structural elements (cracking in masonry walls, as well as cracking and detachment of finished plaster and ceilings), and light structural damages (bending cracking and the perimeter sliding in concrete walls). These damages were attributable to the accumulation of the effects of previous earthquakes (mainly due to the September 1985 and April 1989 earthquakes). A light shear cracking also appeared in some columns of the parking area due to differential settlements. After the September 14, 1995 earthquake (event 95-1), more cracks in walls appeared. The bigger cracks were covered with plaster. In addition, some suspended ceiling elements fell down. The magnitude of previous settlements increased and the width of cracks in columns went up to 0.85 mm.

The deficient behaviour of the structure observed as a consequence of the moderately intense earthquakes between 1986 and 1995 led the owners to make a second rehabilitation. This time, the building was strengthened in the transverse direction (T) by steel bracing which was attached in the central bay of the exterior transversal frame through an additional steel and reinforced concrete frame. These coupling frames were put on all bays of the transversal façades. The vertical members of these frames were attached by using steel bars welded to the steel plates and glued to the concrete columns with epoxy resin through perforations. The bracing elements were square box-cross sections formed with steel plates welded to the

new coupling frames. The bracing system consisted of continuous X-bracing across two stories (Figures 1, 2 and 4).

The widths of the cracks in columns greater than 0.5 mm were injected with epoxy resin. The masonry walls with major damage were partially or totally replaced; the larger cracks were repaired with the injection of epoxy resin and then a mortar or plaster cover was applied. Moreover, an emergency steel staircase at the southwest corner of the building was built. At one end, it was supported by the building at each one of its storeys and by two steel columns at the other extreme. These steel columns were connected to two new reinforced concrete columns built over the full height of the adjoining structure.

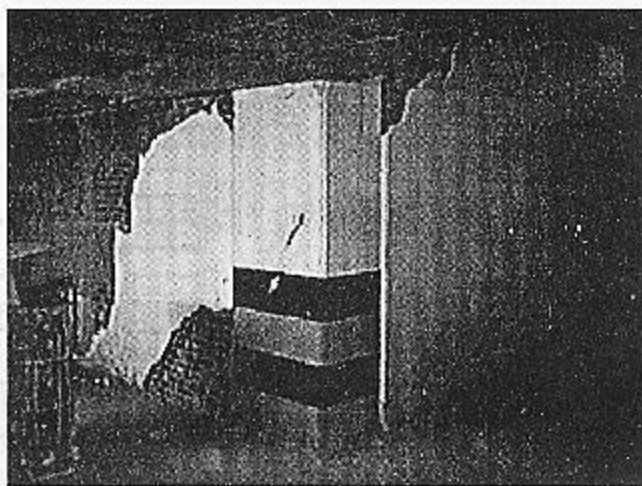
Fig. 5 Reopening of cracking at basement column 2D, parking view

The June 15 and September 30, 1999 earthquakes, events 99-1 and 99-3 respectively, produced diverse damages in the building. On several stories, detachment of finished plaster and ceilings was observed and some suspended ceiling elements fell down. Some parapets in contact with the columns at the last garage storey showed some damage, except those with a flexible material joint. All the masonry walls were damaged (Figures 5 and 6).

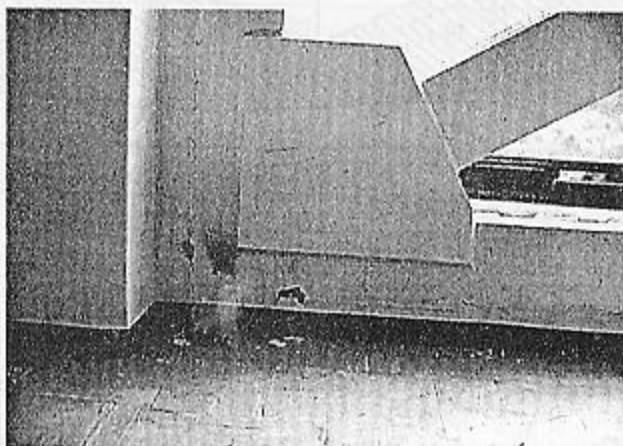
Fig. 7 Perimeter cracking at concrete-steel and concrete-concrete interfaces between new and old structural elements

Some cracking at the perimeter of the concrete-steel and concrete-concrete interfaces between the old and new elements was detected (Figure 7). In addition, at the parking stories, light cracking, perpendicular or inclined with respect to the metallic elements, was perceived. Effects of the 99-3 event increased the number of cracks, and their widths were less than 0.2 mm.

After the second rehabilitation, the deterioration in the interfaces between the new and old structural elements of the transversal façades caused a considerable observed reduction of lateral stiffness. This source of non-linear behaviour and those mentioned before contributed to the appreciable decrease of the vibration frequencies.
