## **STRUCTURAL DAMAGES ON THE COAST OF TAMIL NADU DUE TO TSUNAMI CAUSED BY DECEMBER 26, 2004 SUMATRA EARTHQUAKE**

B.K. Maheshwari, M.L. Sharma and J.P. Narayan

Department of Earthquake Engineering  
Indian Institute of Technology Roorkee, Roorkee-247667

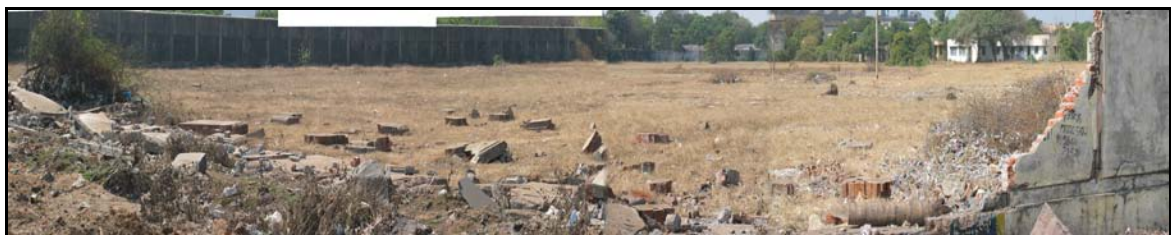
Fig. 3 The boundary wall of about 50 m length damaged in Cherain Nagar (Chennai)

Figure 3 shows the damage to a boundary wall near tollgate in Cherain Nagar (Chennai). Run-up observed in this area was 3-4 m (see Table 1). The wall was located about 50 m from the seacoast after crossing the 10 m wide road. The coast height near this locality was about 3 m only and tsunami waves could cross the breakwater made to prevent it. The boundary wall (made of brick masonry) was severely damaged. Damage was in partial length of wall only where the tsunami struck first and hydrodynamic force of the tsunami exceeded the bending capacity of the wall. Once water entered inside and pressure equalized on both sides of the wall, this reduced the overturning moment and further damage. Wall being unreinforced, this type of damage was inevitable. From Tables 2 and 3, the level of damage may be characterized as of Grade 4 in Type A structure.

- Collapse of compound walls should be avoided. Adequate depth of foundations for compound walls should be provided and erosion of soil should be checked.

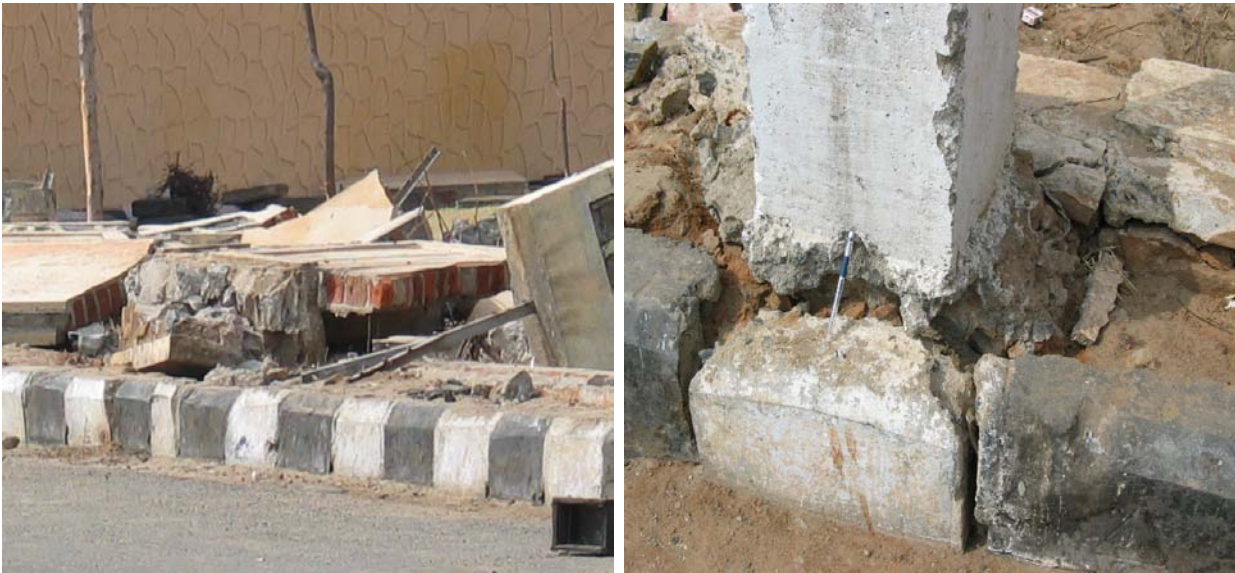
Compound wall of the Madras Lighthouse (Chennai) partially collapsed due to the tsunami (see Figure 4). According to Table 1, the run-up in this area was 4-5 m. Boundary wall was of brick masonry with concrete posts. A few concrete posts of the wall (to the south of the lighthouse) were even detached from the wall and damaged. It appears that the tsunami attacked the joints as posts were toppled from the joints with base. As shown in Figure 4, a post got displaced laterally by about 10 cm (after collapse of infill walls). Approximate size of a post was 0.45×0.3×1.5 m, with a weight of about 5 kN. Displacement of such a heavy weight shows that the lateral force exerted by the waves was indeed intense. Also it can be observed that compared to Figure 3, quality of the material used (concrete) here was better and the damage can be classified as Grade 4 in Type B in the 4-5 m zone of tsunami run-up height.

Fig. 4 Collapse of the compound wall of Madras Lighthouse (Chennai) (concrete posts of the wall separated; second figure shows that another post is displaced laterally by about 10 cm)

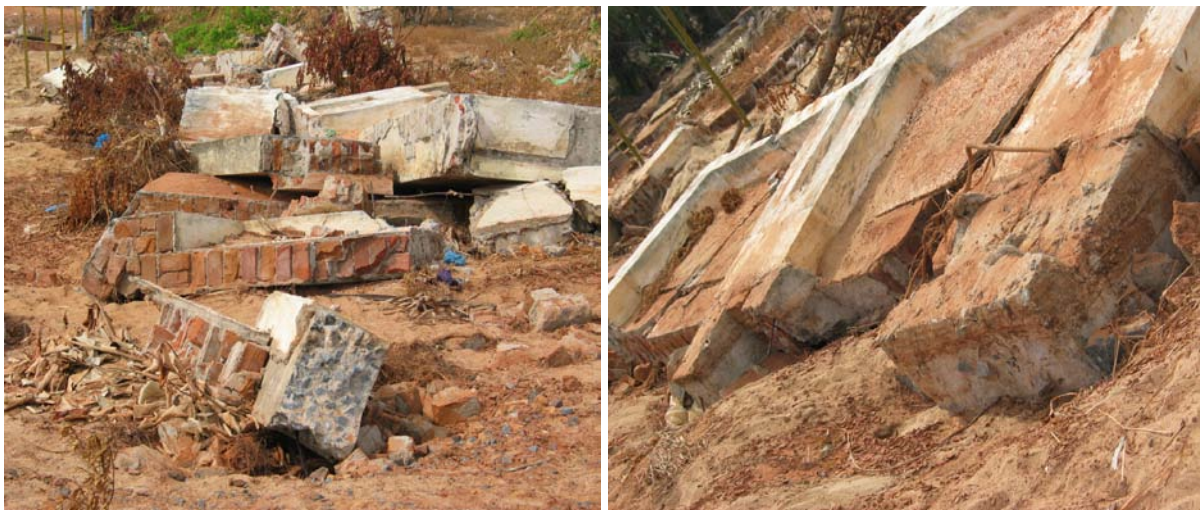
The boundary wall of a school in Chinapattam (run-up 4-5 m, see Table 1) was damaged as shown in Figure 5. Some of the parts of the wall were transported up to a distance of about 10 m. The wall was made of brick masonry with concrete posts. At most places the wall got uprooted from the base and toppled as a unit. Level of damage (Grade 4 in Type B) is due to high run-up elevation. Figure 6 shows that front (boundary) walls of few buildings got damaged while the roofs were intact. Brick masonry got damaged even when cement was the cementing material. It could be observed that though the boundary wall collapsed due to the tsunami, it helped to save the other parts of the building.

Fig. 5 Collapse of brick masonry compound wall of a school in Chinapattam (Pondicherry)

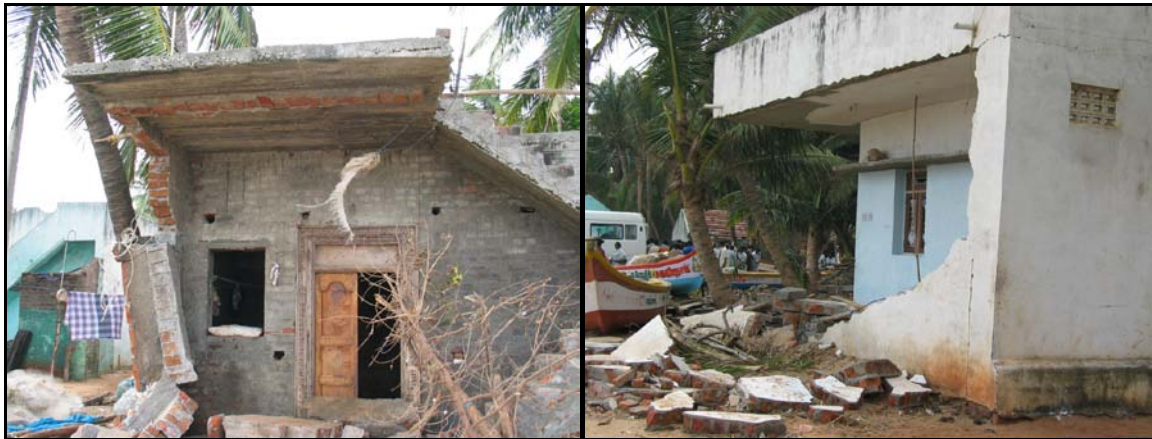
Fig. 6 Collapse of compound walls of residential houses in Chinapattam (these walls protected the houses from damage)

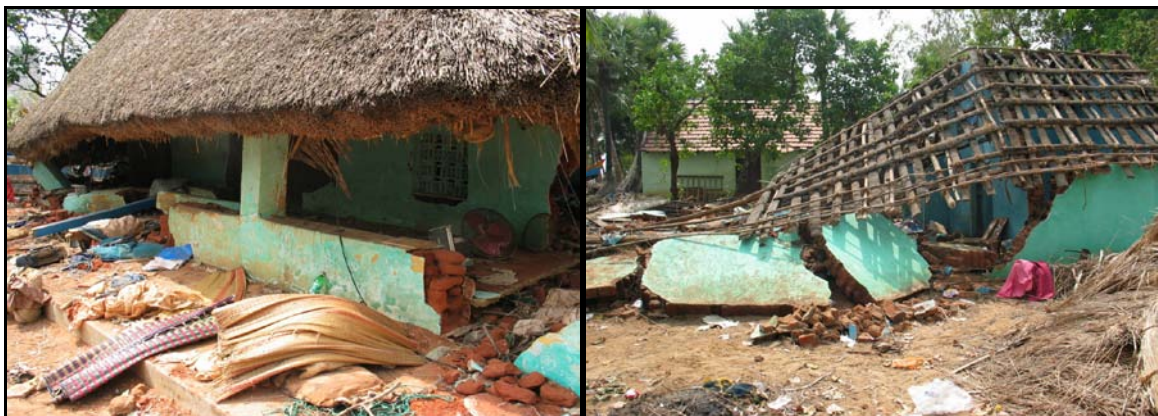
Fig. 7 Collapse of brick masonry houses in Kudukuppam (Villupuram)

Figure 7 shows the collapse of brick masonry houses in Kudukuppam (with run-up of 4.0 m). The huts collapsed as walls and columns were constructed by using mud as a cementing material, and had thatched roofs. The collapse was as anticipated due to the use of very poor cementing material in the construction. The damage can be characterized as of Grade 5 in Type A buildings.

- Brick masonry should be designed to avoid its collapse. Though it may not be designed to be totally tsunami-resistant but to avoid its collapse, adequate reinforcement should be provided.

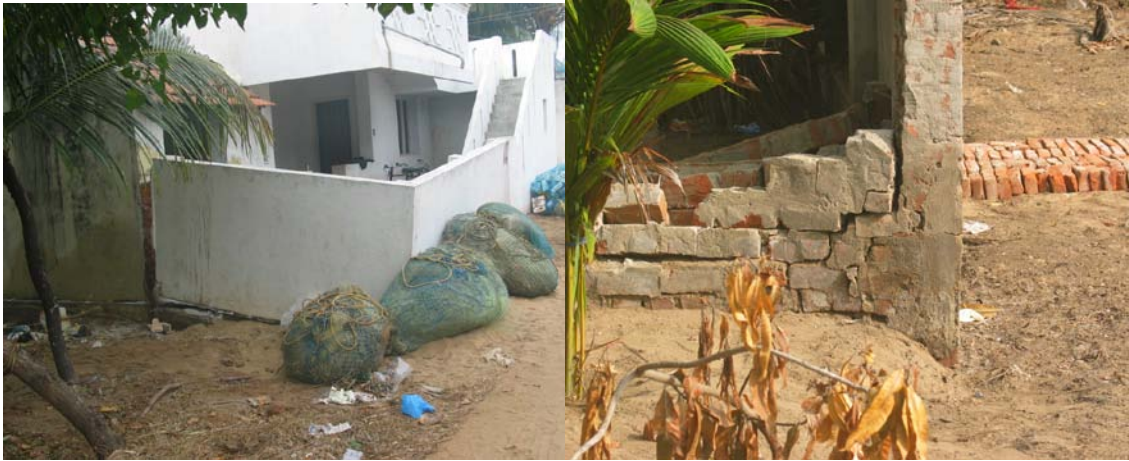
Some of the typical structural damage in the Talenguda village (Cuddalore) is shown in Figure 8. This area had the run-up of 5-6 m. It can be observed that even though the run-up is higher than that shown for Figure 7, the damage is not so severe because of the better quality of construction. Level of damage in the left photograph can be characterized as of Grade 4 in Type B. Joints of a compound wall (made of brick masonry) with the main wall opened and tilted due to settlement of the soil below. Right photograph of Figure 8 shows that the collapse was due to opening of joints and low bending capacity of the brick masonry. This indicates vulnerability of brick masonry to tsunamis.

Fig. 8 Damage to boundary walls in Talenguda (Cuddalore) due to damage to brick masonry

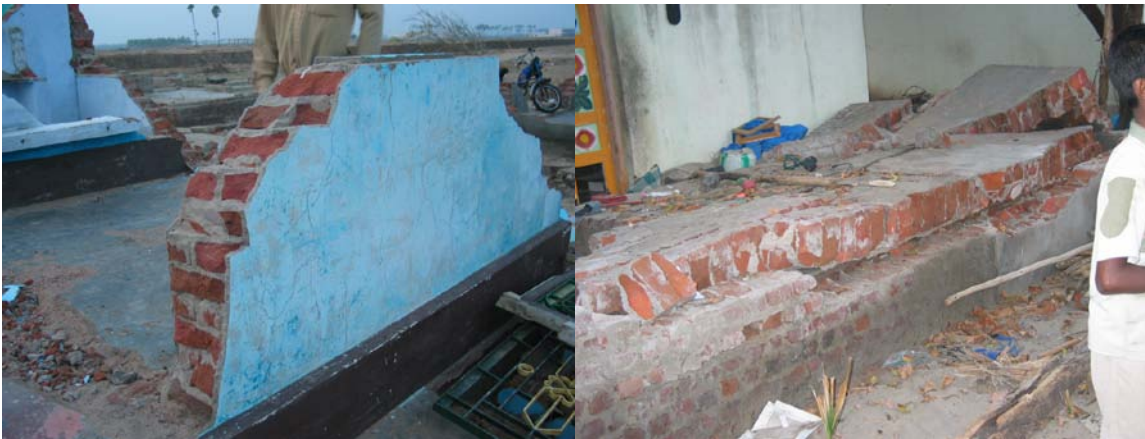
Opening of brick joints was observed at many other places also. For example Figure 9 shows collapse of a house in Amman Kerapattu village (in Nagappattinam district) near Karaikal due to breaking of bricks even when lime mortar (not mud) was used as a cementing material. This area had the run-up of 8-9 m (see Table 1), which is consistent with the breaking of bricks and collapse of walls observed here and thus with the damage of Grade 5 in Type B.

Fig. 9 Damage to brick masonry in Amman Kerapattu village (Nagappattinam) near Karaikal (even bricks used with lime mortar got broken here and wall collapsed)

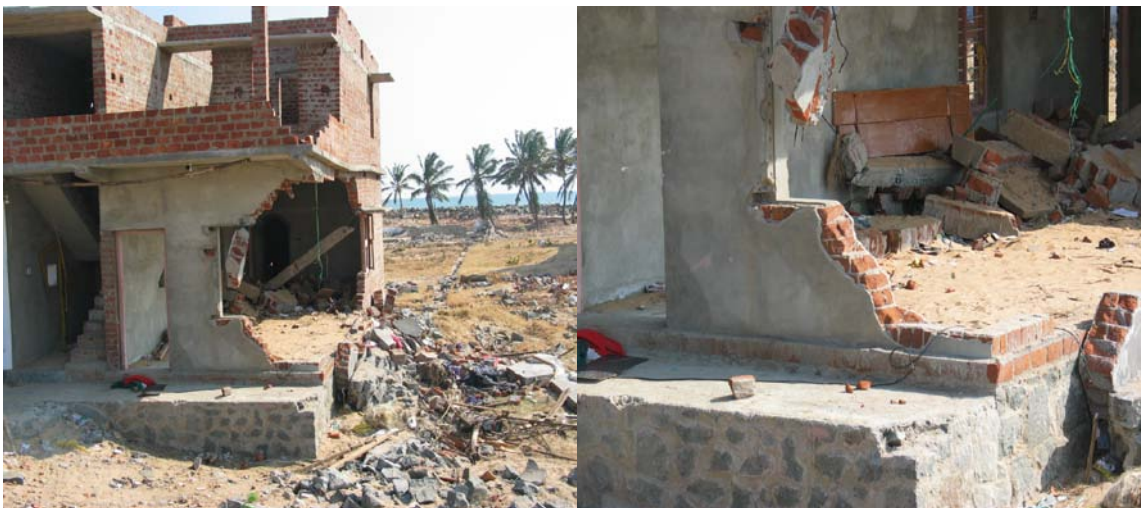
Tsunami caused heavy damage to brick masonry buildings not only on the east coast but also on the west coast. Figures 10 and 11 show heavy damages to the brick masonry buildings in Keelamankudy and Meelamankudy villages, respectively. Both villages are located on the west coast in the Kanyakumari district, and had run-up equal to 12 m. These villages are about 100 km North-West of Kanyakumari

city. It can be noticed that this damage was severe even with the use of cement mortar. Level of damage may be characterized as “many buildings of Type B subjected to damage of Grade 5”, which is consistent with the high level of run-up.

Fig. 10 Collapse of a brick masonry building under construction at Keelamanakudy (Kanyakumari)

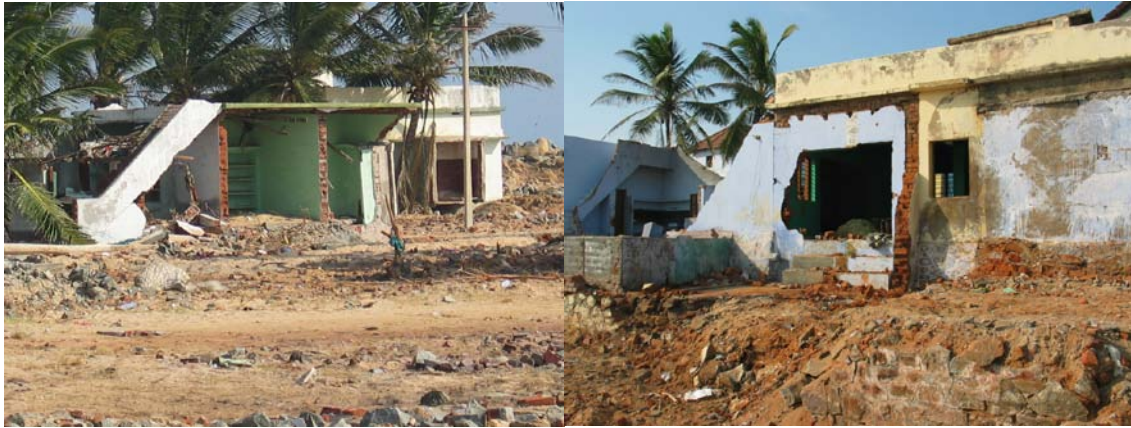
Fig. 11 Widespread damages to buildings in Meelamanakudy (Kanyakumari) (most of the houses were of brick masonry which performed poorly during the tsunami attack)

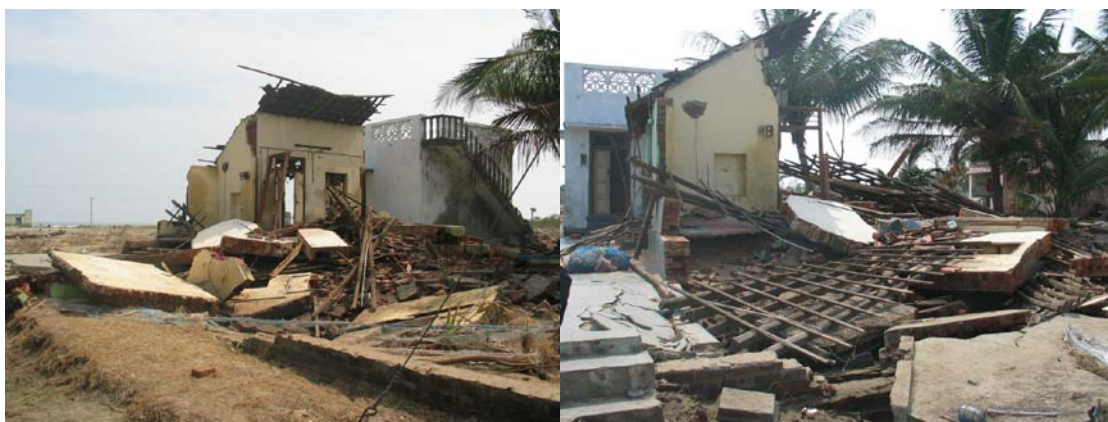
Figure 12 shows the collapse of fishermen's houses in Kuddukullam village just south of Cuddalore. Construction material used was very poor and the collapse of these houses due to the tsunami was obvious. Level of run-up in the area was also considerably high (8-9 m).

Fig. 12 Collapse of adobe houses in Kuddukullam village (near Cuddalore)

- There was widespread collapse of adobe houses due to the tsunami. Though these structures, made of poor quality of material, are good in fulfilling the functional needs of economically weaker sections, those are not expected to perform well during a lateral loading. Construction of these houses should be avoided. Else, these should be designed such that roof and walls act as a single unit. This would improve their performance against a tsunami of low run-up.

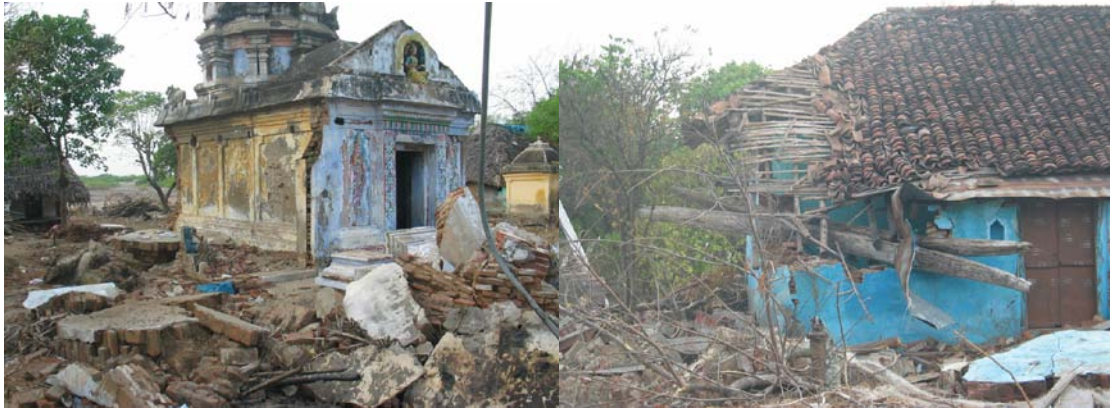
Figure 13 shows damage to the houses in Kuddupattanam (south of Chidambaram city) in the Nagappattinam district. Though level of run-up is high (8-9 m), damage is not so severe especially for the house in the left photograph of Figure 13. Reason for this is attributed to the Medu effect as described by Narayan et al. (2005). As these houses were situated on Medu (naturally elevated landmass), those were saved from collapsing. Fig. 14 shows collapse of the adobe houses in Nabyarnagar (Nagappattinam). The level of run-up was 10-12 m and the collapse of these poorly constructed houses was as expected.

Fig. 13 Damage to small houses in Kuddupattanam (south of Chidambaram), Nagappattinam

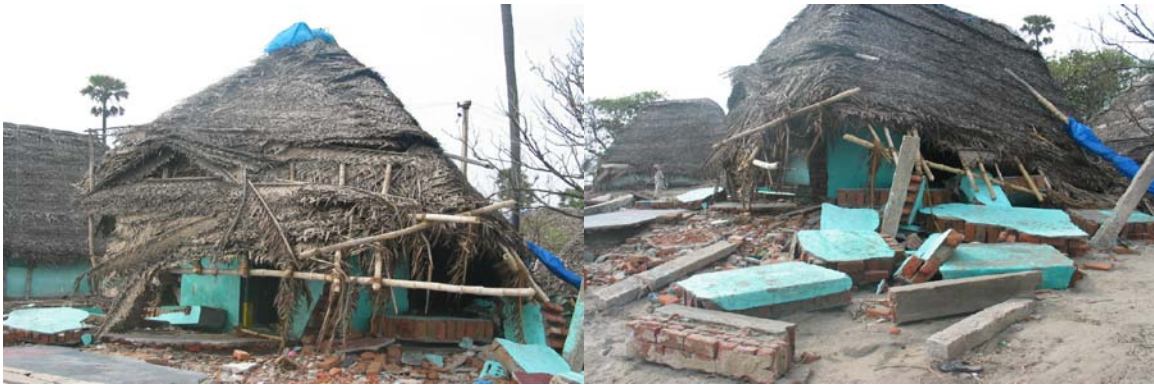
Fig. 14 Collapse of adobe houses in Nabiyar Nagar (Nagappattinam) due to tsunami

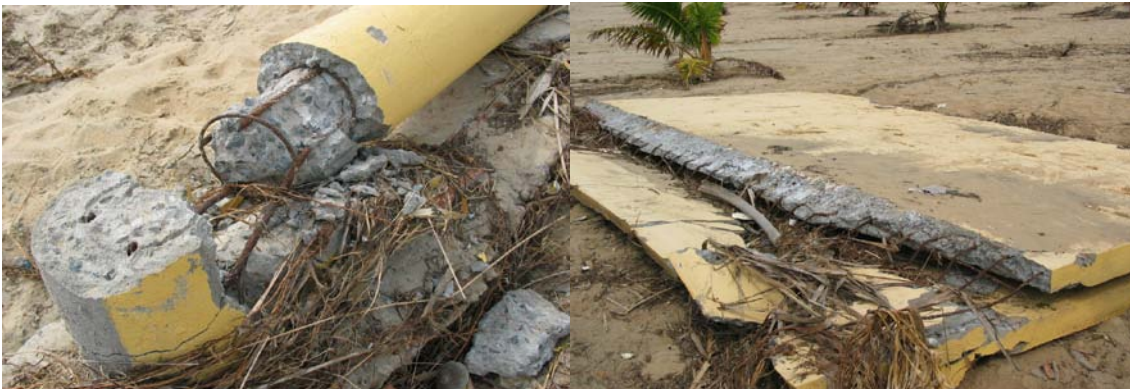
Figure 15 shows one of the collapsed columns of Sri Karneshwara Natraj Temple in Kudukuppam (Villupuram), where the run-up was 4.0 m. Damage may be classified as of Grade 5 in Type B, which is on higher side and not correlating well with the run-up. There are many reasons for this inconsistency. Though details about the amount of reinforcement were not available but general observations suggest that the reinforcement was inadequate with respect to cross-sectional area of the column. Thus flexural capacity of column was not enough to resist the hydrodynamic forces of tsunami. Moreover, at the base of the columns, isolated footings were used instead of combined footings, and failure of foundation also contributed to the collapse of these columns. Once columns collapsed, this led to toppling of roof and it moved few meters away. Here the run-up was not very high; however primary reason of the collapse was foundation failure as shown in Figure 16.

Fig. 15 Left: One of the failed reinforced concrete columns of Sri Karneshwara Natraj Temple, Kudukuppam (Villupuram); Right: Toppled roof, which moved few meters away

- Damage to the modern construction (concrete buildings/structures) can be avoided by introducing earthquake-resistant design concept, and thus by giving full attention to their detailing and ductility requirement according to the latest seismic codes.

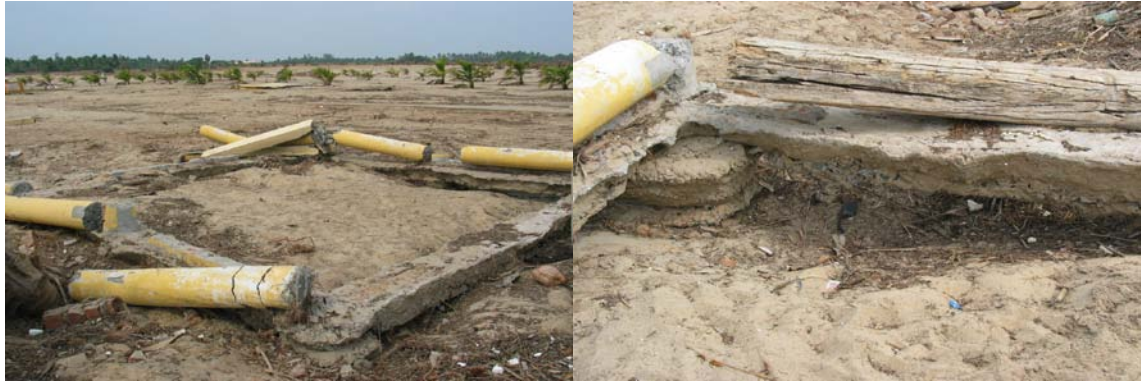
**Fig. 16** Foundation of collapsed Sri Karneshwara Natraj Temple (Kudukuppam) (only isolated footings under the columns were used)

Figure 16 depicts the foundation of collapsed Sri Karneshwara Natraj Temple (Kudukuppam). It can be observed that foundation below the structure was very abnormal. Only isolated spread footings below the column bases were provided. There was no embedment/foundation below the square ring joining the column bases. No combined foundation was provided below these columns. It appears that the base ring (except below the columns) was directly placed on the soil (without any embedment) as can be seen in the photographs. Such footings cannot withstand the forces of tsunamis and the collapse was as expected.

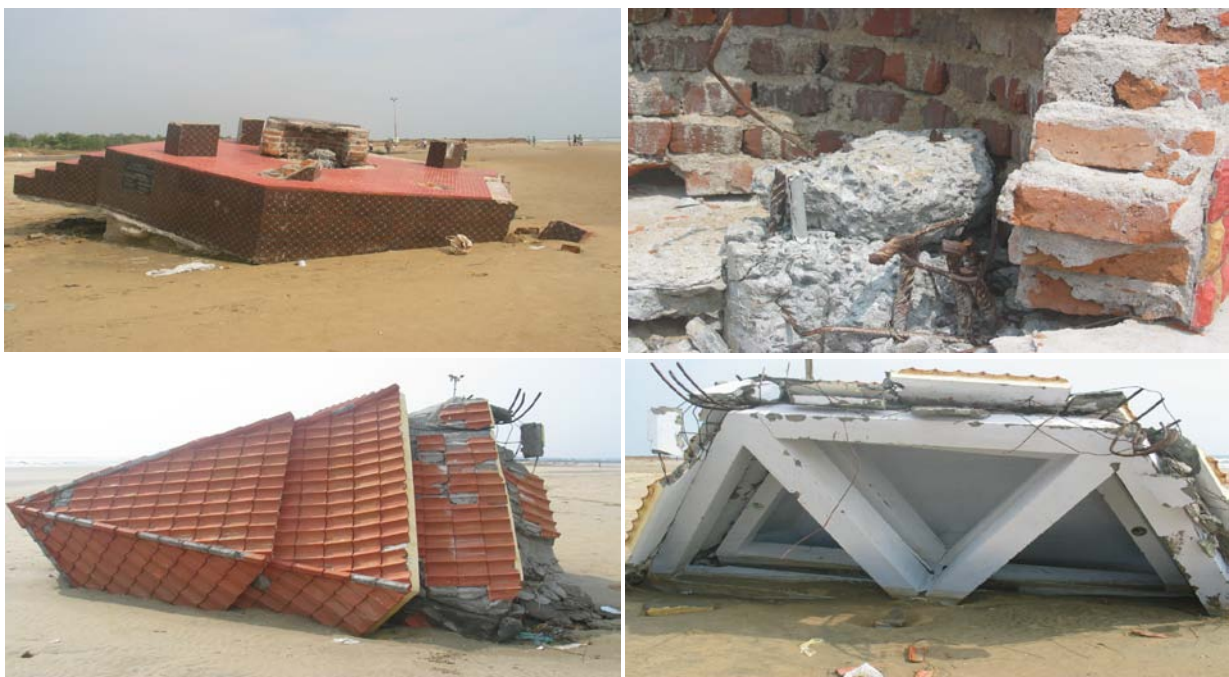
Figure 17 shows the collapse of a monument in Devanam Kuppam (Cuddalore), with a run-up of 6-7 m. Level of damage can be classified as of Grade 5 in Type B and many reasons of this damage could be observed. First, erosion and settlement of soil due to the tsunami tilted the base of the structure. Second, the roof was supported by just one column at the center, which collapsed. It may be observed that reinforcement used in the column was inadequate. Third, the roof was toppled and washed 20 m away. For the roof, quality of construction was relatively better and it remained relatively intact. Beams of the roof performed well and they kept the roof intact even after its displacement by a few meters.

**Fig. 17** Damage and collapse of a small monument in Devanam Kuppam (Cuddalore) (top left: tilted base due to settlement and erosion of soil; top right: heavy roof supported by a single column only; a collapsed RCC column without adequate reinforcement; bottom: displaced roof that toppled and moved away but remained relatively intact due to adequate reinforcement)

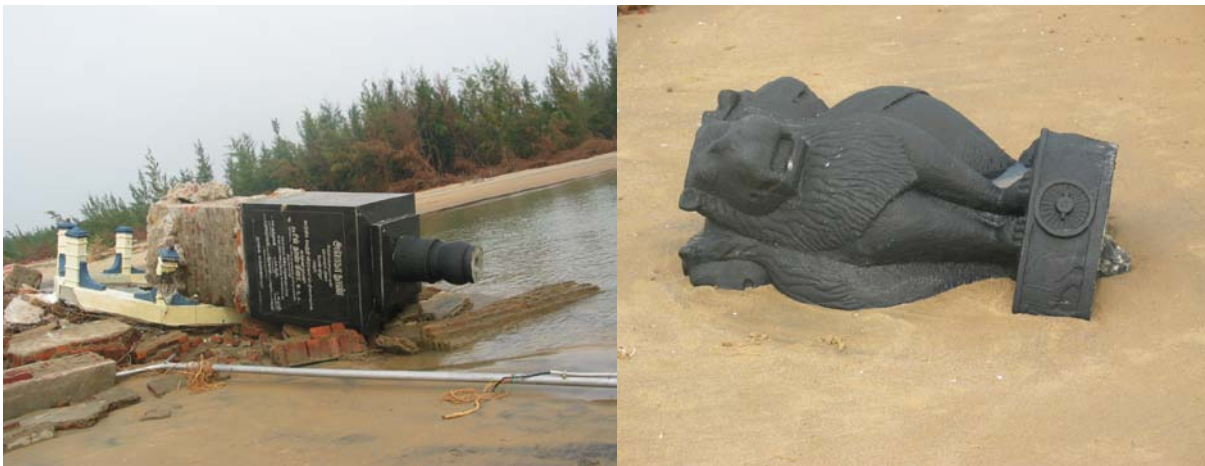
A memorial column at Nagappattinam beach, which was erected to celebrate Republic Day after the Kargil war got severely damaged (see Figure 18). It may be seen in the photograph that the Singnadh is broken from the post inside the memorial column. Broken post and its base can be clearly noticed. Also different parts and pieces of the memorial column, and an uprooted electric pole may be observed. Severe damage to the concrete post and many other concrete structures (i.e., Grade 5 in Type B) at the Nagappattinam beach is consistent with the high level of run-up (10-12 m in Table 1). It may be observed in Figure 18 that the depth of embedment of the footing was not adequate and that this also contributed to the damage.

Fig. 18 Memorial column at Nagappattinam Beach that got uprooted, and Singnadh (on top of it) that got broken and moved away (the column was erected to celebrate Republic Day after the Kargil war)

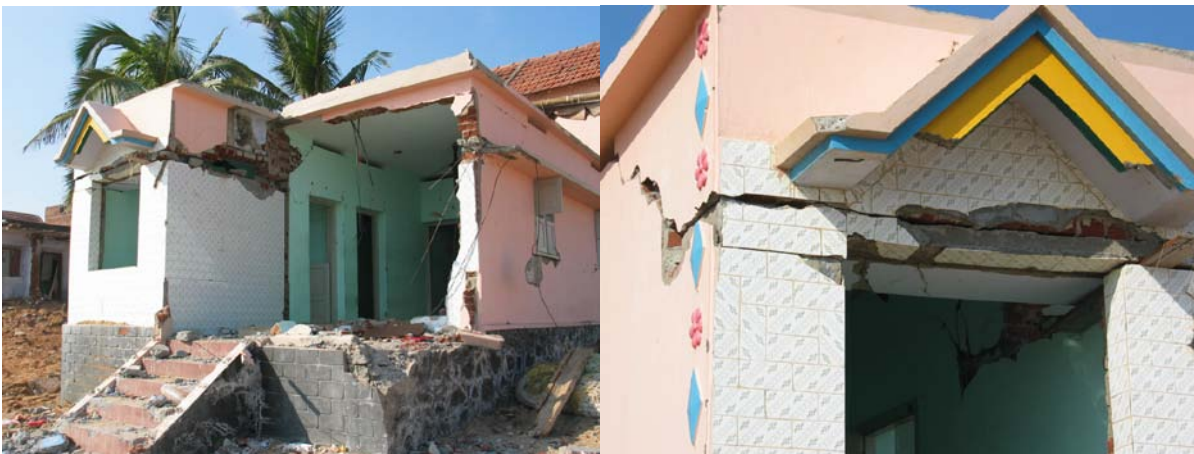
Widespread damage to masonry buildings, including those with good quality of construction, was noticed especially in the Kanyakumari district. Most affected villages were Keelamanakudy and Meelamanakudy (where the run-up measured was about 12 m). Some of the damages to the brick masonry in these villages have already been discussed in Figures 10 and 11. Further, Figures 19 and 20 show general collapse of newly constructed buildings in the Meelamanakudy village of Kanyakumari.

Fig. 19 Heavy damage to a building in Meelamankudy: (a) complete failure of joints at lintel band, (b) a close up view showing that there was lateral displacement of top part towards the right side

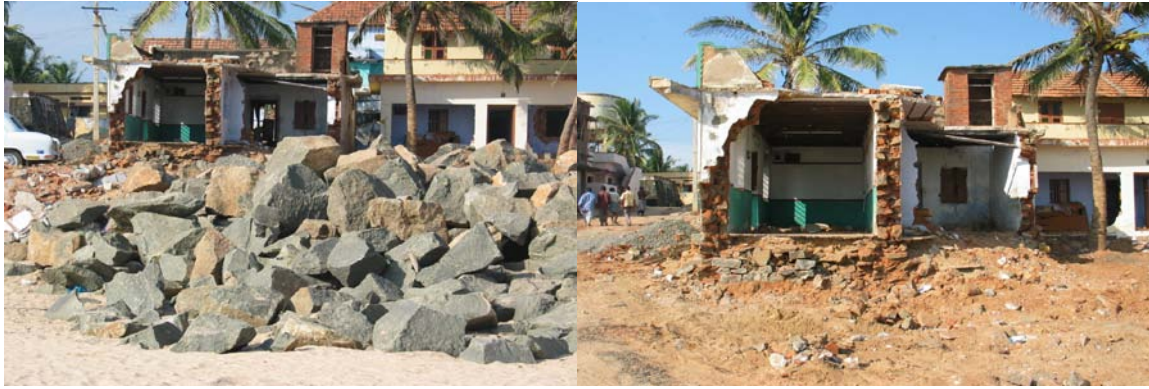
Fig. 20 Collapse of another building in Meelamanakudy (Kanyakumari) (close-up view of the collapsed front wall shows how vulnerable the brick masonry was to tsunami)

There were spectacular damages to the residential buildings in the Meelamanakudy village. All the houses, which are of single story, appeared to be modern type constructions. These were not fishermen’s huts, but reinforced concrete frame buildings with masonry infills. Almost every house along the seashore suffered heavy damage even though the buildings looked relatively new. Damage was all over, from foundation to the roof level including walls and columns. Figures 19 and 20 show few of the damaged houses. All these damages were due to the tsunami only and patterns of damages even suggest that these were more severe than those due to an earthquake. In fact almost all houses of this village suffered intense damages with a few having partially/fully collapsed. This intense damage may be attributed to low-lying area and a high value of run-up (12 m). Inundation was very high (see Table 1). It caused heavy erosion to road also. Thus level of damage (of Grade 5 in Type C) is very much consistent with the level of run-up.

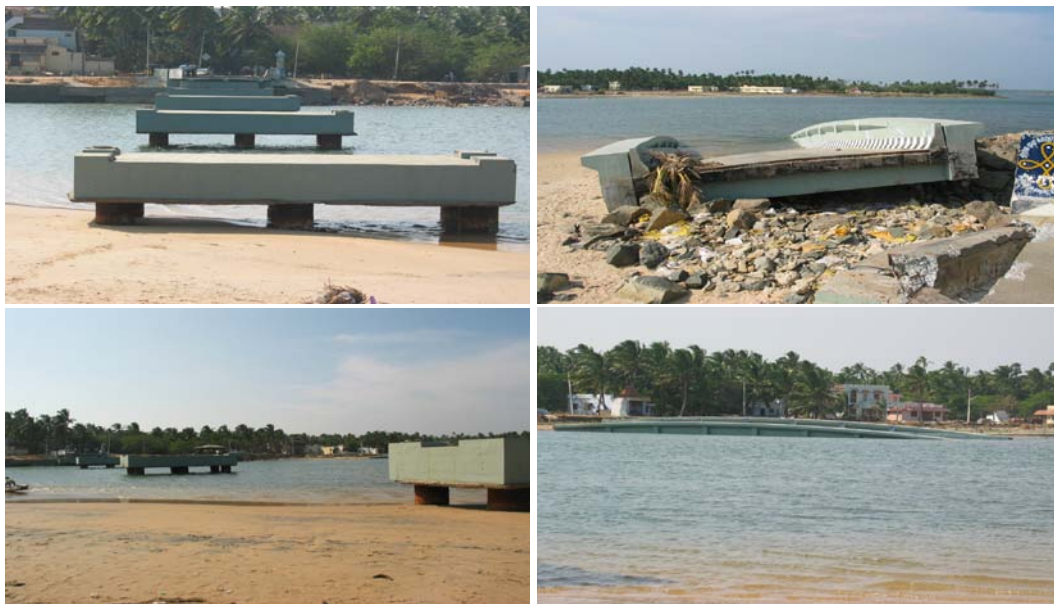
Fig. 21 Damaged bridge on the river Palyar in Keelamanakudy: (clockwise from top left) (a) the substructure left after 4 spans of the deck got washed away; (b) a span washed away by about 20 m; (c) another span moved by about 50 m; (d) bare substructure (with 2 spans still missing)

A bridge on the river Palyar, connecting the Keelamanakudy and Meelamanakudy villages has been badly damaged (see Figure 21). All the four spans of the bridge got washed away. Out of these four spans, two were still missing (up to the date of the survey) and two spans have moved away by about 20 and 50 m (see Figure 21). These spans got displaced from the bearings and separated from the substructure (pile foundation including pile cap). No damage was observed in the substructure and it appeared intact. It seems that the deck got separated due to the bearing failure. Broken parts of the bearings indicated that

mechanical bearings were used. With the help of the measured dimensions, it is estimated that the weight of a span would be about 200-300 tonnes. Displacement of such a heavy structure indicates the intensity of the hydrodynamic force applied by the tsunami. It was a tremendous pressure that washed away the spans. Washing away of bridge's deck may be classified as the damage of Grade 5 in Type C structure, which is again consistent with the level of run-up.

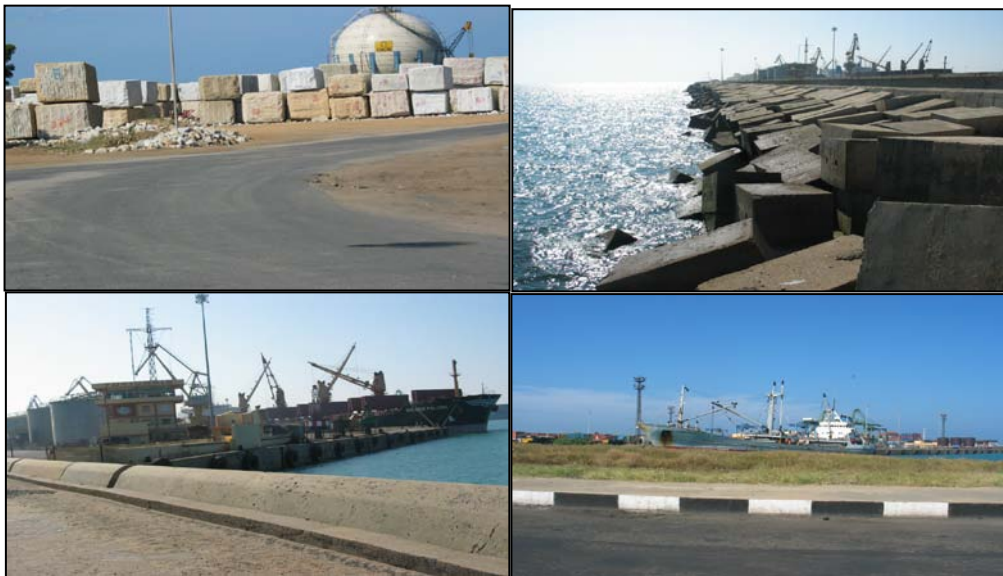
Size of the harbor area is approximately 4450×1250 m. On one side of this area is seashore, where administrative buildings of TPT are located while out of the two other sides, one is for pipeline and another is for approach road (see Figure 22). Closing these two sides are breakwaters (with large boulders) thus encompassing the whole area. Harbor was designed and constructed according to Indian Standard seismic codes and was commissioned in 1978. No damage has been reported to the harbor and facilities here, as the quality of construction is very good (based on personal communication with the TPT authorities). Moreover, being shielded by Sri Lanka, this area had a very low run-up (3.0 m). Here the level of damage may be categorized as of Grade 1 in Type C, which is very consistent with the run-up.

Fig. 22 Pictures taken at Tuticorin harbor showing no damage to the facilities there and life remaining normal at the port (clockwise from top left: an oil storage tank; very heavy stones (about 10 tonnes each) to protect the break-water; a ship moored near the seashore; close-up view of another ship)
