EARTHQUAKE IN SOUTH INDIA ON 20th MARCH 1984

R. NARAYANA IYENGAR¹ AND K. MEERA²

ABSTRACT

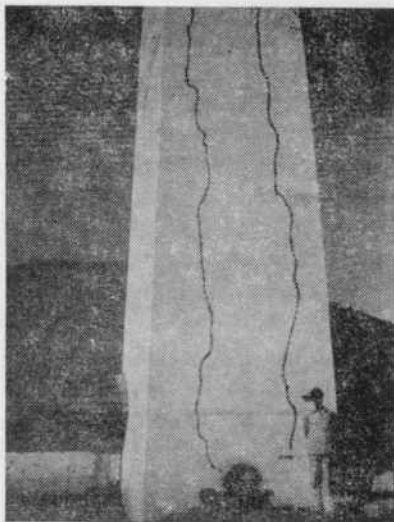
The earthquake was felt by all. About 2 km from Denkanikota, tiles stacked in a tile factory rattled and a few fell down also. Existing cracks widened as a result of the earthquake. A structure of type B in the premises of the factory developed cracks. New Horizontal and Vertical cracks developed in a brick chimney 3 × 3 m at base and 25 m in height. (Fig. 4). However in a nearby factory no cracks were observed on a recently constructed similar chimney. Logs stacked in the forest range office got dislodged.

Fig. 4. Damage to brick chimney of a tile factory in Denkanikota.

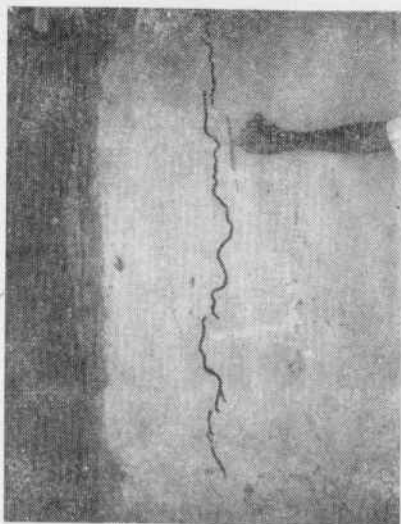
resembling the operation of a wet stone grinder. Through running cracks in walls of buildings of type B, have occurred. Existing cracks have widened after the earthquake in type A and type B structures (Fig. 5).

Fig. 5. Cracks in a mud house in Kelamangalam

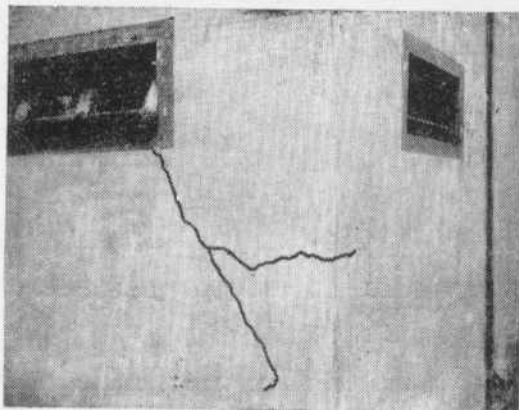
In the office of the Assistant Commissioner (structure of type B), already existing cracks widened (Fig. 6). In a building under construction adjacent

Fig. 6. Cracks developed in the Assistant Commissioner's Office, Kelamangalam.

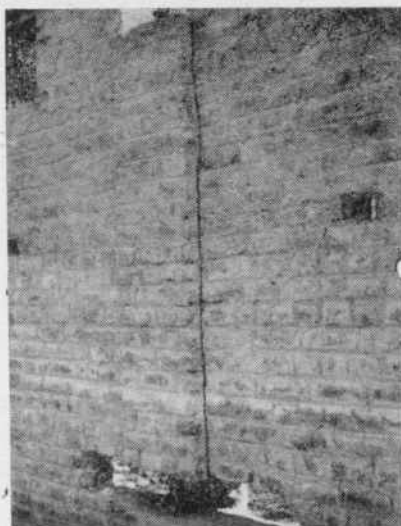
to the Assistant Commissioner's Office, vertical cracks have developed at all brick column-wall junctions (Fig. 7) in the north south direction. The opening seen at the bottom is made after the shock for inserting bond stones.

Fig. 7. Crack in column-wall junction of a building under construction.

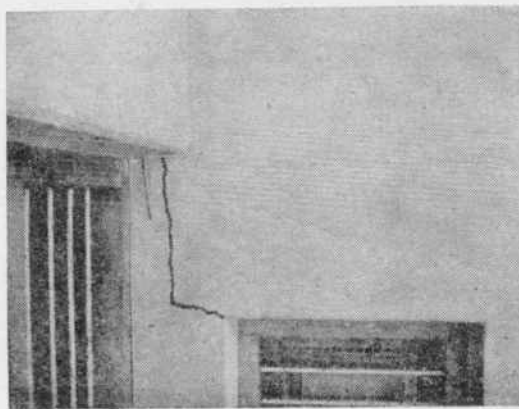
In a doctor's residence, (structure of type B) cracks run continuously through the wall and floor (Fig. 8). The roof has developed plaster cracks.

Fig. 8. Residential building with fresh cracks.

The cracks in the roof and floor run roughly in the north-south direction. Cracks were also observed in the Primary health centre hospital.

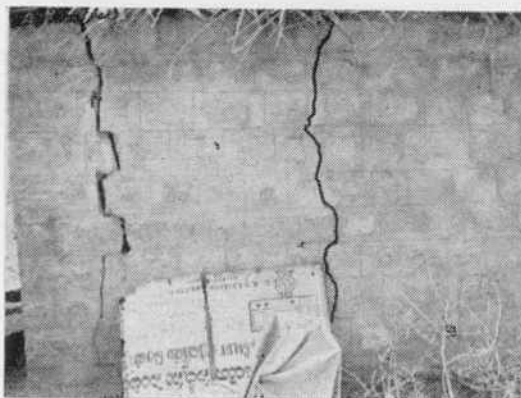
In buildings of type A, existing cracks have got widened (Fig. 9).

Fig. 9. Widening of cracks in a stone masonry wall.

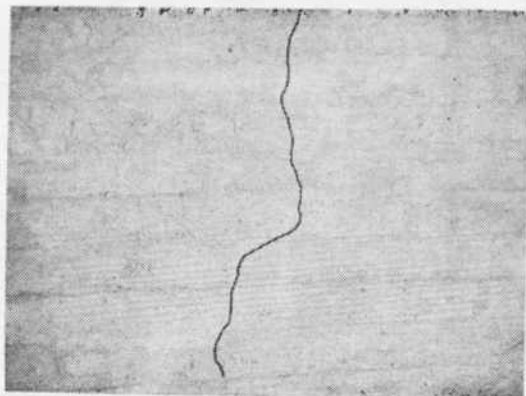
Local people reported of cracks and damage to the road bridge across the river Sanat Kumar. The bridge is of three spans with a steel girder deck. The piers and abutments are of stone masonry. Vertical cracks in the piers were observed by the authors during the investigation. However, it was not

possible to conclude whether they were new or already existing cracks (Fig. 10).

Fig. 10. Crack in the abutment of a road bridge.

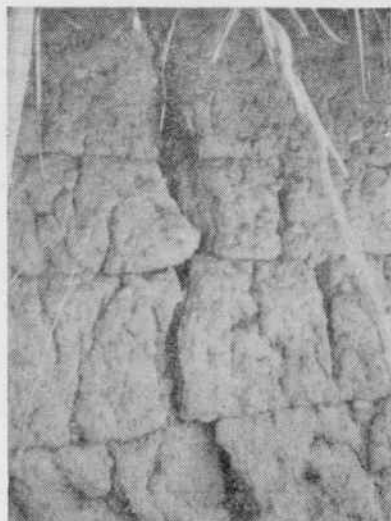
The earthquake was intensely felt by all. The people reported a general feeling of swinging action. Everyone panicked and ran out of their homes. All structures of type A and B have cracked (Fig. 11).

Fig. 11. Typical cracks in mud houses in Kowthalam.

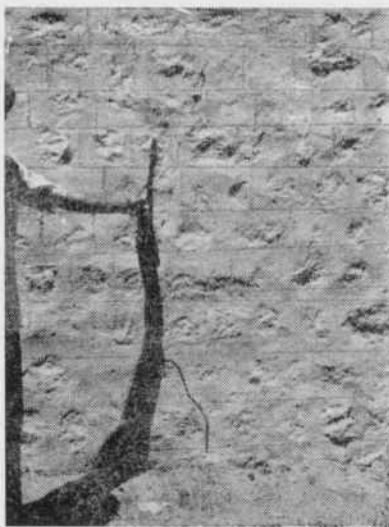
In the old school building (structure of type B) freshly developed vertical cracks are visible in parallel walls (Fig. 12). In the new school building under construction, vertical cracks have developed in parallel walls below window sill level. The cracks are very severe and do not lie along bonds. Bricks in all the courses including the stone masonry in the plinth courses have broken (Fig. 13). In a flour mill, vertical cracks have developed in parallel walls (Fig. 14). It may be mentioned here that this village has

Fig. 12. Crack in the old school building in Kowthalam.

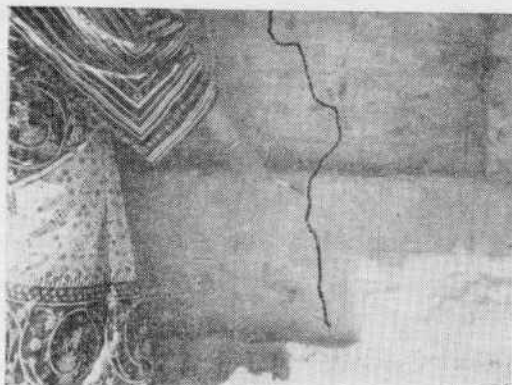
Fig. 13. Rupturing of stones in the foundation of a new school building under construction in Kowthalam.

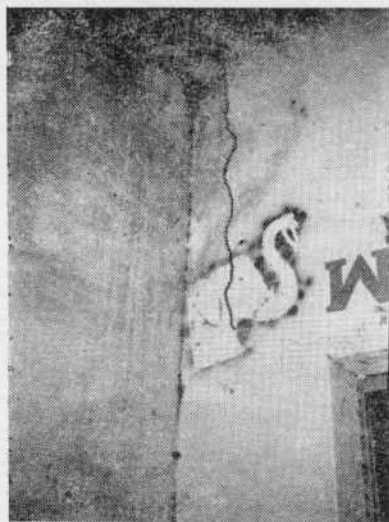
Fig. 14. Cracks in the wall of a flour mill in Kowthalam.

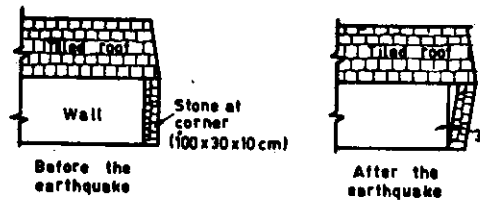
Fig. 15

a stone slab (Fig. 15) used as a supporting column at the corner tilted by about 3° . The only special structure near this village is the old earthen bund with a small reservoir. This has withstood the earthquake very well without any visible serious damage.

Tilting of corner stone in a mud house.

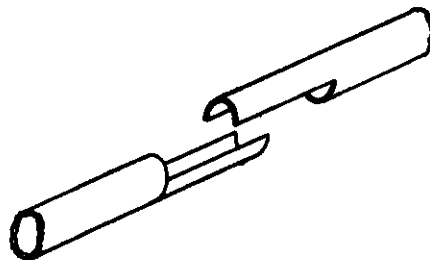
suffered the maximum damage. The cracks have a general pattern of being vertical and in the north south direction. Light objects like utensils in most of the houses overturned. A steel trunk ($70 \times 27 \times 38$ cms) kept on a masonry platform at a height of 75 cms above the floor level fell down. A 2 m tall papaya tree with a circular base of about 30 cms diameter got up-rooted. In one of the houses, portions of a mud wall collapsed. In another house a bamboo rafter was dislodged. Two supporting posts (3.5 m high, 10 cms dia) of the roof, one embedded in the ground and another embedded in a platform rocked and tilted by 3° to the vertical. Another interesting observation is that a spliced bamboo rafter got dislocated. In the same place

Spliced joint in rafter after earthquake.
