PAST, PRESENT & FUTURE OF ASEISMIC DESIGN AND CONSTRUCTION OF BUILDINGS IN AND AROUND SHILLONG IN MEGHALAYA

D.N. JAGTIANI AND S.G. JOSHI**

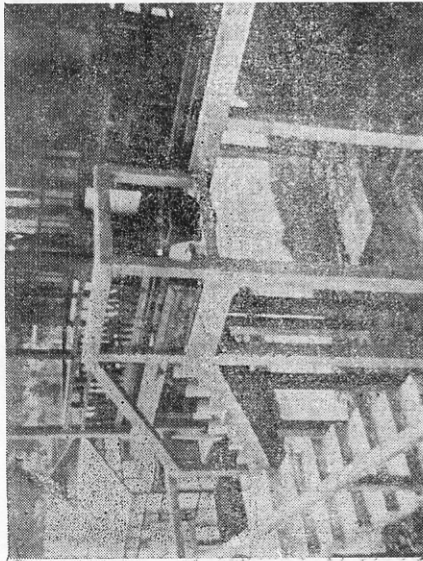
A building has been seen constructed on such stilts with size of RCC column of 6" x 6" height 12'—0" and 1:2:4 concrete mix. These columns have not been braced or tied with ties at any level except below the floor level at tops of the stilts/columns. This building is standing for last 4 to 5 years. The design of this building seems to have been based on practical experience rather than the present precautionary measure recommended in the IS Codes (i. e. IS: 1893-1966 and IS-4326-1967).

Fig. 1. Building Constructed with Slender columns and without ties at footing or at any other level.

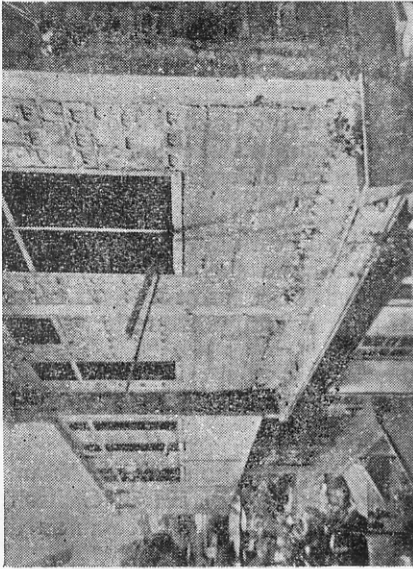
Fig. 2. Half Brick reinforced external walls without sufficient bands in the wall panels. Internal partition walls are without reinforcement at any course.

Construction by ASSAM PWD, CPWD (ASSAM) Circle and ASSAM State Electricity Board etc. seem to have been mainly of two types viz (a) framed structures (b) Assam type construction (construction activities of MES have been dealt separately in the subsequent para). Different practices have been observed to be followed by various departments. In some buildings, it is observed that precautions like diagonal bracings in the columns below plinth have been provided whereas other similar buildings are constructed without this provision. (See Figure No 2)

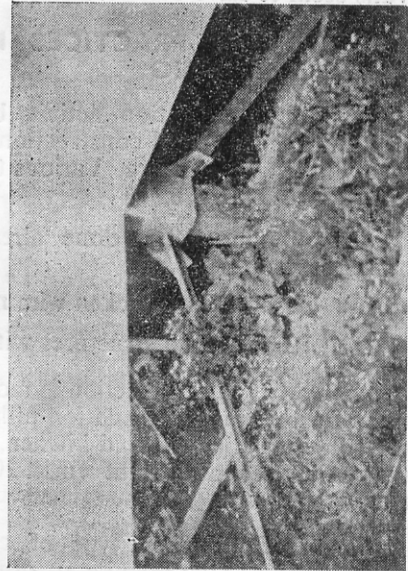
Fig. 3. Diagonal Bracing to the columns—Strengthening Measure.

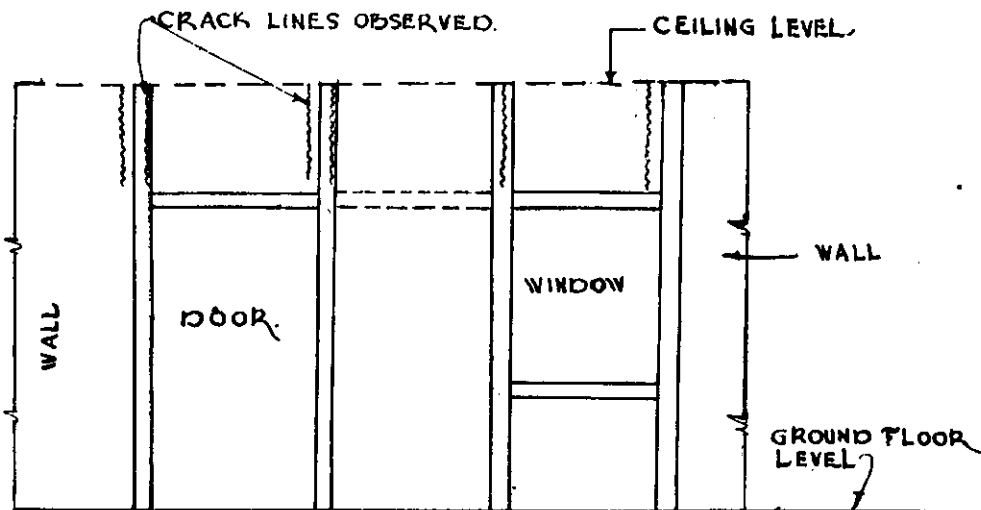
Fig. 4.

(a) In ASSAM type construction, generally it was seen that the structures have stood sound during and after sufficiently severe earthquake shocks also. However, cracks were especially seen along the vertical continuous posts of door/windows frames as shown in fig. 4.
