## ENGINEERING FEATURES OF THE SAN FERNANDO EARTHQUAKE

E.E.R.L., C.I.T., PASADENA\*

### INTRODUCTION

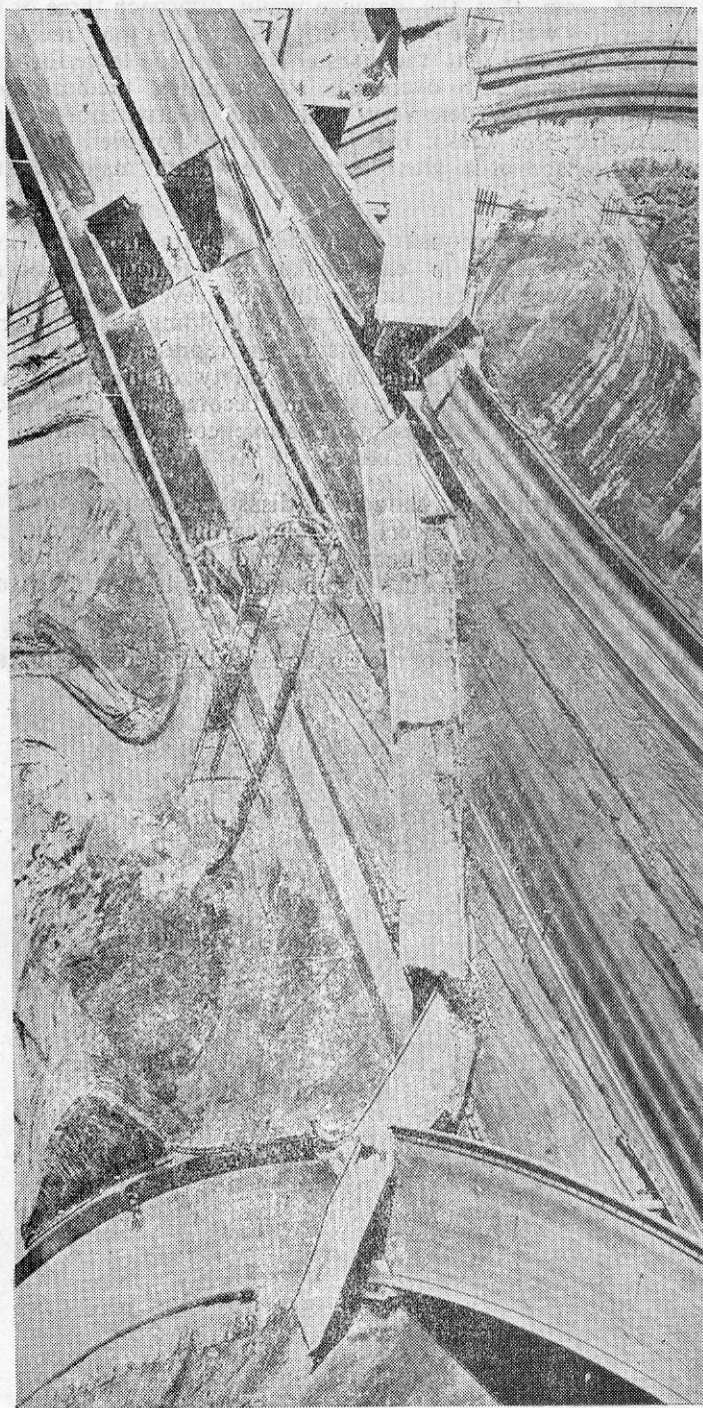
Fig. 1. Aerial Photo of Freeway Interchange

This aerial view shows a portion of the interchange between the Foothill and Golden State Freeways. Nearly every bridge and overpass structure in the interchange was seriously damaged by the earthquake.

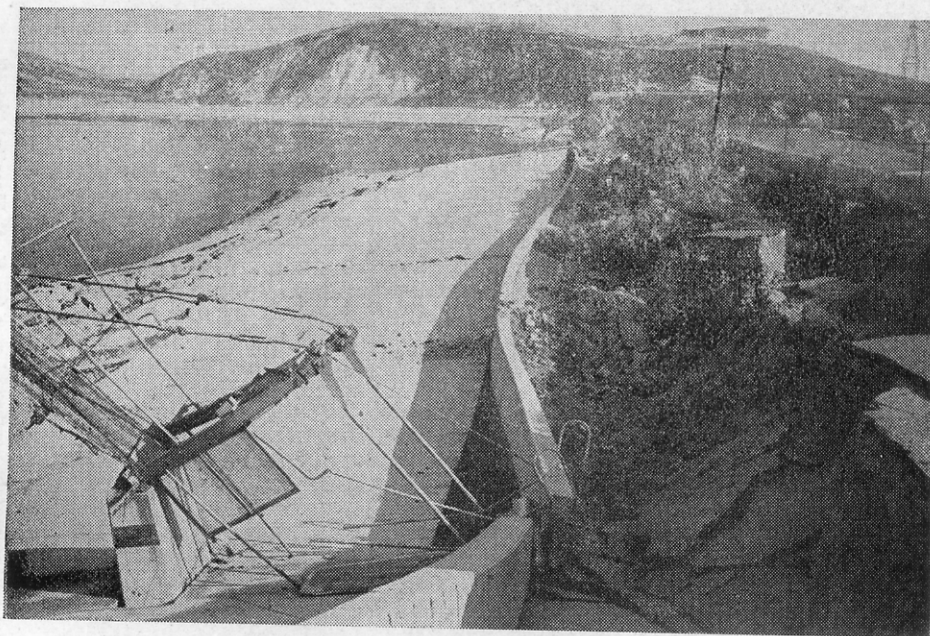
**Fig. 2. Lower Van Norman Dam**

This aerial view of the Lower Van Norman Lake on the day of the earthquake shows the spectacular damage to the earth-fill dam. A major section of the dam slid into the reservoir in an arcuate slide, leaving a scarp of some five feet between the water level and the top of the remaining portion of the dam. The cracks forming on the lower face of the dam, to the left, are incipient slides and show how near the catastrophe actually was. If the period of intense shaking had lasted somewhat longer, the dam would surely have given way. Both the lower and upper Van Normal dams, built in the 1910's and 1920's were damaged, but a new earth dam, located on the same site, survived the shock with no apparent structural damage.

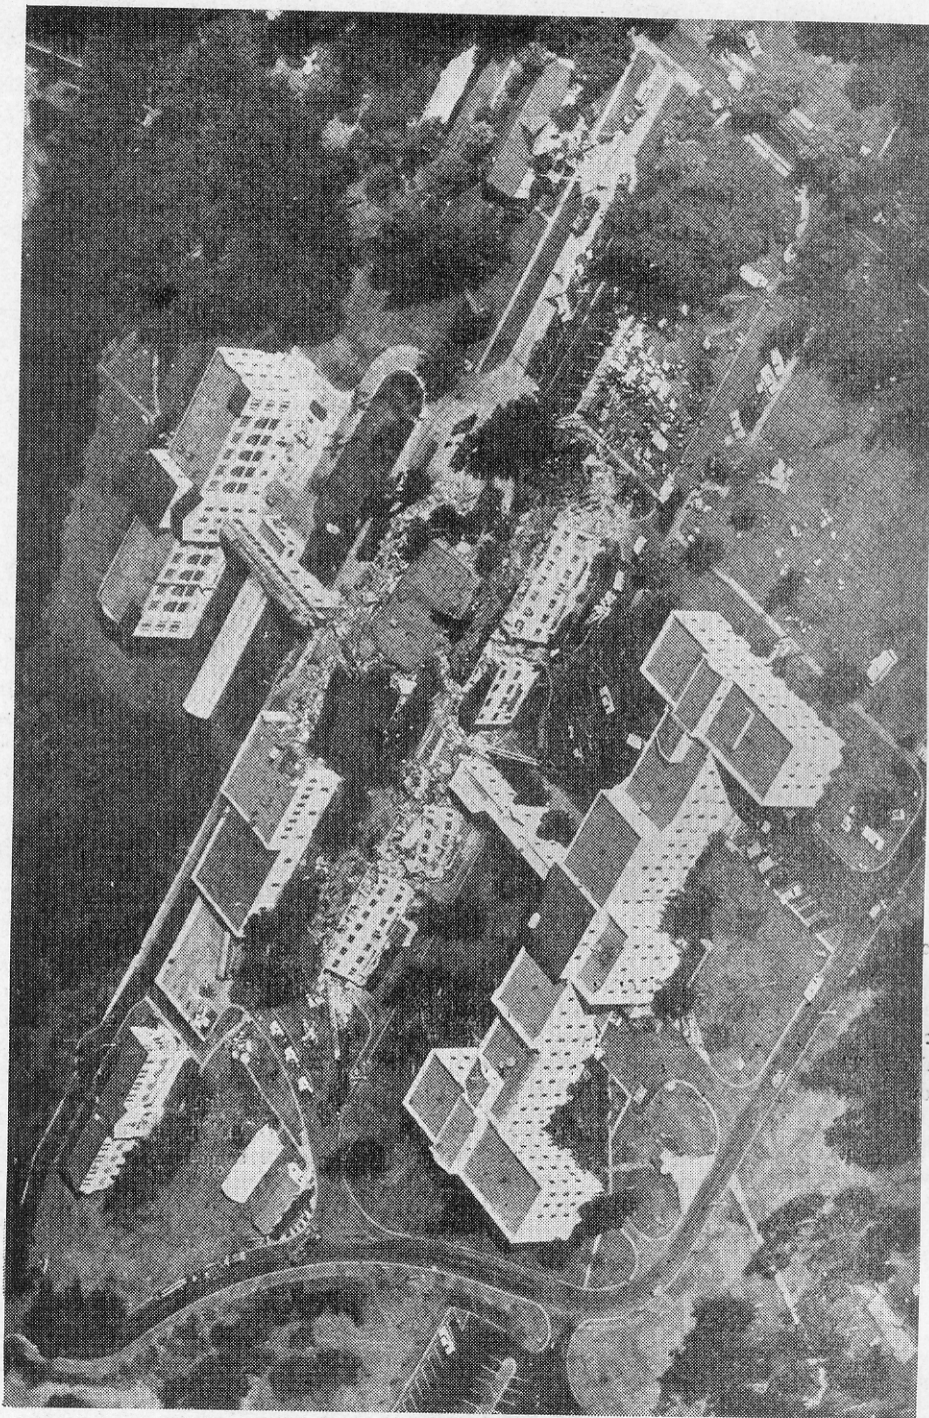
Fig. 3. Aerial Photo of V. A. Hospital

Taken the day of the earthquake, this photo looks approximately northward over the V. A. Hospital in Sylmar. The collapsed structures, seen in the center of the photograph, were both built in 1926 before earthquake-resistant design procedures were embodied in the building codes. The adjacent major structures were built in 1937 and 1947 and received no significant structural damage.

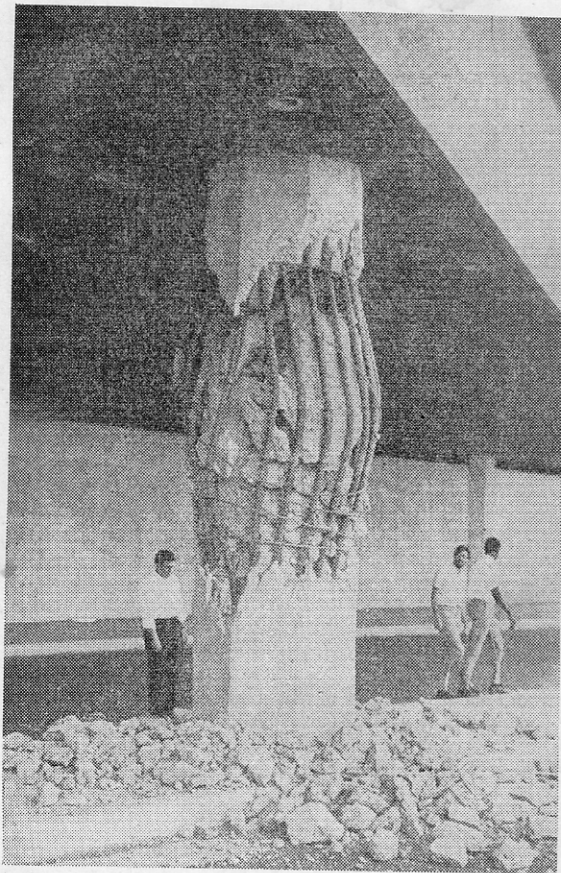
←  
**Fig. 4.** Damaged columns on the Foothill Boulevard overcrossing of the Foothill Freeway. The complex failure of the bridge was aggravated by the inadequate ties confining the 2-1/4-inch diameter main reinforcing steel.

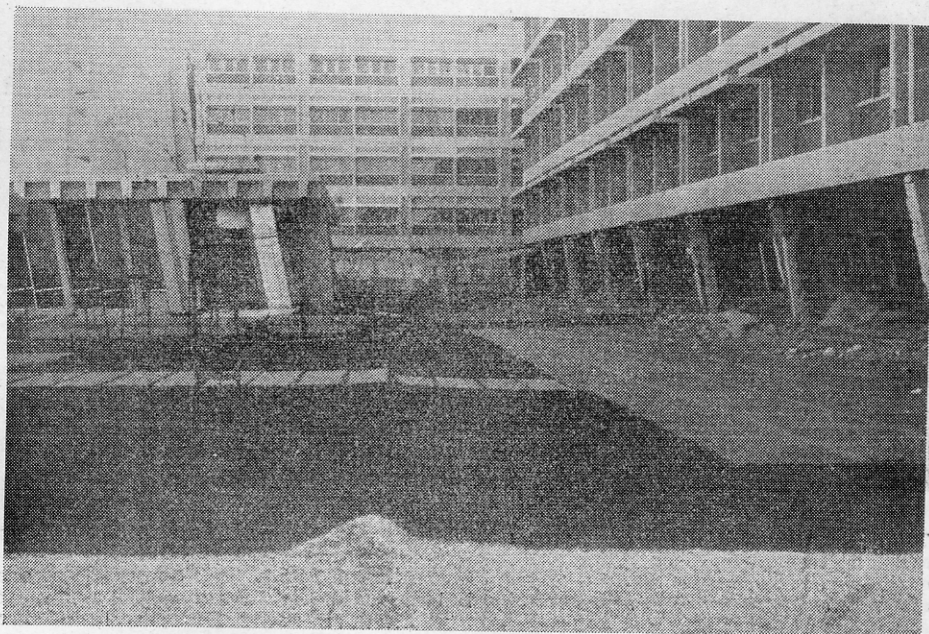
**Fig. 5.** This view of the Olive View Hospital, looking east, shows a closeup of the column failures. The corner column is a tied column; the side columns are spirally reinforced and performed much better. The small one-story structure at the left is the auditorium. It shows a failure of the connection between the roof and the supporting columns. In the foreground at far right can be seen the bottom of one of the five-story end sections which failed at its framed support and toppled into the basement.

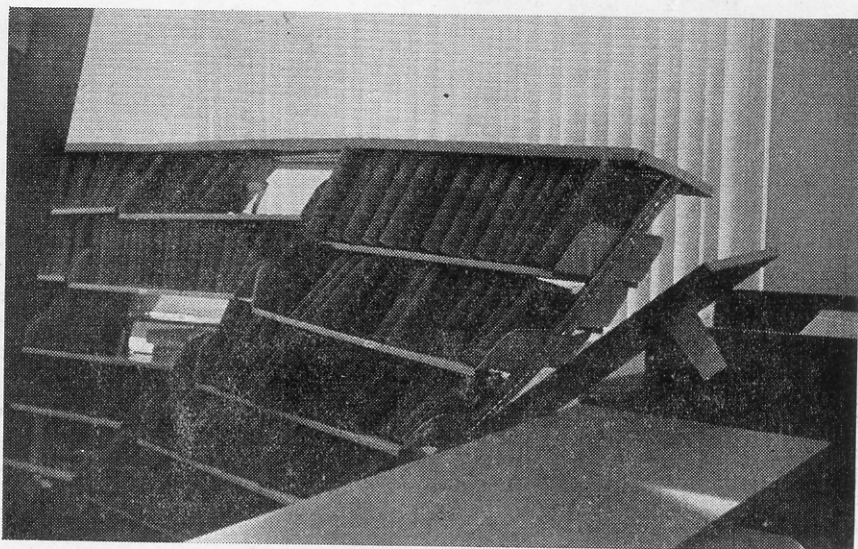
Fig. 6. Nearly all of the bookshelves on the upper floors on the east side of Millikan Library collapsed, and some bookshelves failed as far down as the second floor. The accelerograph at the base of the library recorded a maximum acceleration of 15%g and the instrument at the top showed about 35%g. All told, some 75,000 of 200,000 volumes were spilled to the floor.

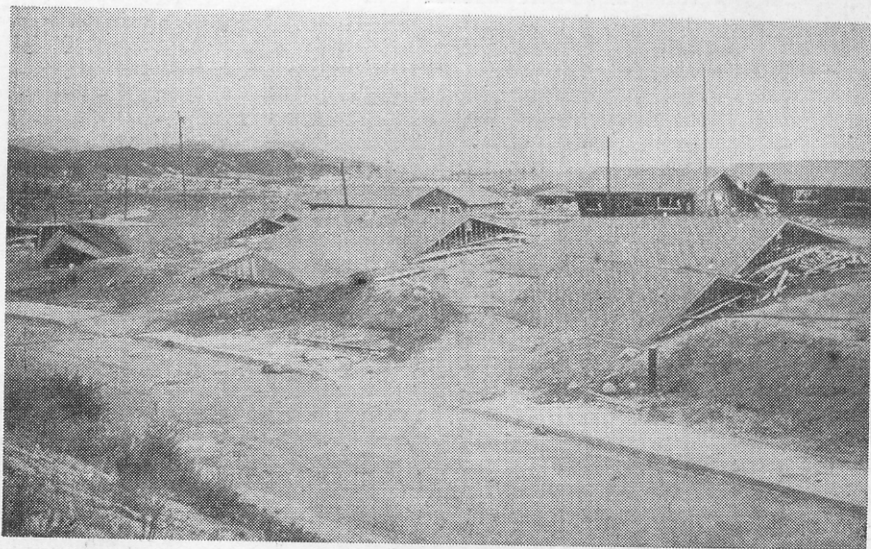
Fig. 7. The typical southern California wood frame house, light in weight, and relatively strong, is normally safe during earthquakes. The homes in this picture, taken in a residential subdivision in the Pacoima Canyon area, were in various stages of construction. Those in front which completely collapsed were at the framing stage. Those in the background were covered outside with tarpaper and wire mesh preparatory to stuccoing. One or two homes, not visible in this picture, had already been stuccoed, and these survived without failure.
