REMEDIAL MEASURES FOR THE FOUNDATION OF A DIESEL GENERATOR

A. S. ARYA* AND M. K. GUPTA**

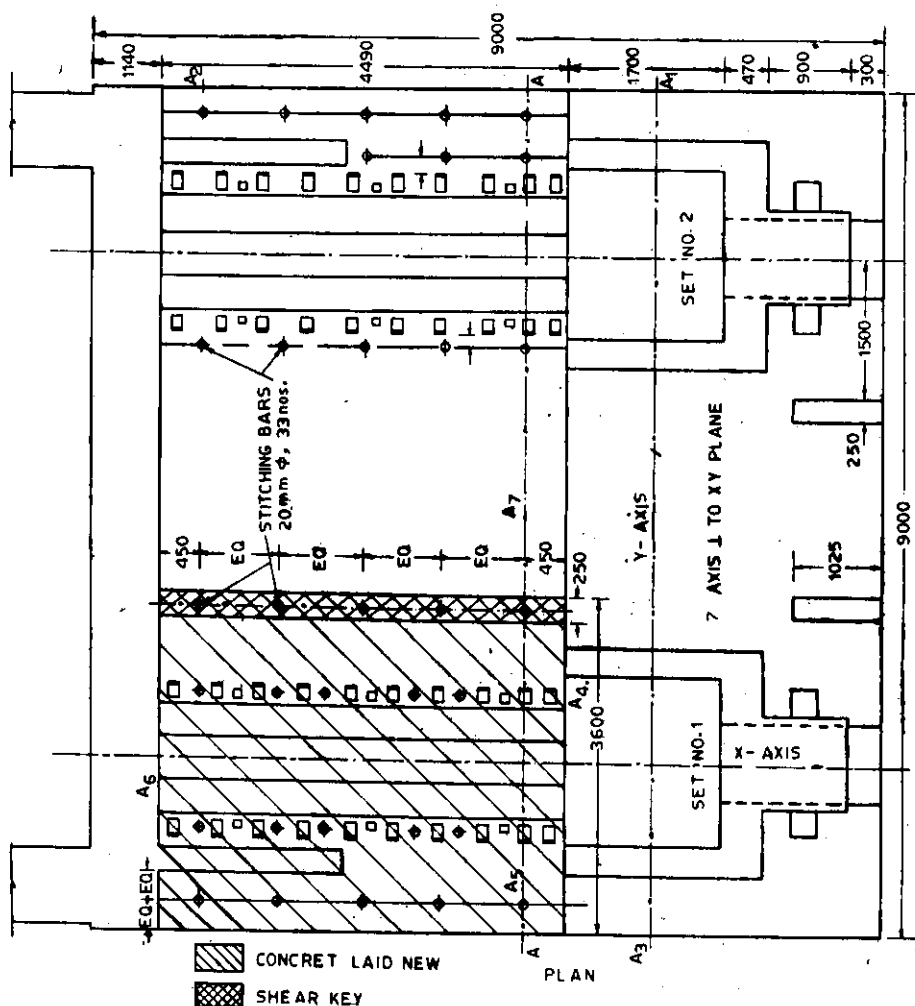
Fig. 1. Plan of generator foundations

After removing the engine the foundation was examined and a cold joint was suspected at a depth of 800 mm from the top of the foundation. Unfortunately without conducting tests to confirm it, a portion of block $4.49 \text{ m} \times 3.6 \text{ m} \times 0.8 \text{ m}$ deep was removed as shown hatched in Fig. 1. The problem was referred to the authors at this stage for checking how significant was the cold joint, if any, in the dynamic behaviour of the foundation and what remedial measures could be adopted to restore the footing to near original characteristics before installing the engine again. The observations taken and remedies suggested are described herein.

When the second engine (Set No. 2) was running on load, the acceleration measurements on block were taken with the help of Millar acceleration pickup, Brush Amplifier and Brush Ink writing oscillograph. The acceleration was measured at 4 locations, A_1 to A_4 as shown in Fig. 1, below and above the suspected horizontal cold joint at a depth of 800 mm from top of the block in the three directions X, Y, Z perpendicular to each other. Table 1 shows the acceleration amplitudes at these locations in various directions before the repair work was carried out.

From Table 1, it is observed that there is no marked difference between the accelerations below and above the suspected cold joint at any location in any direction. This indicates that the block was infact behaving as one unit and the cold joint suspected was not really 'cold'.

(e) A similar scheme of bolts was suggested for the second engine also in view of the suspected cold joint as discussed earlier. Since the second engine was in position and a channel 800mm deep also existed, it permitted only 3 bolts to be provided in one of the rows. Five bolts were also provided in the shear key shown cross hatched in Fig. 1. Thus 33 stitching bolts were suggested in all at locations shown in Fig. 1.
