PRELIMINARY REPORT ON JANUARY 19, 1975 KINNAUR EARTHQUAKE IN HIMACHAL PRADESH

INTRODUCTION

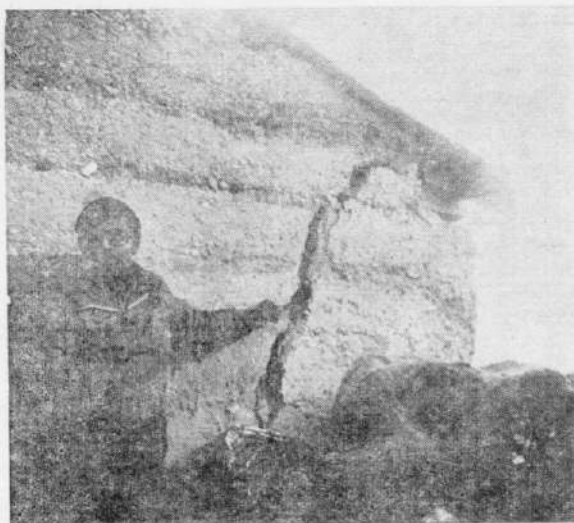
The mud houses in most of the villages upto a distance of 100 km from Kaurik developed cracks in the walls (Fig. 4) and got tilted. Most of the mud houses from Indo-Tibet border upto Leo have been badly affected often resulting in collapse of the structure. Stone masonry houses showed similar behaviour. However, dressed stone masonry construction in cement mortar with light sloping roofs suffered little damage. Light weight structures made of corrugated iron sheets nailed on timber frame-work did not suffer any damage. Damage to buildings in some of the severely affected villages is described below.

Fig. 4. Cracks in mud house at Pinauti village.

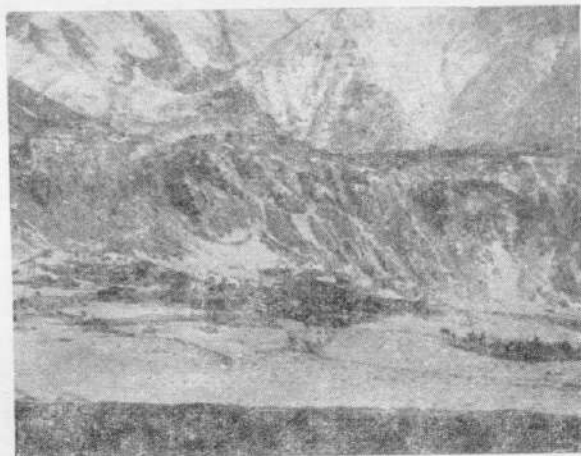
Damage at Kaurik: This village consisted of twelve houses. Figure 5 shows a general view of damaged Kaurik village. All the houses were constructed in cast-in-situ mud walls (Fig. 6) and mud bricks with heavy flat roofs which collapsed during the earthquake. The village rests on the flat top of a glacial moraine. Extensive fractures and dislocations in the ground were observed. A timber frame house (Fig. 7) with walls of

Fig. 5. A general view of the Kaurik village showing complete collapse of structures during the earthquake. Sliding of boulders and other materials at the crest of the terrace can be seen in the background.

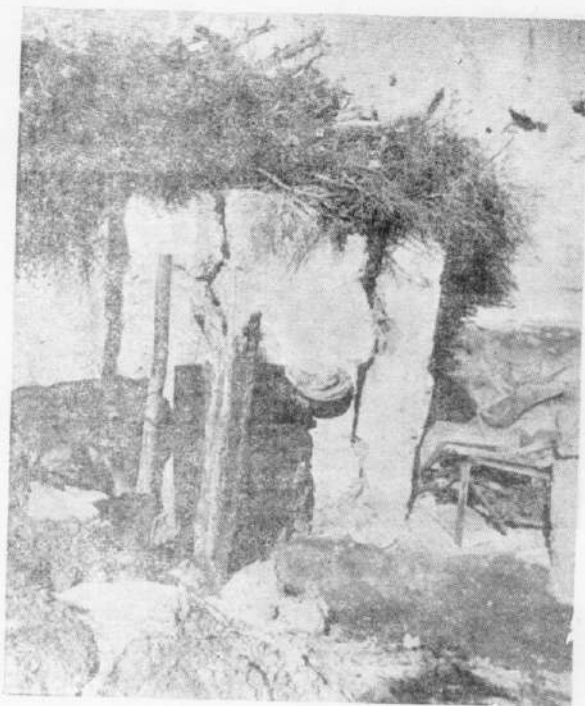
Fig. 6. Collapse and fall of a house made of cast insitu mud walls at Kaurik village.

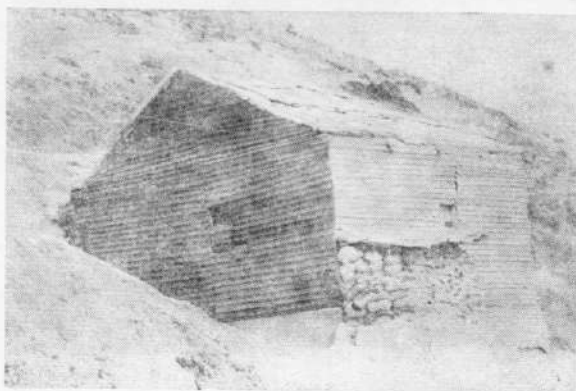
Fig. 7. A timber frame house over a concrete water tank which suffered very less damage. Fall of plaster and fine cracks were seen in the walls of the tank.

timber planks located on a hill slope 3 km south of Kaurik village, however, did not suffer any damage. This structure rested on a stone masonry water tank in cement mortar, the walls of which show fall of plaster and minor cracks. Small iron sheets covering the sloping roof were dislodged.

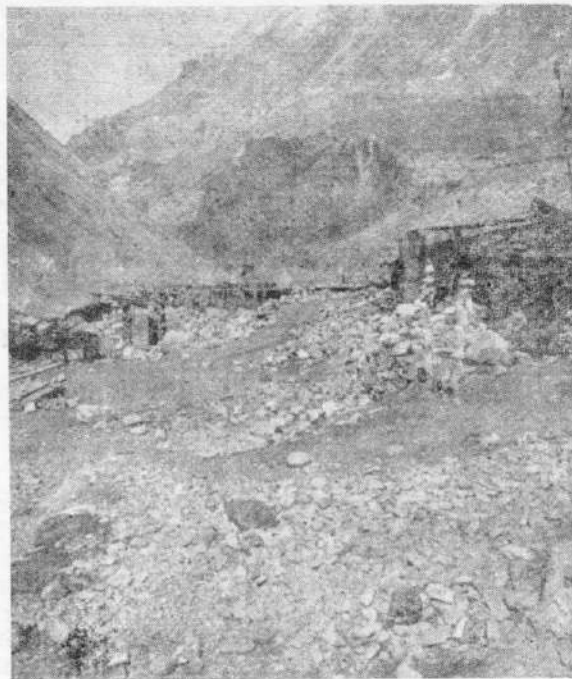
Fig. 8. Collapsed RRSM houses at Sumdoh village.

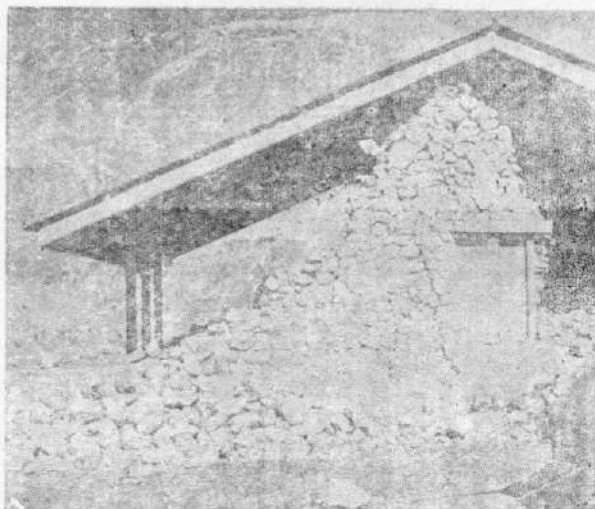
Fig 9. Damage to gable end wall of P. W. D. rest house at Sumdoh village.

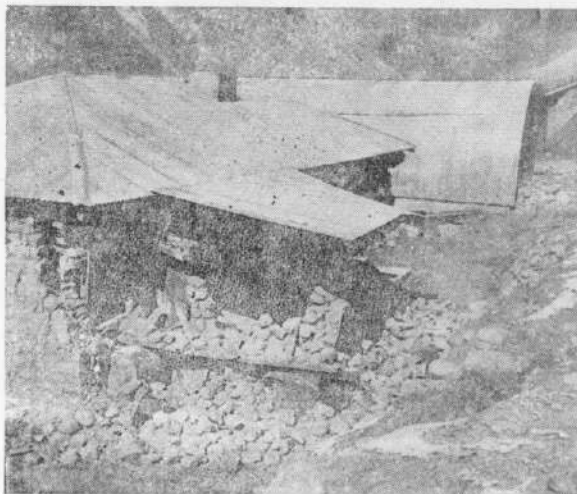
Fig. 10. Collapse of RRSM of the Asstt. Engineer's residence, Semicircular shed (P.W.D. store) seen in the background did not suffer any damage except the collapse of the stone masonry side walls.

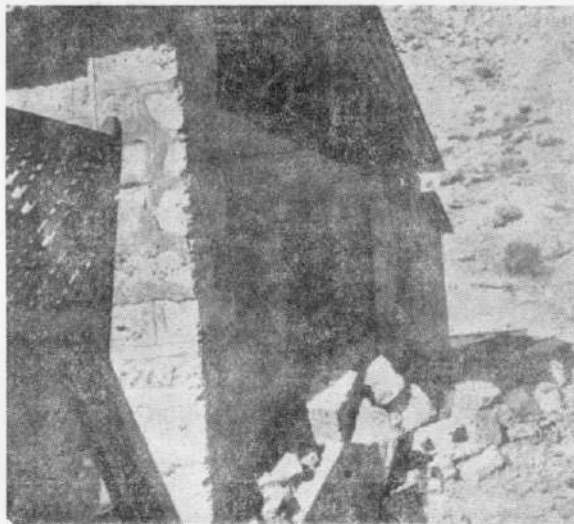
Some recent constructions near Sumdoh village on the terrace on right bank of Parachu river were constructed in hollow concrete blocks. Fig. 11 shows the collapse of the gable end wall of a hall whereas the columns and corrugated iron sheet roof resting on steel trusses did not suffer any damage. Fig. 12 shows tilting of the filler wall in such construction. Fig. 13 shows cylindrical shed made of corrugated iron sheets nailed on timber arches. The end wall made in timber frame with concrete blocks as filler walls did not suffer significant damage, except cracks along mortar joints. Some of the E-W walls collapsed completely.

Fig. 11. Collapse of gable end wall, made of hollow concrete blocks near Sumdoh village.

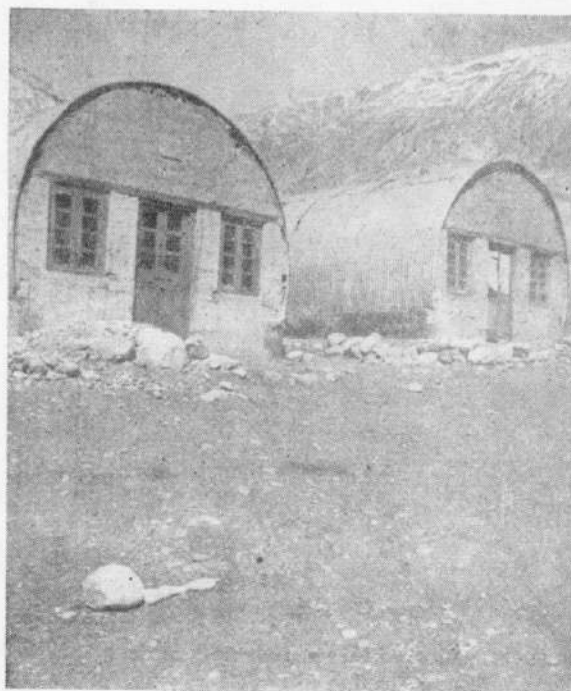
Fig. 13. Cylindrical sheds of corrugated iron sheets which suffered no damage except development of cracks on the side walls near Sumdoh village.

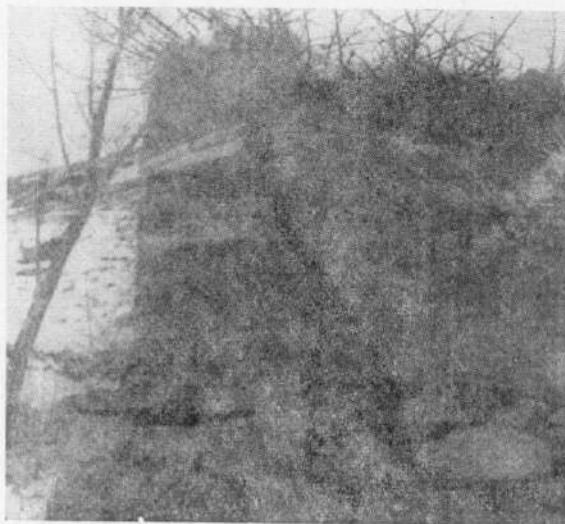
Damage at Shalkar: Village Shalkar is situated on a fine grained glacial till. Most of the houses are made of mud as clay (Glacial till) is available locally. Fig. 14 shows cast-insitu mud walls (90 cm thick) which developed huge cracks and tilted. Such buildings rest on a 1 to 1.5 m high plinth of RRSB without mortar. Fig. 15 shows badly cracked damaged wall of a house in which all other walls have collapsed. Many houses had a ground floor in RRSB and the second storey in sundried mud bricks. Fig. 16 shows collapse of the east-west mud brick wall of a double storey house. The first storey of this house is in RRSB in mud mortar. Fig. 17 shows the collapse of Police check post on H.T. Road which was constructed in RRSB in mud mortar. The big boulder approximately 2.5 m long rolling down from left seen below the collapsed roof, caused severe damage to the building.

Fig. 14. Cast insitu mud walls showing tilting and development of cracks at Shalkar village.

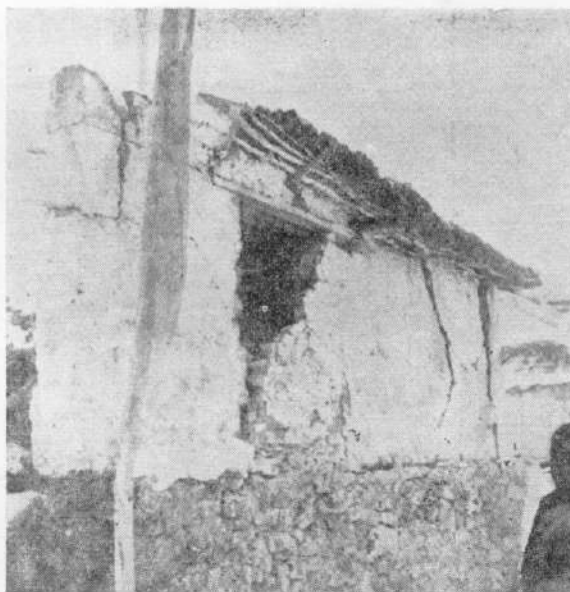
Fig. 15. A badly damaged wall resting on plinth of RRSM without mortar. (All other walls of the house have collapsed) at Shalkar village.

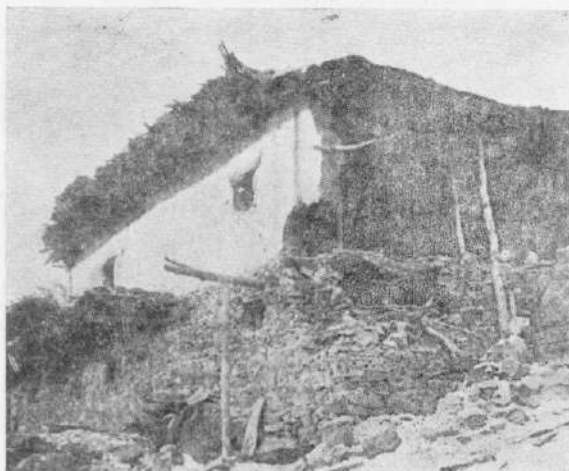
Fig. 16. Complete collapse of E-W wall of mud brick of a double storey house at Shalkar village. The ground floor is in RRS in mud mortar.

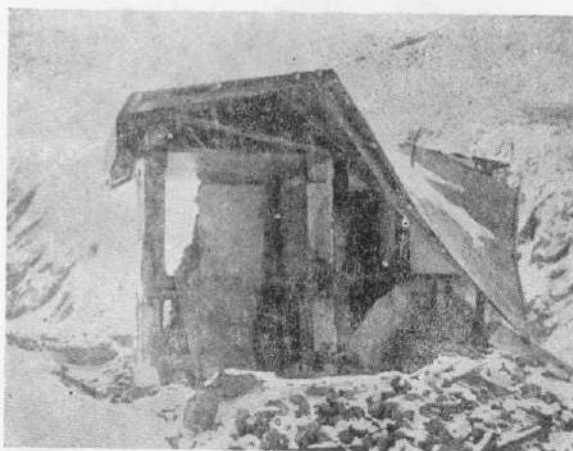
Fig. 17. Collapse of police check post at Hindustan Tibet road, Shalkar. A big boulder rolling down from left seen below the collapsed roof, caused severe damage to the building.

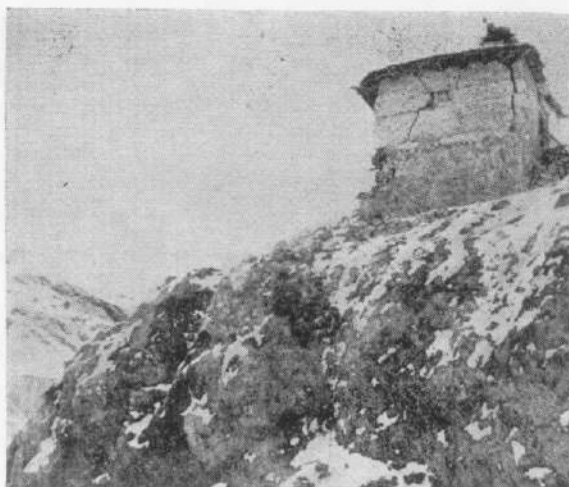
Fig. 18. Severe damage to the priest's house at Shalkar village.

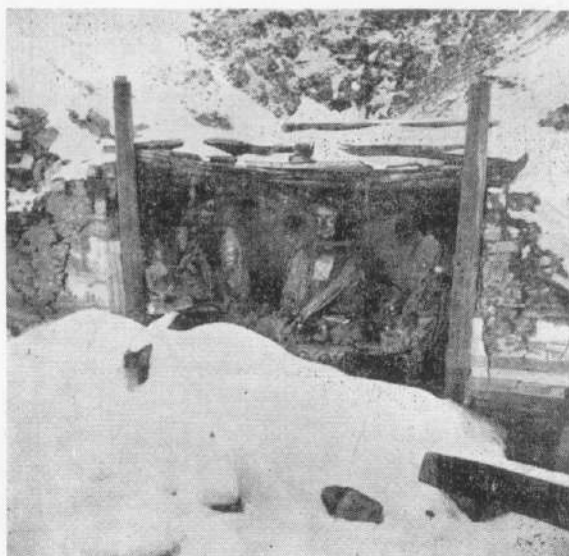
Fig. 19. Total collapse of temple housing Buddha idols at Shalkar village.

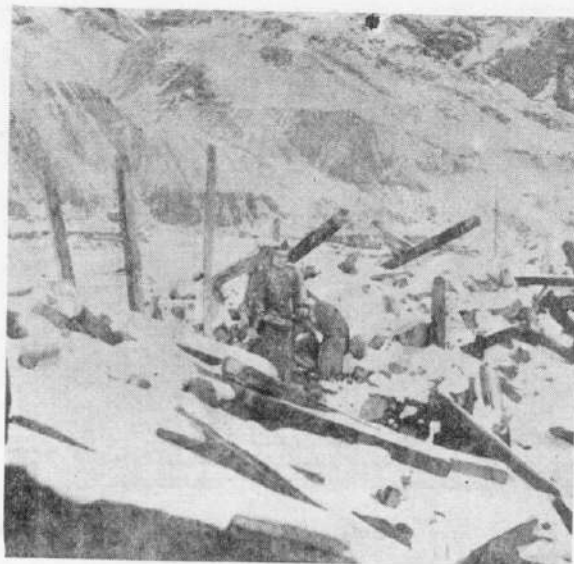
Fig. 20. Total collapse of timber frame work of a temple at Shalkar village. The Buddha idol is also damaged.

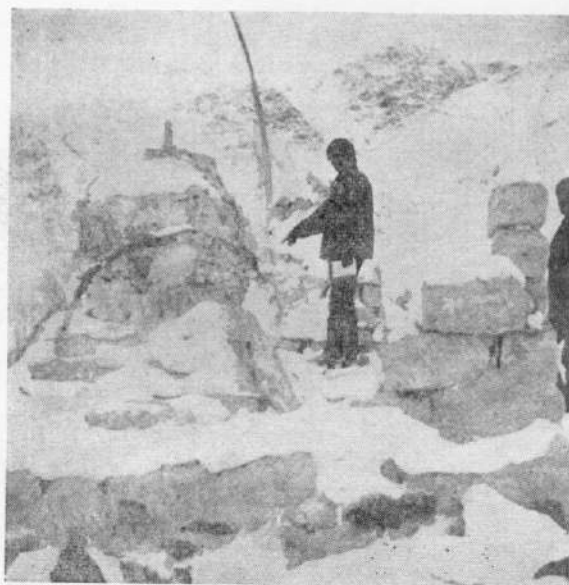
Fig. 21. Damages to 'mane' at Shalkar village; that in front shows cracks whereas the spherical dome of that in the background had collapsed and the masonry rolled down.

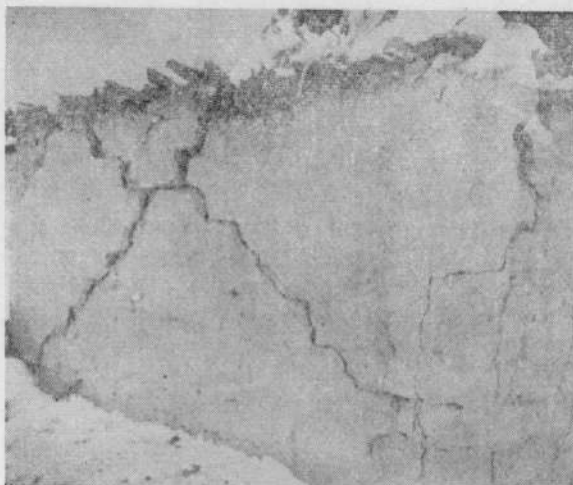
Fig. 22. Diagonal cracks along mortar joints in mud brick house at Chango village.

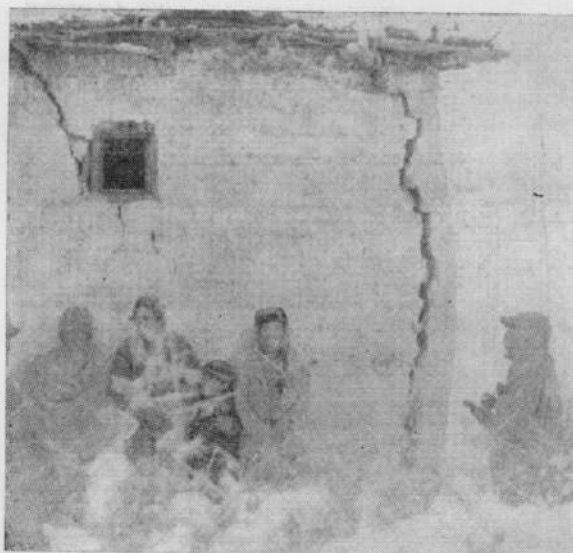
Fig. 23. Bulging of the end wall and cracks propagating from window openings of a mud brick house at Chango village.

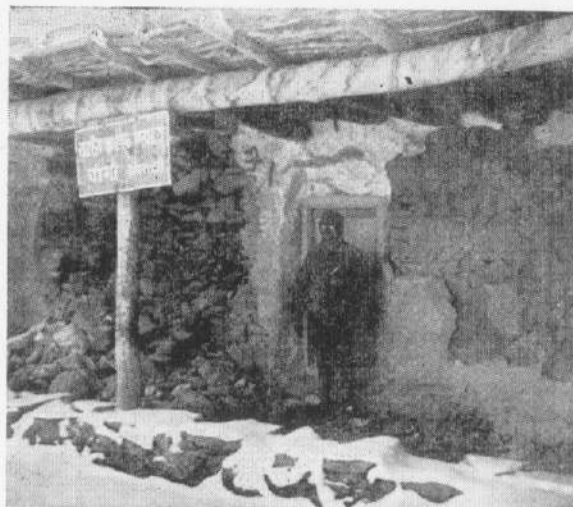
Fig. 24. Failure of RRSM interior walls of the primary school building at Chango village.

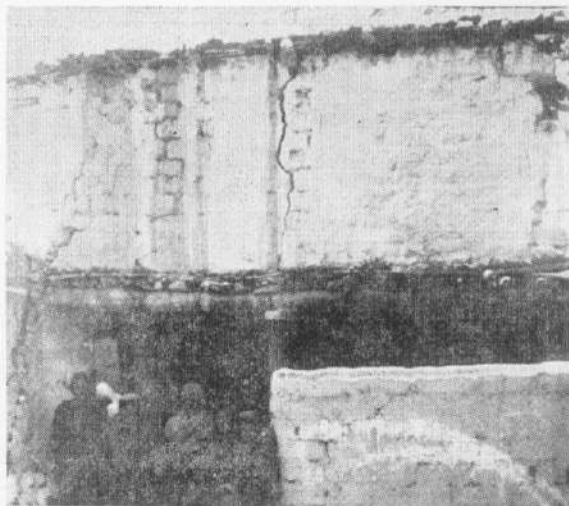
houses, have suffered extensive damage. Fig. 25 shows extensive cracks in mud brick masonry on first floor with partial collapse in back walls.

Fig. 25. Extensive cracks in mud brick masonry on second storey resting on timber posts, with partial collapse of back walls at Chango village.

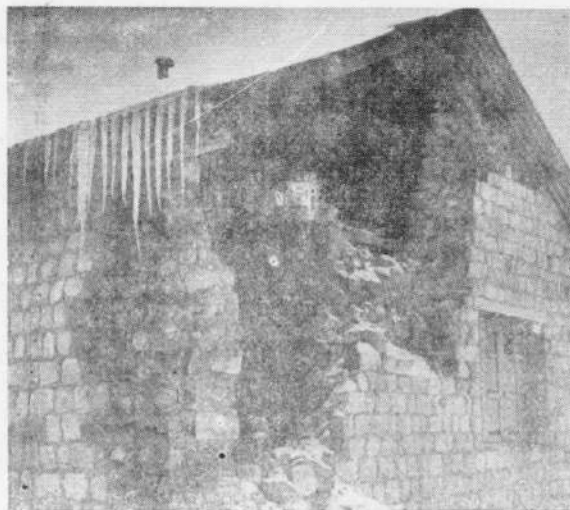
Fig. 26. Collapse of stone masonry gable end wall in Patwarikhana, at Chango village. Dressed stone was used in the outer facings whereas random rubble stone was used in the inner facings with muck filled in between,

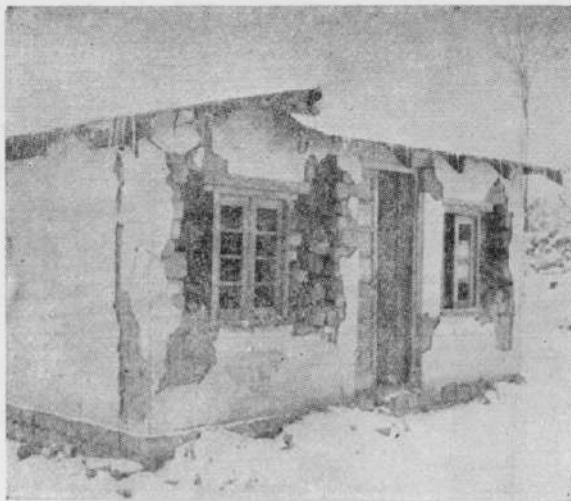
Fig. 28. Fall of plaster and development of cracks in the "gramsevak" building at Chango village.

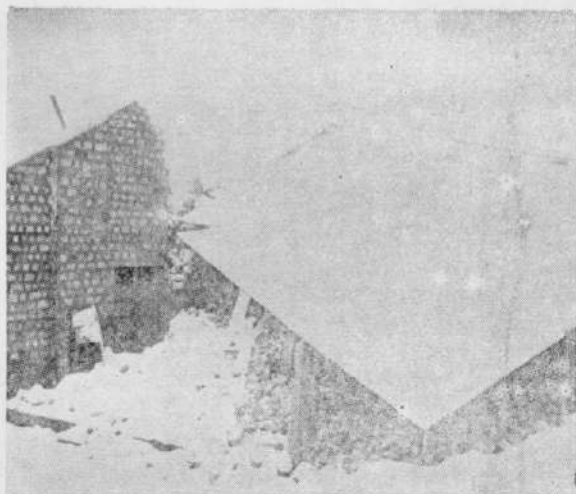
Fig. 29. Collapse of stone masonry wall and roof in peon's hut at Chango village.

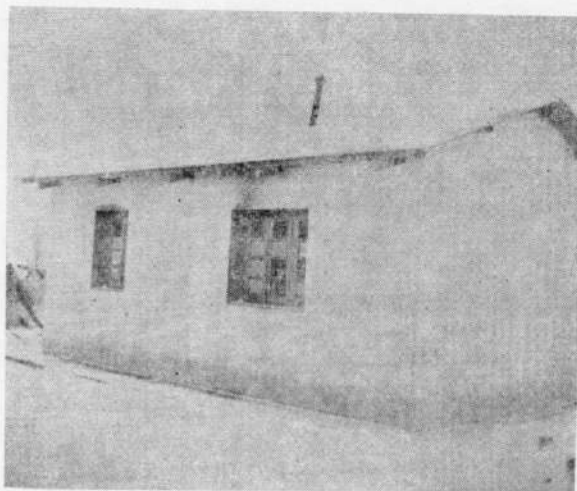
Fig. 30. Revenue building built in stone masonry in cement mortar suffered no damage except for minor development of cracks at Chango village.

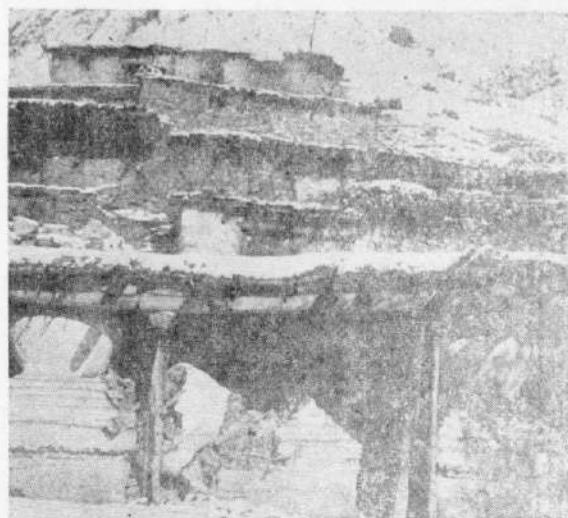
Fig. 31. Damage to 'Mane' and stone masonry houses at Leo village. The houses show cracks at all five levels from the central 'Mane' in N-S direction.

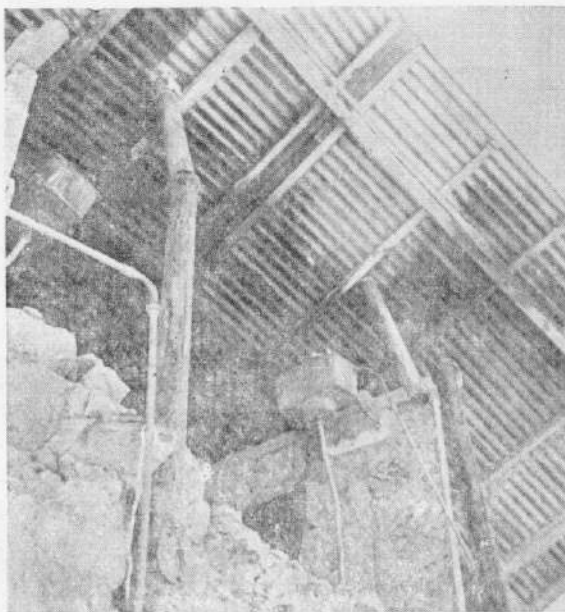
Fig. 32. Collapse of gable end wall in a house at Leo village. A timber frame interior wall with stone masonry filler built in Kashmir Dhaji-Dewari type construction did not collapse. Movement of the roof resulted in tilting and dislocation of sewage ventilation pipes.

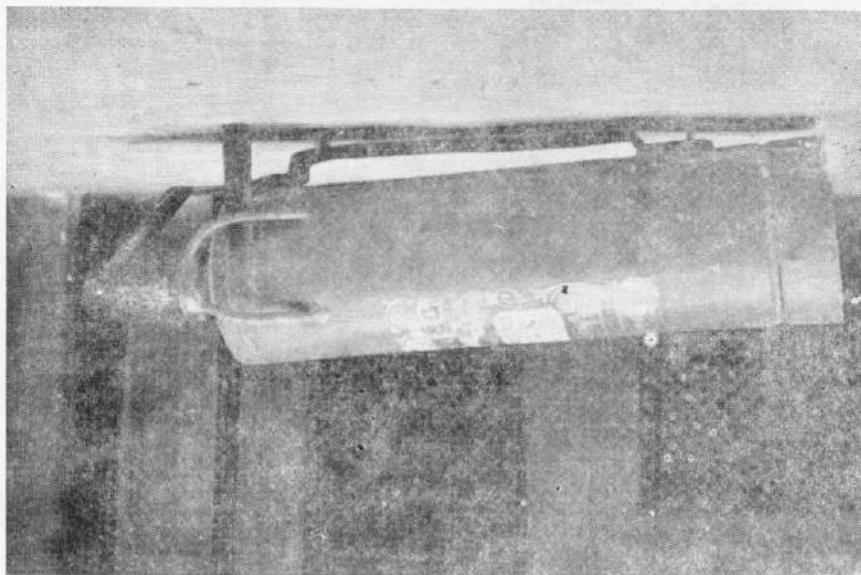
Fig. 35. Detachment of fire extinguisher from the wall inside police station Building at Leo village.

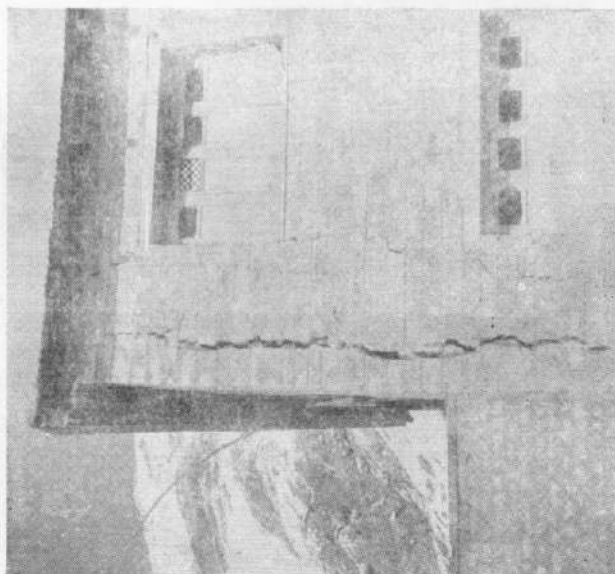
Fig. 34. Bulging of walls due to cracks from roof to floor level on the police station building at Leo village.

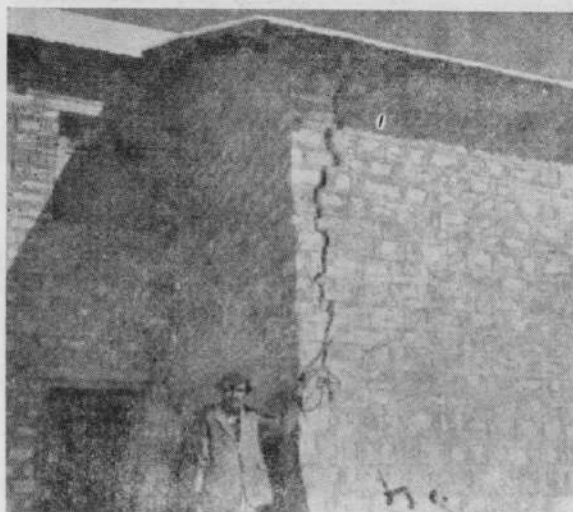
Fig. 36. Vertical cracks at the junction of walls in Ayurvedic hospital at Leo village,

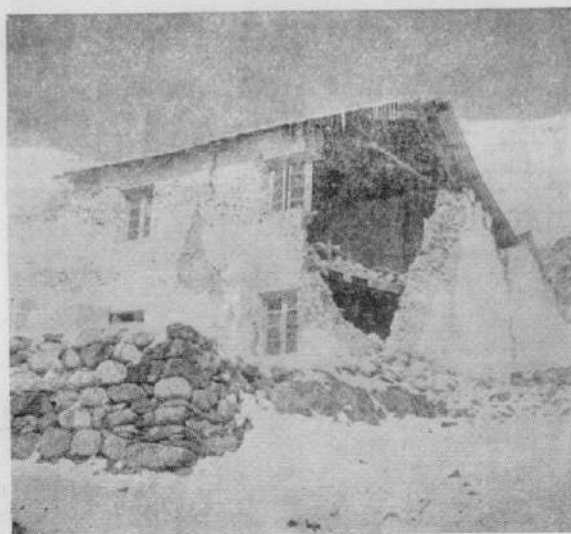
Fig. 37. Collapse of gable end wall of two storeyed compounder's residence at Leo village. Fall of mud plaster can be seen on the walls.

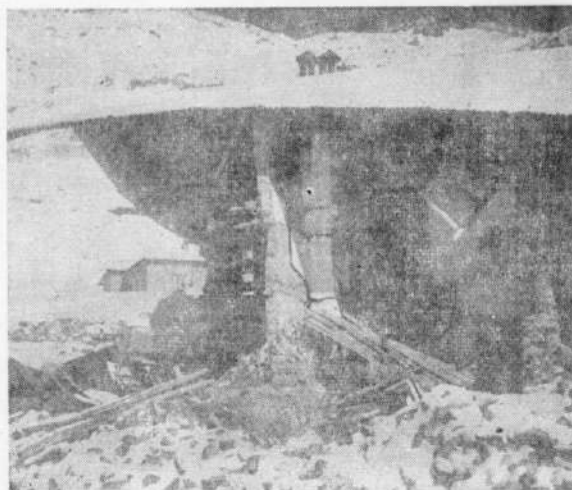
Fig. 39. Collapse of outer and inner walls and failure of roof trusses in the office-cum-residence of Agricultural Authority at Leo village. Single storeyed stone masonry house in cement mortar seen in the background developed only cracks along mortar joints and plaster fell down in the interior.

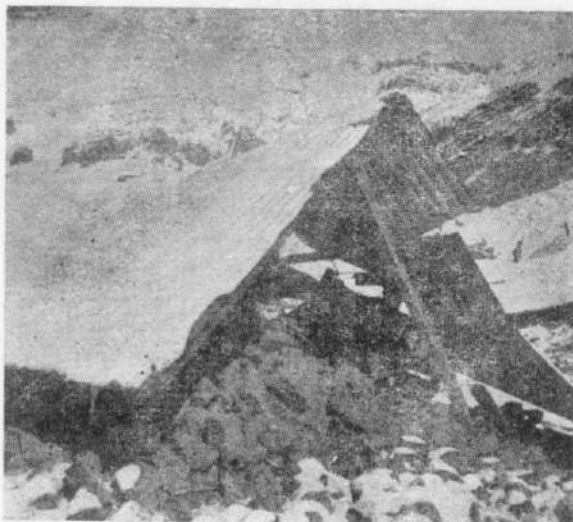
Fig. 40. Total collapse of Tehsil office building at Leo village.

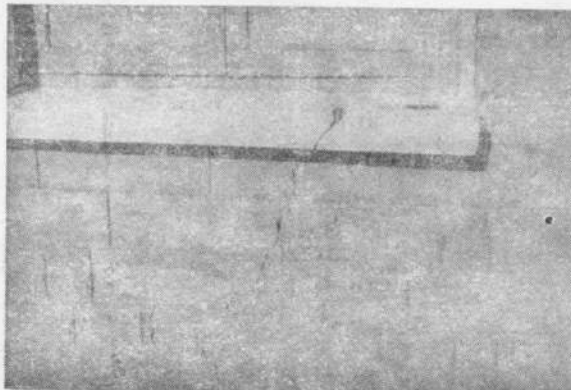
Damage at Pooh: Pooh village is situated on a hill slope (Fig. 42) consisting of glacial moraine. Most of the houses were of stone masonry in mud mortar which developed cracks along mortar joints, which were often 1-2 cms in width. Fig. 43 shows cracks along mortar joints and window sill in SDM court building.

Fig. 43. Cracks along mortar joints and window sill in S.D.M's Court at Pooh village.

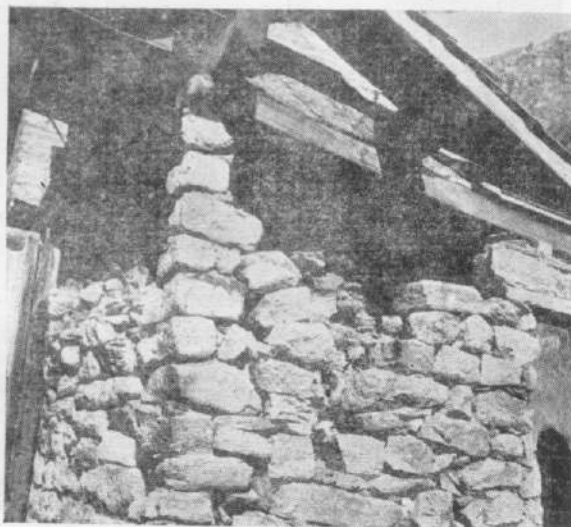
Fig. 45. A house with RRSW without mortar suffered heavy damage at Tapri village.

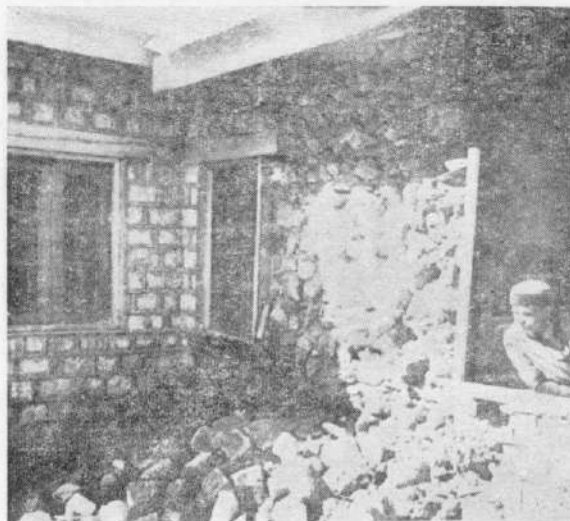
Fig. 46. Falling of DSM facings at the residence of S.D.O. at Tapri village.

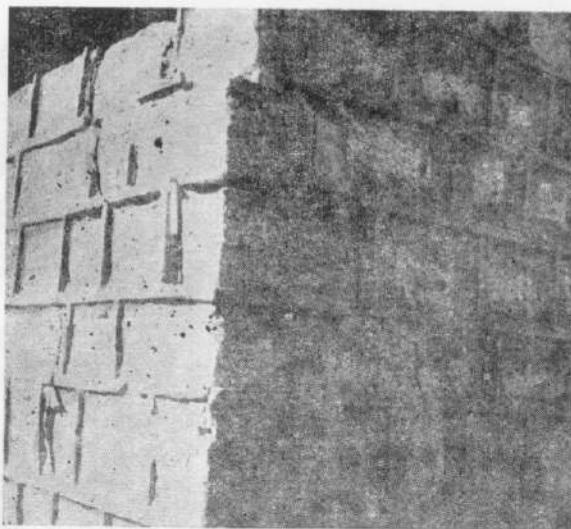
interior of the house. Cracks in DSM were developed along mortar joints starting from window openings and at the junction of walls at the P.W.D. rest house. Fig. 47 shows reopening along pre-existing cracks, which probably had developed due to differential settlement of the foundation soil.

Fig. 47. Reopening of pre-existing cracks in P.W.D. rest house at Tapri village. Cement pointing along mortar joints had fallen.

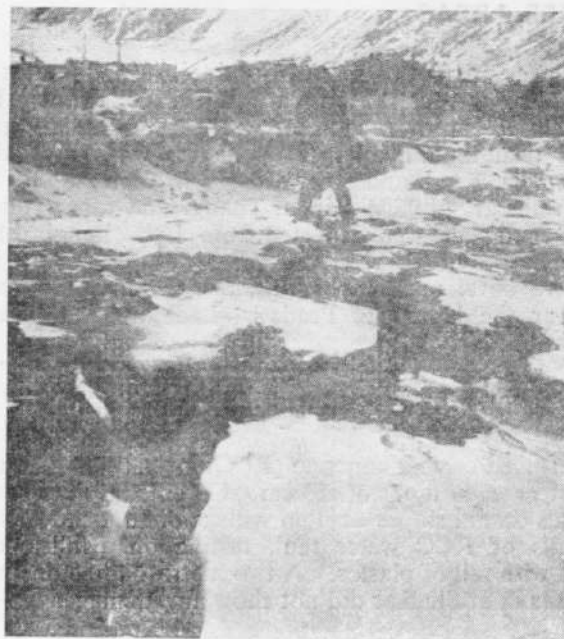
Thick succession of glacial moraine at Kaurik village developed wide and extensive fractures. Fig. 48 shows a fissure which passes through the village. Individual fissures extended to nearly 15–20 m trending N 33° to N 35° (Fig. 49). Width of the openings varied from a few centimeters to 100 cm and the downthrow of the ground towards west was noted upto 100 cm (Fig. 50). The fracture zone having a width of 10 to 15 m with individual fractures running en echelon to each other could be traced

Fig. 48. Ground fissure which cut across Kaurik village.

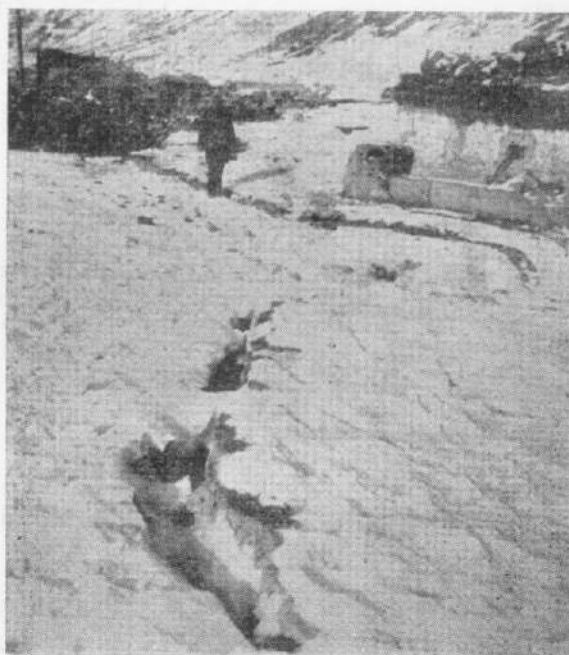
Fig. 49. En-echelon ground fissures near Kaurik village. Individual fissures run for 15-20 meters separated by 10-15 meters.

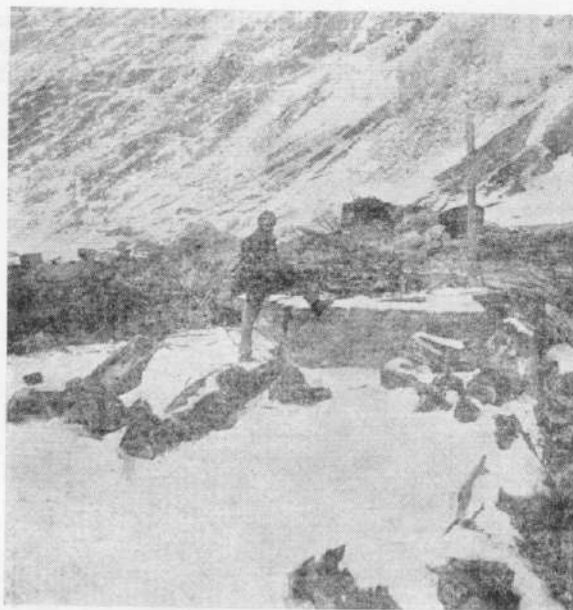
Fig. 50. Vertical scarpment along a ground fissure at Kaurik village,

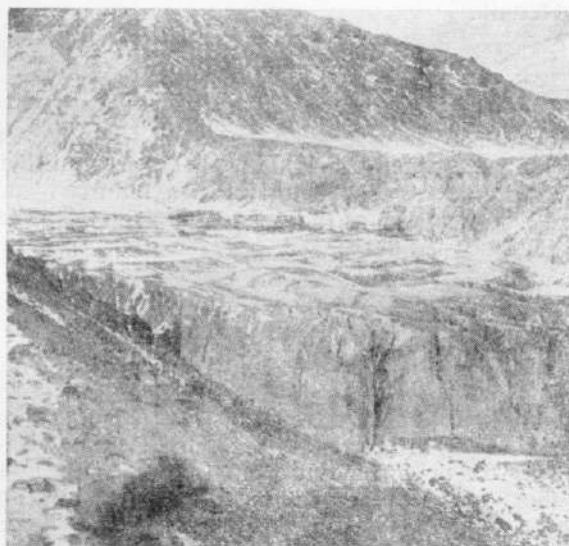
Fig. 51. Sliding and fall of glacial moraine from the crest of the terraces at Kaurik village.

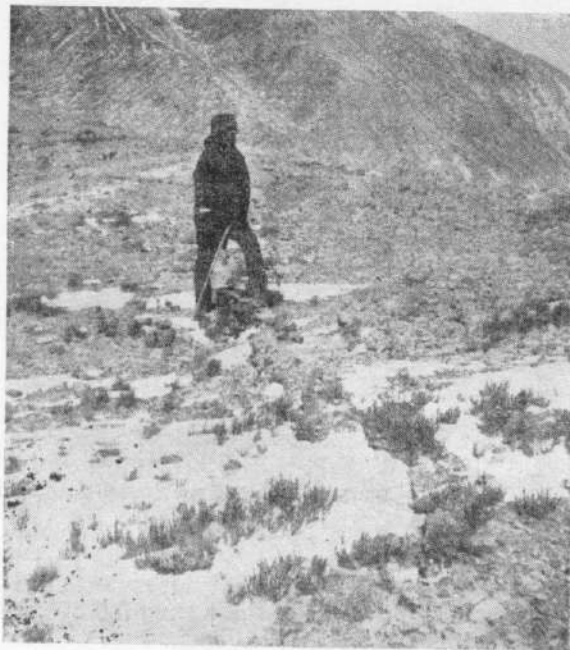
At a place between Sumdoh and Kaurik the fissures in the ground with trend towards $N 25^\circ$, transverse to the ridge covered with glacial moraine, were noted (Fig-52). The opening along the fissures were varying from a fraction of a centimeter to 15 cm.

Fig. 52. Ground fissures on a ridge between Sumdoh and Kaurik.

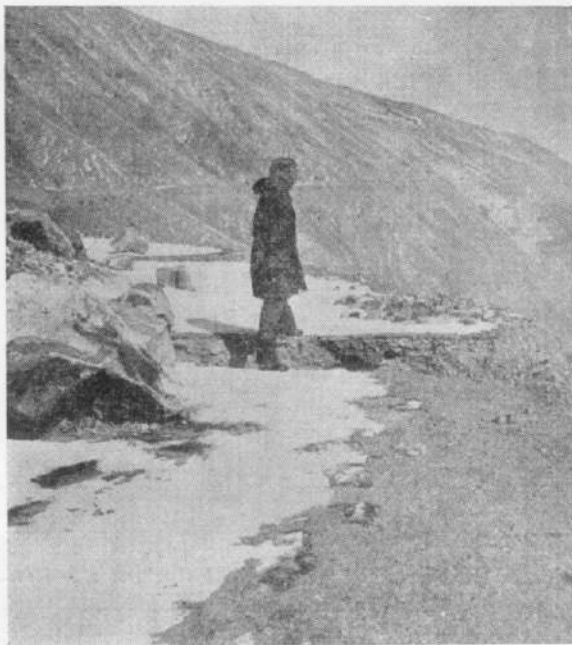
Fissures trending $N 350^\circ$ transverse to the road, forming step faults with down throw side towards west were noted on Hindustan-Tibet road between Sumdoh and Kaurik (Fig. 53). The fractures extended towards the hill mass and had openings upto 60 cm in width (Fig. 54). The depth of the openings was noted to extend upto 4 to 5 m and the fissures probably extended deeper.

Fig. 53. Step faulting with down throw side towards west on Hindustan Tibet road between Sumdoh and Kaurik.

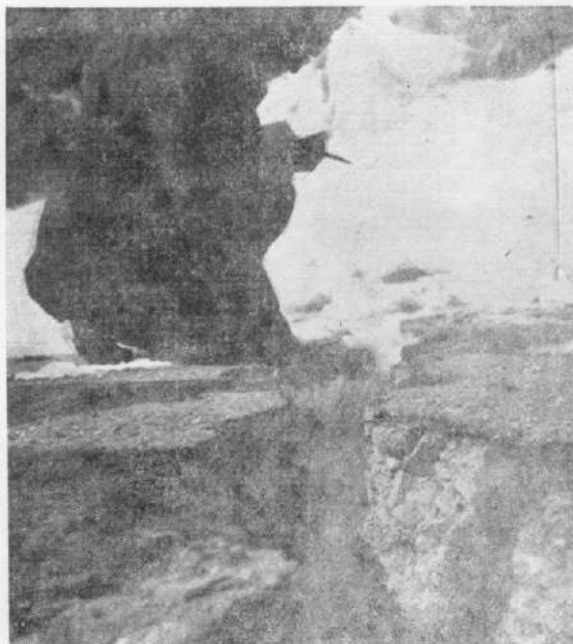
Fig. 54. Ground fissures transverse to the road with openings upto 60 cm in width between Sumdoh and Kaurik. The extension of the fissure in the hill mass covered with snow is seen in the background.

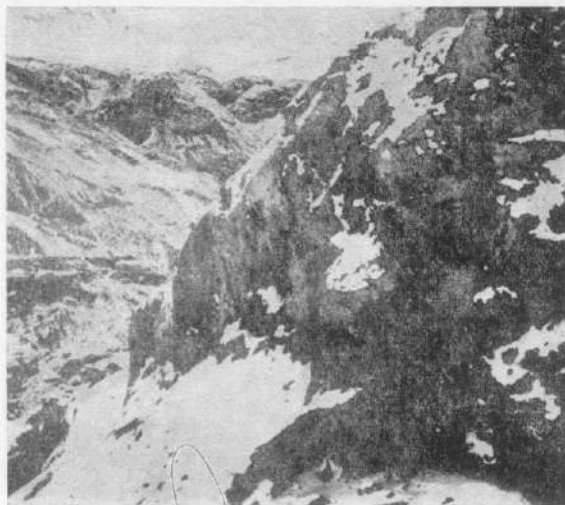
Fig. 55. Steeply dipping to vertical fractures along pre-existing joints in carbonaceous shales near Shalkar village.

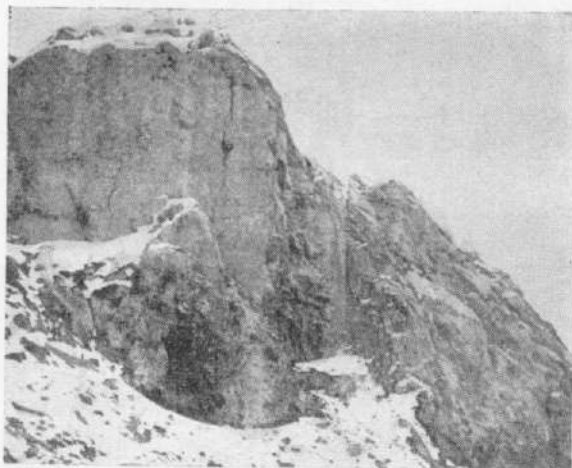
Fig. 56. Vertical fractures in lacustrine clay deposits near Shalkar village.

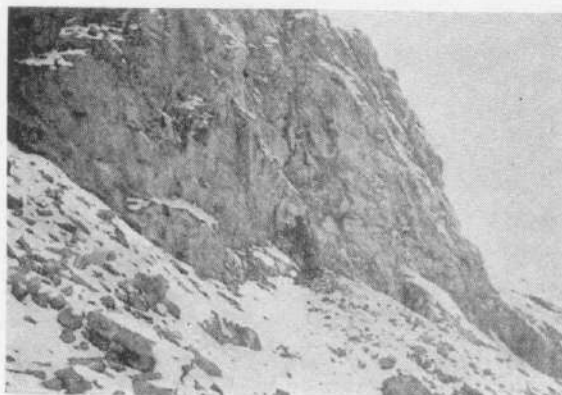
Fig. 57. Vertical fractures and dislodging of tabular slabs of clay (in the fore ground) near Shalkar village.

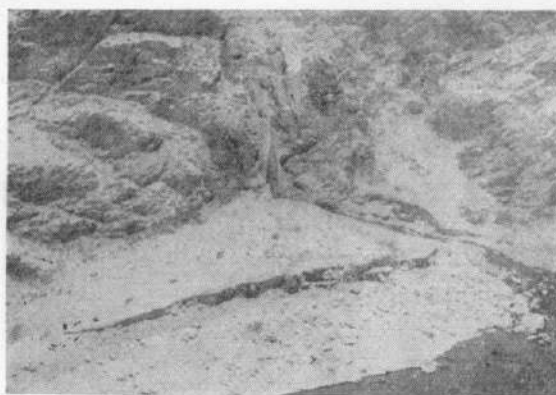
Fig. 58. Ground fissures along Spiti river trending N 20° between Chango and Mallang.

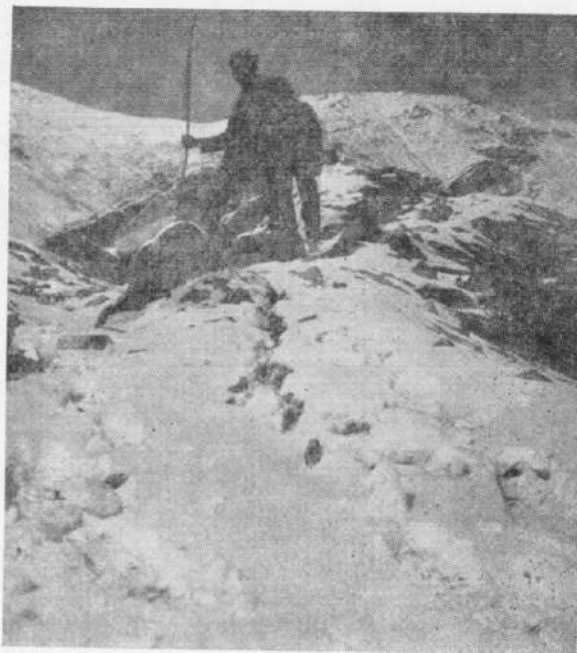
Extensive fractures developed on the top of the glacial moraine ridge (Fig. 59) trending towards N 345°. A transverse natural subterranean water passage below the ridge was reported to have choked due to dislocation of the rock mass. The width of the fissures varied upto 75 cms (Fig. 60). Similar ground fractures were noted on the hill slopes above the Leo village (Fig. 61) with a trend towards N 10°.

Fig. 59. Ground fissures along the top on a glacial moraine ridge near Leo village.

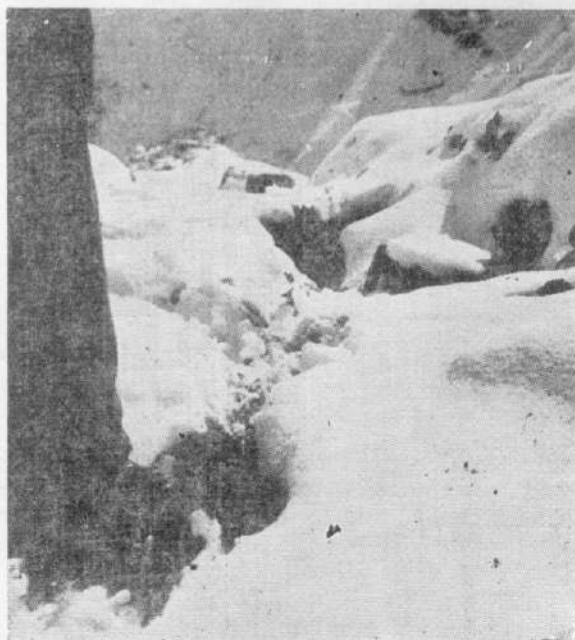
Fig. 60. Close up of a fissure with opening from 60-75 cm in width on glacial moraine ridge near Leo village.

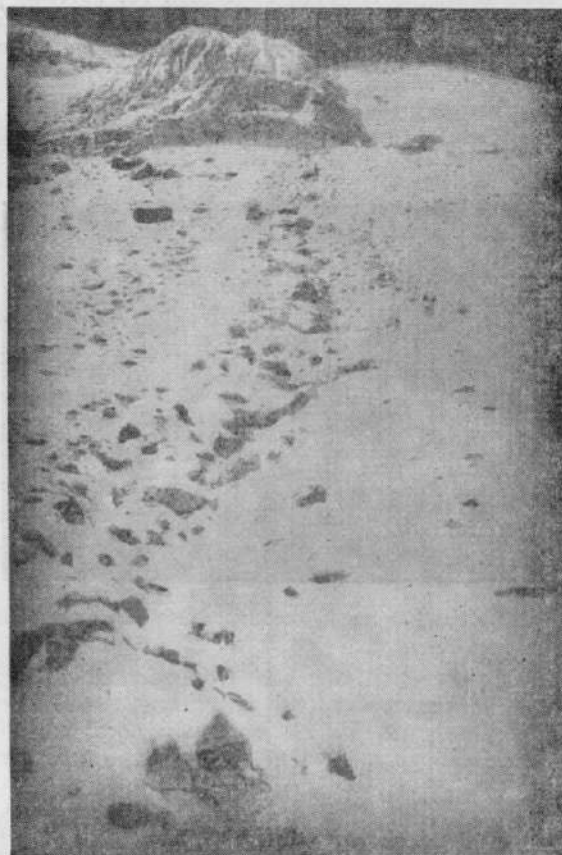
Fig. 61. Ground fissure (covered with snow) along the hill slopes above the Leo village.

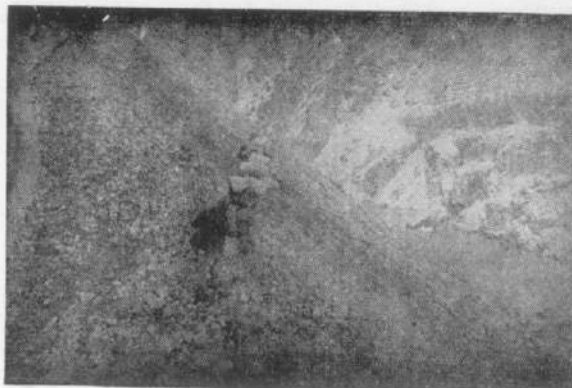
Figure 63 shows extensive landslides along part of a four kilometer stretch of Hindustan Tibet road on the right bank of Spiti river. These hill slopes were composed

Fig. 63. Land slides in carbonaceous shales along the Hindustan Tibet road.

of thinly bedded black carbonaceous shales with close spaced jointing. No trace of the original pavement could be observed along this stretch. The steep rock slopes on the left bank of this stretch, however, did not show extensive landslide probably due to favourable attitude of the bedding and joint planes in relation to the hill slopes. Fig. 64

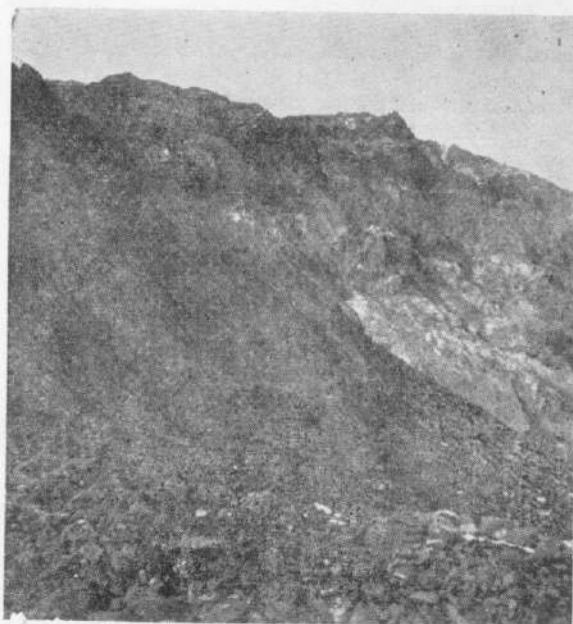
Fig. 64. Sliding of rock wedge in carbonaceous shale with scree at its bottom on H.T. road between Shalkar and Sumdoh.

shows a slided rock wedge with scree at its bottom at another site on the same road alignment. Fig. 65 shows rock fall debris in a steep slope composed of quartzites on the right bank of Spiti river. This fissure also shows extensive landslides and fall of scree material forming talus fans on the left bank.

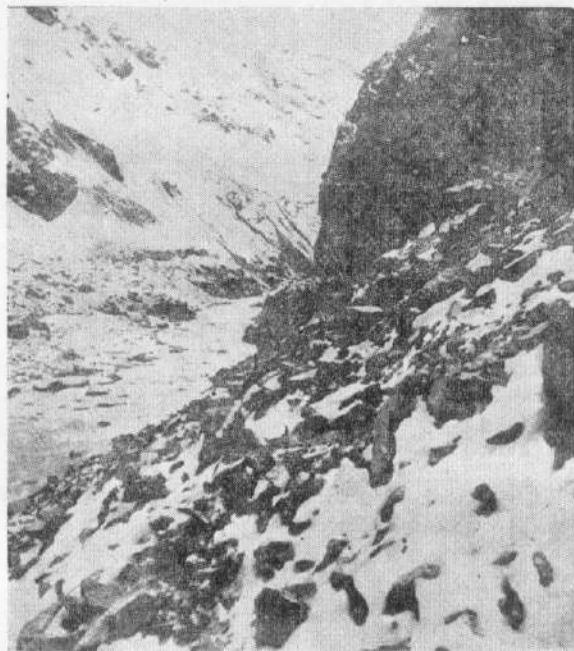
Fig. 65. Rock fall debris in a steep quartzite slopes along H.T. road between Shalkar and Sumdho.

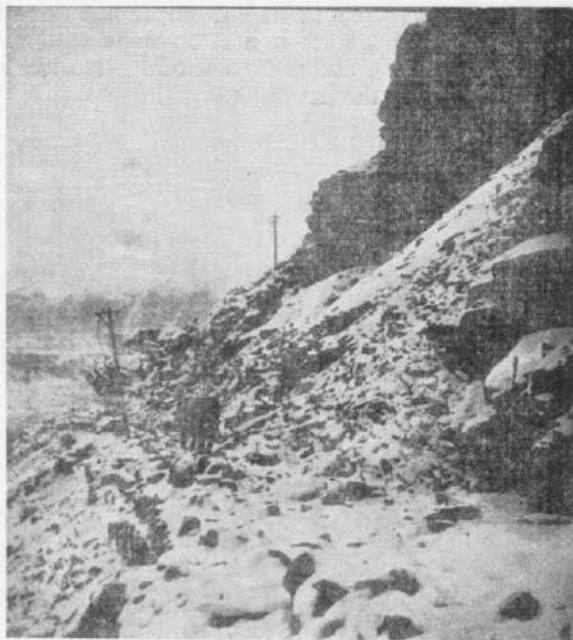
Fig. 66. Rock slides in quartzites along H.T. road between Chango and Shalkar.

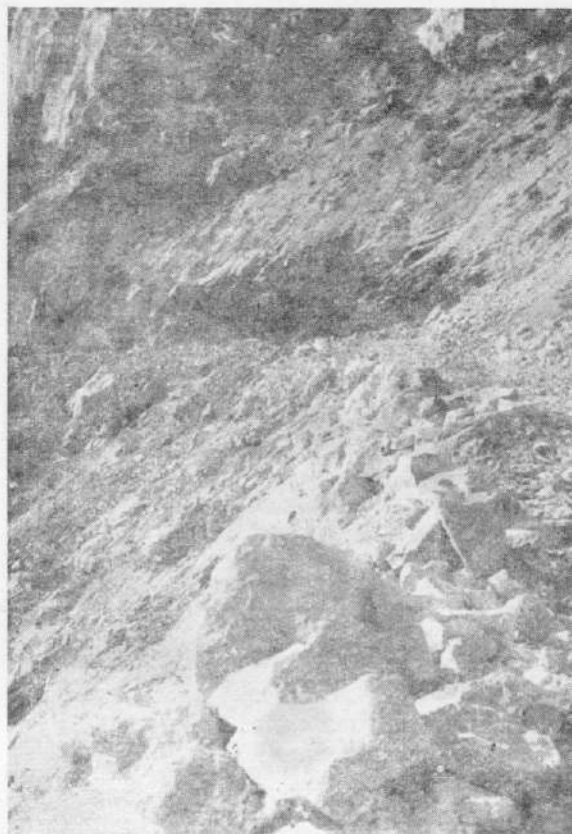
Fig. 68. Extensive rock slide in granite gneisses along H.T. road near Kah.

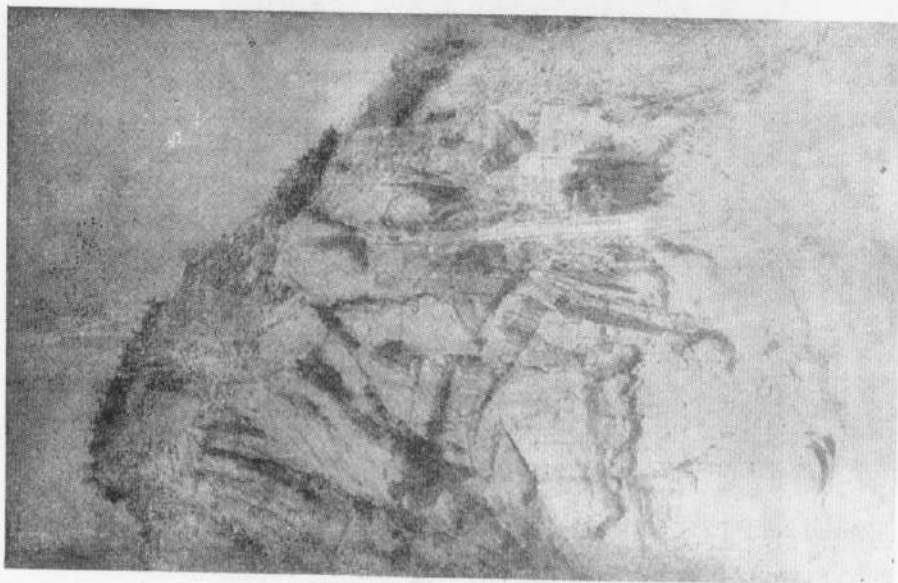
Fig. 71. Openings along pre-existing discontinuity surfaces along transverse cutting of a steep hill slope near Leo village.

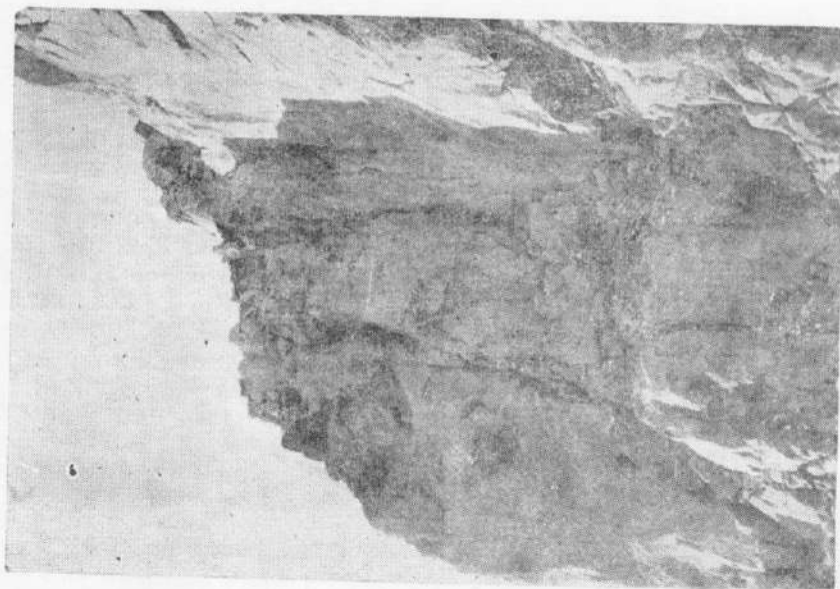
Fig. 70. Widening of pre-existing relief joints and loosening of rock mass at a steep hill slope cutting near Kah.

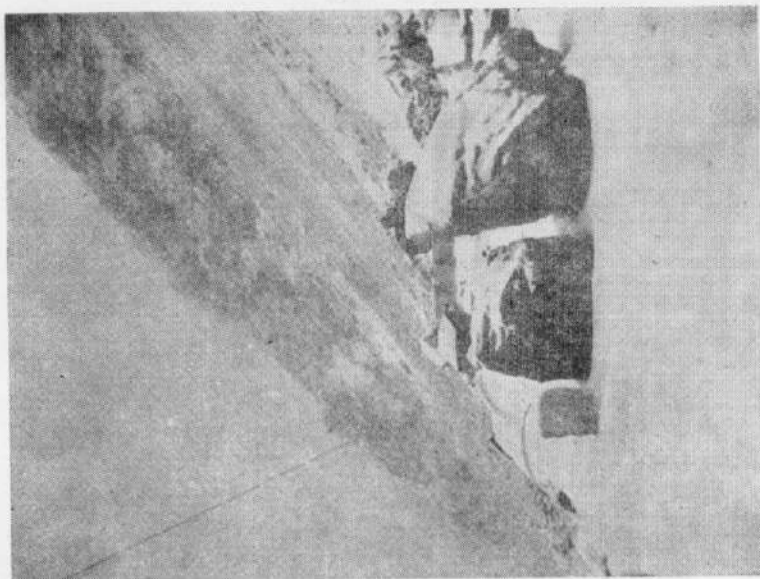
Fig. 73. Huge boulders fallen on road pavement between Malling and Chango. A huge landslide is seen in the back-ground which has washed out the road completely.
