PRELIMINARY REPORT ON JANUARY 19, 1975 KINNAUR EARTHQUAKE IN HIMACHAL PRADESH

INTRODUCTION

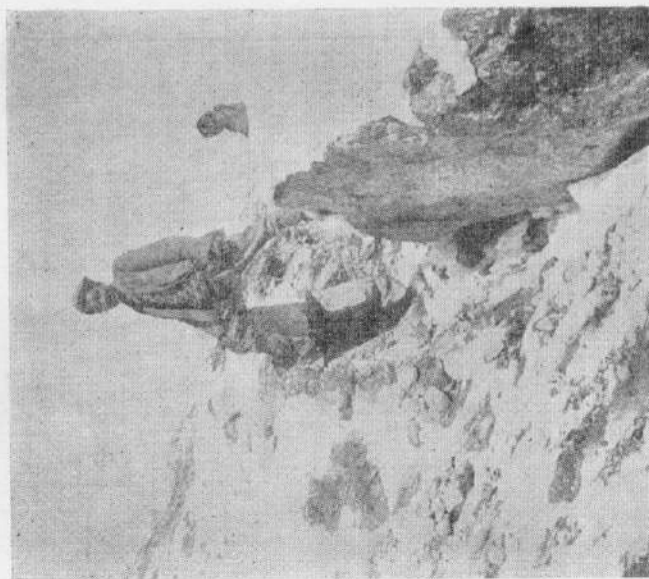
Fig. 72. Huge boulder dislodged and shifted at the crest of the hill slope at Leo.

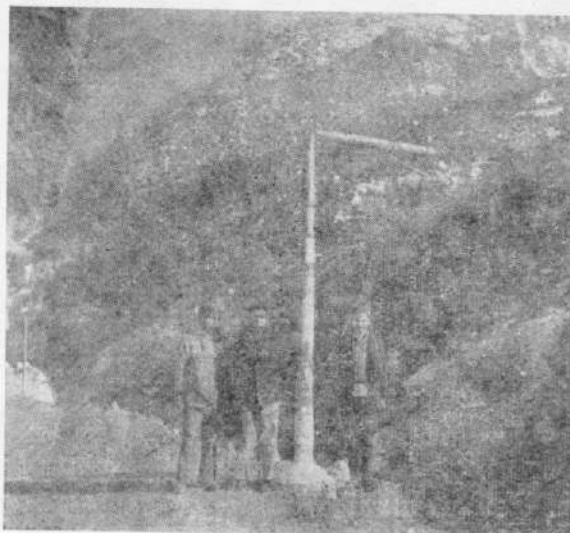
resulting in damage to them. Fig. 74 show a telegraph pole bent due to impact of a flying boulder.

Fig. 74. Bending of telegraph pole resulting from impact of a flying boulder due to rock falls in the hill slope.

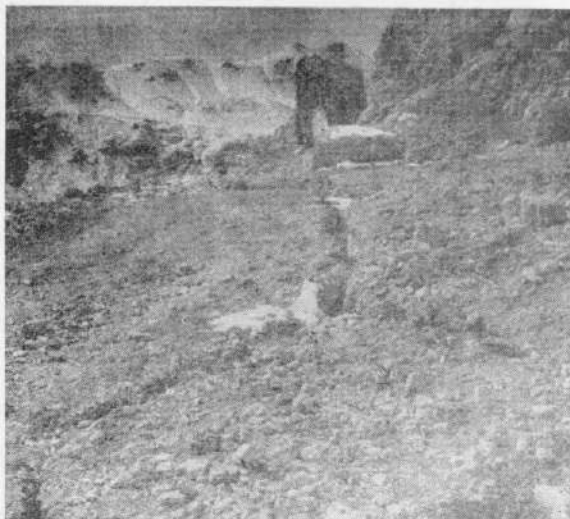
Fig. 75. Fissures developed at the top of a glacial moraine hill on the right bank of Parachu near Sumdoh.

fissures which may lead to sliding of the level terrace in the river valley towards west. Similar fissures were observed along road pavement on glacial moraines (Fig. 76) with wide openings upto 50 cm in width.

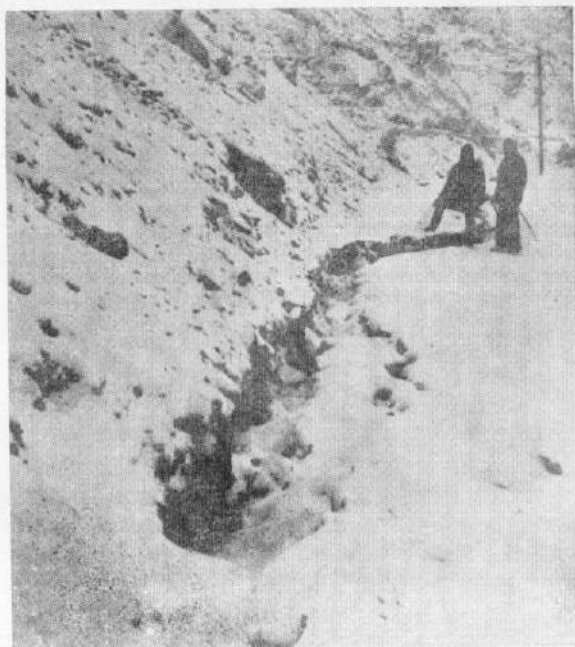
Fig. 76. Fissures parallel to the road on glacial moraine hill side between Malling and Chango.

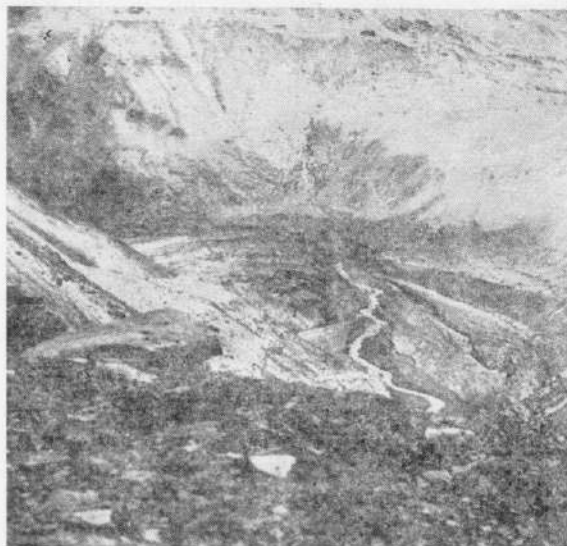
Fig. 77. Daming of Parachu river due to heavy land slide between Sumdoh and Kaurik. The new path carved out by the river along the left bank is seen in the middle. Fissures in the river bed are also seen in the right hand side.
