SEISMIC RISK TO SCHOOL BUILDINGS IN SOME ASIAN COUNTRIES

A.S. ARYA¹, B. CHANDRA² AND PRATIMA RANI³

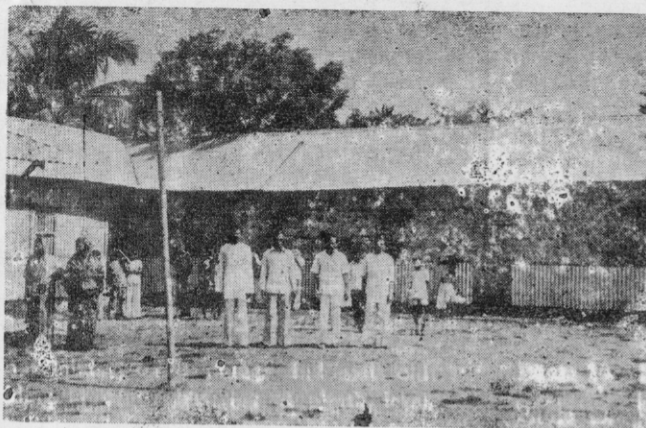
Photo 1 Government Primary School, Khilgaon, Dacca, Bangladesh. Building at left with timber post-truss construction, aluminium sheet roofing and GI cladding. Building at right with wooden rounds posts, GI sheet roofing and bamboo mat cladding.

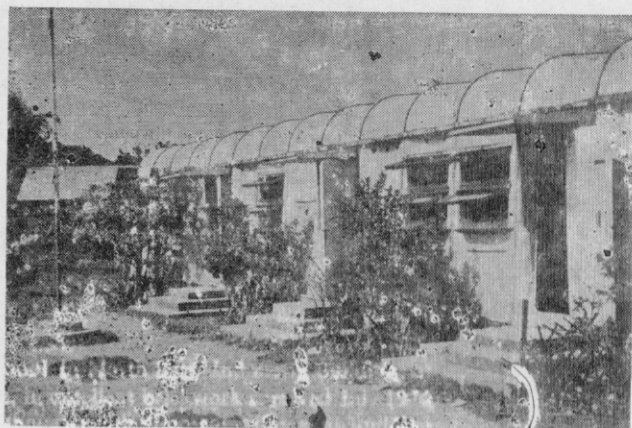
Photo 2 Government Primary School, East Khilgaon, Dacca, Bangladesh. Long sides and roof of jute plastic, ends brick wall upto eave level (too hot, but no corrosion problem in coastal areas).

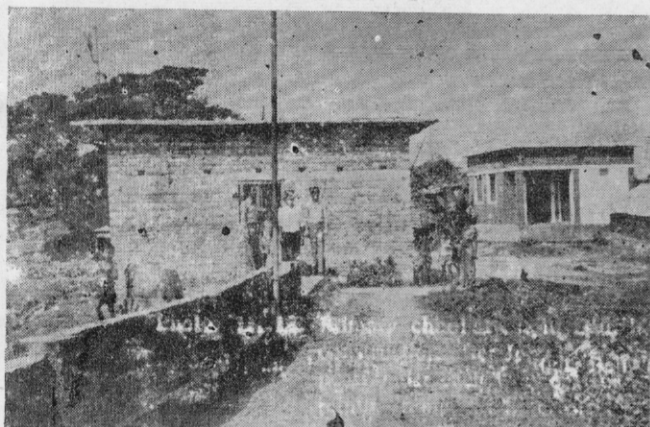
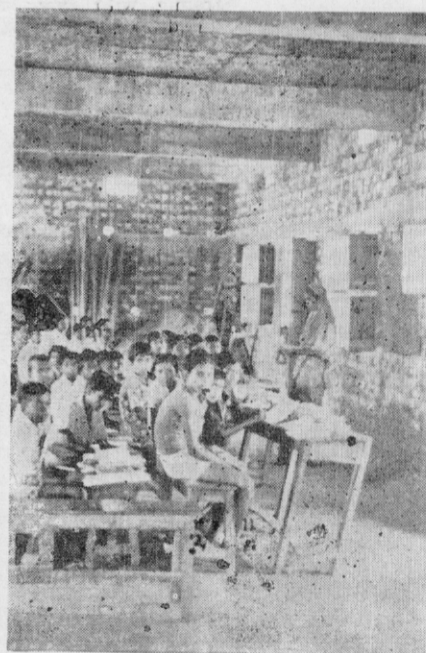
The school buildings as described above are not fully earthquake resistant but there are certain good features. The use of 1:6 cement-sand mortar for brickwork in foundations and walls and provision of plinth and lintel level bands are good features for earthquake resistance but may be adequate in mild seismic zones only. Absence of cross walls and converting the building into a long barrack type enclosure will very largely reduce its resistance to earthquake ground motions as well as cyclone wind pressures due to large unsupported length of walls.

Photos 3, 4 Matul pashchim Para Primary School Dacca, Bangladesh. One brick wall in 1:6 cement-sand mortar, RC T-beam roof, RC lintel band all round. No partitions, several classes in same room.

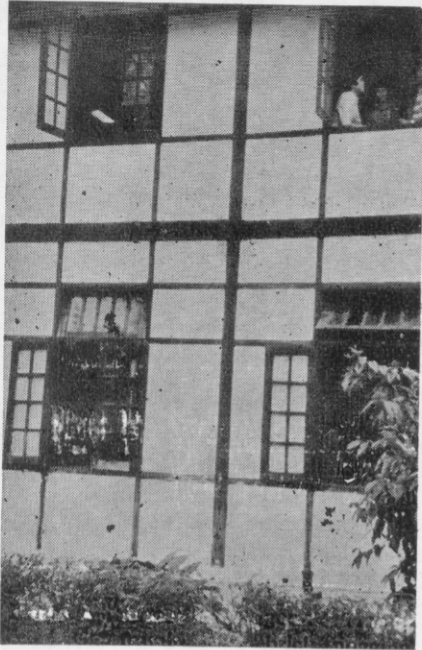
Photo 5. School in Rangoon. Timber framig with brick nogging on diagonals, good quality construction

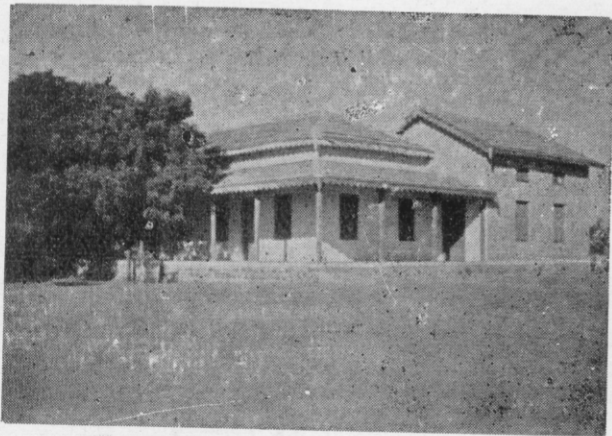
Photo 7. Primary School at Anjar, Random rubble masonry construction, has no strengthening provisions for seismic forces, no damage to the building in 1956 Anjar Earthquake to good construction.

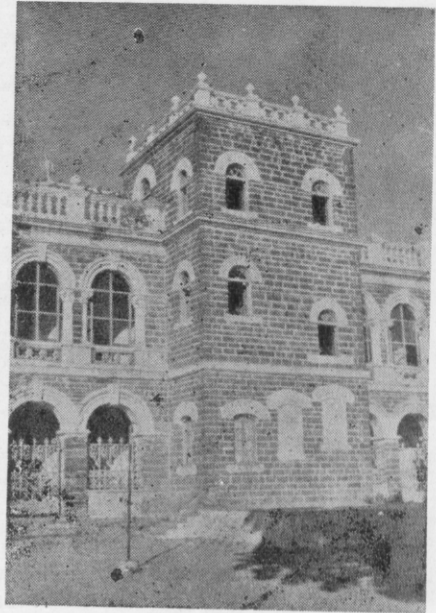
Photo 6. Alfred High School at Bhuj, India. A dressed stone masonry construction. It is a hundred year old buiding and has withstood several earthquakes due to excellent construction.

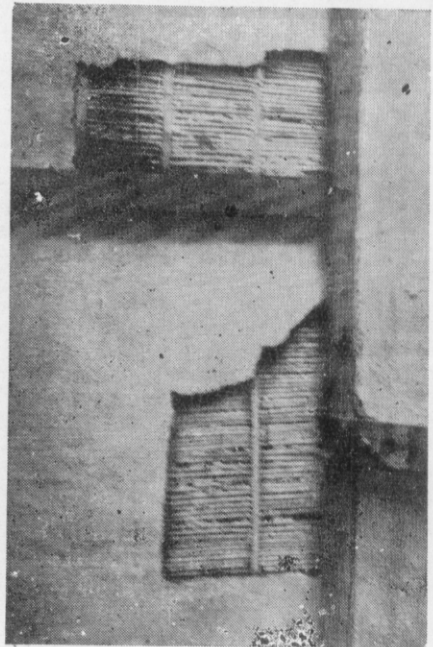
Photo 8. Ekra Construction of Assam, India wooden frames filled with Ekra, plastered with mortar, An earthquake resistant construction.

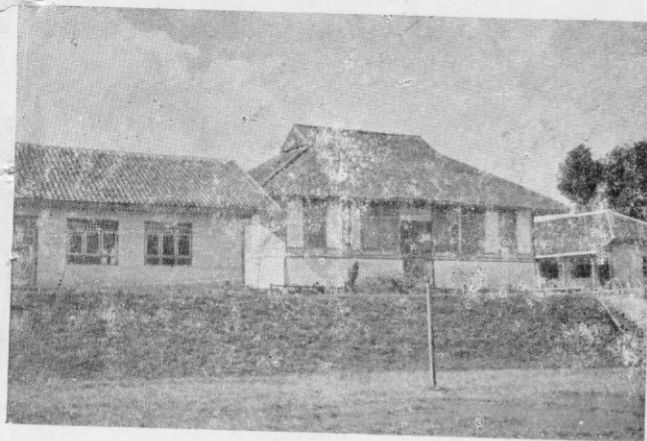
Photo 9. School Buliding off Bandung. Indonesia old building at centre has ring at plinth level, Buliding at left, new addition, has no such provision.

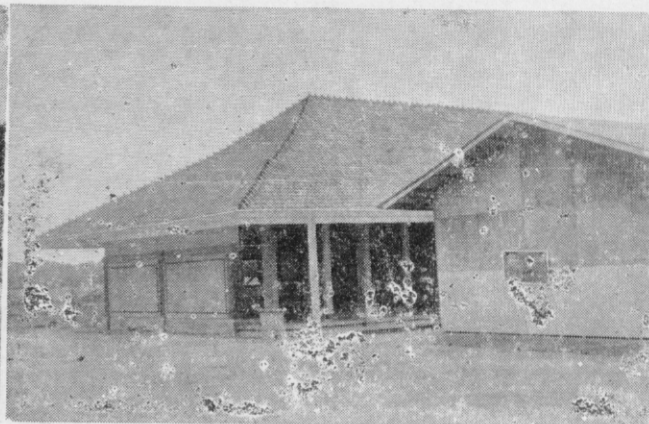
Photo 10. School in North Bali, Indonesia Building at left, in excellent brickwork survived July 1976 earthquake with almost on damage, Building at right, new after earthquake with braced timber frames and plywood cladding.

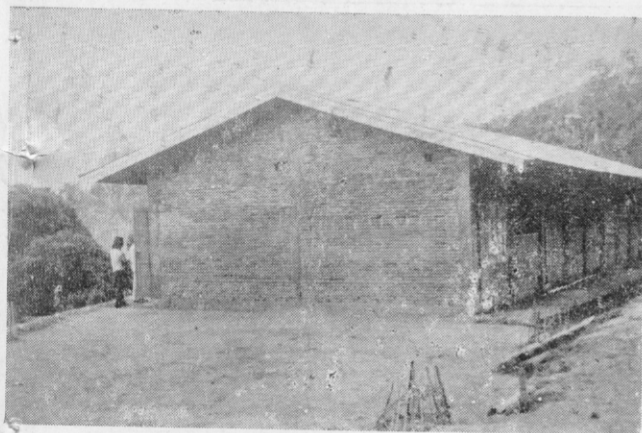
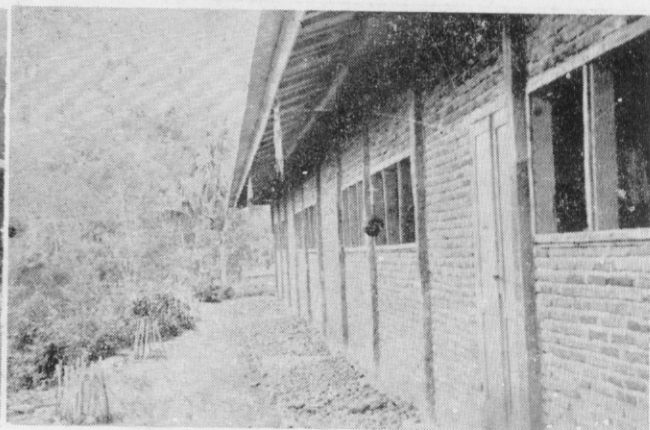
Photo 11, 12 Primary school at Gitgit, Bali. Indonesia New construction after July 1976 earthquake. RC posts under each wooden truss, Ring beam at plinth, none at lintel or eave level, Brick wall panels, brick, gable, Quality of construction substandard

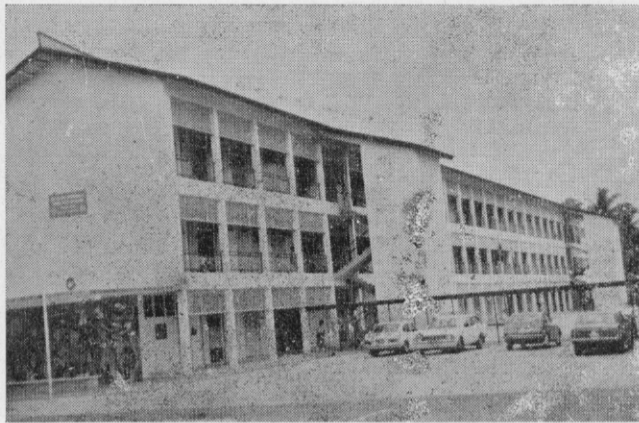
Photo 13. National Secondary School, Kuala Lumpur. Malaysia
RC Frame Building with Wooden truss roof. Stair
block separate, structurally connected at roof level.

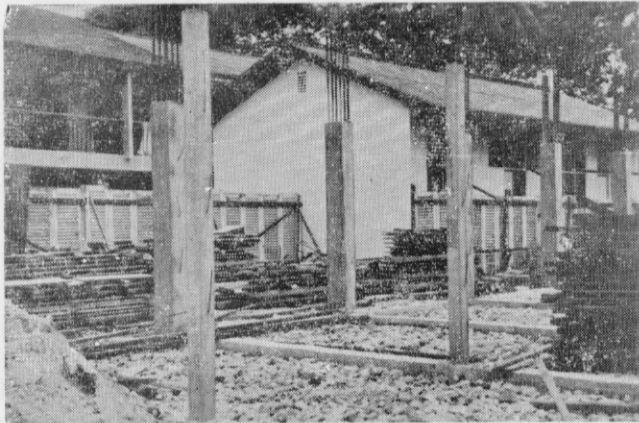
Photo 14. Two storey school building under construction at
Kuala Lumpur. Malaysia RC piles, RC columns,
interconnecting RC beams at plinth level.

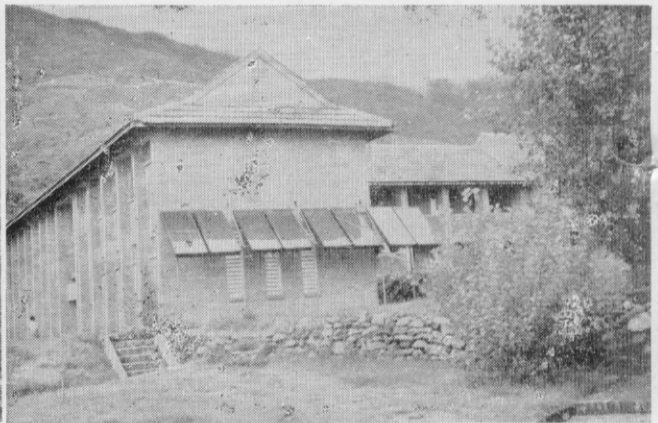
Photo 15. British Aided School in Kathmandu, Nepal.
Good quality brick construction with RC
ring beams, slab and beam floors (inclined
plates are for collecting solar heat for
water heating).

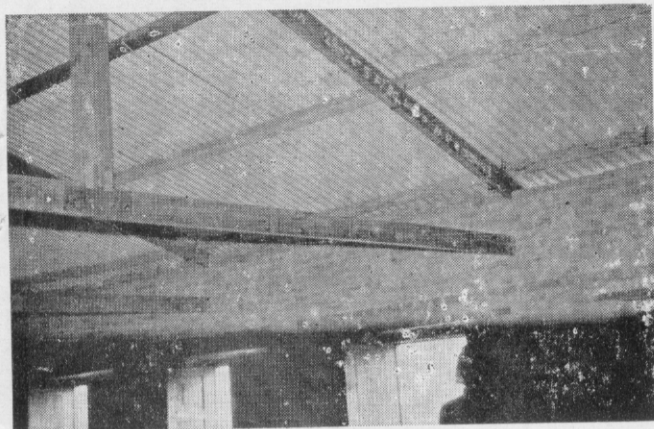
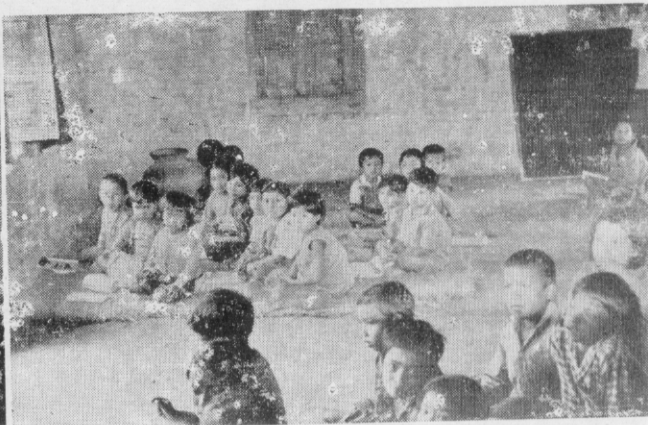
Photo 16, 17 Primary School at Banepa, Nepal. Brick walls steel channel truss, aluminium sheeting, trusses built into wall, on partitions, several classes in same room.

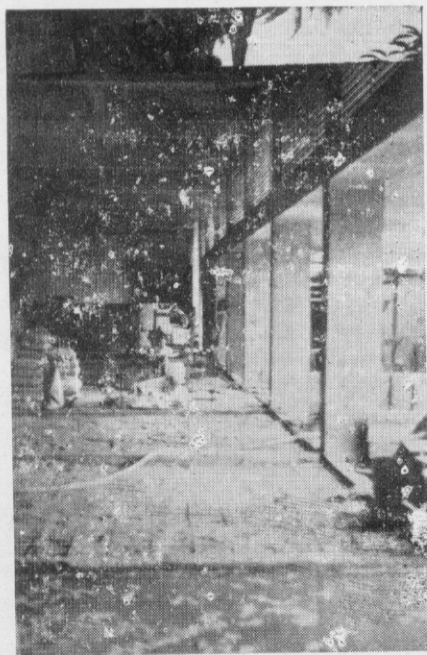
Photo 18. Four storey school construction, Bangkok, Thailand. RC frame building, pile foundations. RC beams at plinth level bothways seen in the photo.

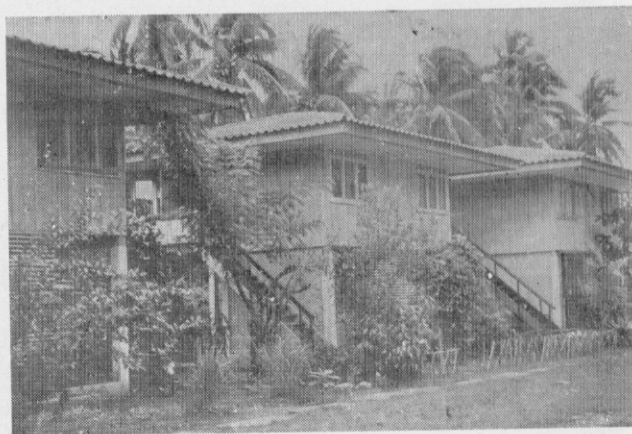
Photo 19. Two storey Teachers' Houses, Bangkok, Thailand. Lower storey, RC posts, brick walls. Upper storey, timber floor joists & planks, timber posts & roofing system.
