## EARTHQUAKE IN SOUTH INDIA ON 20th MARCH 1984

R. NARAYANA IYENGAR<sup>1</sup> AND K. MEERA<sup>2</sup>

### ABSTRACT

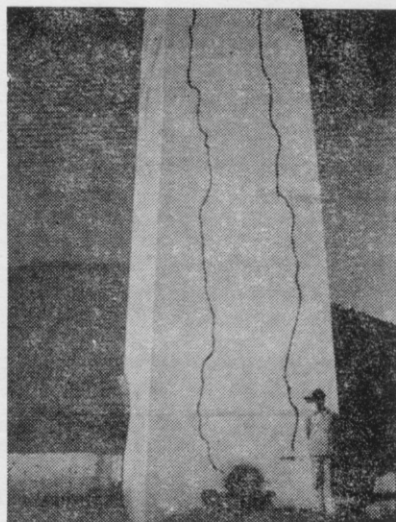
The earthquake was felt by all. About 2 km from Denkanikota, tiles stacked in a tile factory rattled and a few fell down also. Existing cracks widened as a result of the earthquake. A structure of type B in the premises of the factory developed cracks. New Horizontal and Vertical cracks developed in a brick chimney  $3 \times 3$  m at base and 25 m in height. (Fig. 4). However in a nearby factory no cracks were observed on a recently constructed similar chimney. Logs stacked in the forest range office got dislodged.

Fig. 4. Damage to brick chimney of a tile factory in Denkanikota.

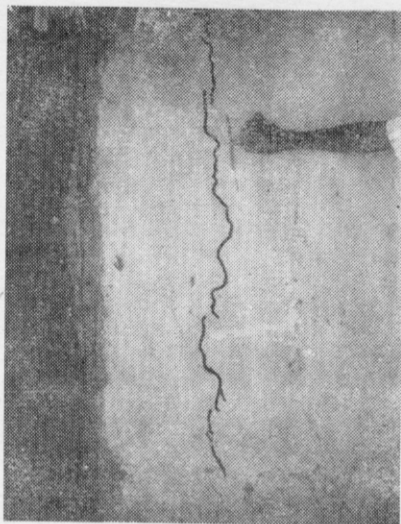
resembling the operation of a wet stone grinder. Through running cracks in walls of buildings of type B, have occurred. Existing cracks have widened after the earthquake in type A and type B structures (Fig. 5).

Fig. 5. Cracks in a mud house in Kelamangalam

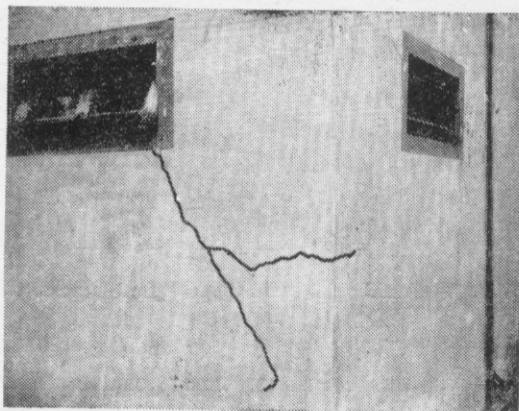
In the office of the Assistant Commissioner (structure of type B), already existing cracks widened (Fig. 6). In a building under construction adjacent

Fig. 6. Cracks developed in the Assistant Commissioner's Office, Kelamangalam.

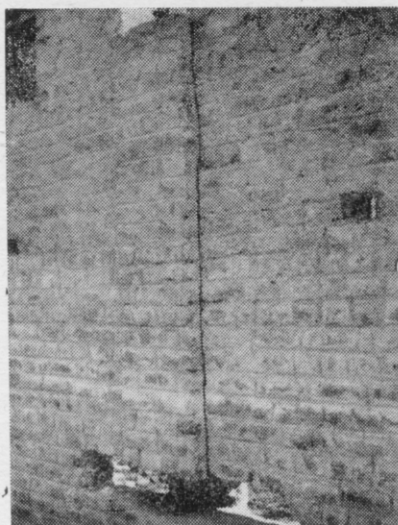
to the Assistant Commissioner's Office, vertical cracks have developed at all brick column-wall junctions (Fig. 7) in the north south direction. The opening seen at the bottom is made after the shock for inserting bond stones.

Fig. 7. Crack in column-wall junction of a building under construction.

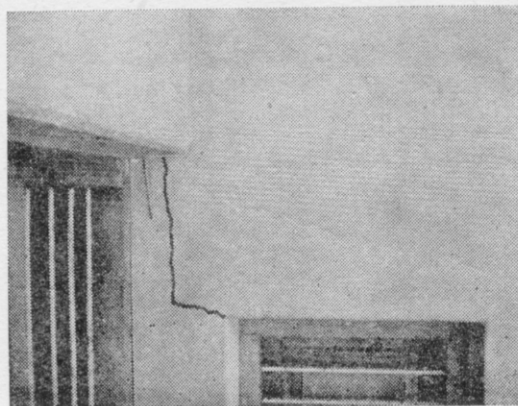
In a doctor's residence, (structure of type B) cracks run continuously through the wall and floor (Fig. 8). The roof has developed plaster cracks.

Fig. 8. Residential building with fresh cracks.

The cracks in the roof and floor run roughly in the north-south direction. Cracks were also observed in the Primary health centre hospital.

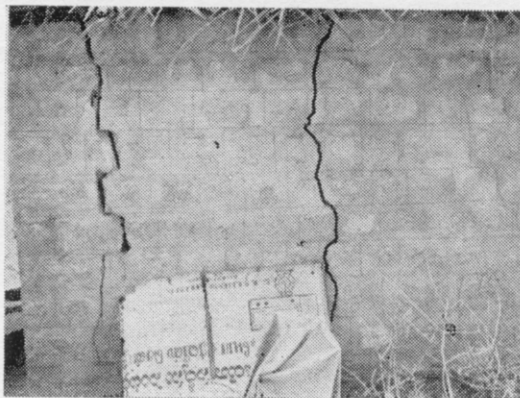
In buildings of type A, existing cracks have got widened (Fig. 9).

Fig. 9. Widening of cracks in a stone masonry wall.

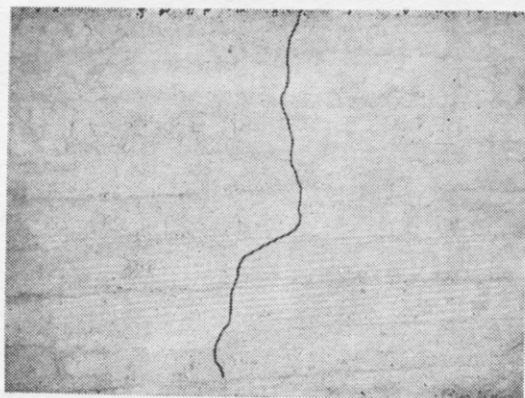
Local people reported of cracks and damage to the road bridge across the river Sanat Kumar. The bridge is of three spans with a steel girder deck. The piers and abutments are of stone masonry. Vertical cracks in the piers were observed by the authors during the investigation. However, it was not

possible to conclude whether they were new or already existing cracks (Fig. 10).

Fig. 10. Crack in the abutment of a road bridge.

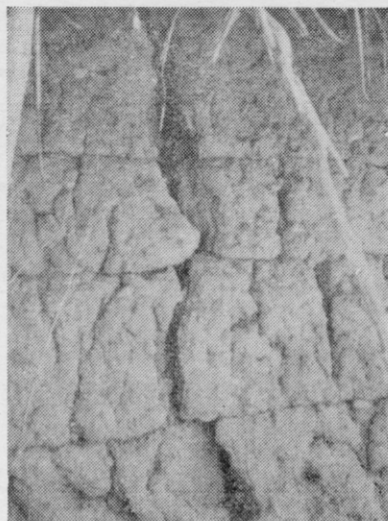
The earthquake was intensely felt by all. The people reported a general feeling of swinging action. Everyone panicked and ran out of their homes. All structures of type A and B have cracked (Fig. 11).

Fig. 11. Typical cracks in mud houses in Kowthalam.

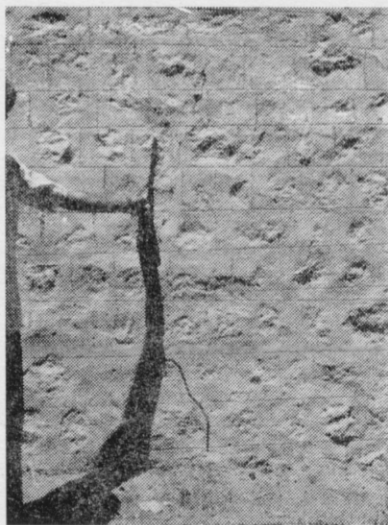
In the old school building (structure of type B) freshly developed vertical cracks are visible in parallel walls (Fig. 12). In the new school building under construction, vertical cracks have developed in parallel walls below window sill level. The cracks are very severe and do not lie along bonds. Bricks in all the courses including the stone masonry in the plinth courses have broken (Fig. 13). In a flour mill, vertical cracks have developed in parallel walls (Fig. 14). It may be mentioned here that this village has

Fig. 12. Crack in the old school building in Kowthalam.

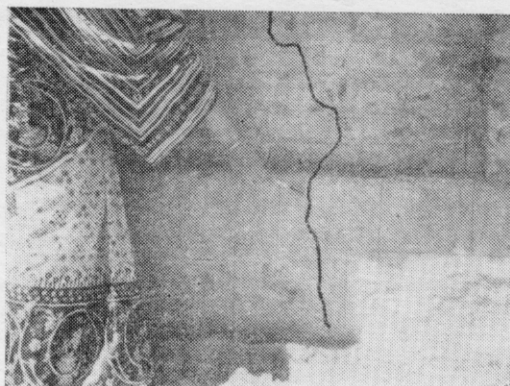
Fig. 13. Rupturing of stones in the foundation of a new school building under construction in Kowthalam.

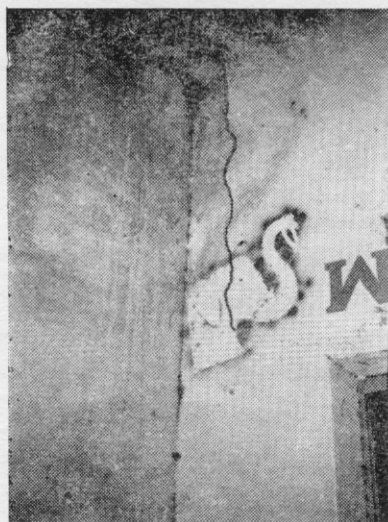
Fig. 14. Cracks in the wall of a flour mill in Kowthalam.

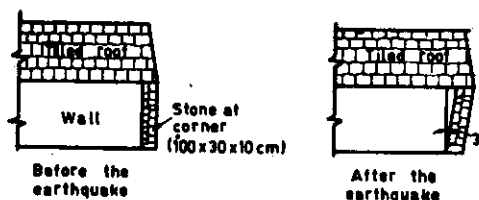
Fig. 15

a stone slab (Fig. 15) used as a supporting column at the corner tilted by about  $3^\circ$ . The only special structure near this village is the old earthen bund with a small reservoir. This has withstood the earthquake very well without any visible serious damage.

Tilting of corner stone in a mud house.

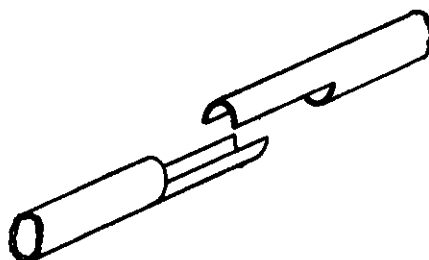
suffered the maximum damage. The cracks have a general pattern of being vertical and in the north south direction. Light objects like utensils in most of the houses overturned. A steel trunk ( $70 \times 27 \times 38$  cms) kept on a masonry platform at a height of 75 cms above the floor level fell down. A 2 m tall papaya tree with a circular base of about 30 cms diameter got uprooted. In one of the houses, portions of a mud wall collapsed. In another house a bamboo rafter was dislodged. Two supporting posts (3.5 m high, 10 cms dia) of the roof, one embedded in the ground and another embedded in a platform rocked and tilted by  $3^\circ$  to the vertical. Another interesting observation is that a spliced bamboo rafter got dislocated. In the same place

Spliced joint in rafter after earthquake.
