## BIGGEST EARTHQUAKE IN JAPAN

DR. M. HOSHIYA<sup>1</sup>, PROF. T. CHIBA<sup>2</sup>, DR. T. KATADA<sup>3</sup>, MR. E. SAITO<sup>4</sup>,  
 PROF. H. OHNO<sup>5</sup>, DR. J. N. MANDAL<sup>6</sup> AND MR. K. YAMAMOTO<sup>7</sup>

The severe earthquake and subsequent tsunami hit the coastal of northern part of Japan shortly after noon on May 26, 1983. The magnitude of earthquake was 7.7 on the Richter scale. This earthquake is called "Japan Sea Chubu 1983 Earthquake" by the Meteorological Agency. So far it was one of the biggest earthquakes in Japan. The list of major earthquakes and tsunami are given in Table—1.

The investigation team, composed of the writers, with the first name designed as the Team Leader, rushed to the distress spot immediately after the earthquake occurred. It is the nation's worst earthquake in 35 years in Akita.

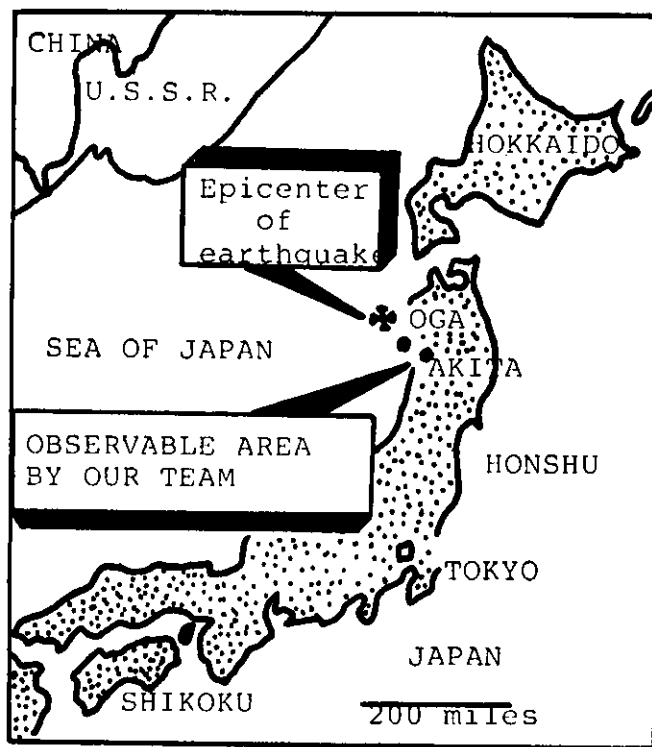
Fig. 1. Epicenter of Recent Earthquake in Japan.

The epicenter of earthquake was located about 40 kilometers below the sea of Japan and about 160 kilometers away from the coast of Akita in the Japan sea (Fig. 1). The intensity of present earthquake in different places of Japan are shown in Fig. 2 on the Japanese scale of 7. The shaded areas were hit by tsunami also hit the south Korean coasts almost 90 minutes after the earthquake.

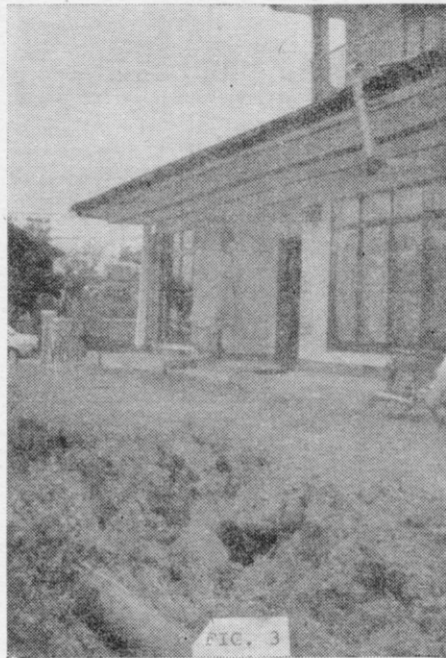
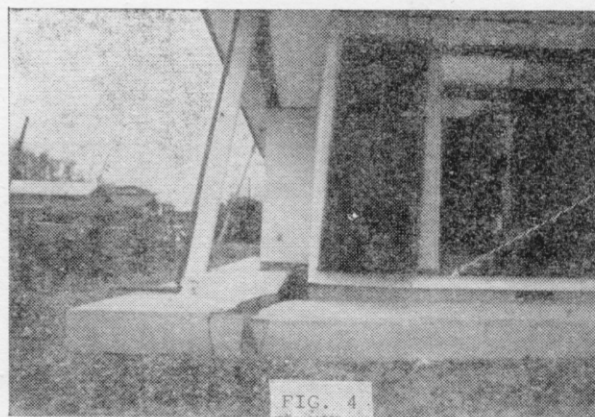
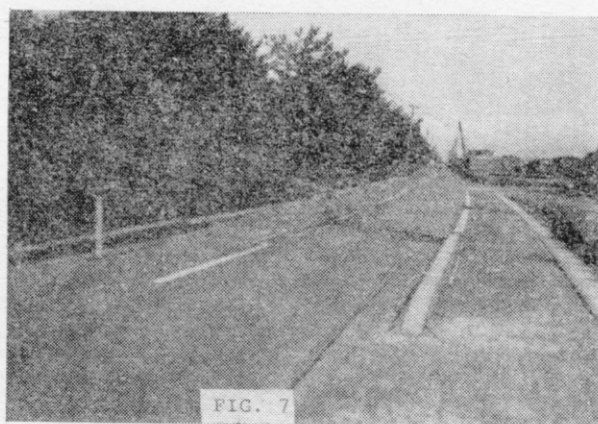
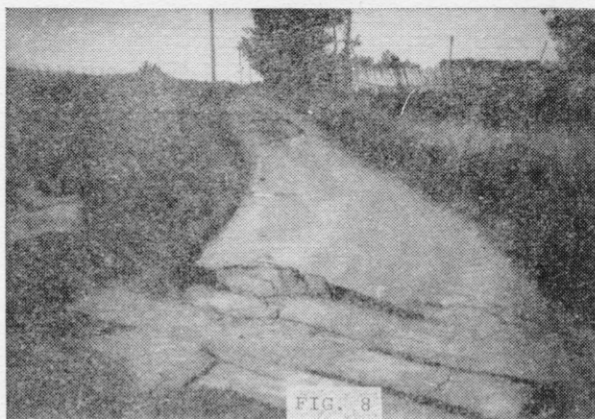
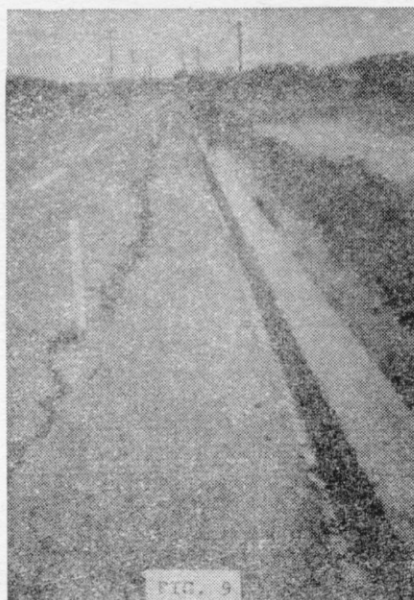
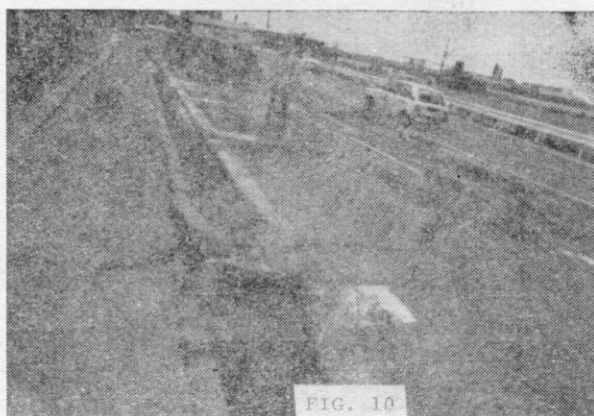
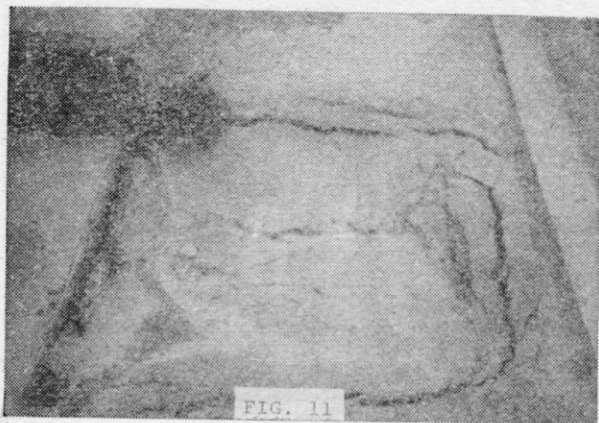
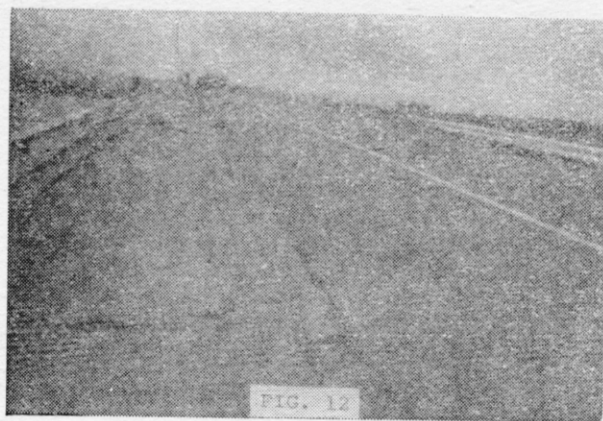
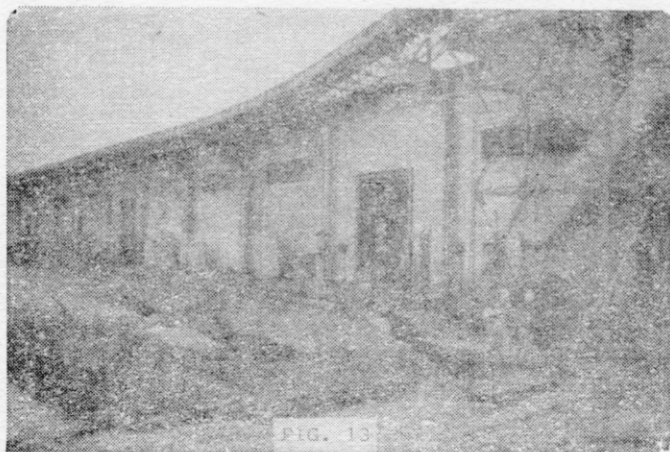
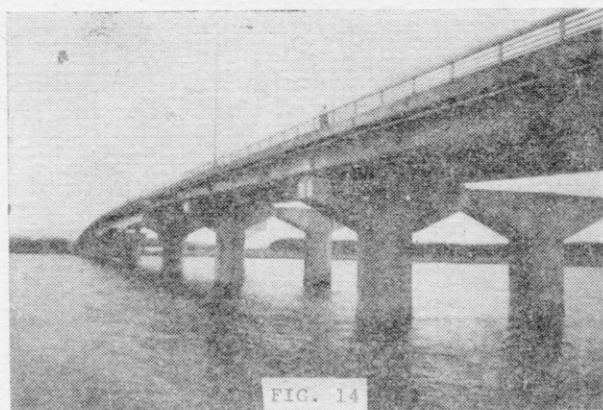
The recent earthquake and tsunami spread over the eight prefectures of Japan. The residential buildings, numerous roads, highway and bridges of Akita have been shown cracks due to the earthquake as given in Figs. 3 to 14.

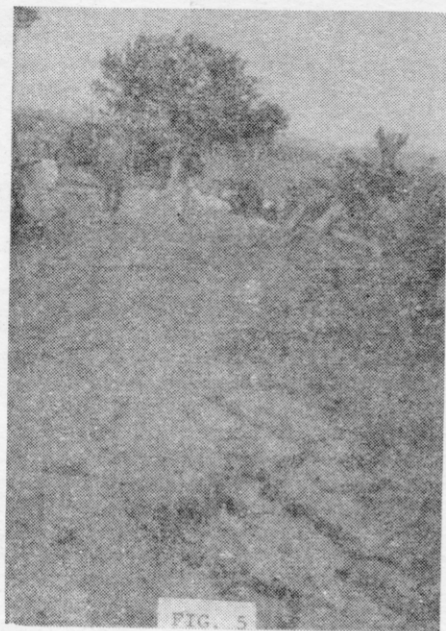
FIG. 5

From the Fig. 32, it is interesting to note that the pole of power supply lines are inclined towards the opposite direction as shown by small arrows along the Oga Road (Fig. 6). The inclination of the concrete fencing of the road are also in opposite direction as shown by large arrows. No other residential buildings on the surrounding areas damaged but the residential building of Figs. 3 and 4 (Same building) was damaged due to earthquake. It is further to note that the ground surfaces show the shear crack patterns as shown in Fig. 5.

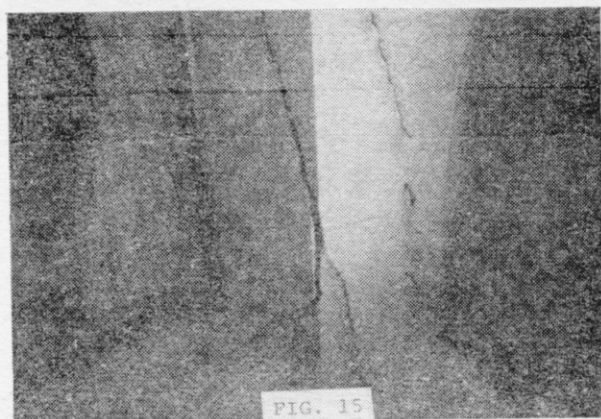
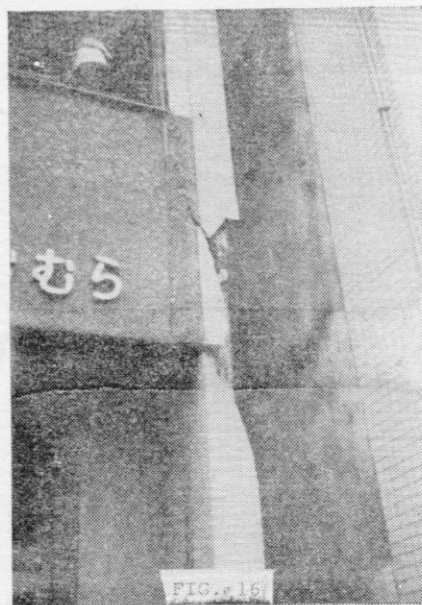
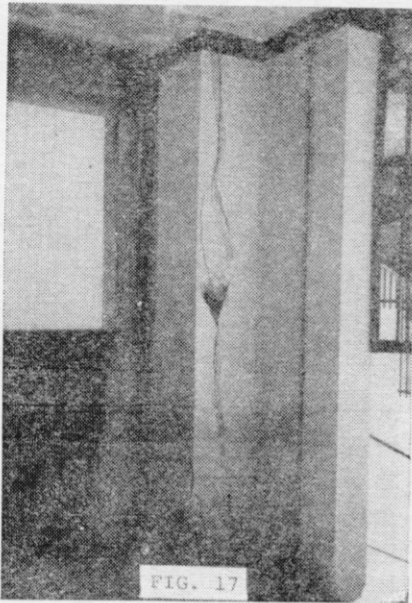
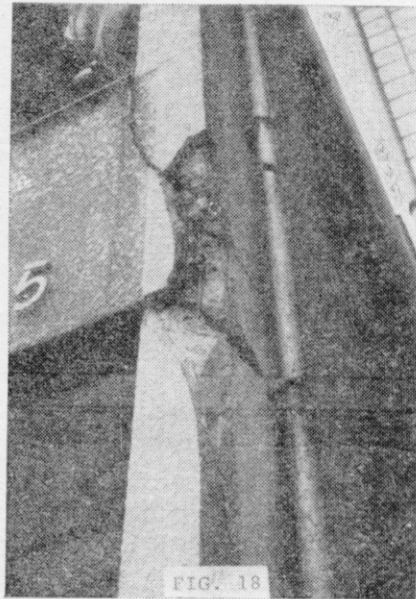
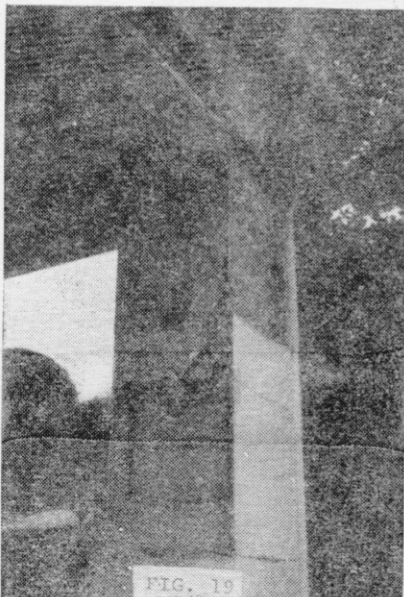
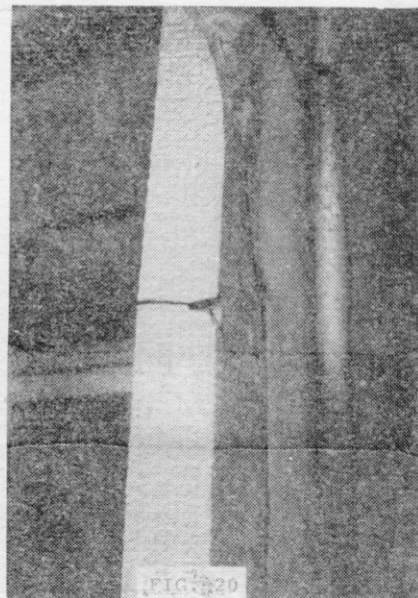
The columns of the building have been damaged (See Figs. 15 to 20). Liquefactions have also been observed in some places of Akita and the pattern of

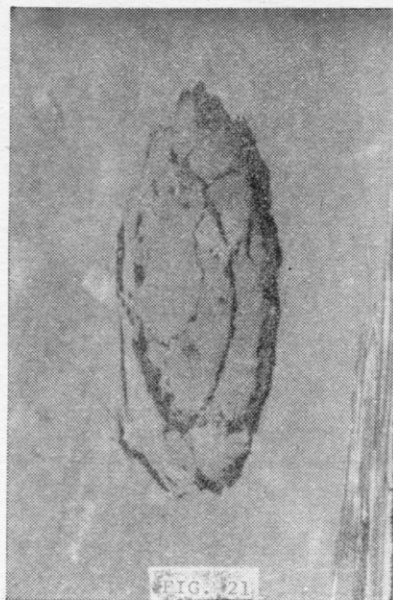
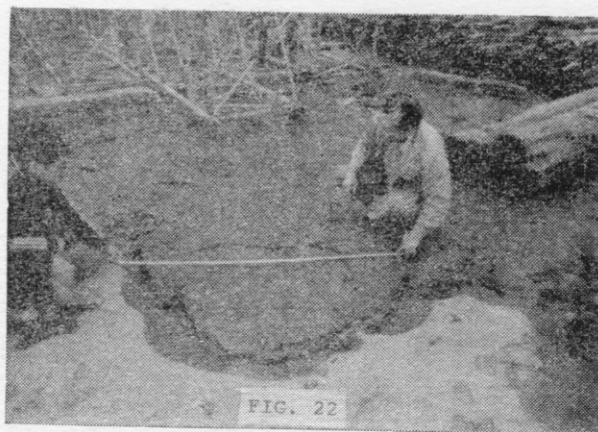
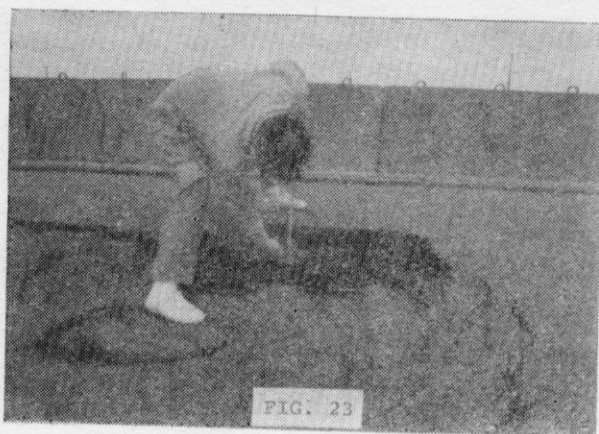
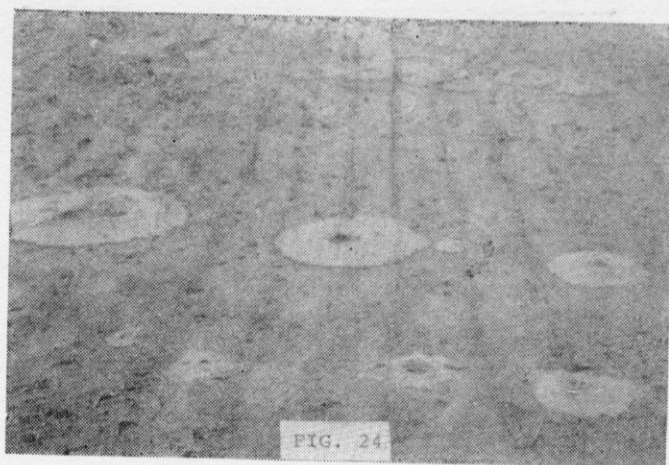
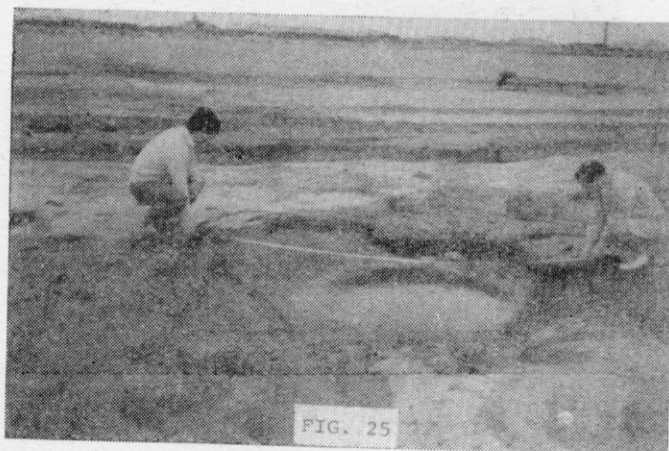
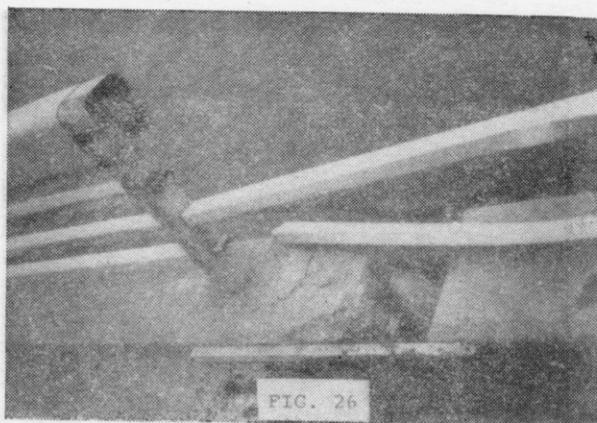
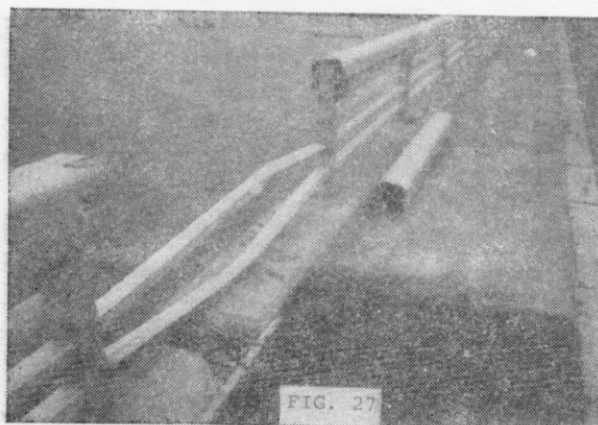
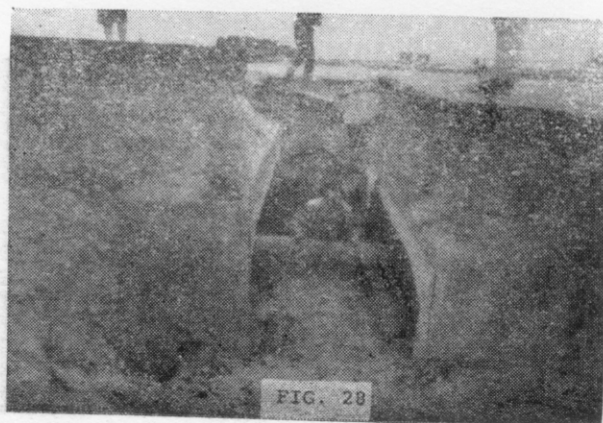
liquefactions are shown in Figs. 21 to 25. The railing of the road has been shifted due to earthquake (See Figs. 26 and 27). The pipe line, the sea port and the crane have also been damaged as shown in Figs. 28 to 31 due to recent severe earthquake in Japan.
