DAMAGES DURING DHAMAR EARTHQUAKE OF DECEMBER 13, 1982 IN YEMEN ARAB REPUBLIC

A.S. ARYA, L.S. SRIVASTAVA AND SATYENDRA P. GUPTA*

SYNOPSIS

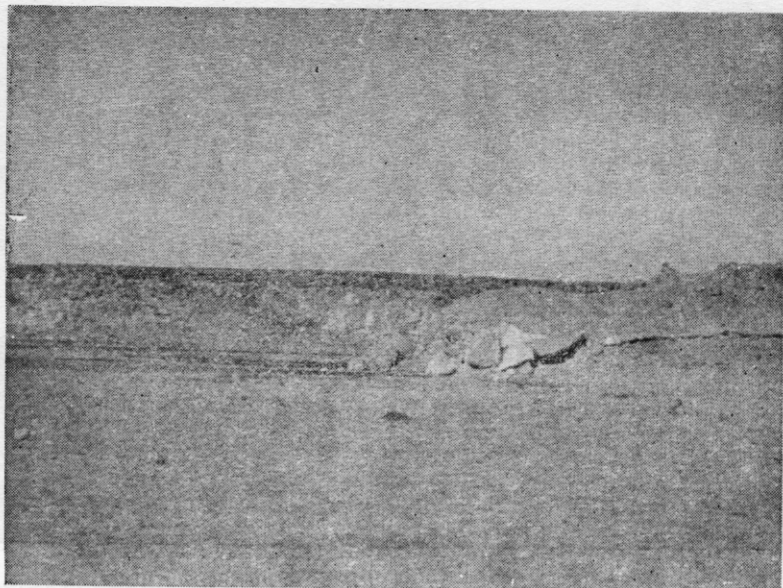
Sliding and overturning of utensils, furnitures and other loose objects was reported in the region and at Dawran a 3 m \times 3 m \times 2.5 m iron sheet box grocery shop facing S60°W direction and supported on 30 cm long, 7.5 cm wide angle iron legs was overturned as its front legs were bent. A similar shop resting on rock boulder platform did not undergo any movement. Photo 1 shows rupture of stone on a hill and photo 2 shows rock fall on a mountain and dislodging of boulders.

Photo 1. Rupture of stone on a hill due to force of Earthquake near village Qubatil.

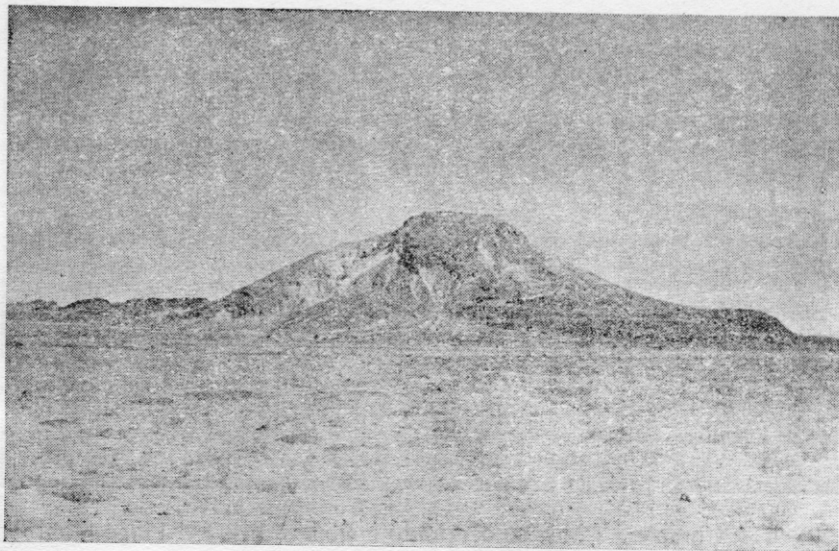
Photo 2. Rock fall and slide on the mountain near village Alisi.

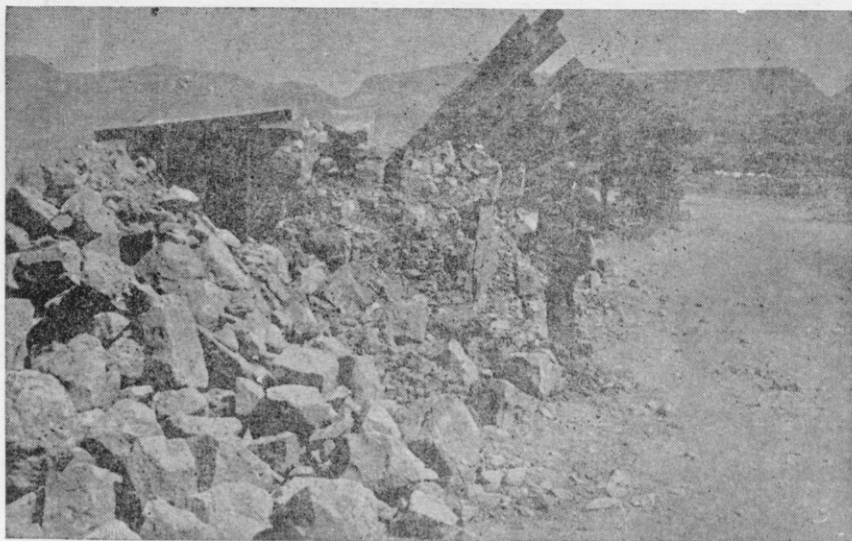
Photo 3. Complete Collapse of a single storied dwelling of random stone construction near Dohran.

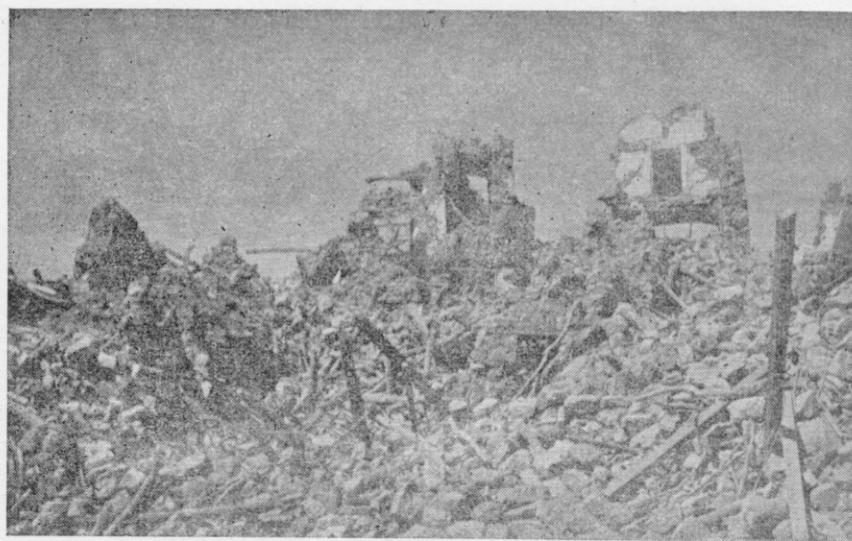
Photo 4. Complete Collapse of random stone house in village Dohran.

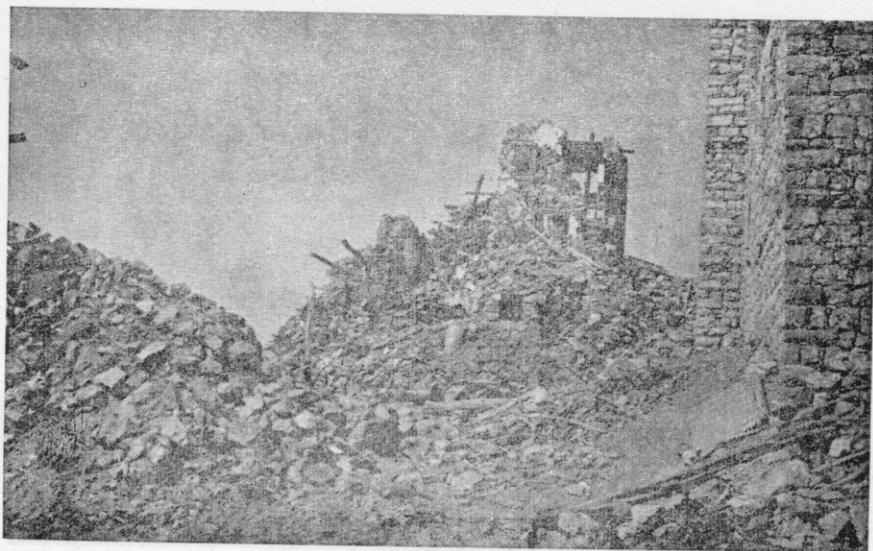
Photo 5. Collapse of houses built of random rubble stone in village Dohran.

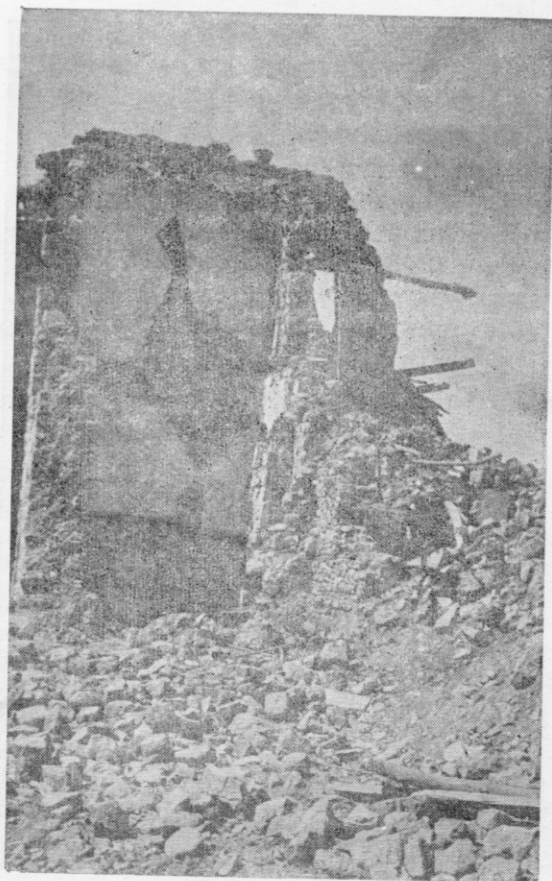
Photo 6. Complete Collapse of a house of random stone construction with muck filling in the hearting of walls at village Dohran.

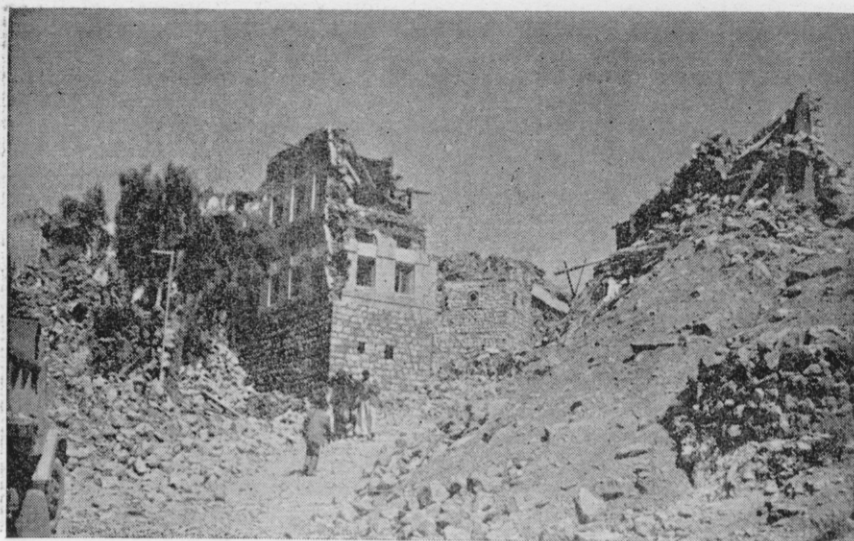
Photo 7. Collapse of stone built dwellings in village Dohran.

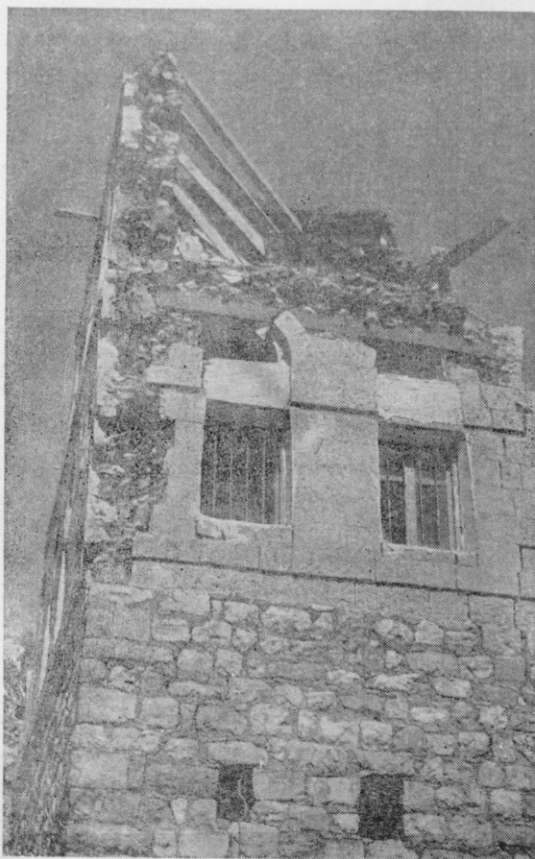
Photo 8. Collapse of third storey and cracks in lower storey walls, very heavy floors in houses seen in village Dohran.

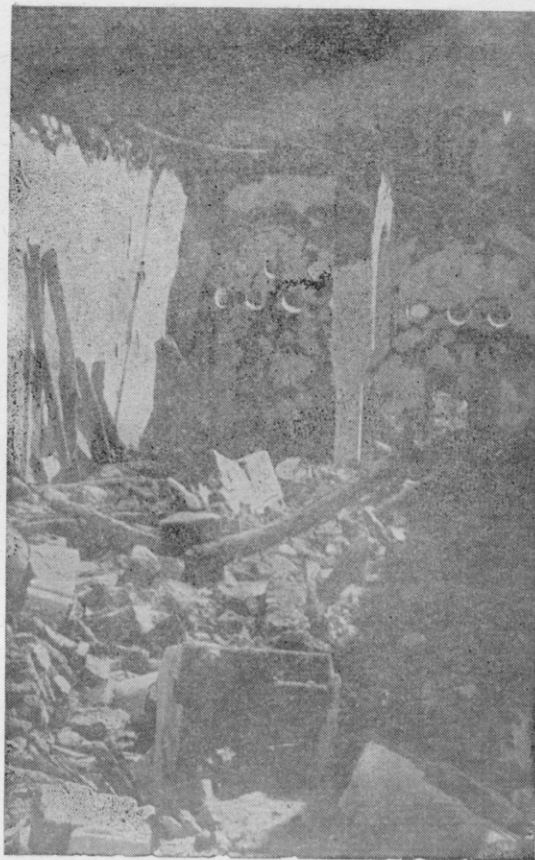
Photo 9. Collapse of Dohran Mādarsa-cum-Mosque, some Arches and posts still standing.

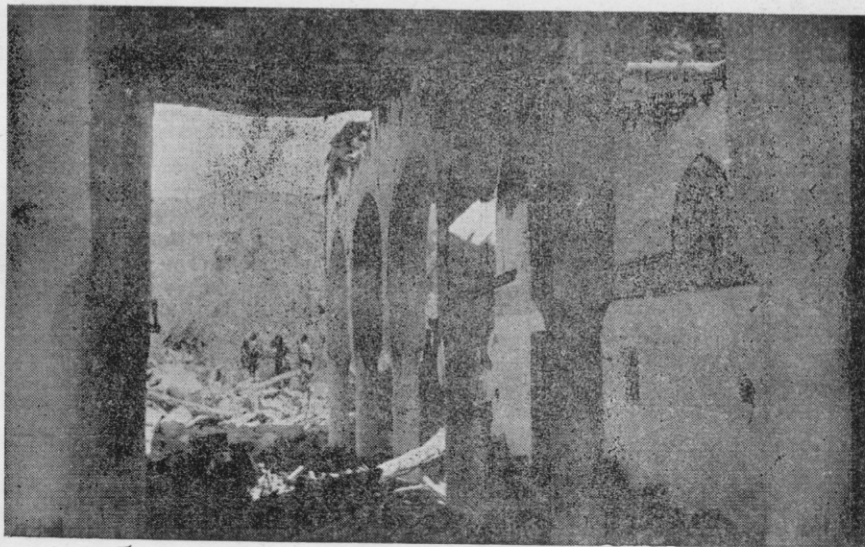
Photo 10. Undamaged portion of Dohran Madarsa-cum-Mosque, standing posts, arches and damage in the roof.

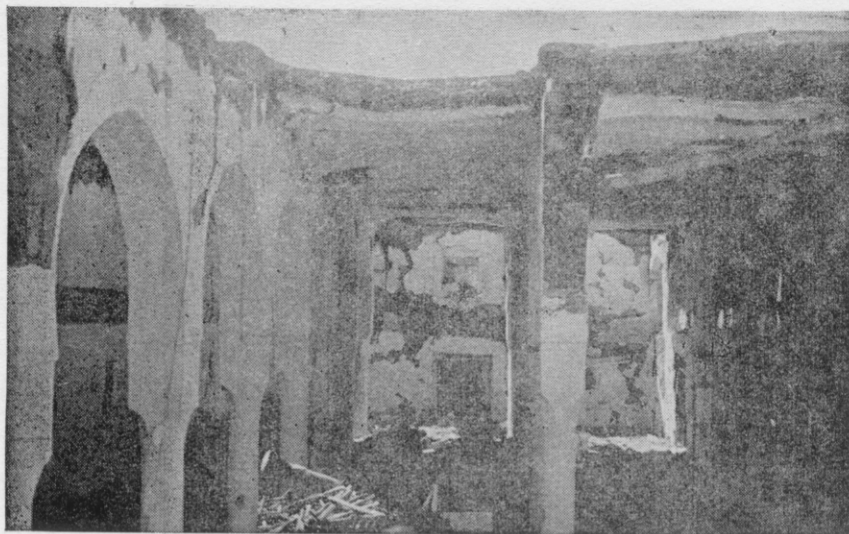
Photo 11. Damages to the Dohran Madarsa-cum-Mosque, fallen wood pieces from roof, cracked and peeled off plaster on walls and pillars.

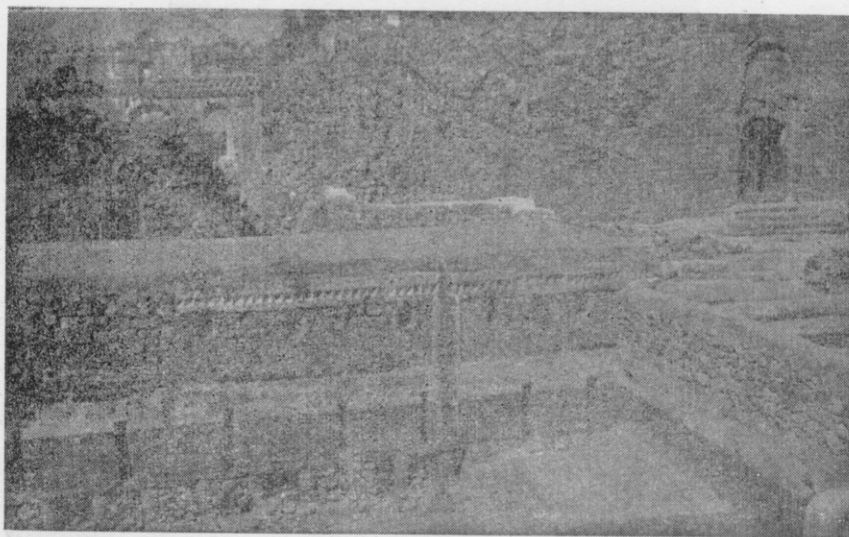
- (ii) Bulging of the wall masonry outward or inward and falling away of half the wall-thickness eitherway as shown in photo 12 and 15 was also a common sight. The outer wythe consisting of stones with outer face roughly dressed separated from the hearting of the wall and fell out at innumerable places exposing the inner muck-filling of the wall. The exposed cross-sections of masonry walls clearly showed the separate building up of the two wythes of the wall with small stone and earth filling in between them, without practically any mechanical connection which could be achieved by the use of "through" stones. At many places this must have led to the complete shattering of the wall resulting in only a heap of rubble as shown in photo 3, 4, 5, 6, 7 and 9 and falling of the roof along with it as shown in photo 8. Another adverse effect seen in the old masonry walls was that of washing away of the mud mortar from the joints leaving gaps between the stones so that their relative movement became easier leading to destruction of the walls.

Photo 12. Back portion of Dohran Madarsa-cum-Mosque wall, one leaf of stone fallen, random combination of stone and brick wall construction may be seen in the foreground.

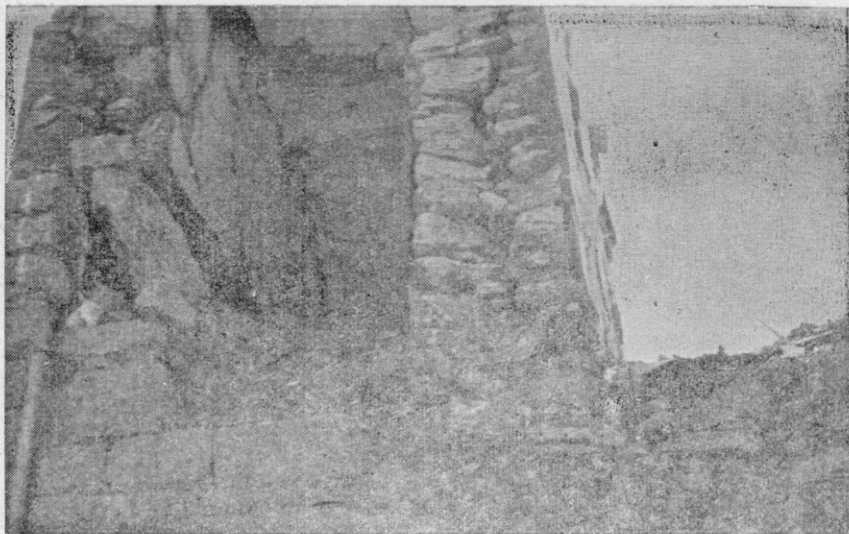
Photo 13. Random rubble stone wall, no interlocking between inner outer faces of stones at Village Hizrat Mangada.

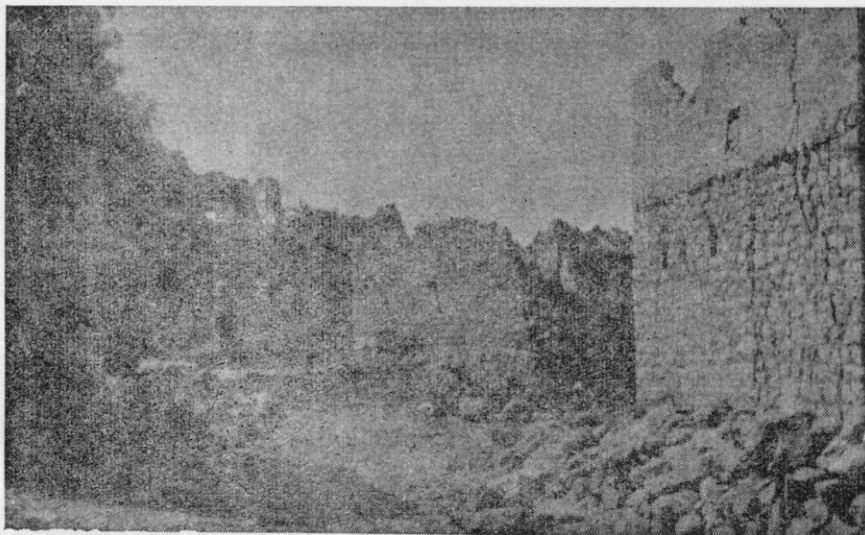
Photo 14. Construction using random stone in lower floor and adobe on upper floor in village Dohran, cracks and collapse of wall.

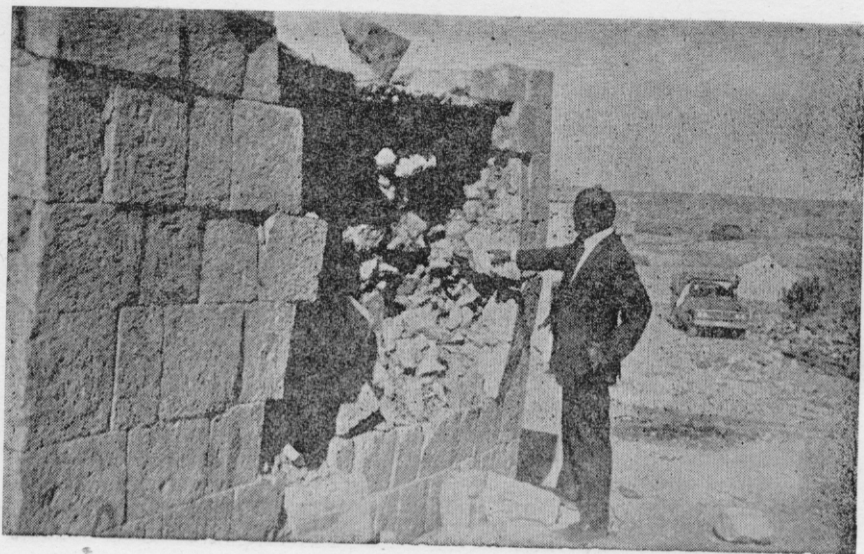
Photo 15. Outside dressed stone wall and inside small random stone and muck filling at Village Qubatil. Collapse of outer leaf of dressed stone.

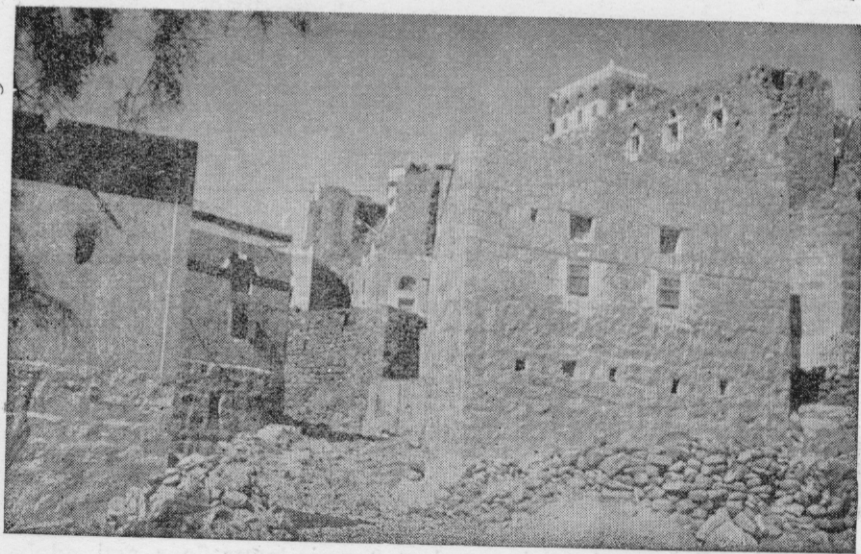
Photo 16. Damage to corners and walls in upper floors of dwellings, random provision of wood pieces over window in village Dhi-Hawlan.

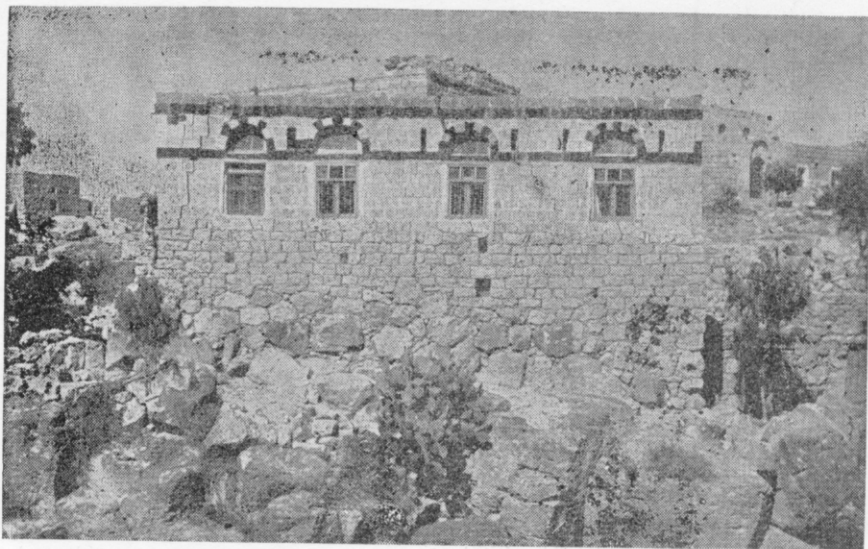
Photo 17. Random stone and coursed stone construction, cracks and separation at corner of wall at Village Hizrat Mangada.

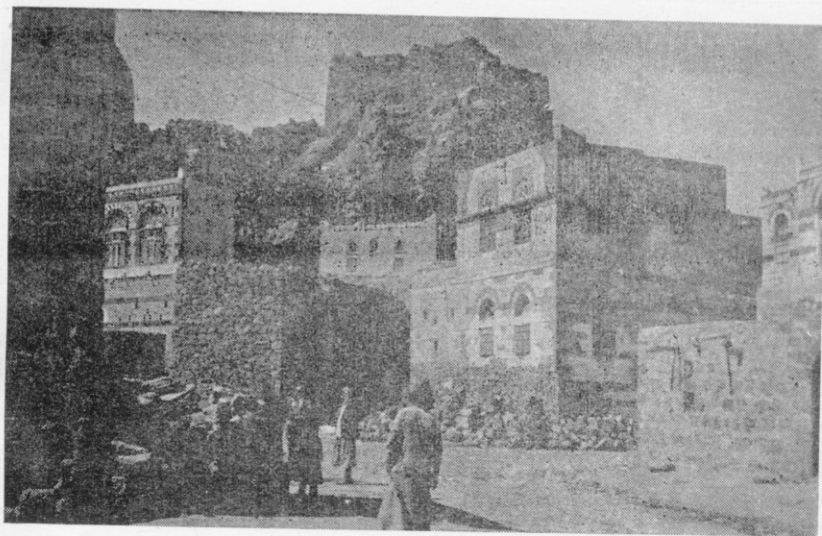
Photo 18. Collapse of upper floor of a house on hill top. Other houses cracked but not collapsed in village Warakah. Separation of walls seen at their intersections.

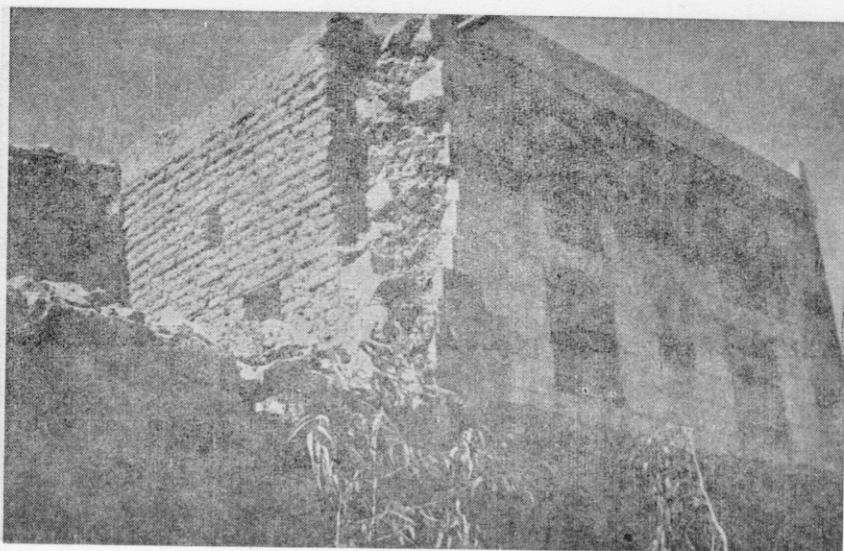
Photo 19. One face dressed coursed stone and another face random stone in front wall and adobe construction along side wall of a house, no interlocking at corner of wall and damage at corner in Village Warakah.

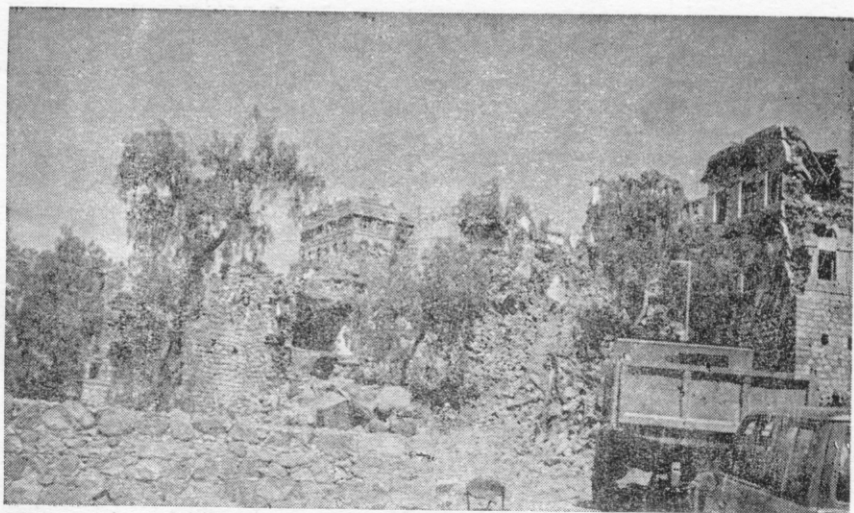
Photo 22. Destruction of houses in village Dohran.

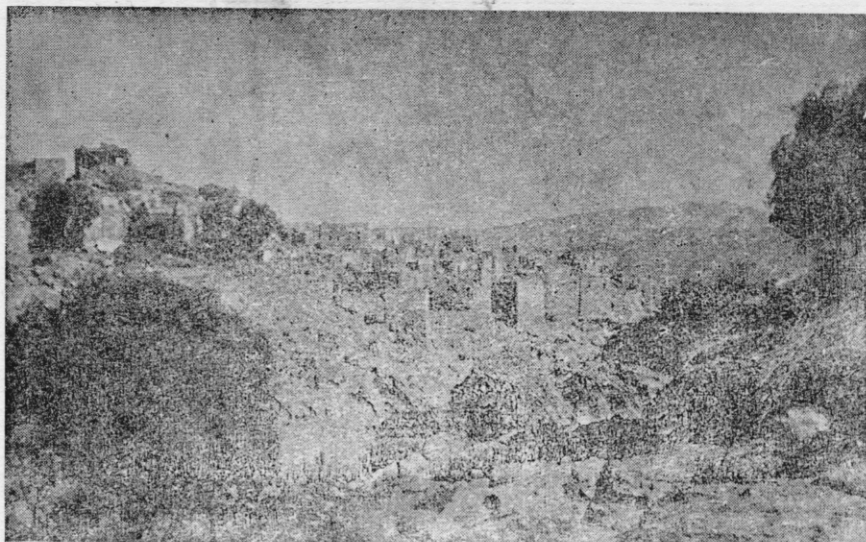
Photo 23. General view of severe damages of houses on a hill top near Hizarat Mangada.

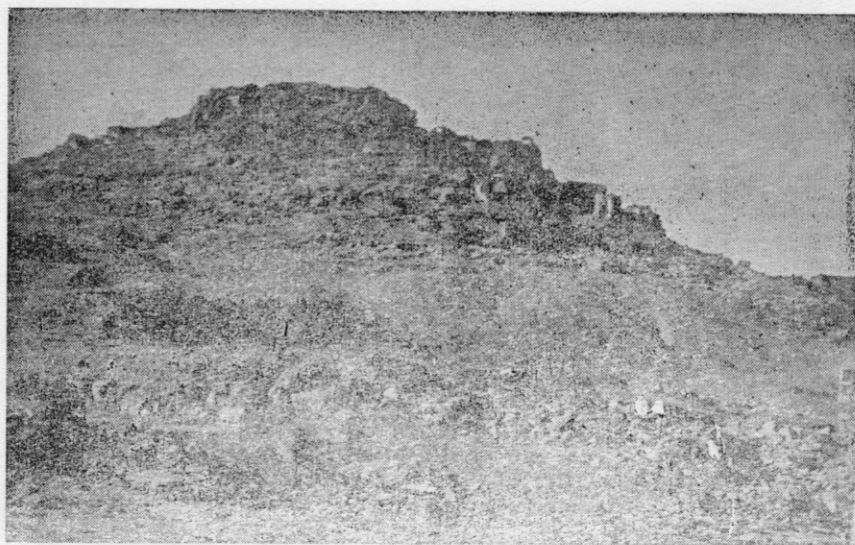
Photo 24. Complete destruction of all houses situated on hill top in Qubatil. The random stones littered all over the hill slopes.

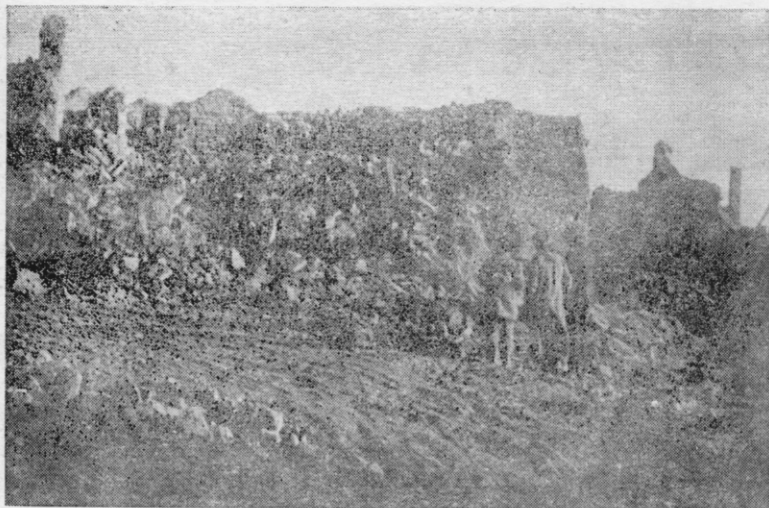
at corners and junction takes place easily under ground shaking, the cracks passing through the blocks themselves. Afterwards the walls fails either due to bending or shearing combined with the compressive loads, the whole house crashing down. Adobe walls do not on the other hand, have the bulging tendency as in masonry walls since they have flat courses and bonding between outer and inner faces. The effect of roof and intermediate floors is similar to that stated above for masonry buildings. A number of single storeyed clay-block houses showed practically no damage at all in the same areas where collapse of two or three storey houses had occurred. Photo 27, 28 and 29 shows the damages to the adobe and mud houses.

Photo 27. Destruction of adobe Houses at village Al-Olayb.

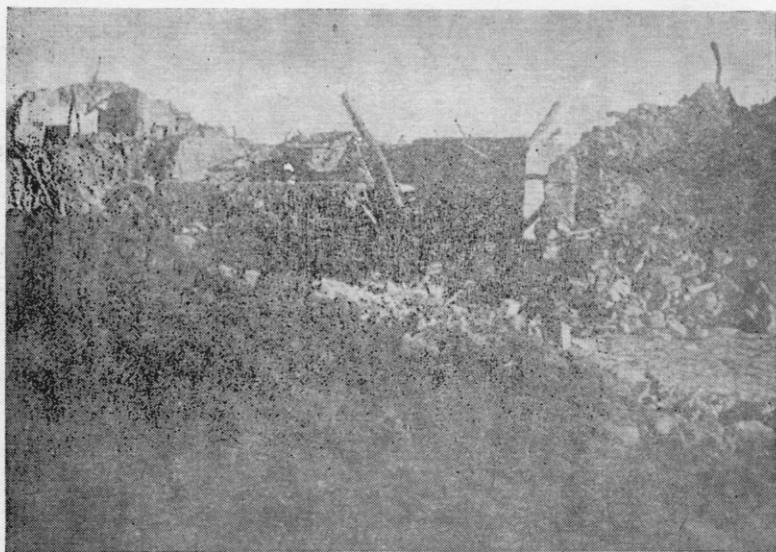
Photo 28. Destruction of adobe Houses in village Al-Olayb. See choking of streets.

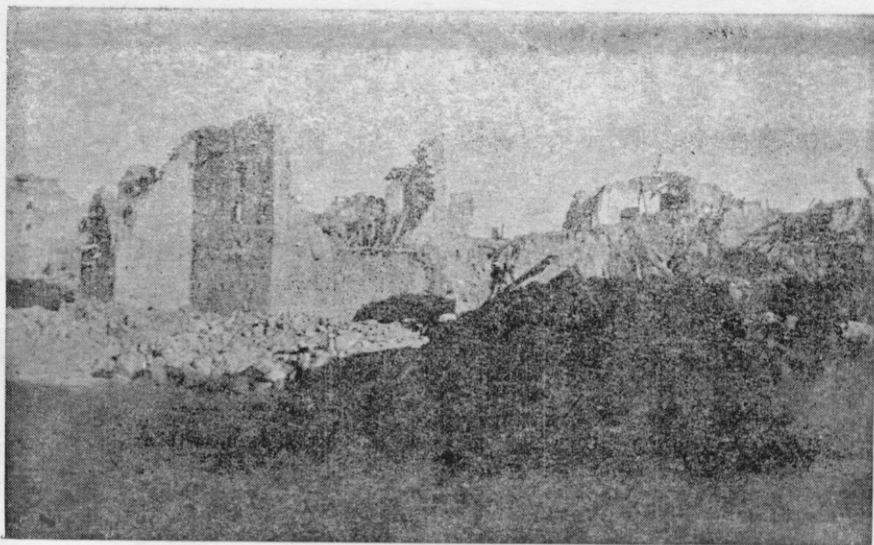
Photo 29. Damages to adobe construction in village Al-Olayb.

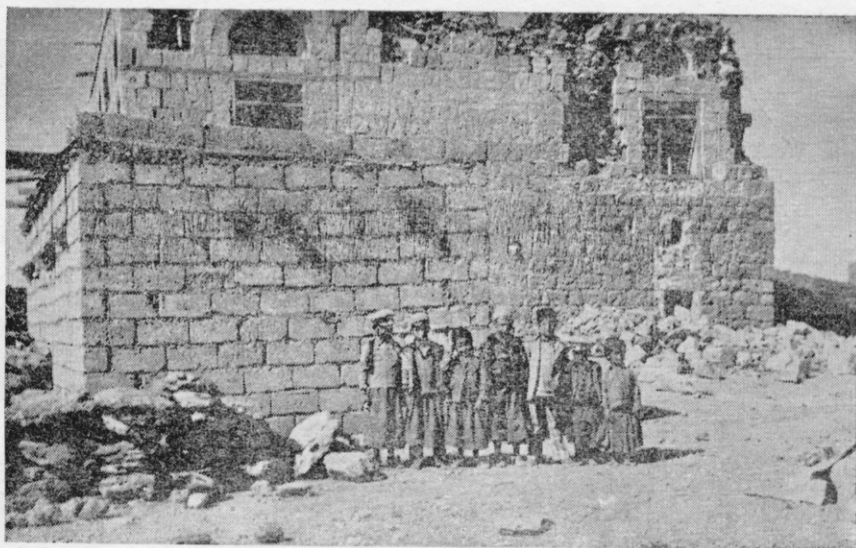
Photo 30. A single storeyed house built from solid concrete blocks in gypsum mortar remains undamaged and a two storeyed stone house badly damaged with collapse of corners in village Hizarat Mangada (See discontinuous use of wood pieces).

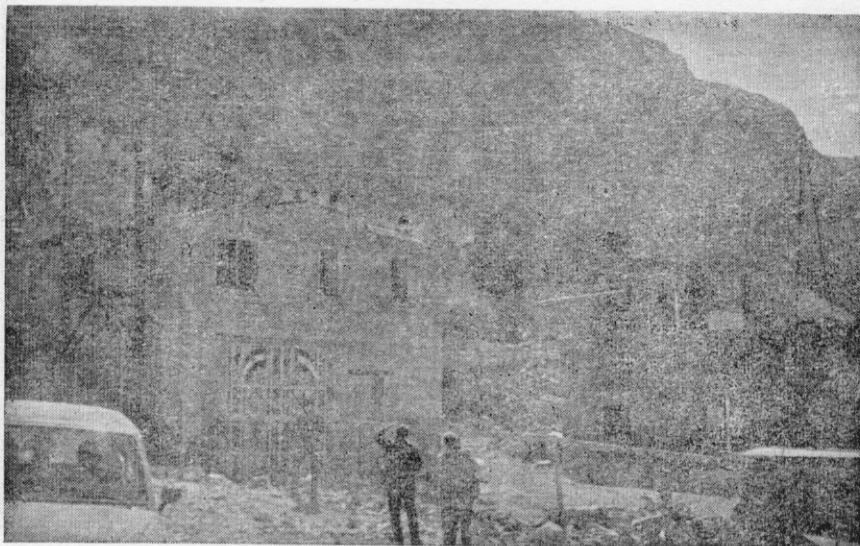
Photo 31. Electrical substation building, minor crack in wall in village Dohran (Dressed stone masonry in cement mortar).

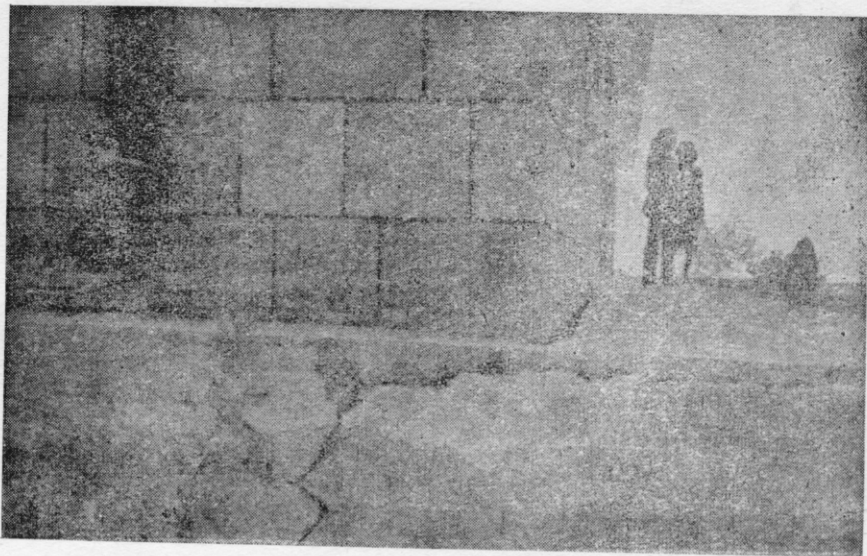
Photo 33. Cracks and separation on the North-East corner of the foundation and wall of the Dohran Dispensary. Sinking of outside passage.

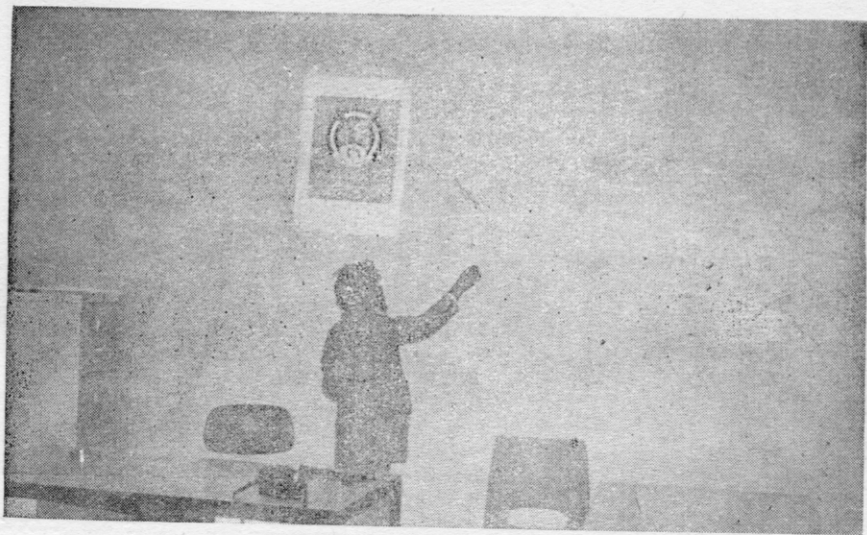
Photo 34. Diagonal cracks in the wall (inside view) in a room of the Dohran Dispensary, stone masonry consisting of half-dressed stones built in gypsum mortar.

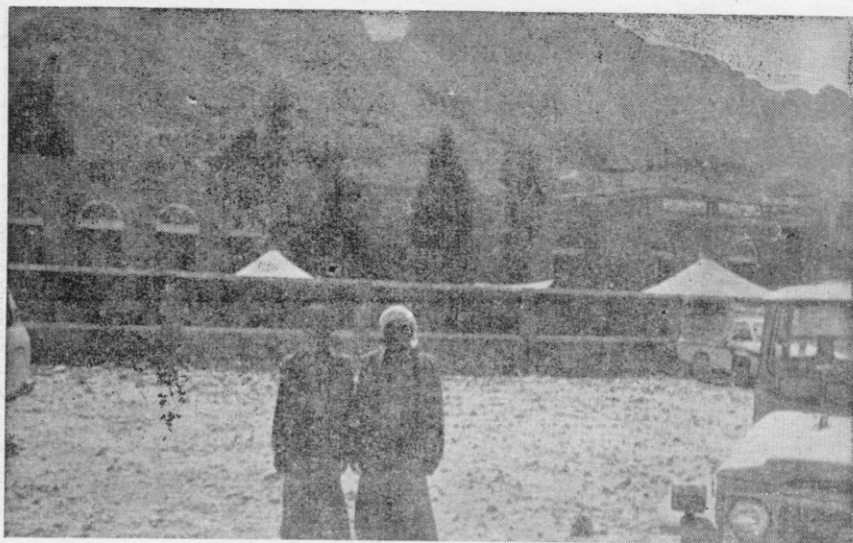
Photo 35. No damage, only minor cracks in the Dohran Madarsa (Masonry as in Dohran Dispensary.)

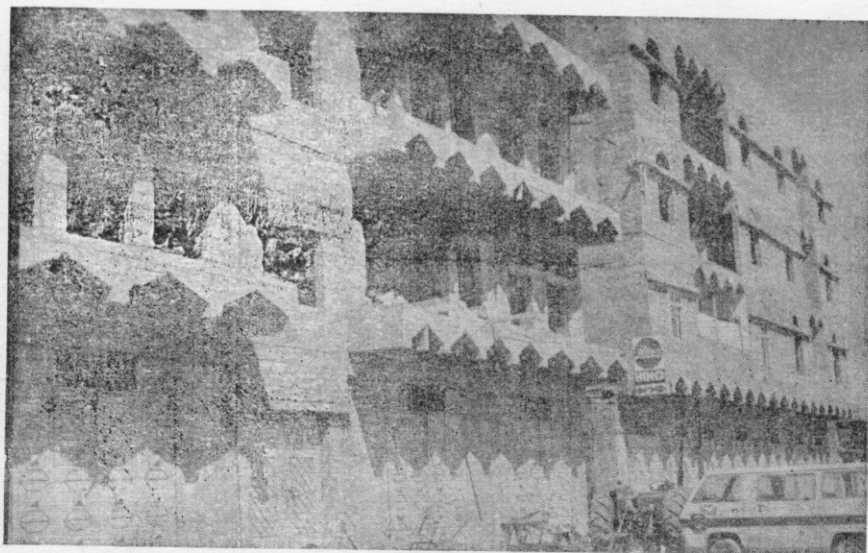
Photo 36. Reinforced concrete framed structures with concrete block wall filling in Dhamar, no damage reported. (Balcony wall filled with concrete block may fall in severe shaking, proper bonding and strength required.)

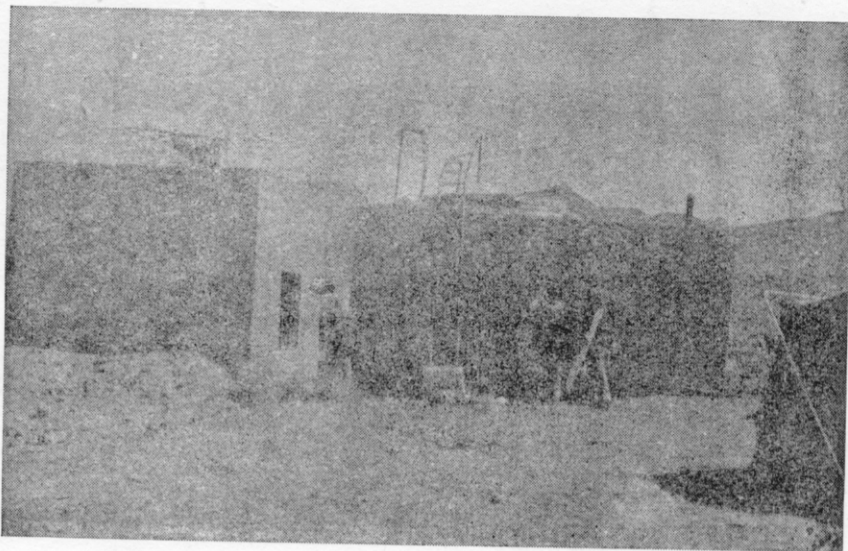
A concrete water tank of rectangular section measuring $7.5 \text{ m} \times 6.5 \text{ m} \times 3.1 \text{ m}$ and supported by seven reinforced concrete columns 3 m tall and $25 \times 30 \text{ cm}$ in cross-section crashed to the ground due to the collapse of the columns. Calculations indicated that the columns were too weak to take the horizontal accelerations in MM VIII area since their ultimate moment capacity would be exhausted at only 6 percent of gravity acceleration and hence the failure of columns is not surprising. Photo 37 shows the water tank on the ground and photo 38 and 39 shows the column failure with exposed reinforcement. A serious weakness of the reinforced concrete columns was lack of lateral ties which are required at closer spacing of about 7.5 cm near the column ends so as to confine the concrete and impart ductility to the columns.

Photo 37. Collapse of a reinforced concrete water tank near village Dohran, the adjoining pump house suffered cracks in the walls.

For safeguarding other tanks of similar types, it is recommended that stone block masonry or brick walls in 1 : 6 cement-sand mortar should be tightly infilled between the column on the periphery so as to increase the stiffness as well as the lateral strength of the supporting structure.

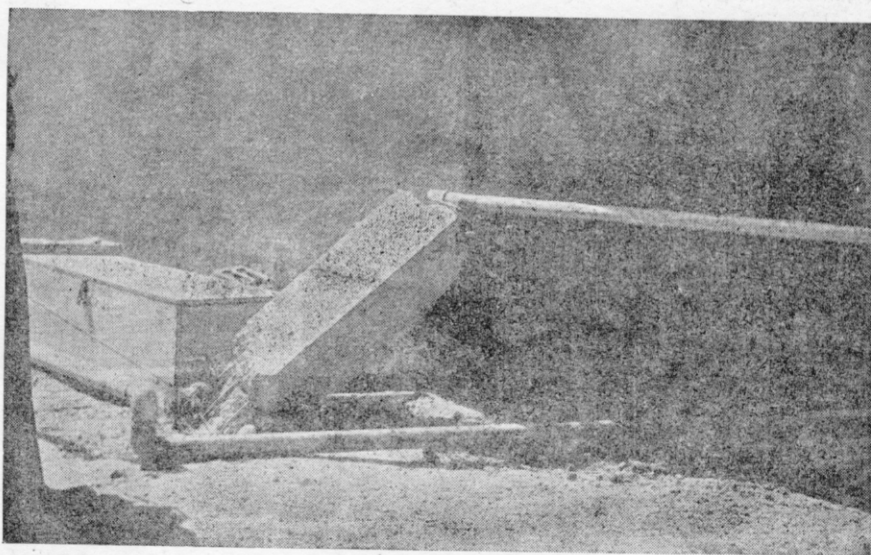
Photo 38. Damage to reinforced water tank columns, inadequate reinforcement and ties.

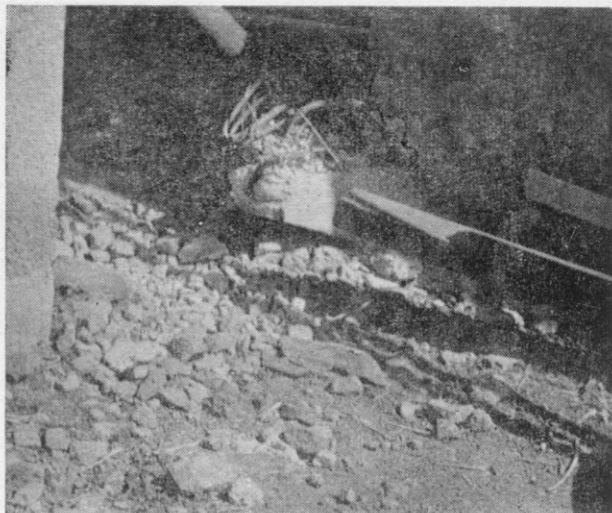
Photo 39. Buckling of reinforcements in the columns of water tank, badly mixed concrete and few reinforcements.
