## **DAMAGE TO BUILDINGS DURING DECEMBER 31, 1984 CACHAR EARTHQUAKE, NORTHEAST INDIA**

**P. N. AGRAWAL\***

**KEY WORDS:** Earthquake Damage Survey, Building Damage, Cachar Earthquake.

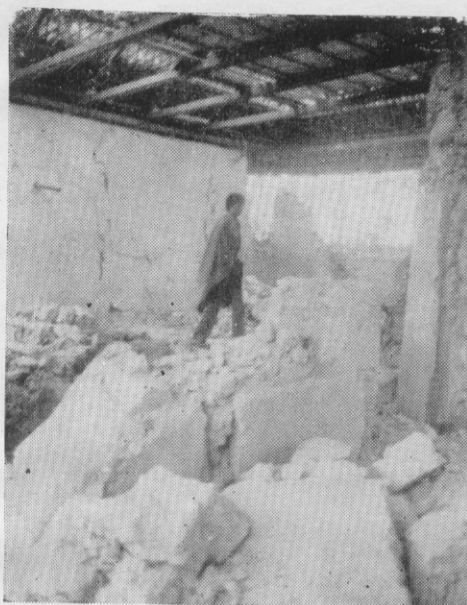
The mud houses suffered very severe damage at various localities the farthest from the epicentre being Lakhipur and Chotamamda. It was impossible to find even one mud house which had escaped damage. Figure 2 shows a mud house at Kajidhar II whose walls have failed and fell inside killing five persons sleeping in the house. Generally the roofs of these mud houses were so well constructed that even with severe damage to walls the roofs mostly remained undamaged. Only after earthquake damage to walls the roof material is being removed for its reuse for new construction. Figure 3 shows that the damage is concentrated at opening in the walls from where vertical cracks have extended in the total height. Figure 4 shows a mud house at Chotamamda where the wall collapse killed three people sleeping inside. This house is one of those few examples where the roof had also failed and collapsed. Another house in figure 5 also clearly show the development of mostly vertical cracks in the mud houses. The corner is damaged more due to the separation of the two walls. Generally the damage has been more or less uniformly distributed along the longer walls. For some houses the roof of the verandha on timber posts has been tilted and efforts to restore them to original condition were in progress.

*Fig. 2. Damage to mud house with thick walls and thatched roof of very good timber cum bamboo frame at Kajdhar II-five people sleeping inside buried to death due to collapse of walls in this house.*

The construction of mud houses by the Bihari immigrants to ensure safety against cyclonic storms has not been found suitable for the earthquake shaking. Fortunately, the roofs have mostly remained undamaged otherwise it would have further, added to the fatalities. The poor people have found them more economical as mud being the main construction material is available free of cost making them cheaper to even bamboo huts. Another advantage is that ordinary people can do most construction by themselves. The current practice of mud construction is not at all suitable to the natural environment and needs substantial improvements. Prismatic roof design dispensing with the need of gable walls is a good feature. The use of braced timber frames with mud filler walls, use of bamboo matting as reinforcement in mud walls and reduction of free wall height by providing lintel level timber or bamboo bands are some of the simple possible improvements. The aseismic features of Dhajji-dewari mud construction of Kashmir Valley can be adopted with advantage in this region also. Unlike Kashmir where mud construction is preferred for thermal stability here it would be to provide greater safety during cyclonic storms. The relative suitability, practicability and economy of these and several such other alternatives will have to be worked out and the recommendations evolved will have to be popularised amongst residents.

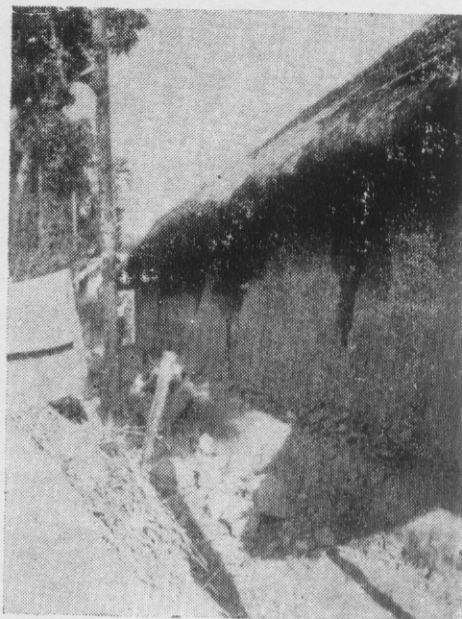
*Fig. 3 A mud house at Sonaimukh whose longer wall has been damaged-cracks have travelled from the openings more or less vertically perhaps top to bottom.*

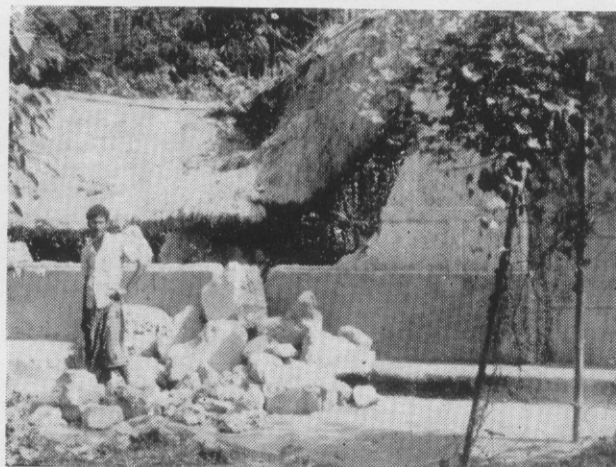
*Fig. 4. Mud house at Chotamamda with thatched roof whose collapse of a wall led to death of three persons inside-this is one of those few examples where the roof had also been broken.*

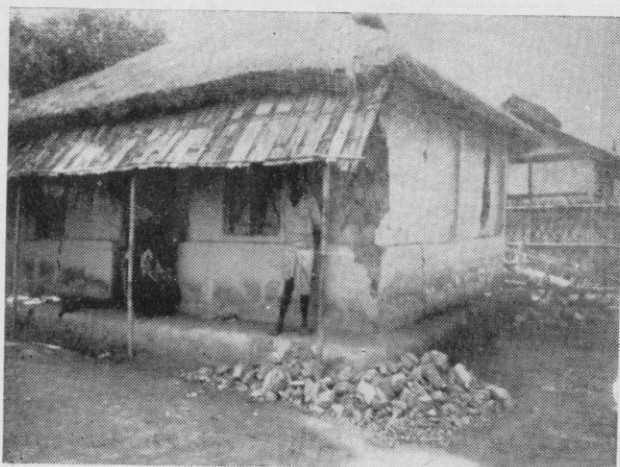
*Fig. 5. More or less vertical cracks in the walls of mud houses and failure at the junction of the walls at Sonaimukh.*

The free placement of roofs on the walls, even to allow its sliding, as in seen is the building in figure 25 is not a good practice. Suitably placed connections between the roof and walls would improve the overall strength of the building as a whole. Even in the mud construction the vertical bending cracks in the walls could be considerably reduced if the roofs were fixed to walls along their lengths at few points. A reference to the Manual of Earthquake Resistant Non-Engineered Construction would be found useful for these aspects discussed here.

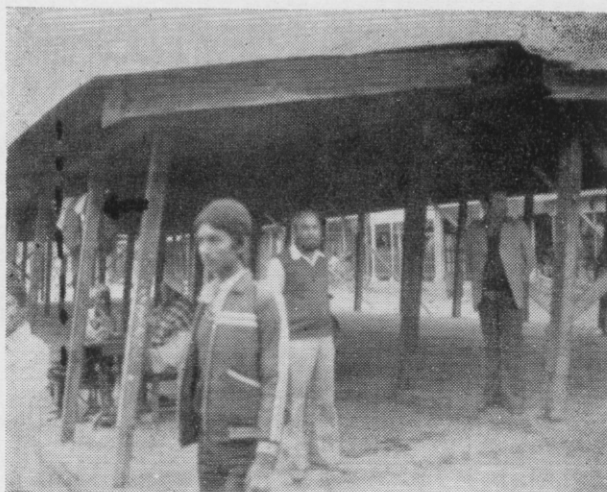
There were several timber shade with roofs of G.I. sheets at Sonaimukh. The one in figure 6 is a large one about  $30 \times 10$  m for the daily market at Sonaimukh and had been tilted by about  $30^\circ$ . It has been partly restored to verticality with the help of inclined timber supports. Much more flexible and small shed with two diagonal braces in figure 7 did not get damaged. At this location the adjoining mud houses were badly damaged. Figure 8 shows the damage to a house using walls in bamboo mating. A long row of shops seen in figure 9 with timber construction, G.I. roofs and bamboo matting wall has been tilted by as much as  $45^\circ$ . An individual store room at Sonaimukh rest house in figure 10 has been tilted. In figure 11 a shop with tiled roof has been tilted where as the adjoining similar one with roof of G.I. sheets has remained undamaged.

*Fig. 6. 30 × 10m timber shed for daily market at Sonaimukh was tilted by about 30° market is being restored to verticality.*

Use of diagonal braces in timber construction is essential. Even the good Assam type construction requires effective use of the diagonal bracings. The tilting of several shops, houses and sheds could have been avoided. It is also seen that the timber columns in such construction are made just to rest on ground or connected to a short masonry or RCC base with the help of steel flats. The burying of columns to one third or half the height of the building is recommended to increase its lateral stability and to eliminate the possibility of tilting. Such practice is common in coastal areas where the huts have greater flexibility due to higher floors to take care of high tide conditions. The heavier roof on one shop in figure 11 made it to tilt whereas the other adjoining one with lighter roof remained vertical. This kind of damage could be avoided if the suggestions made here are adopted.

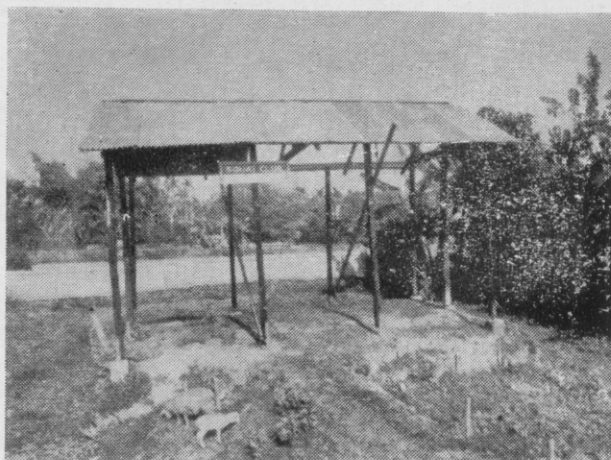
*Fig. 7. 9×6 mm timber shed at Sonaimukh with only two cross diagonal braces in adjacent bays remained undamaged.*

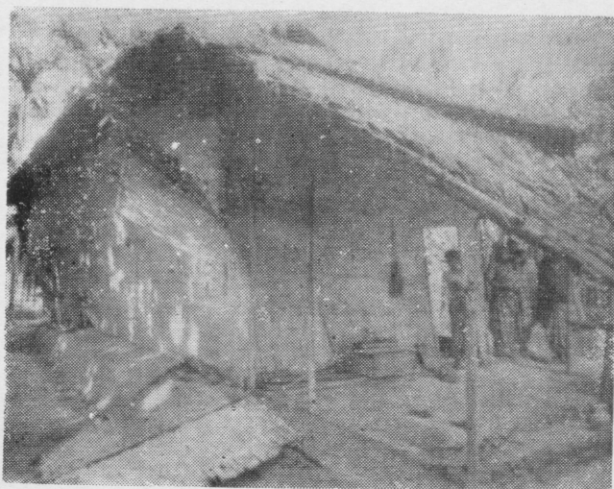
*Fig. 8. A thached hut with walls in bamboo mat and mud plaster is tilted and mud plaster is partly peeled off.*

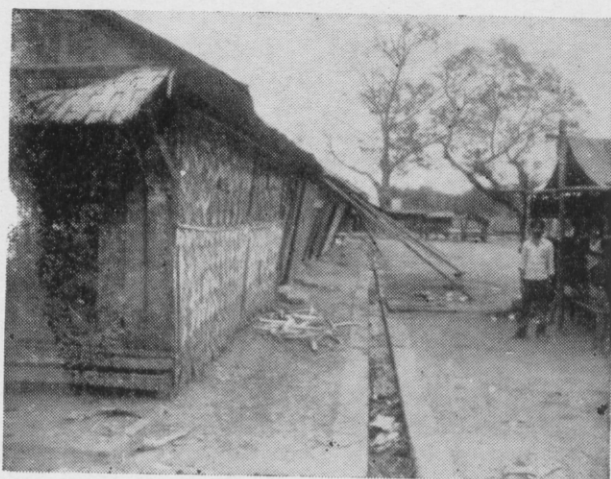
*Fig. 9. Tilting of a row of shops in the Sonaimukh market-efforts to restore them to vertical by giving supports as in photograph were already in progress.*

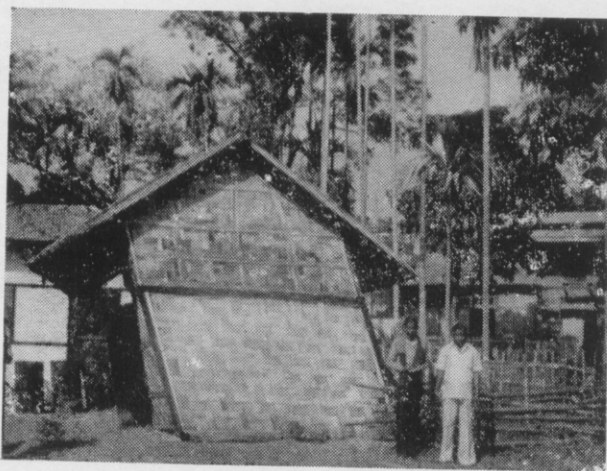
*Fig. 10. Tilting of a very light hut in timber and bamboo at the compound of Sonaimukh inspection house.*

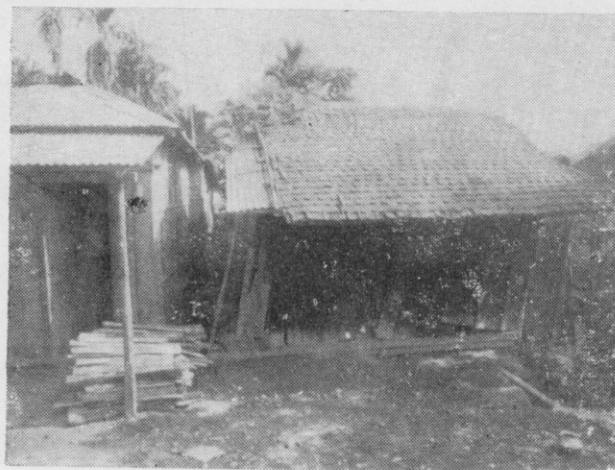
*Fig. 11. Tilting of yet another individual shop with roof in tiles.*

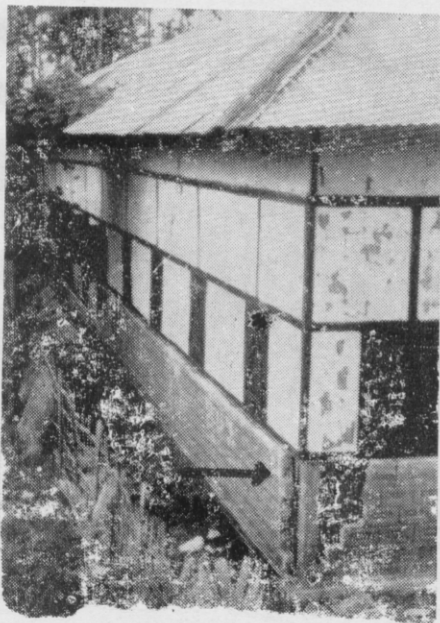
The damage to Assam type construction was generally limited to the brick masonry portions. Figure 12 shows the damage to brick masonry

*Fig. 12. Damage to the school building at Satakarkanur-the brick masonry below window level has failed at corner and at other places as indicated.*

below the window level in the school building at Satkarkandi. Figures 13 and 14 are for the school building at Sonaimukh in which masonry extended to ventilator height. The lintel level reinforcement has partly held back from falling the broken and tilted wall. It was interesting to note that the broken masonry wall did not show failure of the mortar joints but mostly the shearing of the bricks. Figure 15 is another school block at Sonaimukh where both the longitudinal walls and most cross walls have been raised to ground whereas the timber shed stands vertically. Few windows on the rear wall were left hanging from the lintel level. Figure 16 shows a house at Sonaimukh where the damage is more to the backyard boundary wall and its junction with the building. A close up of the small cabin on left side is shown in figure 17 where even beam has been damaged. The columns of a brick masonry building with G.I. roof have failed at roughly their mid height but escaped falling as seen in figure 18.

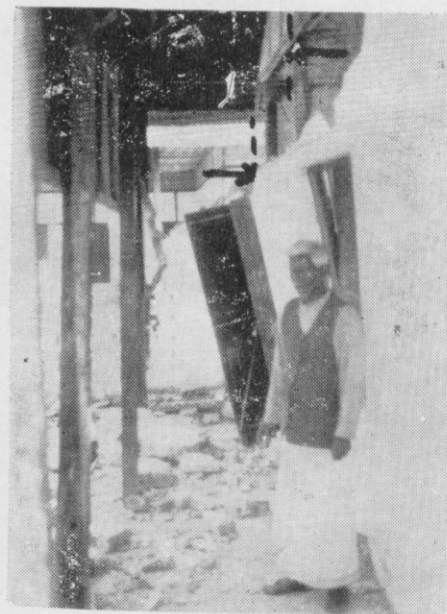
*Fig. 13. Very extensive damage to a timber cum brick masonry building of school at Sonaimukh-the tilted door hangs with masonry due to lintel level reinforcement.*

Assam type construction seems most suited for the area. The use of brick masonry in walls to increase the dead weight of the building and improve its stability during cyclonic storms is a good idea but its use has to be improved with respect to the placement of masonry and its interconnections with timber members. The horizontal continuity in masonry walls created by placing them outside the timber columns/frames, most conspicuous example of which was seen in Sonaimukh school building has proved to be very hazardous. Placing of masonry walls inside the timber panels with

suitable interconnections would have substantially reduced the damage during the earthquake under study.

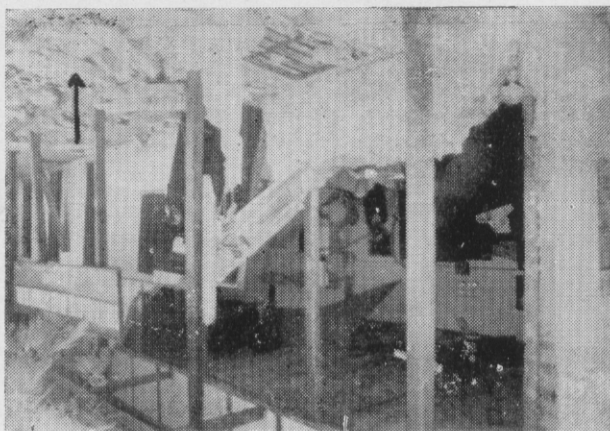
*Fig 14. A view from left side of the building in figure 13-the broken masonry generally showed shearing of the bricks rather than splitting along the plaster.*

The bricks used in the area are found not to possess the desired strength. The mortar used has been generally of good quality not allowing the mortar joints to be opened up. Improvements are required in the shear strength of the bricks which may be possible by their better burning, may be adding some other soil to take care of possible chemical deficiencies, etc. This in itself is an important aspect of the construction in the area and suitable test and studies are required.

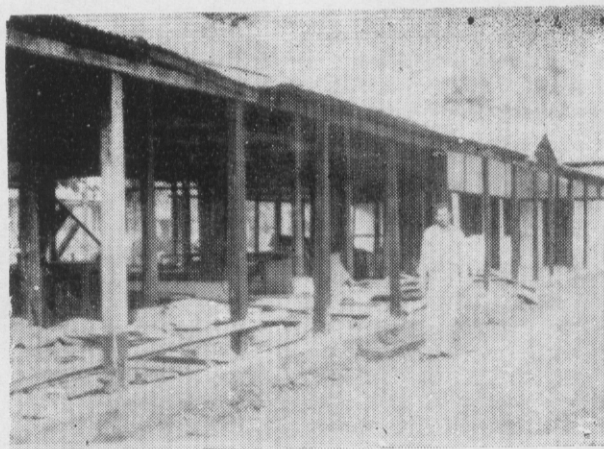
*Fig. 15. Complete collapse of brick masonry walls (including partition walls) in a school building at Sonaimukh-some wooden window frames remained hanging on the rear face.*

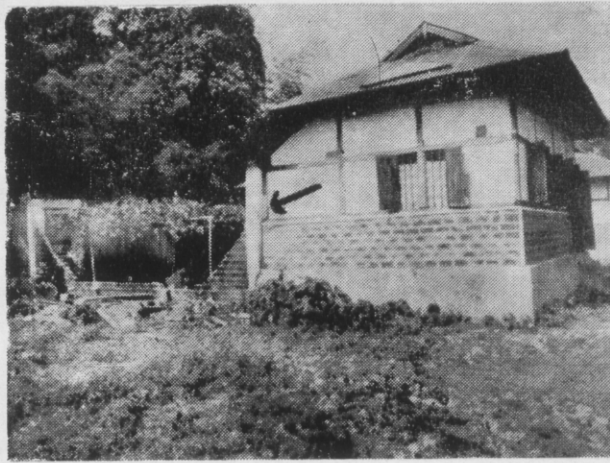
*Fig. 16. Separation of column from the wall and collapse of the backyard wall in brick masonry.*

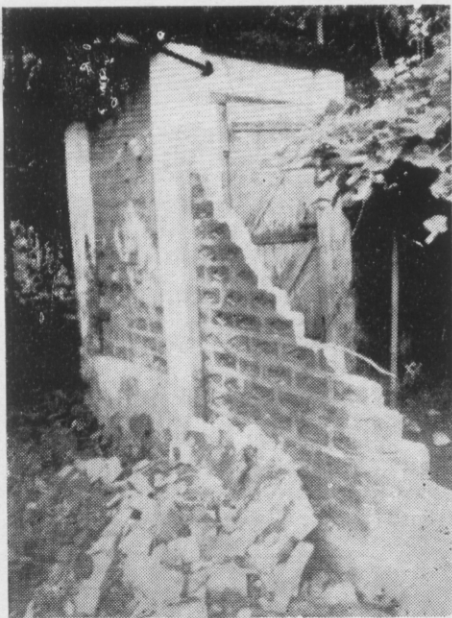
*Fig. 17. Closeup of the left end of the back yard in figure 16 and damage to the beam along the door.*

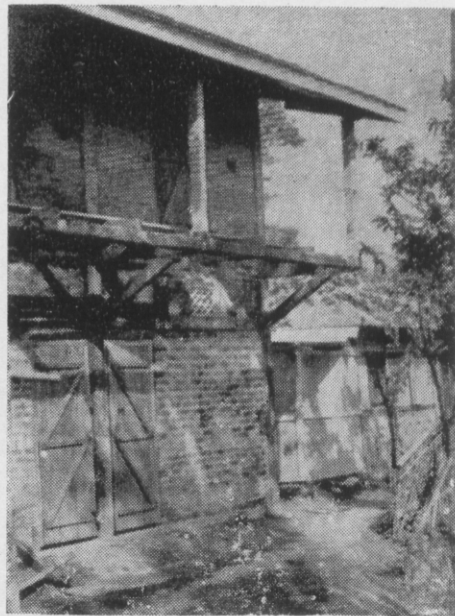
*Fig. 19. An undamaged RCC frame building with brick masonry filler walls close to most extensive ground failure at Sonaimukh.*

An incomplete building with RCC frame seen in figure 19, and close to the major ground damage area along Barak river behind Sonaimukh Police station, has remained undamaged. Two shops in some what similar RCC construction in Sonaimukh market had, however, some minor cracks in filler walls and in one of the beams at lintel level. A frame to support a water tank at Sonaimukh in figure 20 had also some what similar damage to RCC beams. A tubular steel frame construction with filler walls in brick masonry is seen in figures 21 and 22. This was located at a hillock near B.D.O's office at Sonaimukh. Damage to two diagonally opposite corners of this building is shown. The broken and separated walls have swung like hinged doors due to steel bar ties going around the corner steel pipes and embedded in the masonry. The walls have broken not along the plaster joints but through the bricks can also be noticed for this building.

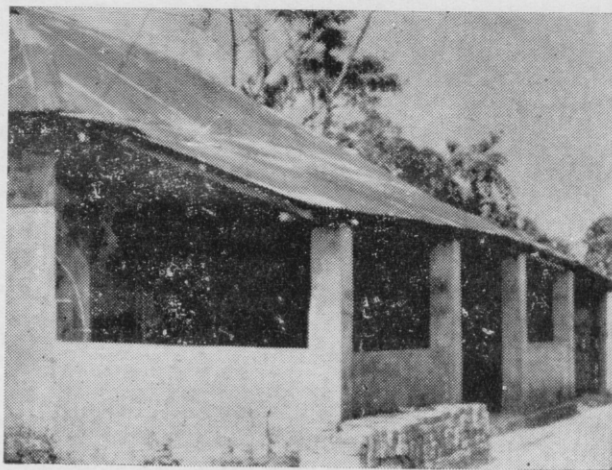
*Fig. 18. Failure of the column at its mid height in a brick masonry building.*

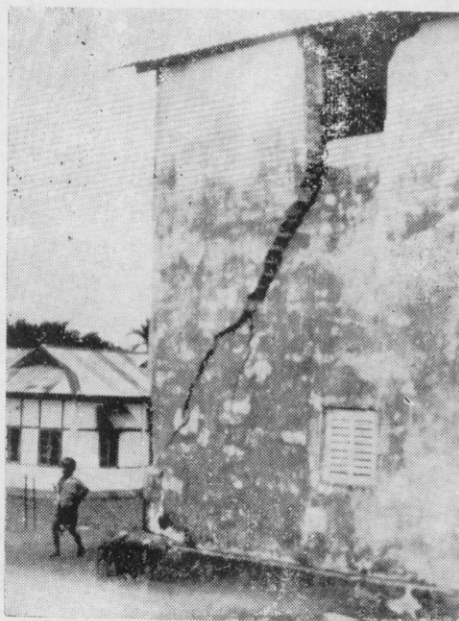
*Fig. 21. Damage to a tubular steel frame shed with brick masonry filler walls-the steel-barties have served as hinges for the broken wall.*

Generally the ceilings in the buildings in the area are much higher. This is because of higher rainfall demanding greater roof slopes. In such buildings the free wall heights must be reduced by use of suitably placed horizontal ties. The damage to tubular steel construction in figures 21 and 22 could be avoided if suitably placed horizontal steel or timber members were used in the walls.

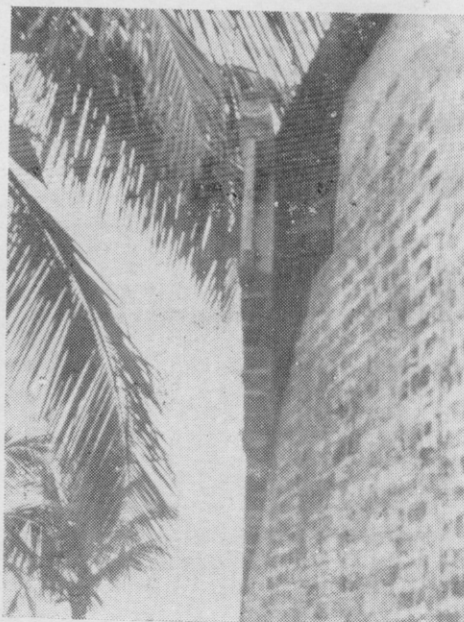
*Fig. 22. The same shed as in figure 21 but its face towards the hillock top-the two damaged corners are diagonally opposite.*

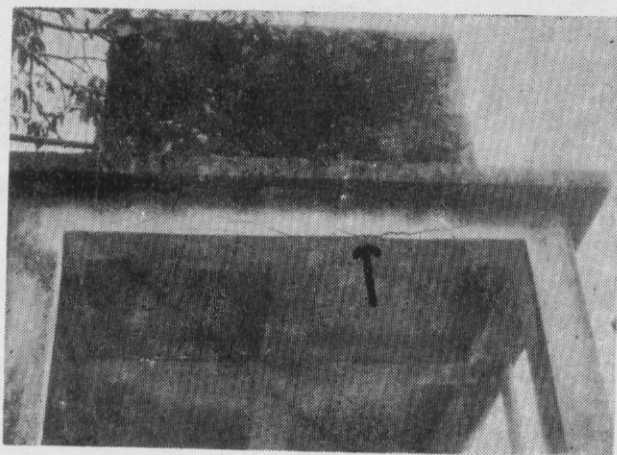
*Fig. 20. Damage to RCC beam supporting a water tank at Sonaimukh.*

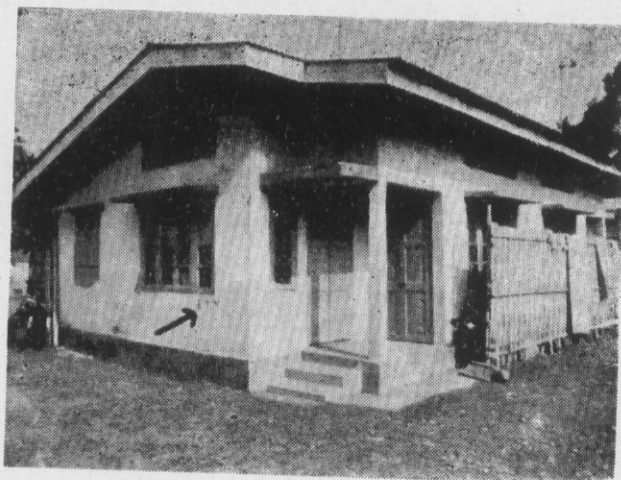
*Fig. 23. Residential quarter at Sonaimukh Police station just adjacent to Barak river bank's major failure-only minor plaster crack below window level.*

A residential building in the Sonaimukh Police station compound as shown in figures 23 to 26 had minor damage. The outside plastering had cracked close to window frames and also the inside plaster on filler walls had diagonal cracks. An interesting damage to the ceiling fan, i.e. bending of its blades is seen in figure 24. There were evidences of large relative displacements between the roof and the walls at the level above ventilator as seen in figure 25. Similar bending of fan blades was seen for atleast a dozen fans in the Sonaimukh school building.

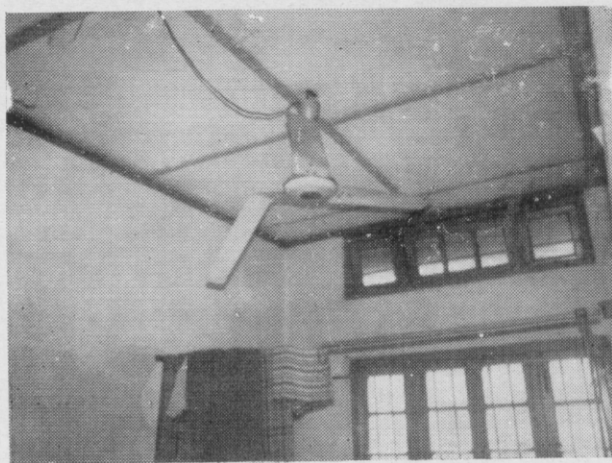
*Fig. 24. Banding of fan blades in the building in figure 23-some evidences of slipping of false ceiling attached to roof above the ventilator were seen.*

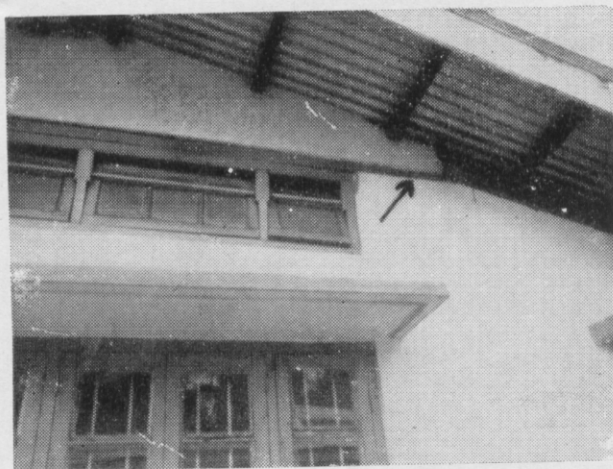
*Fig. 25. Close up of the slide surface between ceiling and walls of the building in figures 23 and 24.*

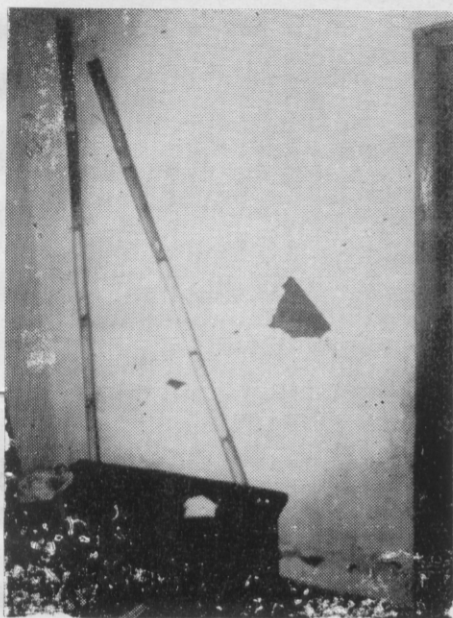
Fig. 26. Damage to plaster inside the building in figure 23.

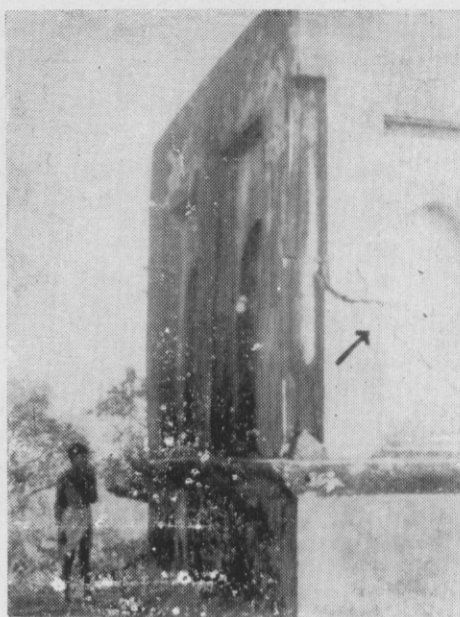
Fig. 27. Damage to a very old Shiva temple in brick masonry.

Figure 27 shows damage to Shiva temple reported to be over 300 years old. An adjoining flexible shed, similar to one in figure 7 with diagonal braces, did not suffer any damage. Number of well constructed mosques had been damaged. Figure 28 shows the collapse of the rear portion of parapet on the roof of a mosque at Kajidhar II. Some

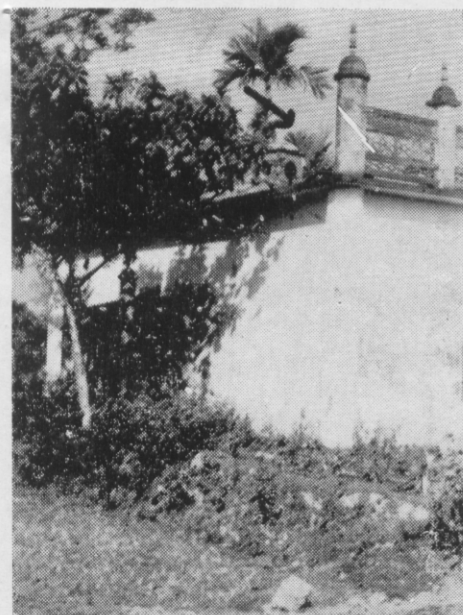
Fig. 28. Collapse of the rear parapet over the roof in a mosque at Kajidhar II.

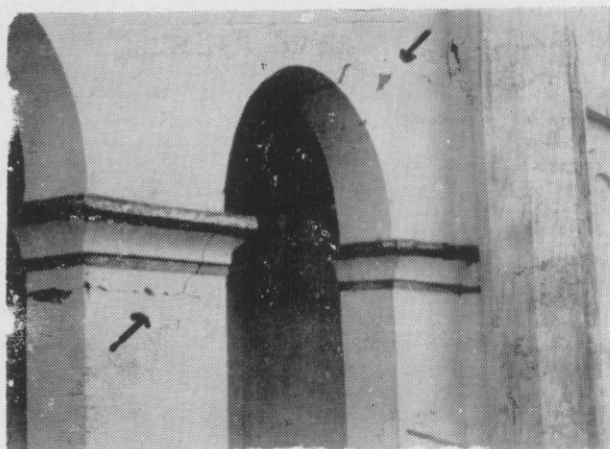
Fig. 29. Failure of columns of a mosque building at Bokrepar.

minor plaster cracks inside and on columns at their junctions with arches could also be seen like for another mosque shown in figure 29. A very well constructed and maintained mosque again at Kajidhar II had been split into two all throughout perhaps as a result of 300 m long ground rupture below the mosque. Figure 30 shows the tilting of the loudspeaker stand at the roof top of mosque at Sonaimukh which had happened at number of distant localities also. Figure 31 shows the broken top of a minar on a mosque which has been thrown apart and is seen lying on the ground. Few mosques even in the localities of greater damage had escaped damage whereas a mouslim Peer at Phluretal near Lakhipur had also been badly damaged.

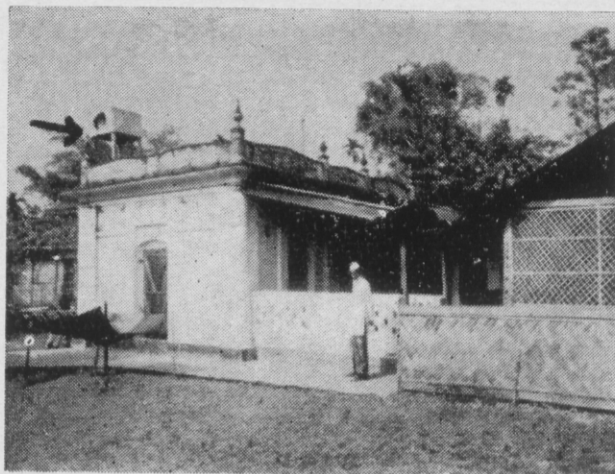
*Fig. 30. The loudspeaker stand on the roof of a mosque at Sonaimukh was tilted.*

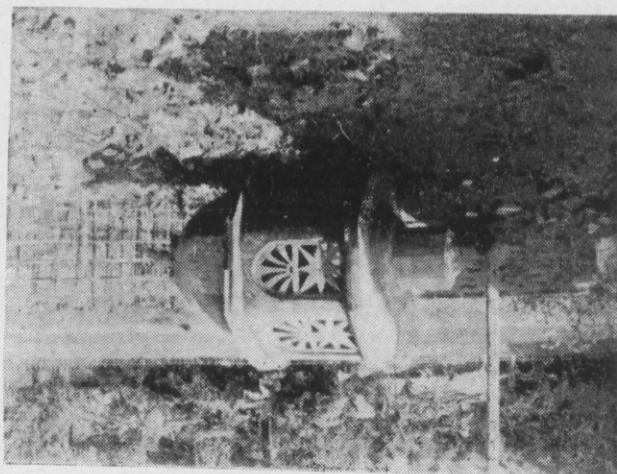
*Fig. 31. Fall of one broken minar of a mosque.*
