## **DAMAGE TO TWO RCC BRIDGES DURING DECEMBER 31, 1984 CACHAR EARTHQUAKE, NORTHEAST INDIA**

**P.N. AGRAWAL\***

Damage to two RCC Bridges within 10 km focal distance during the December 31, 1984 Sonaimukh earthquake of  $M^B$  5.6, in Cachar region of Northeast India, has been described. Sonaimukh bridge has been damaged more compared to Rukni bridge inspite of its being at larger focal distance. The greater damage to Sonaimukh bridge is due to its transverse orientation with respect to the principal direction of ground motion. The retaining walls have also contributed to the reduction in damage for the Rukni bridge. The detailed observations indicate that the two bridges can be repaired.

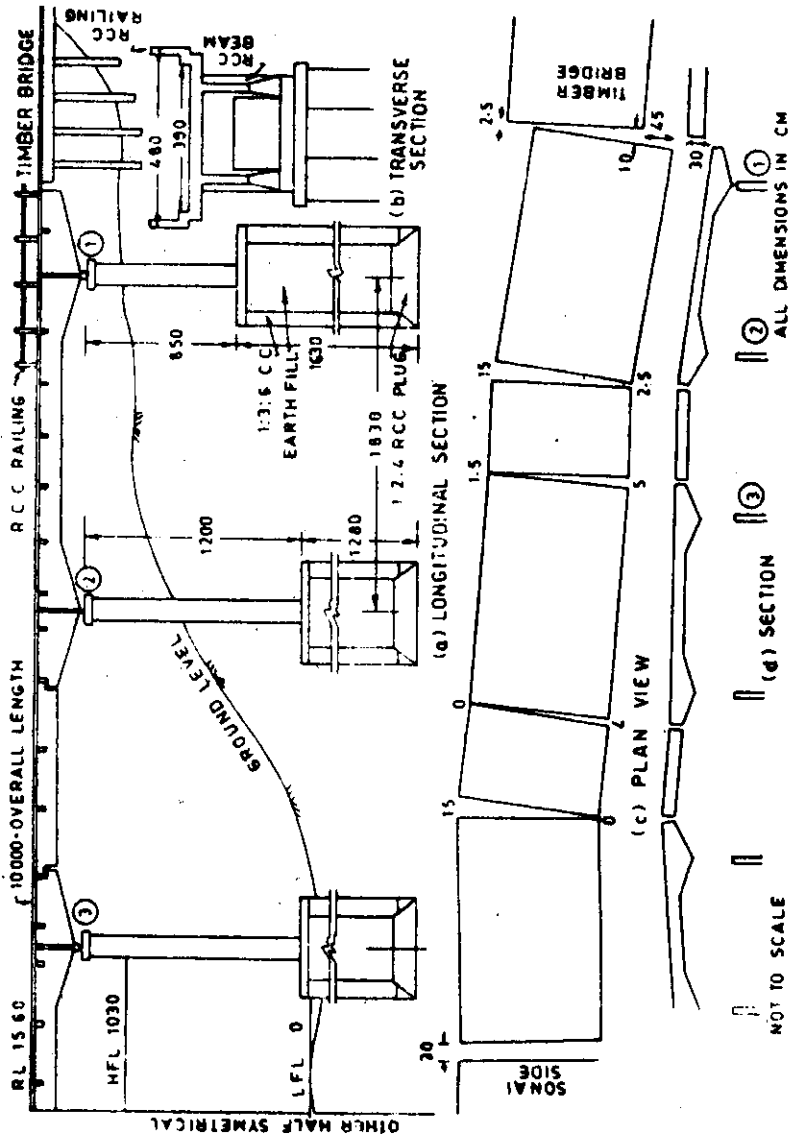
Fig 3. Details of Sonaimukh bridge (a) and (b) Longitudinal and transverse sections, (c) plan view of the deck and (d) section of deck after damage

The plan view of the bridge at deck level after the earthquake is schematically shown in the Figure 3 (c). A section of the bridge deck is also given in the Figure 3 (d). The relative displacements in cm between adjacent spans, abutment and span, and spans and piers have been marked. It can easily be inferred that the direction of ground motion was largely transverse to the bridge. The bridge spans have hardly moved in longitudinal direction whereas the lateral displacement of as much as 45 cm has taken place between the pier (1) and the deck. The resulting curvature of the deck alignment shows that if the ground vibration was only little larger in amplitude or had it continued for a longer duration the central portion of deck would have fallen towards north of the bridge piers. This is in conformity to general observation for fall of east-west oriented walls/objects towards north. The principal direction of the ground motion has been largely N-S.

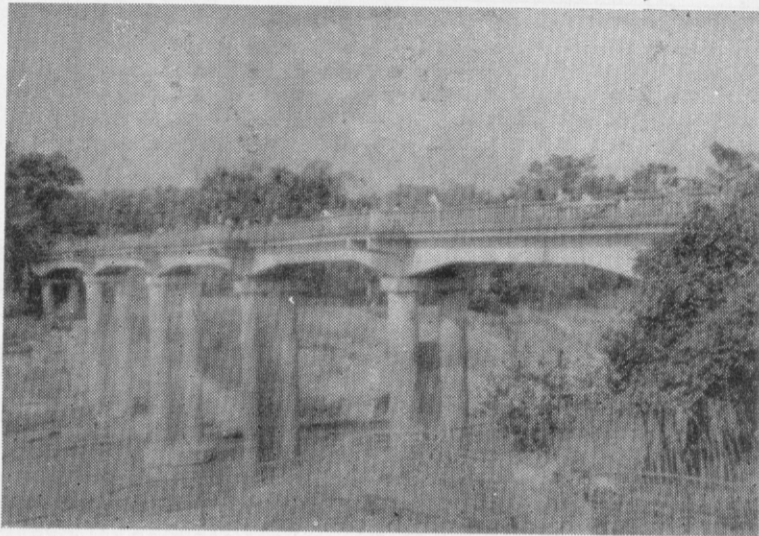
*Fig. 2. General view of the Sonaimukh RCC bridge which was damaged by Dec. 31, 1984 earthquake, Sonaimukh town is beyond left end.*

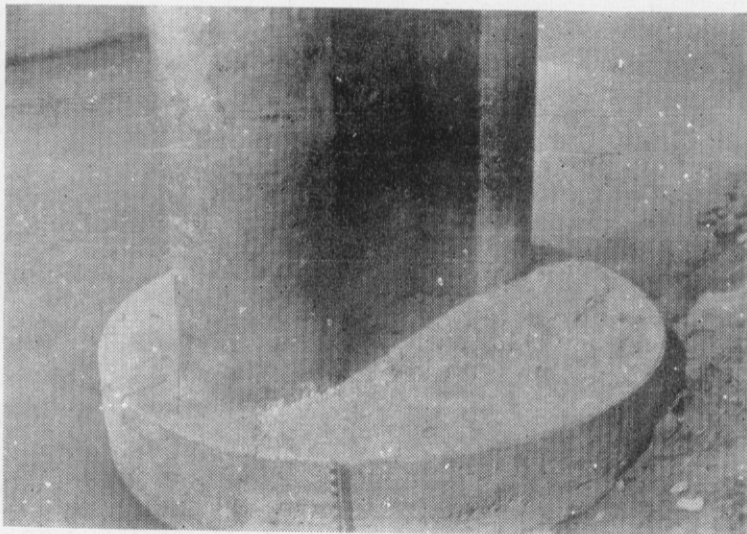
The bridge has been damaged to the extent that it had to be closed for traffic. The damage details are presented here with the help of photographs. The Figure 4 shows the damage to the well cap of the fourth pier from the Sonalmukh side. It is possible that the well has not been damaged. However, the relative displacement and rubbing between well cap and well have also been evidenced by chipping of concrete at their contact. This has been caused due to excessive transverse shaking of the deck and resulting eccentric loads. The plan of the deck is no longer straight. The span joints have opened up but not equally along their length as is seen in the Figure 5. The larger opening of the successive joints is on opposite margins. However, cumulative joint opening is more on the north. At both the ends of the bridge, the deck has moved down relative to ground or timber bridge (Figure 6) by 15 cm and 30 cm, respectively. This is due to loss in the deck height at the roller ends where it has been dislodged from them. The relative lateral displacement of 45 cm between RCC and timber deck is seen in the Figure 7. Although the permanent residual lateral displacement can be accounted for by the displacement of RCC deck itself but the timber section had also vibrated causing snapping of steel bar and flat ties fixing timber beams and columns as seen in the Figure 8.

*Fig. 4. Damage to the well cap below the second pier from right in the Figure 2.*

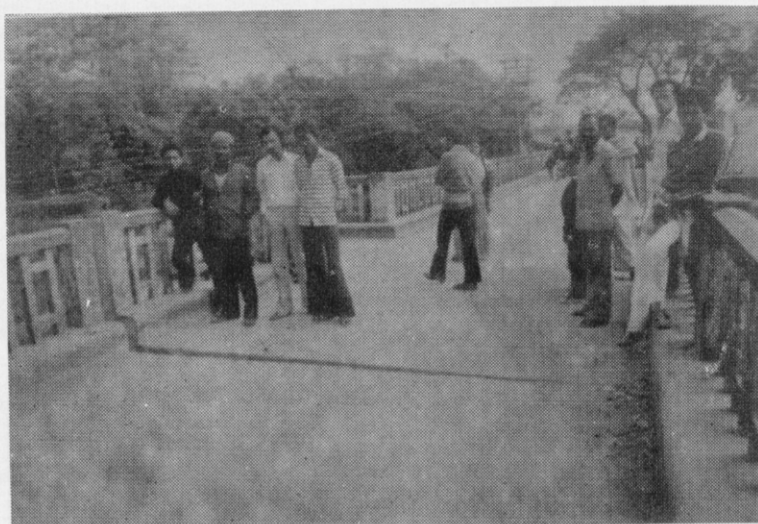
*Fig. 5. Opening of a joint at road level showing relative lateral displacement of deck spans.*

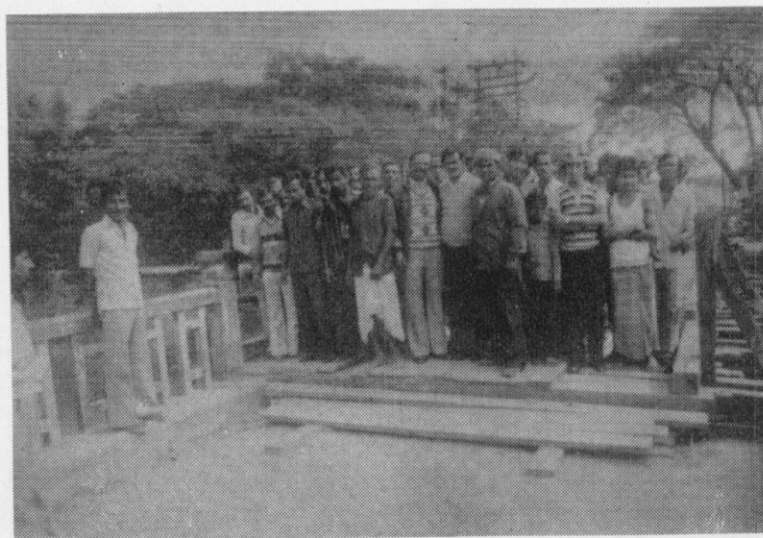
*Fig. 6. 30 cm relative vertical displacement of the RCC deck with respect to timber bridge.*

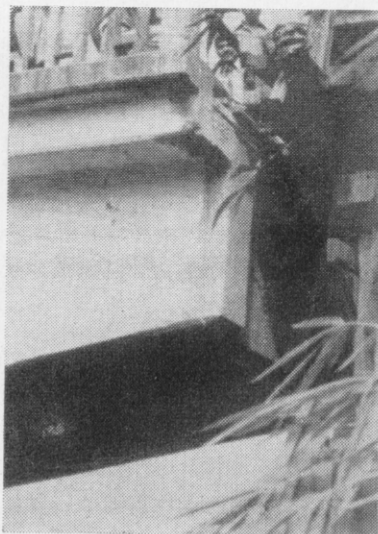
*Fig. 7 45 cm lateral displacement of the RCC deck with respect to timber bridge.*

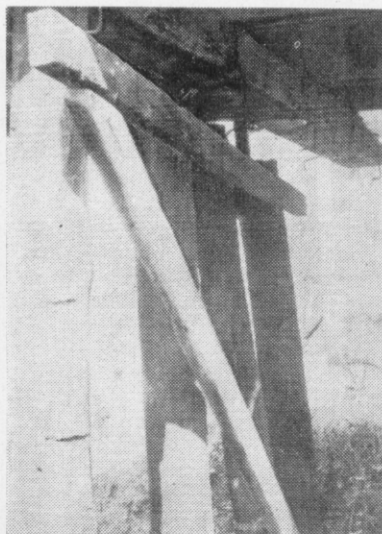
*Fig. 8. Dislodging of timber bridge's vertical support, nearest to RCC deck, from their position by about 60 cm in the direction longitudinal to the bridge.*

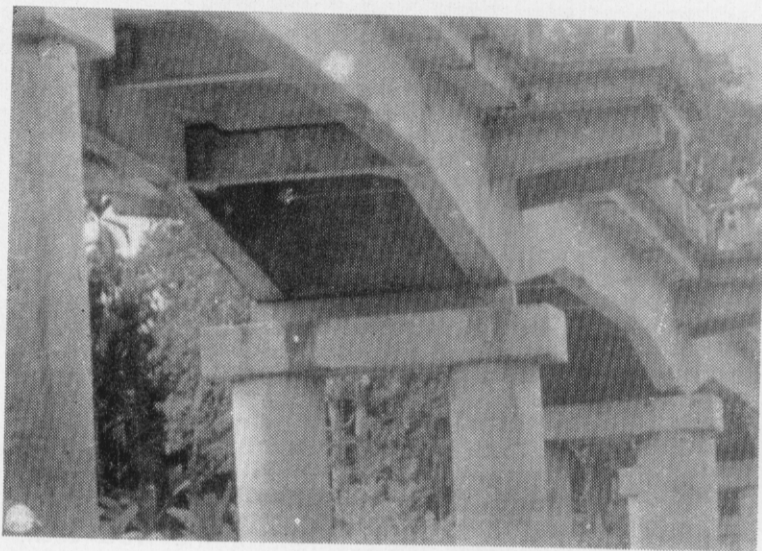
*Fig. 9. Opening and closing of deck joint at road and base level respectively due to relative downward movement of the other end of the span.*

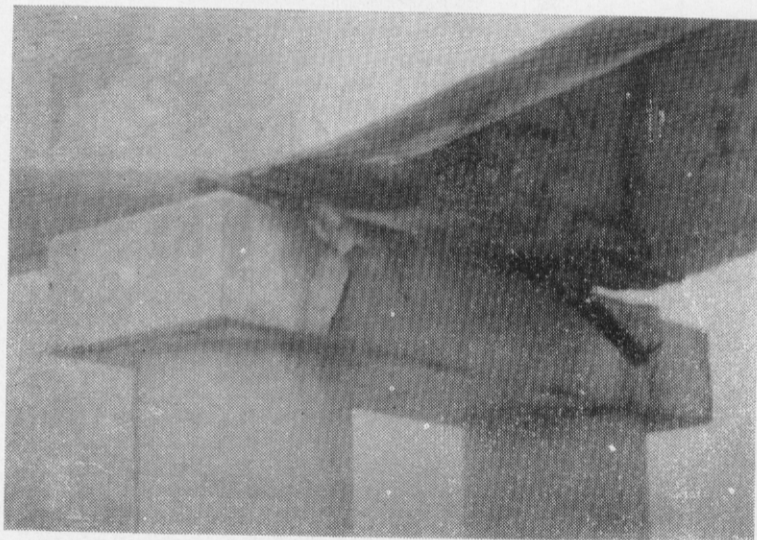
*Fig. 10. Lowering of one end, of the span, first from right but not seen in the Figure 2, by 30 cm due to its being dislodged from the roller bearings.*

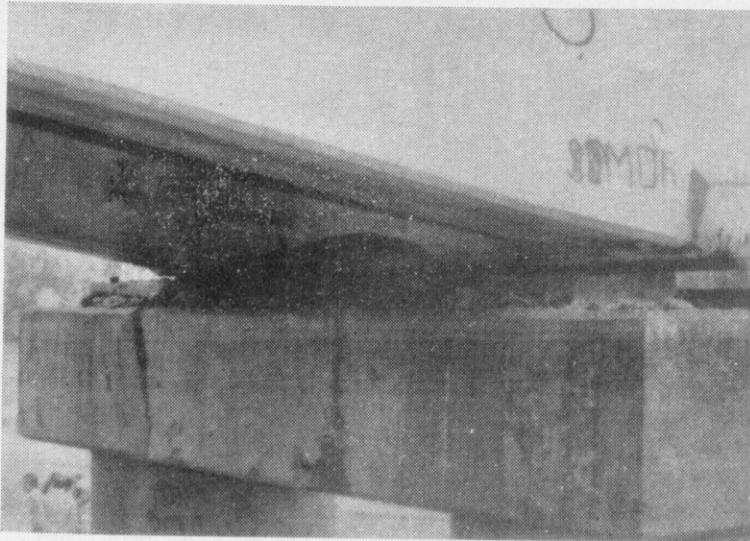
*Fig. 11. Same pier as in the Figure 10 but its view from the back side*

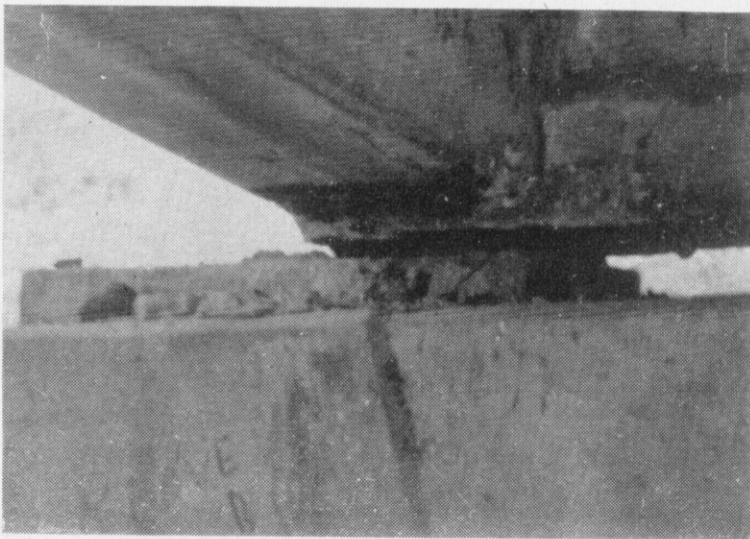
The spacing between the pair of edges, facing each other, of the supported spans has been widened at the road level and narrowed down at the bottom due to loss of height of the other end of one of the spans due to damage to rollers. The freely supported spans have just escaped being dropped from their supports on fixed spans. The widening of one of the gaps between free and fixed spans at road level is seen in the Figure 9. The Figure 10 shows the damage to rollers and drop in height of this end. Another photograph of the same end from back side, in the Figure 11 shows even the chipping of concrete below roller plates. The Figure 12 is close up of only one end to show clearly the lateral displacement of deck by about 45 cm.

*Fig. 12. Close up of the left end in the Figure 11 to show about 45cm relative horizontal displacement of deck with respect to pier.*

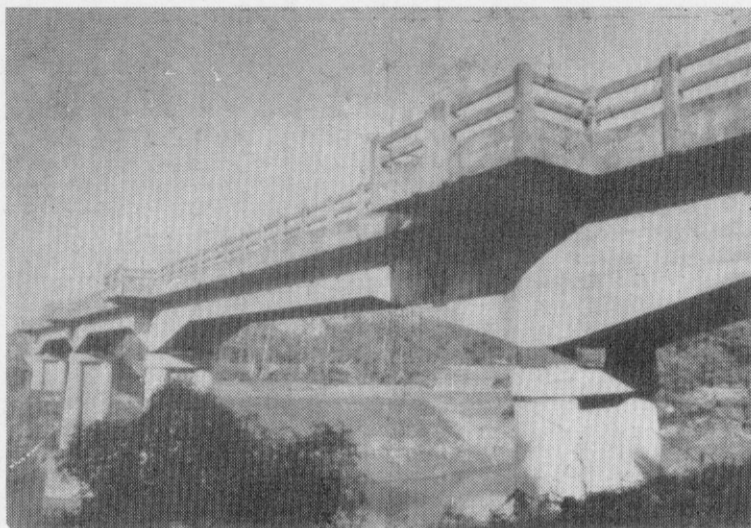
The Rukni bridge with identical design as Sonaimukh bridge was only about 65 m long. The bridge is roughly oriented N-S, consists of two fixed spans on four piers and only one central freely supported span as shown in the Figure 13. The height of the road above the lowest flood level was not measured but is estimated to be about 3 to 4 m less than that of Sonaimukh bridge. Another distinctive feature of this bridge was the construction of retaining walls at both the abutments as is seen in the Figure 14 and 15. It could not be confirmed if these were specially constructed for the present bridge or pre-existed for an earlier suspension bridge at the same location.

*Fig. 13 General view of the Rukni RCC bridge from Sonaimukh end.*

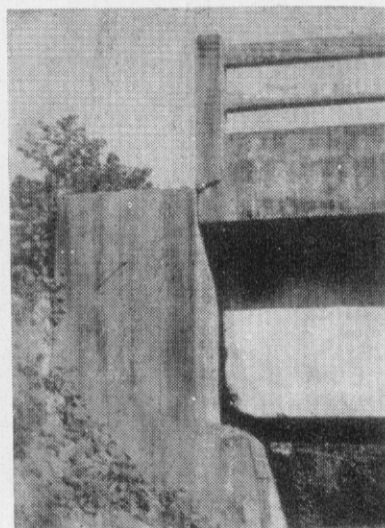
*Fig. 14. 5 cm separation of deck from retaining wall at the end away from Sonaimukh.*

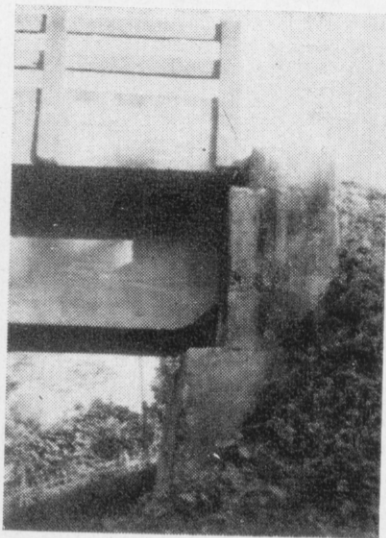
There were clear evidences that the bridge deck was moved dominantly in longitudinal direction, more towards Sonaimukh side, i.e., towards north. The two junctions between free and fixed spans showed evidence of their hammering against each other during vibration and a small opening (2 cm) only at one of the two junctions, which was towards west side, had occurred. The Figures 14 and 15 show the opening and closing of the gaps between retaining walls and deck at the two ends, respectively, which is a clear evidence of northerly movement of the deck. The chipping of concrete at the contact of retaining wall and the deck was seen only for retaining wall in the Figure 15. The retaining wall in the Figure 14 has moved towards north since the road behind and along it had slumped whereas the other one in the Figure 15 was, at its top, pushed into the ground.

*Fig. 15. Hitting and closing of joint between deck and retaining wall at road level at the end close to Sonaimukh.*

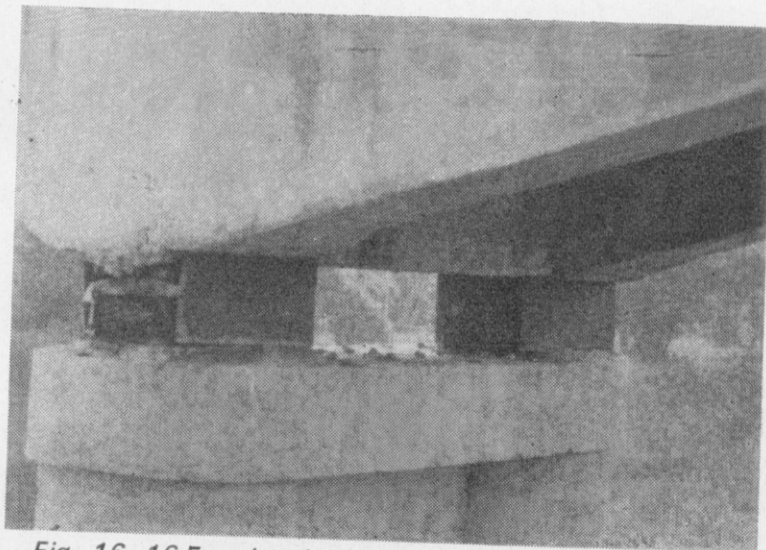
*Fig. 16. 16.5cm lateral (forward) displacement of the deck with respect to pier (first pier from left in Figure 13)*

The lateral displacement of deck with respect to pier at roller bearing end on both the fixed spans was seen. The Figure 16 shows the damage to two roller bearings on the same pier. The chipping of concrete had also occurred, and right and left bearings in the Figure 16 are given in the Figures 17 and 18, respectively. The relative lateral displacement of about 5 cm of deck towards west is clearly seen in these pictures. For a number of days after the earthquake and damage to the bridge it was continued to be fully used for traffic. However, it was recommended not to be used for very heavy traffic until the damaged bearings were replaced with the new ones.

The damage to these two bridges can be repaired. The broken bearings have to be replaced by new ones by suitably lifting the deck spans and restoring them to their original positions. In seismic areas where excessive displacements are possible to be experienced, the use of freely supported deck spans should be avoided. Limiting the total deck span's motion at the bearings may be required not to allow them to easily fall from the respective supports. Also providing suitable guides to restrict the lateral displacement of the deck relative to piers should also be considered.

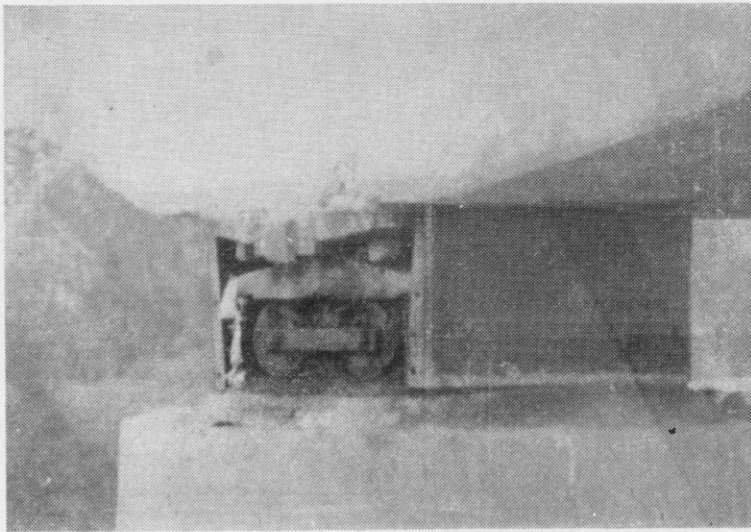
*Fig. 17. Close up of roller bearing on left in Figure 16.*

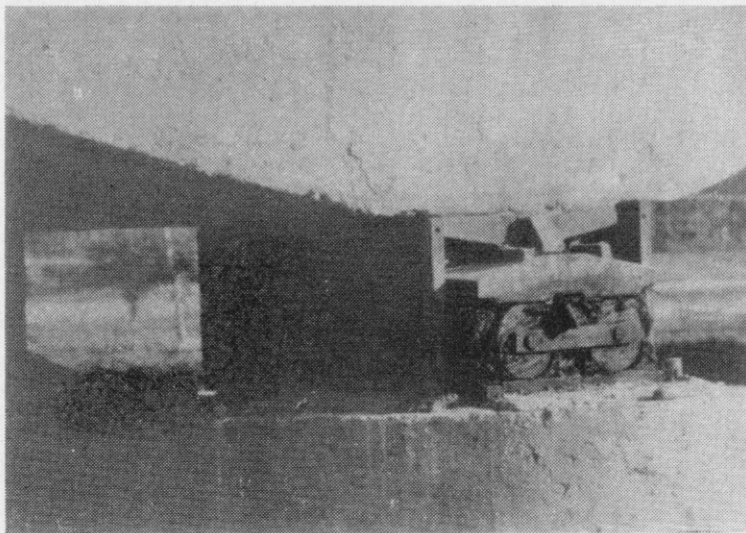
*Fig 18. Close up of roller bearing on right in Figure 16.*
