PERFORMANCE OF KALIABHOMORA BRIDGE ON RIVER BRAHMAPUTRA DURING BURMA-INDIA BORDER REGION EARTHQUAKE OF AUGUST 6, 1988

G.I. Prajapati

Deptt. of Earthquake Engg., University of Roorkee, Roorkee

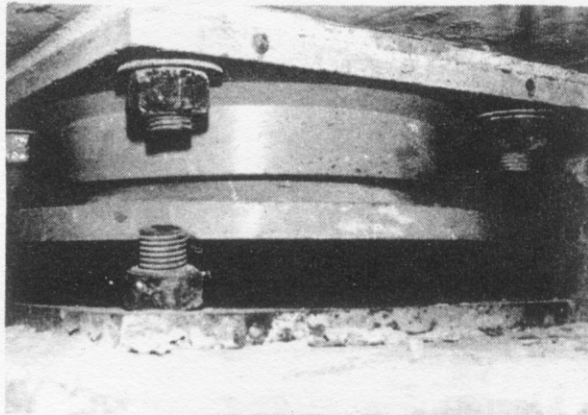
Fig. 6: Bending of Bolts Holding Bottom
Steel Plate of Fixed Bearing

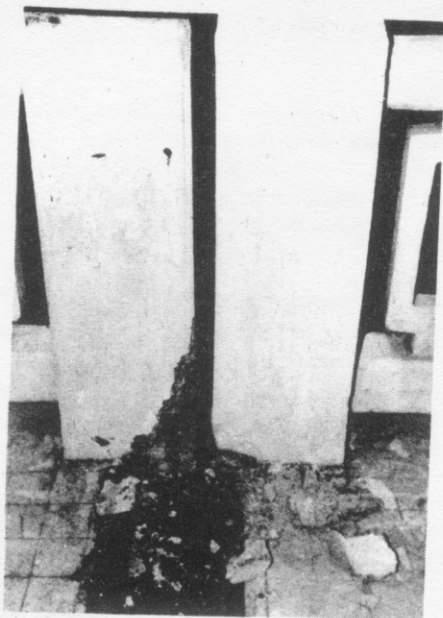
Fig. 7: Damage to Rail Post at Fixed End of Suspended Span

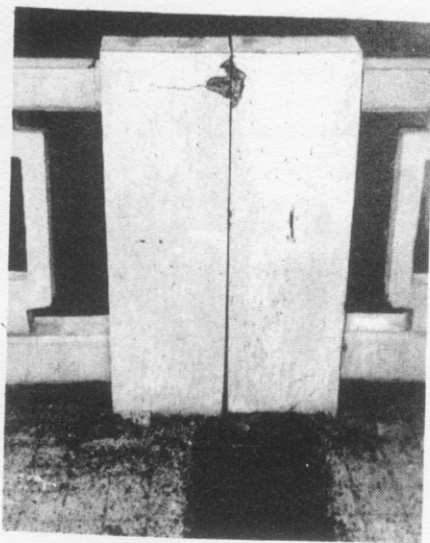
Fig. 8: Closure of Gap between Two Rail Posts at Fixed End of Suspended Span between Piers 14 and 15
