## DAMAGE REPORT OF THE LATUR - OSMANABAD EARTHQUAKE OF SEPTEMBER 30, 1993

A. Sinval, P.R. Bose and R.N. Dubey  
Department of Earthquake Engineering,  
University of Roorkee,  
Roorkee, U.P., India, 247667.

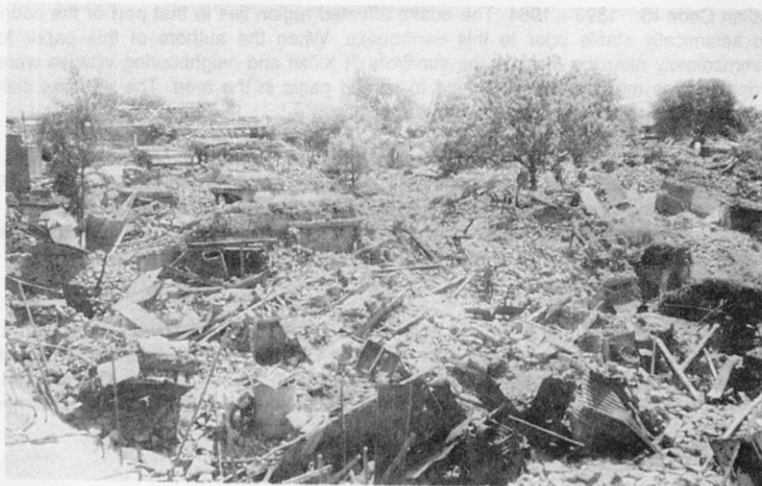
**Fig 2** View of the devastated Killari village.

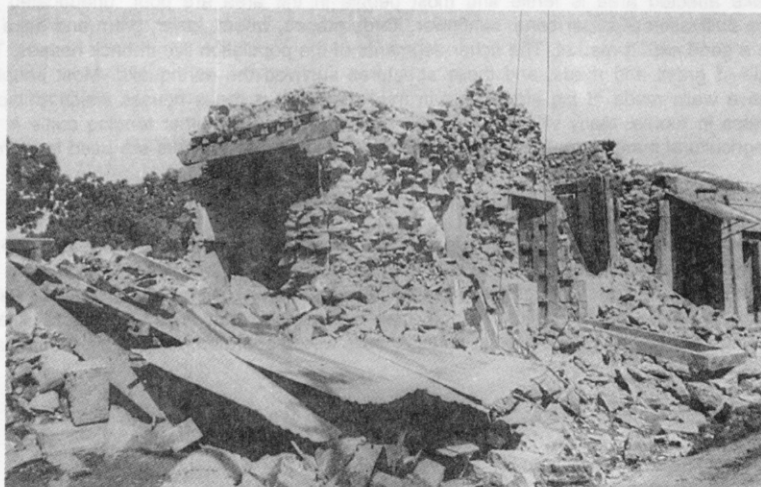
**Fig 3** This heap of stone rubble, timber and mud was street of stone houses at Killari before the earthquake.

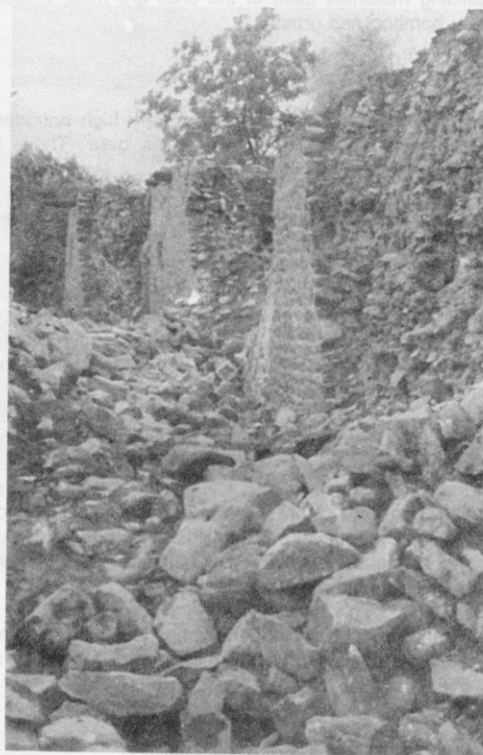
The walls are made of random rubble stone masonry laid in mud mortar with very few and small openings for doors and windows. The walls are usually 70 cm to 1.8 m thick, with 1 m being the norm. Such thick walls are popular as they provide thermal comfort and security. Everywhere typical wythe failure or delamination associated with stone walls is visible due to absence of bond stones, fig 4. The quake has demolished all such houses in the entire meizoseismal area.

**Fig 4** Failure of stone wall. The outer wythe bulged out and collapsed completely, Sastur.

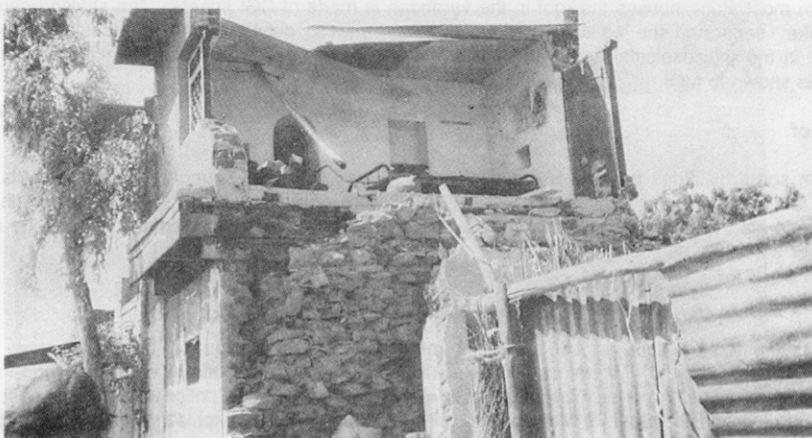
In bigger villages such as at Killari, extensions are sometimes made in existing stone structures either in the front court yard, or when there is a shortage of open space another storey is added on to an existing stone house. The new storey is made of brick or stone blocks which are laid in cement mortar. Mixed construction of this type had very typical failure, fig 6.

**Fig 6** Failure in a construction of mixed type at Killari. Brick was laid in cement-sand mortar to make walls above a stone house. The brick wall slid and came down en masse as there was no connection between old and new type of construction.

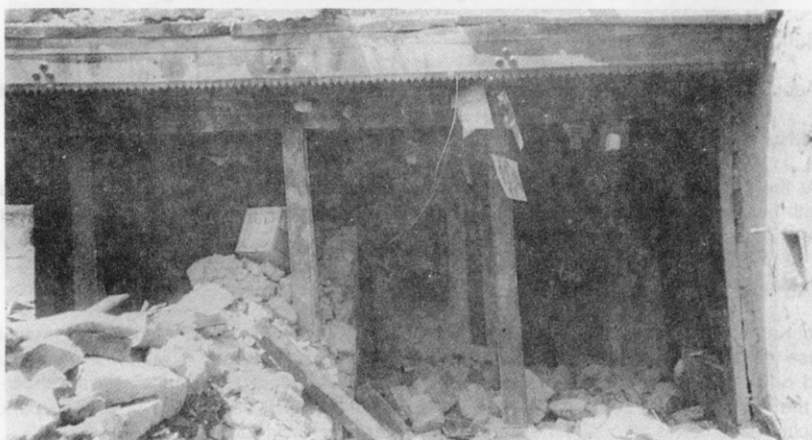
In some houses the earlier construction had a timber frame, later rooms were added which had no framed structure but stone walls only. It is very significant that it was the latter which collapsed and caused casualties and the former which survived and saved the inmates.

**Fig 7** An old stone house with wooden frame has an intact roof at Killari. No casualties occurred in this portion of the house. Newer construction in this and adjoining houses without wood frames collapsed completely and killed the inmates.

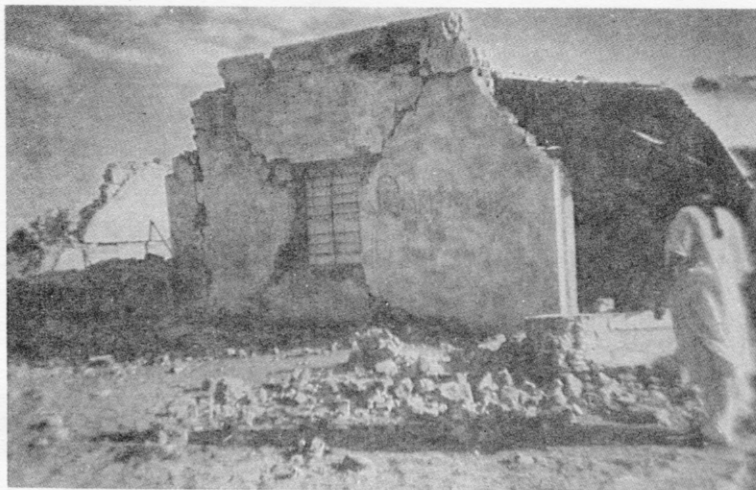
In most stone houses the roof in the verandah is made of CGI sheets. The shaking caused by the earthquake separated the walls at corners, the walls moved outwards and the roof collapsed. School buildings in the meizoseismal area were usually made of brick with CGI roof. Damage to such a school building is shown in fig 8.

Fig 8 Collapsed CGI roof of Government School at Mangrul.

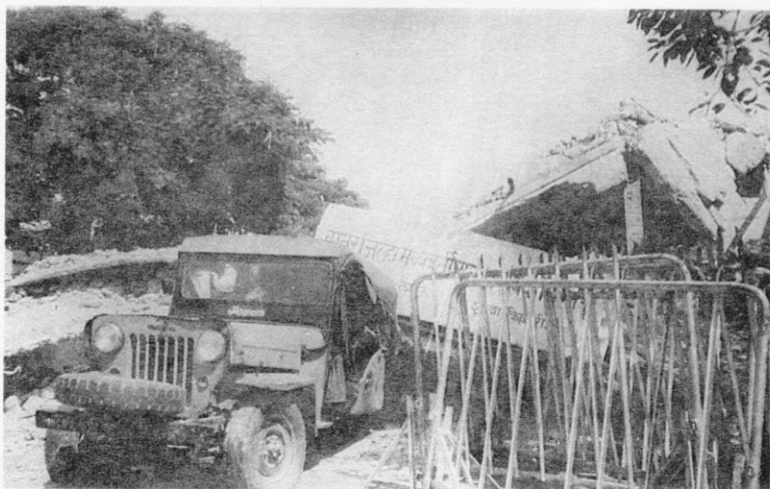
In some buildings the roof is made of an RCC slab which is supported on stone walls where the stone is laid in mud mortar. The earthquake caused failure of stone walls in such buildings, which caused the concrete slab to come down like a sheet, and this proved to be an unmitigated earthquake disaster on September 30, 1993, as shown in fig 9.

Fig 9 A jeep trapped under the collapsed RCC roof of District Cooperative Bank at Killari. The RCC roof rested on stone walls before the earthquake.

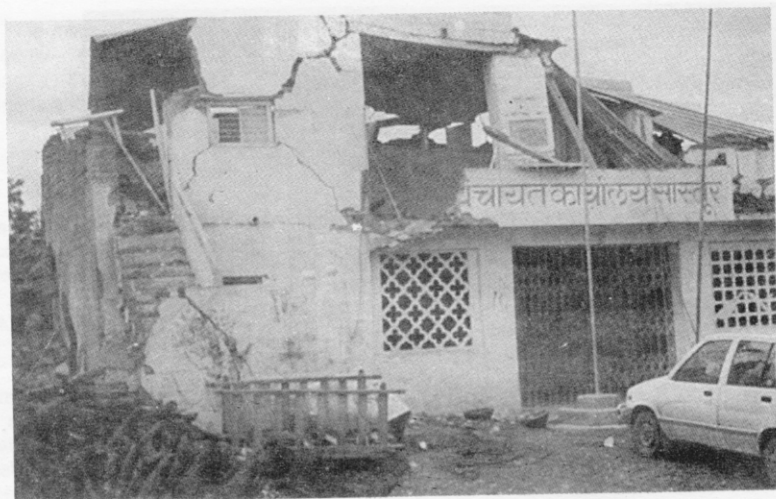
As the local soil is not conducive for manufacture of good quality bricks therefore it is not a common building material. Where bricks were used they were mostly laid in cement - sand mortar and only sometimes in mud mortar. The latter have very thick walls. The police station, the post office, the society building and the Bank of Maharashtra, all at Killari, showed horizontal, vertical and diagonal cracks in walls. Several shops made in this way at Sastur showed partial damage. Damage to the Panchayat Office at Sastur is shown in fig 10.

**Fig 10** Brick building of Panchayat office at Sastur showed extensive damage to the first floor. This was because the tin roof rested on iron rafters and did not have a roof band.

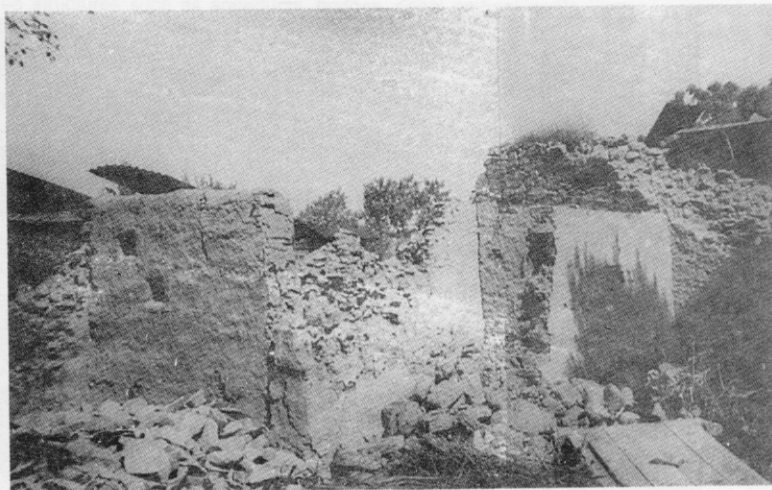
**Fig 12**      *Collapsed adobe house at Killari.*

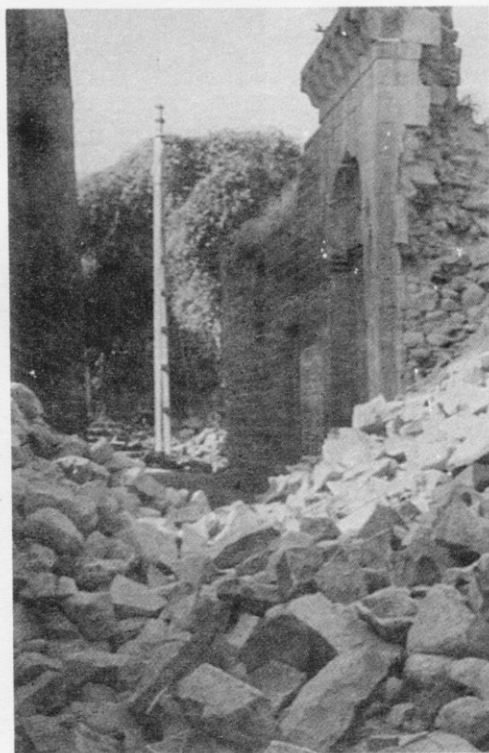
No damage was observed in metalled roads in the epicentral region. However, narrow streets within villages were choked with stones which fell from walls, fig 19, thus making rescue and relief work very difficult. Rain made the kutcha roads slushy and unmotorable.

Fig 19 Blocked street, Lamjana.

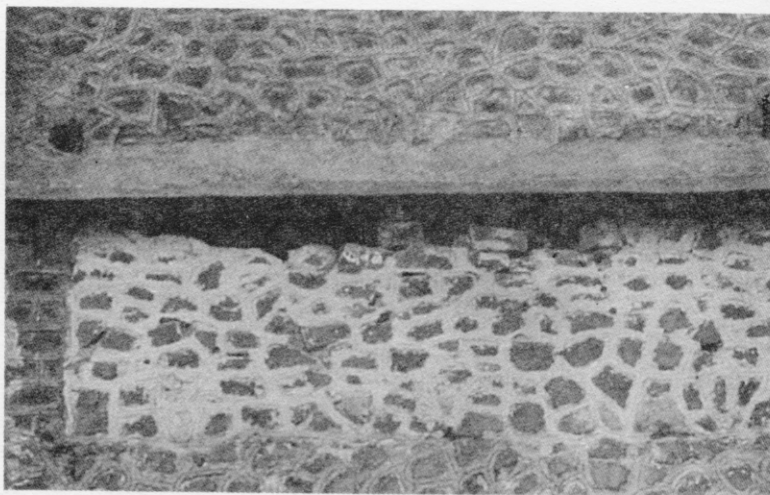
A well engineered structure, the sugar mill at Killari has very heavy machinery installed inside. Damage to this large mill was minimal, fall of plaster was observed at one place only. A portion of the infilled stone masonry fell off, fig 20. Slight damage to the huge chimney was observed at the top in the form of vertical cracks. This sugar mill served as a local centre for collection of relief material in post earthquake operations.

*Fig 20*      *Damaged stone masonry infilled panel in sugar mill at Killari.*

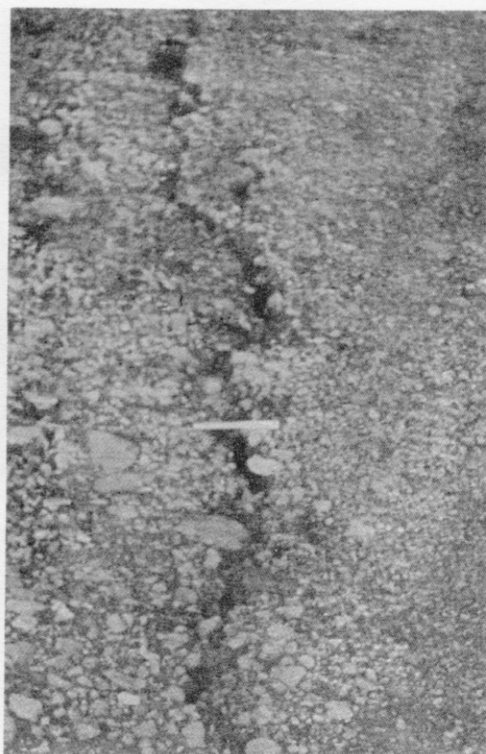
At Ganjankheda a long fissure developed in the left embankment of the canal due to slope failure of loose material, figs 21 and 22. The surface opening was more than 2 cm wide at places, the slope settled about 10 cm. A diagonal fissure in the canal covered 3/4th of the width of the right embankment, in north south direction. It was 4 - 5 cm wide and 12.5 - 25 cm deep at places. A newly constructed aqueduct showed non-structural minor cracking in the railing of the bridge at several places.

*Fig 21*      *Fissure in left embankment of canal near Ganjankheda.*

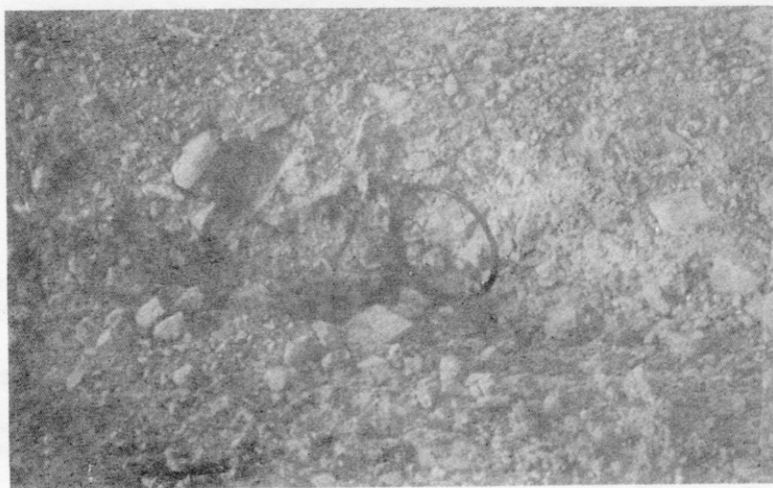
Fig 22 Slope failure of canal embankment at Ganjankheda.

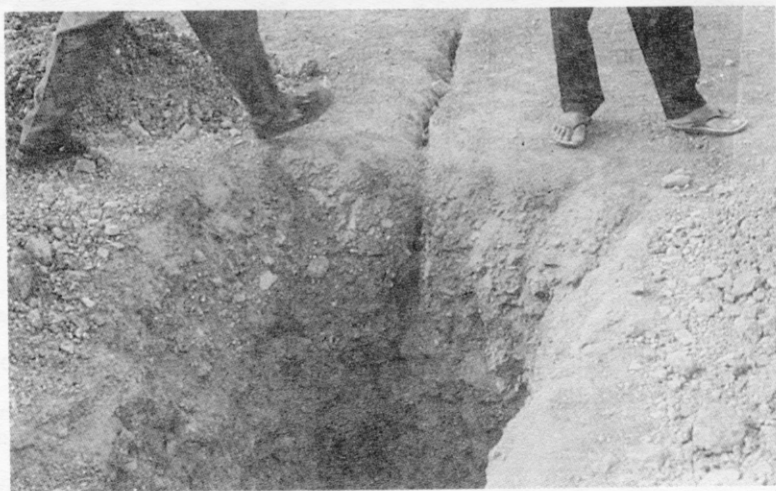
At Makni a 15.4 meter high earth dam consists of a reinforced concrete spillway in the middle and earthenbankments on both sides. A 400 m long fissure was observed in the left embankment which was one meter deep as confirmed by pit opening, fig 23. The embankment partially settled down which was clear from the side of the spillway bridge, fig 24. However, the fissure developed 130 m away from the bridge where anchoring effects of the spillway were lost. A similar failure but of lesser extent occurred on the right embankment also. This type of failure confirms dominance of vertical motion. This kind of typical damage indicates that since an earth dam dampens the vibrations therefore it offers an inherent resistance against earthquakes, the damping being proportional to the deformation. As reported by the dam engineers all gates of the dam leaked after the earthquake and healed on their own 24 hours later.

Fig 23 One meter deep fissure in left embankment of lower Terna dam, as confirmed by pit opening.

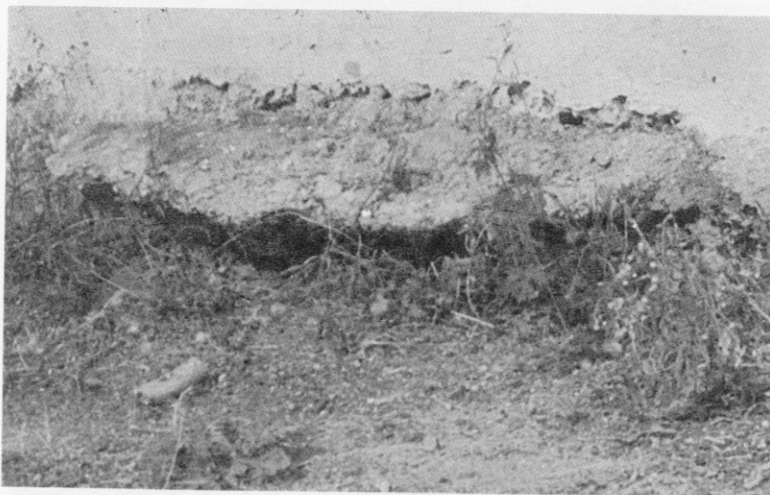
Fig 24 Settlement on left embankment in spillway bridge, Terna Dam.

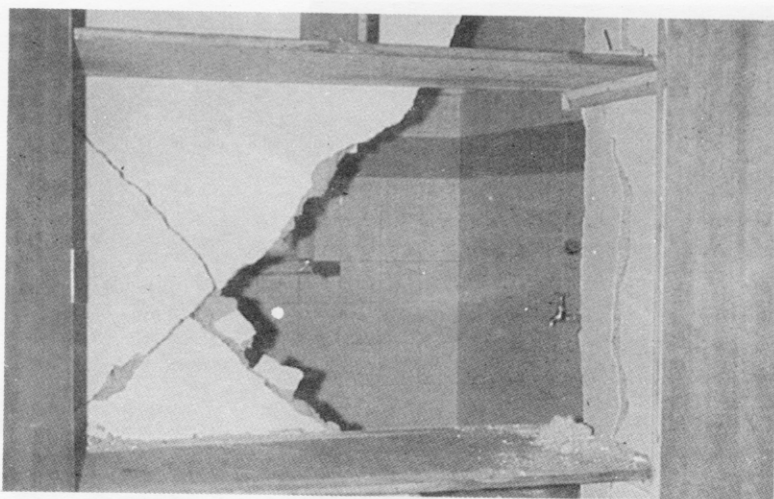
Damage to the rest house for this dam is shown in fig 25. The doors were jammed at the time of the earthquake and inmates had problems in escaping.

Fig 25 In the brick masonry building of rest house of Lower Terna Dam Project at Makni, walls cracked, plaster fell off from walls and part of a half brick thick partition wall collapsed. Fig shows a portion of the collapsed partition wall between bedroom and washroom.

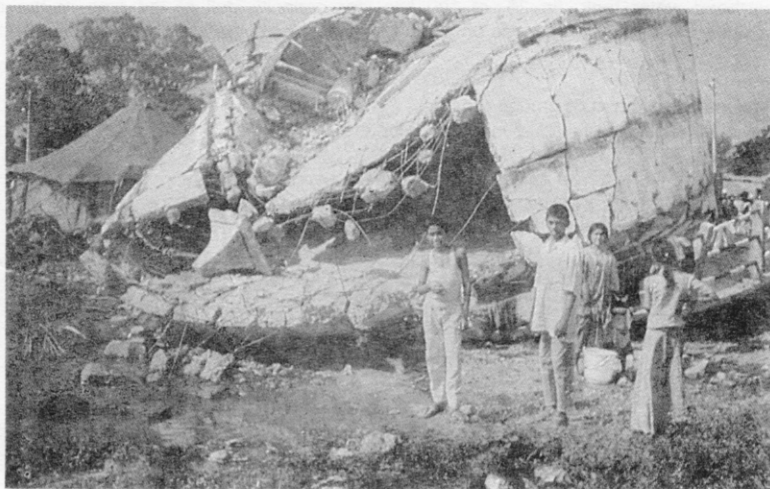
An overhead water tank, fig 26, of 100 kilo liter capacity, full at the time of the earthquake, collapsed completely. The possible reasons of failure could be a combination of one or more of the following factors

1. Torsional component of ground motion
2. The stair case tower was connected with the tank, which increased torsion in the eccentric structure, fig 27.
3. Presence of water at the time of the earthquake generated heavy inertia forces.
4. Inadequate transverse reinforcement was used near joints in columns, fig 28.
5. P - effect, i.e. vertical load vs horizontal displacement effect.

**Fig 26** Failed overhead water tank with domical base at Kawtha.

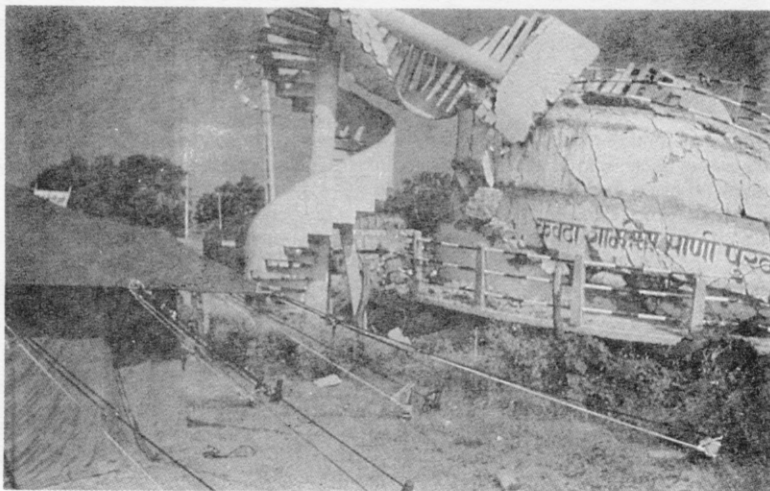
**Fig 27** Failed staircase unit of overhead water tank, Kawtha.

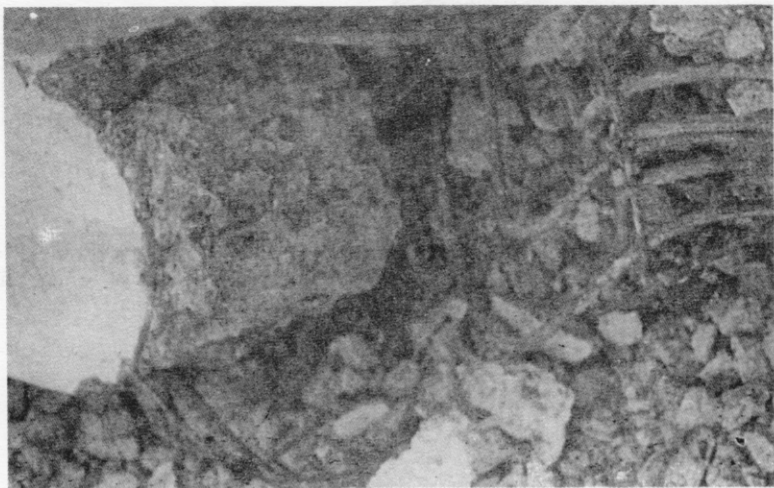
Fig 28 Broken column with inadequate transverse reinforcement, water tank at Kawtha.

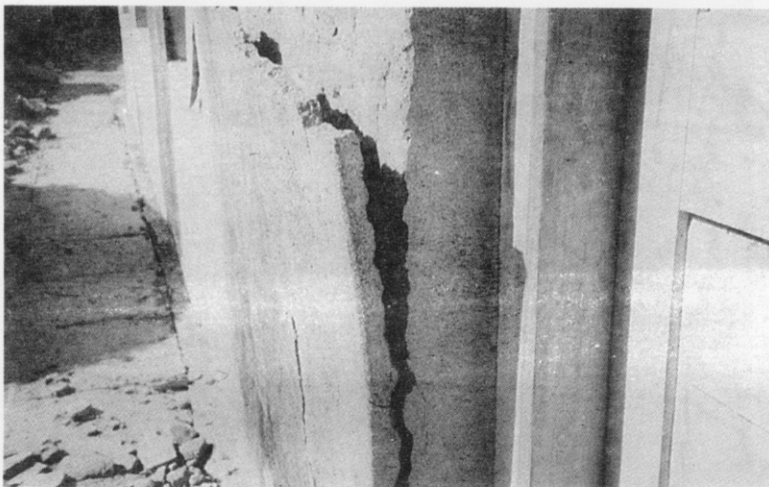
**Fig 31**      *Thick plaster bulged out at Dr. Bhujbal's clinic, Killari.*

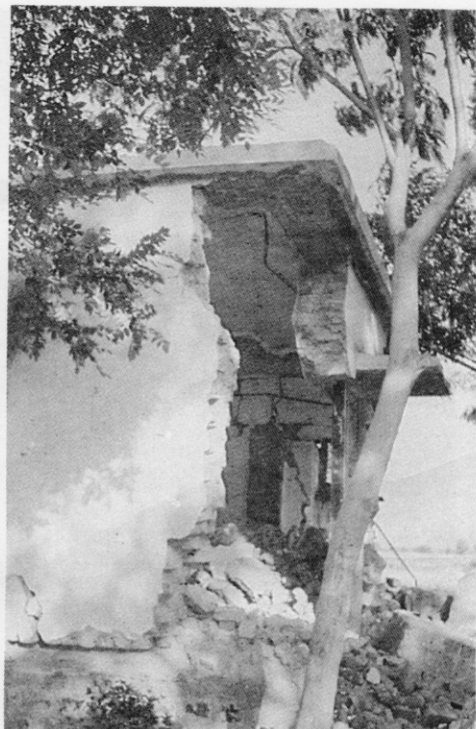
**Fig 32** Brick masonry building of leprosy centre at Mangrul developed large and deep cracks.

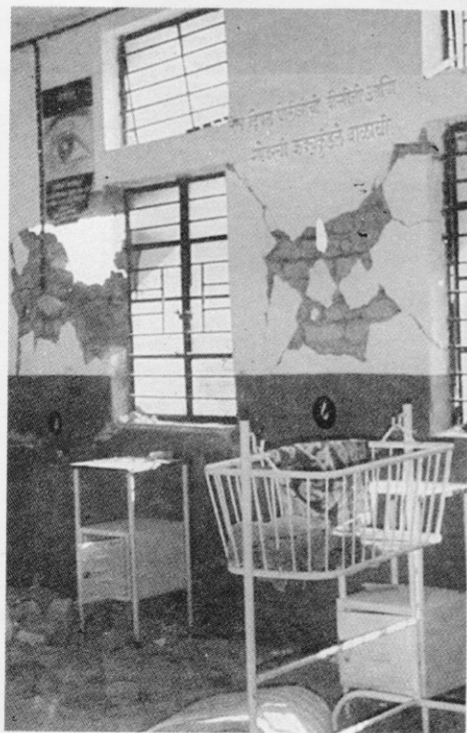
The Rural Hospital at Killari is made of brick masonry in cement - sand mortar. The earthquake caused wide, deep, diagonal and horizontal cracks in walls, fig 33, and some portions of the wall fell off. The doctors showed the authors portions of the walls where cracks had developed due to a previous tremor which occurred on October 18, 1992. These were subsequently repaired, fig 34. Extensive damage was observed to non structural elements like tiles, wash basins, electric fittings etc, fig 35. Several doors of the hospital were jammed. Seven resident patients (2 for tubectomy, 4 for gastro enteritis and one for delivery) escaped after the earthquake. Several houses on the hospital campus developed cracks and roof of the garage and boundary wall of the post mortem room collapsed. An hour after the earthquake the dead and the injured were brought into the hospital premises.

**Fig 33** Portions of wall fell off in the gynecological ward, Rural hospital, Killari.

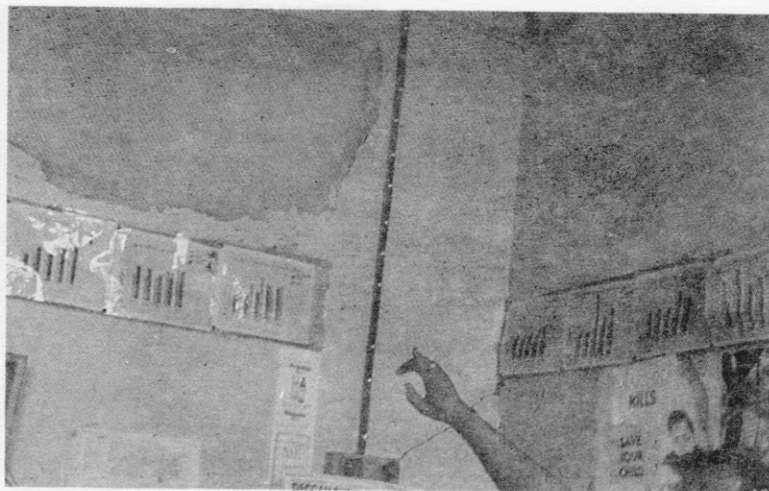
Fig 34 Doctors showing portion of a wall which developed cracks one year earlier, in the tremor of October 18, 1992. These were plastered subsequently, Rural Hospital at Killari.

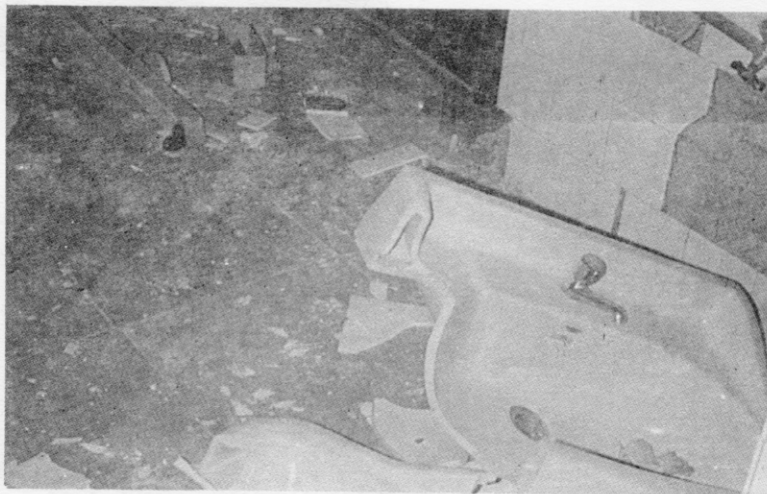
Fig 35 Dislodged electric fittings and wash basin inside the operation theatre at Rural hospital, Killari.

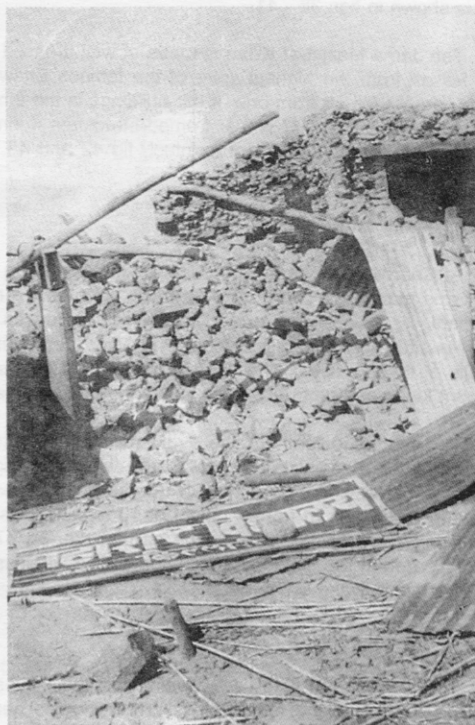
Fig 36

Schools made of random rubble stone masonry collapsed in the quake affected area, such as the Maharashtra Vidyalyaya, fig 36, and Shishu Vihar at Killari. However, since the Dayanand Vidyalyaya at Kawtha was made of dressed stone it sustained the shock. The Zila Parishad Basic School at Limbada is made of brick masonry with a tin roof inclined at a very low angle. Damage to this school was in the form of huge gaps in wall. A small building of a government school at Mangrul, made with one and a half thick brick wall with cement mortar and a tin roof showed huge diagonal cracks. The roof of one room collapsed because of outward movement of wall. Fig 37 shows the damaged school at Sastur which had a tin roof and very thick brick walls laid in poor quality mortar.

**Collapsed building  
of Maharashtra  
Vidyalaya at  
Killari.**

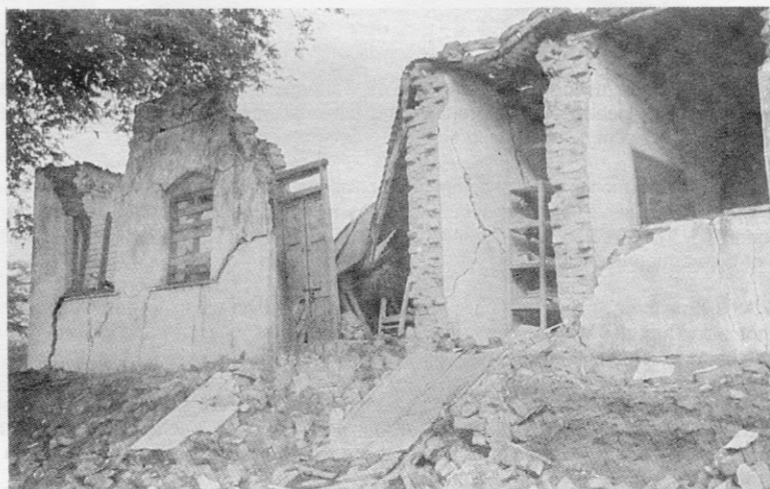
Fig 37

**Collapsed school at Sastur.**

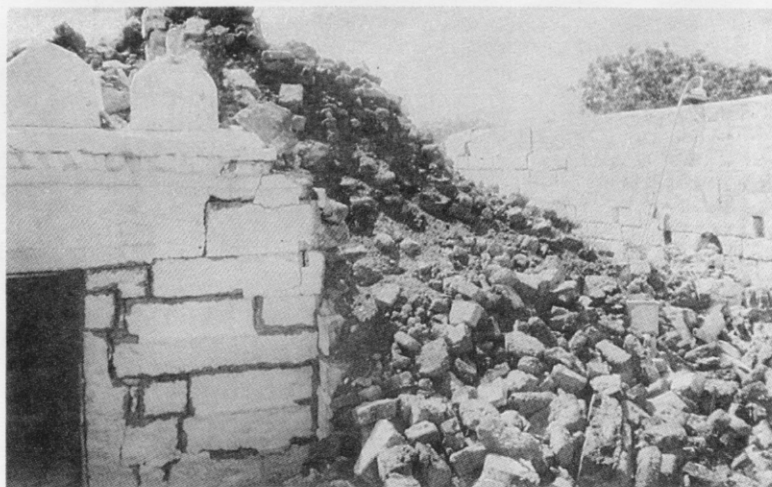
Fig 39 Collapsed dome of Neel Kantheshwar temple at Killari.

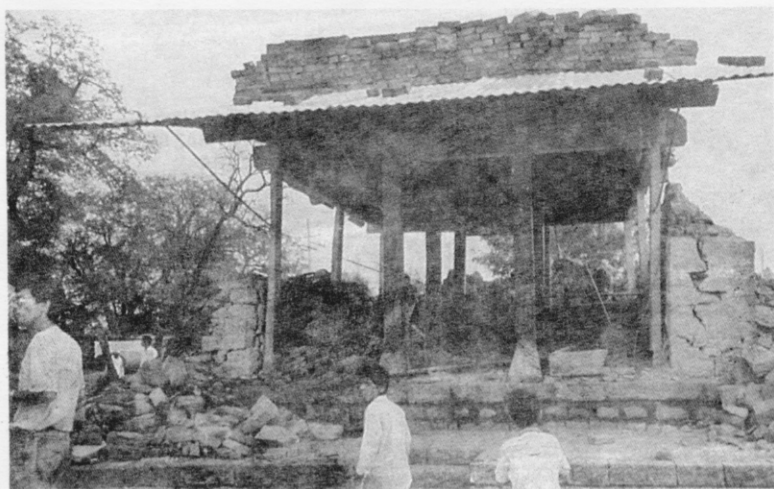
Fig 42 Ganesh temple at Sastur. Walls around the timber frame collapsed outwards while the roof is intact.

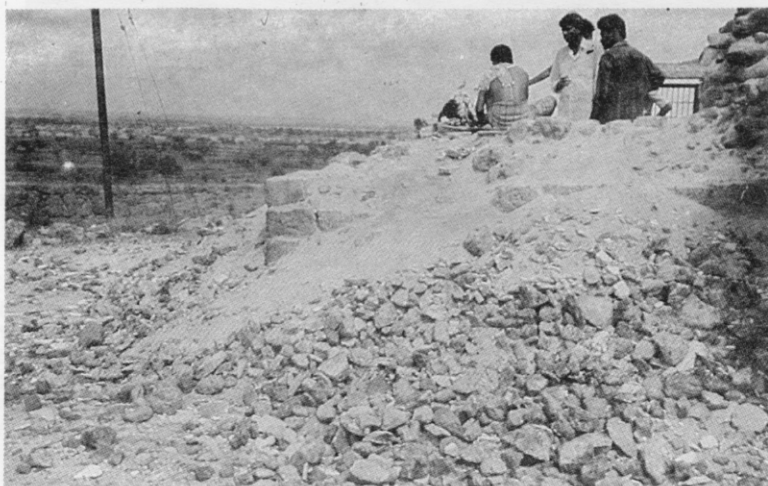
The central column of the Prakash Stambh outside the Renuka Devi temple and the sanctum sanctorum of this ancient temple collapsed completely, fig 45. A new idol has since been installed in the place of the old one. A heavy Kalash, (brass pot) almost 75 kg in weight, fig 46, fell off at a horizontal distance of about 8.25 m from a height of 10 m. The mosque and mazar complex is of a later date and 2 minarets partially collapsed due to the earthquake, fig 47. Plaster fell off the dome and vertical hair line cracks appeared in the mazar of Peer Pasha. The wireless station is a well engineered structure, fig 48 and remained intact in wake of the earthquake.

Fig 45 Completely collapsed sanctum sanctorum of Renuka Devi Temple at Kharosa.

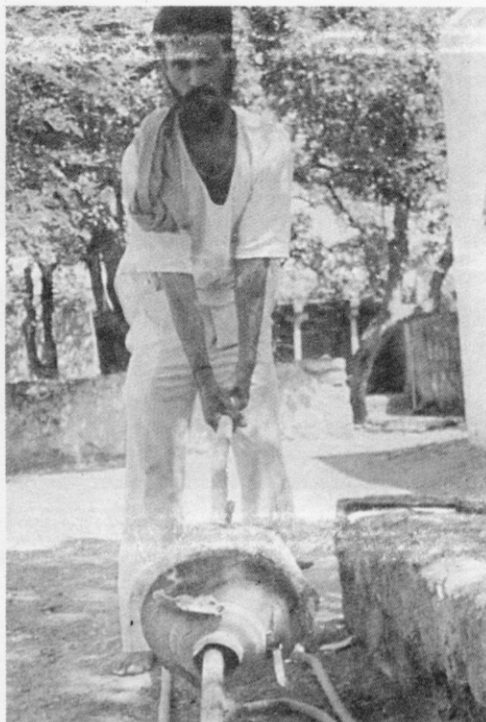
Fig 46      Heavy kalash  
which fell  
off the  
spire of  
Renuka Devi  
temple.

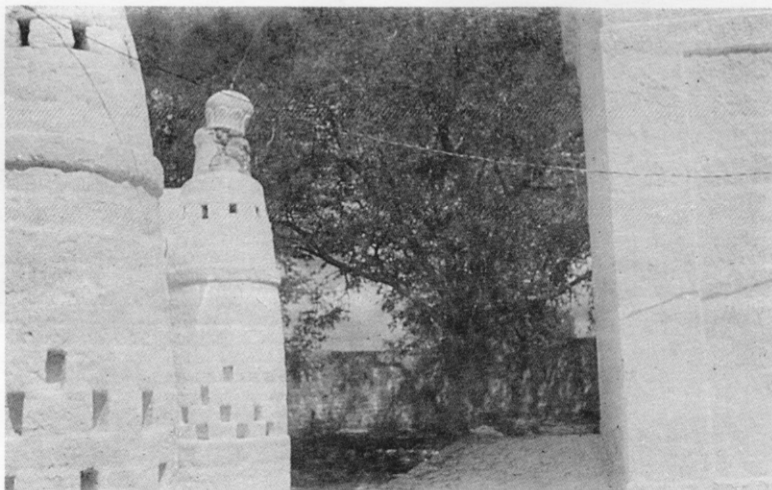
Fig 47      Damaged minaret of mosque at Kharosa.

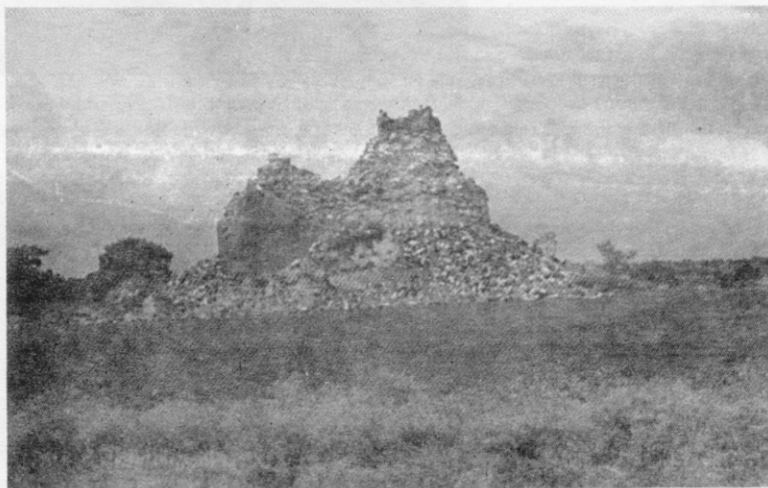
Fig 49 Collapsed Mugal dome near Sastur.

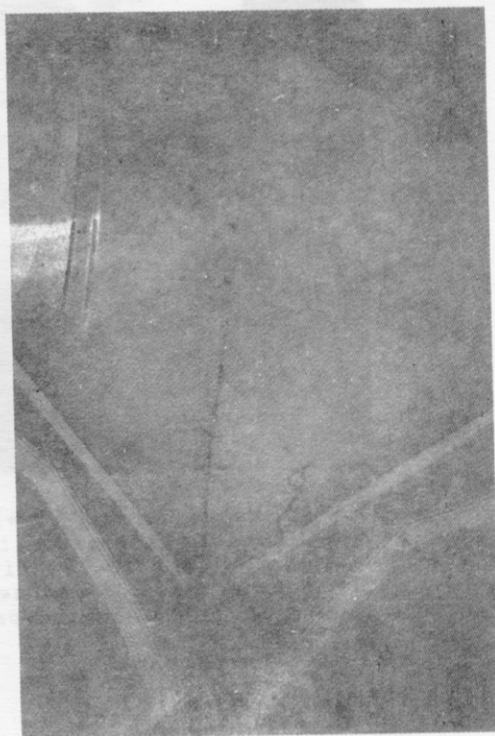
*Fig 51*      *Cracks inside the Bijapur dome.*

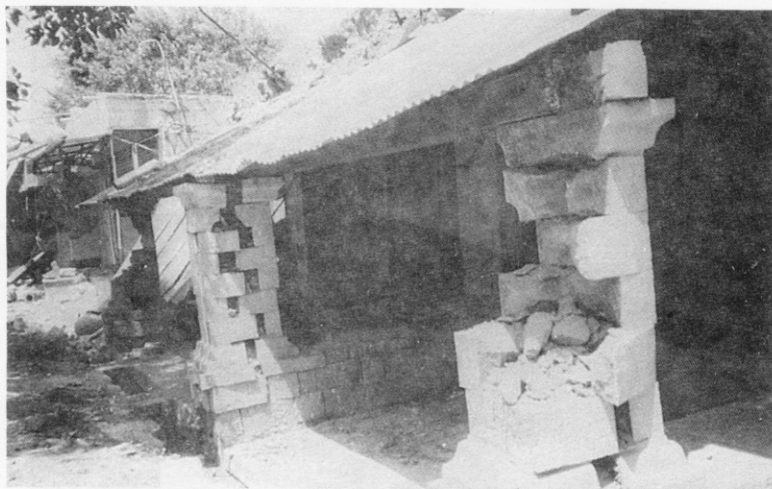
Fig 52 A shop building at Killari with damaged masonry columns. Three masonry columns support the traditional verandah roof which is properly connected with the main structure. Torsional effects are evident.

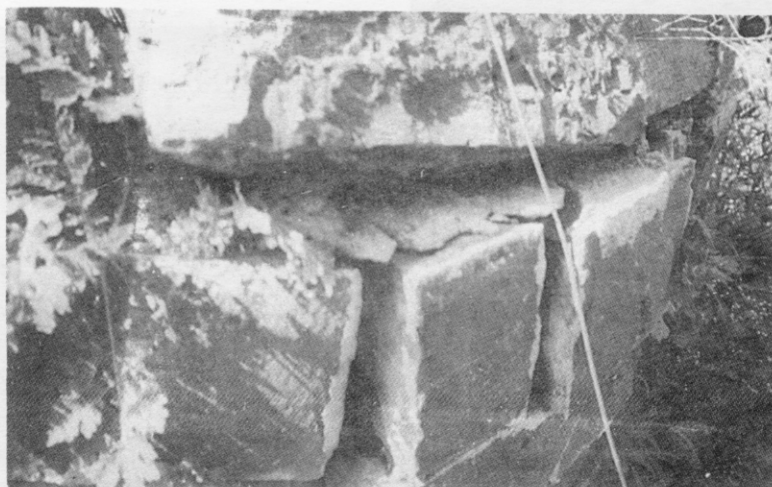
Fig 53 At Maharashtra Vidyalaya in Killari stones were displaced in pillars towards the north by about 4 - 6 cm. The circular pillar was made of 5 layers of hewn stones. One stone was displaced by a lift of 8 cm in 12 cm showing presence of vertical motion.

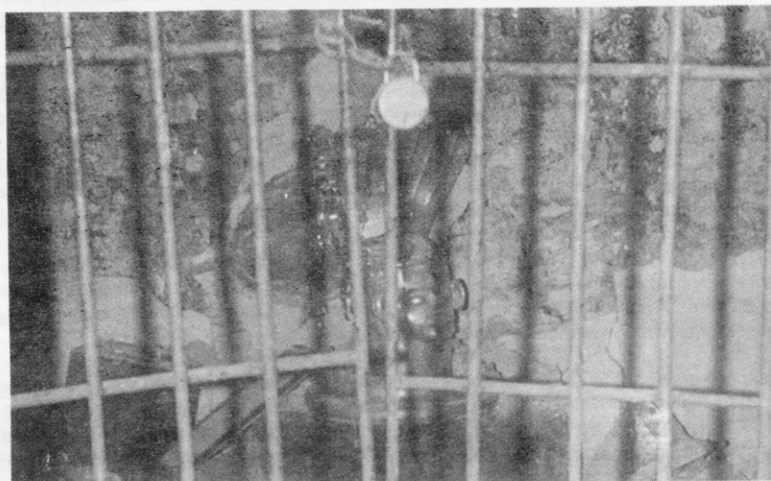
At Limbada torsional motion in north east direction is evident from the rotated statue of Lord Shiva, fig 54. This is also confirmed by deflection of four piers around the temple, the two piers in the east are tilted towards the north while those in the west are tilted towards the south. In Umarga the motion came from north west.

Fig 54 Twisted statue of Lord Shiva at Limbada.
