## REPAIR AND STRENGTHENING OF EARTHQUAKE DAMAGED HOUSES IN MAHARASHTRA

Central Building Research Institute, Roorkee (U.P.)

### ABSTRACT

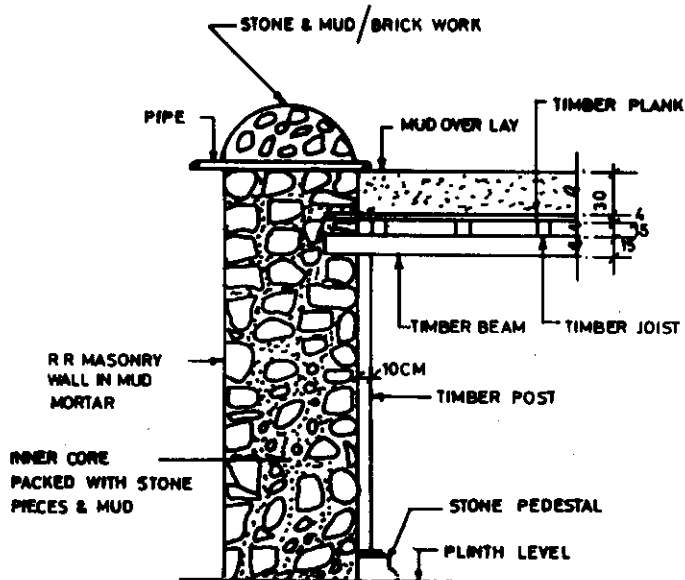
Fig.2 SECTION OF WALL AND ROOF

Some of the walls were fully load bearing while others were partially load bearing with part of the roof load carried by vertical timber members provided adjacent to the wall. Cross section of the load bearing walls used in most of the common houses is shown in Fig.2. The walls were 60 to 100cm thick made of irregular/round shaped stones in mud mortar. In a few of the houses, walls upto 160cm wide were seen. In some houses, flat flaky stones were also used for constructing walls. The walls were made of an outer and an inner wythe and the inner core was packed with small size stones and mud mortar. In some villages in Solapur District, locally available soil containing silt, sand and pebbles and lacking in clay content, had been used for mortar and filling the

inner core. Its binding property was very poor and cannot be categorised as mud mortar as it lacked in clay content. No through stones were provided to tie the inner and outer wythes of the wall together. Thus, the quality of construction of the walls was extremely poor. Many of the walls were built out of plumb.

- \* In most of the houses, the floor was about 1.35m higher than the existing ground level and the ceiling was about 2.2m above the floor level. Thus while the height of inner wythe of the wall was only 2.2m, the height of outer wythe was 3.55m. The inner wythe of wall also had a support, to a limited extent from the roof members, which were partly resting on it. As the outer wythe of walls was less stiff, it collapsed first leading subsequently to failure of inner core of wall during earthquakes. It further resulted in failure of inner wythe.

A proper construction of a monolithic wall (without separate leaves) and provision of full bearing of roof over it, could have reduced the extent of such failures.

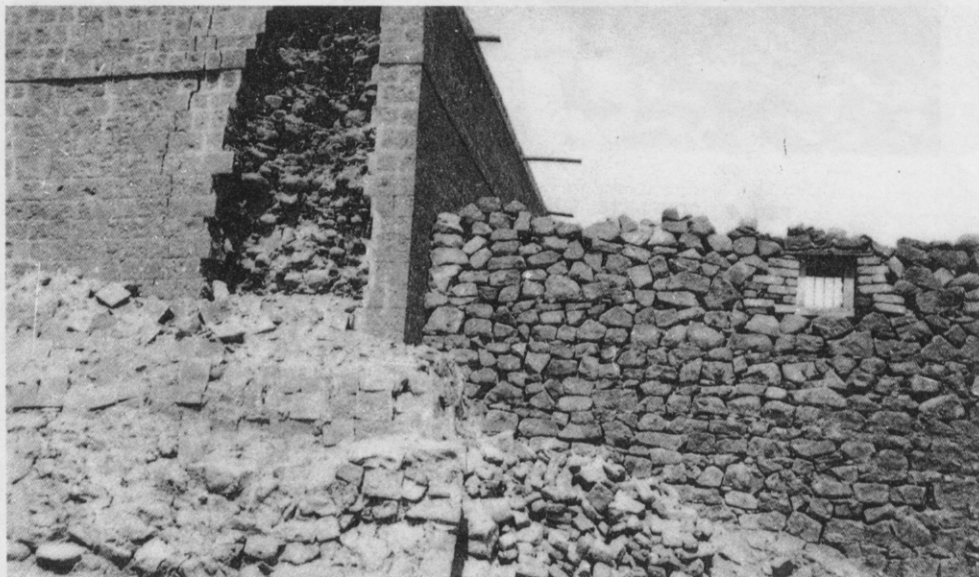
- \* The most common distress observed was vertical cracks at the junctions of walls, specially at the corners of buildings. These cracks occur on the walls at a distance equal to the thickness of the wall, from outer edge of the corner.
- \* In houses having RR masonry pillasters, projecting out of wall, cracks occurred at the junction of pillaster and wall.
- \* Inclined cracks in walls over openings were noticed in some of the damaged houses.
- \* In severely damaged houses, in addition to development of cracks at corners, there was spalling of masonry (mainly outer wythe) at top of wall.
- \* Collapse of outer wythe to the full height of wall and for a distance equal to thickness of the perpendicular wall joining at the corner (Fig.3) was also observed.

Fig.3 COLLAPSE OF OUTER WYTHE OF WALL TO FULL HEIGHT

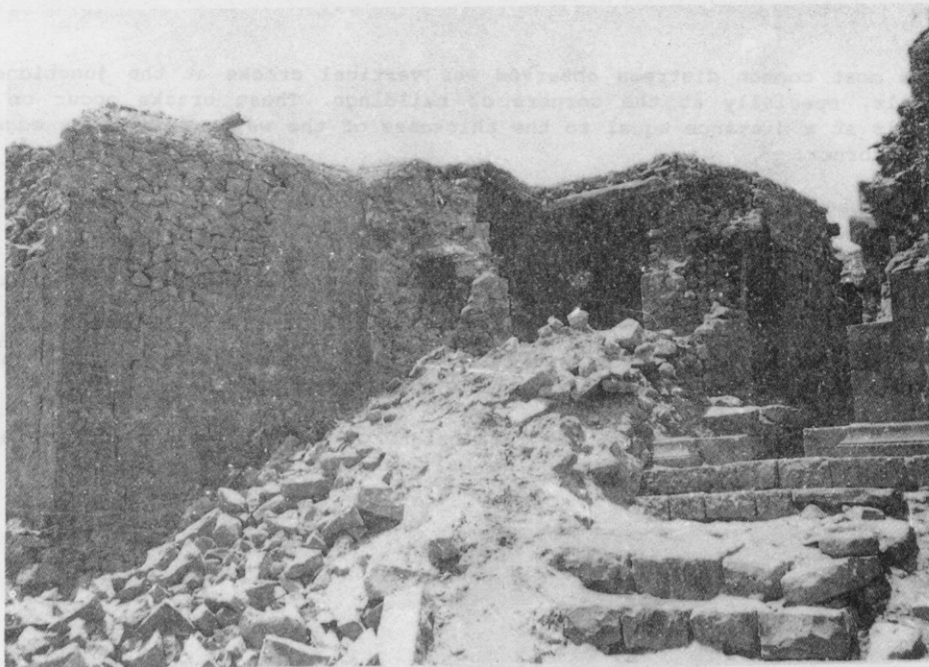
- \* Collapse of masonry in 'V' shape at corners of walls near the top was another distress commonly noticed in severely damaged houses.
- \* Further stage of damage was collapse of complete wall, which was more prevalent in the rear rooms of houses, where the roof was directly resting on walls, without the support of framework.
- \* Complete collapse of outer wythe of wall was another stage of damage (Fig.4). In most cases, walls had completely collapsed with part of roof still resting on timber framework, which had swayed in one direction or the other. (Fig.5)

Fig.4 COMPLETE COLLAPSE OF OUTER WYTHE OF WALL

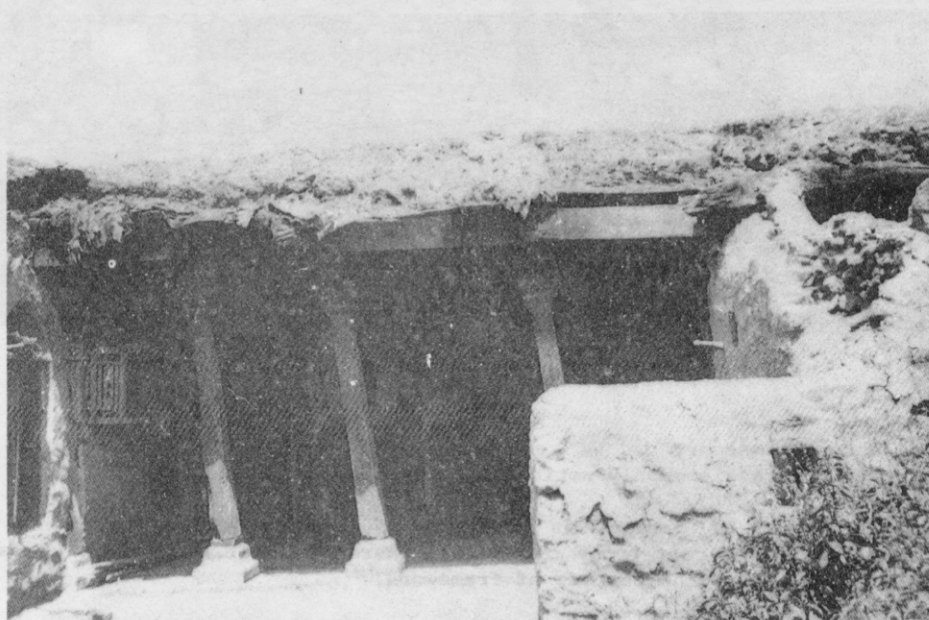
Fig.5 SWAY OF TIMBER FRAME WORK

- \* In case of timber framework, the posts were resting freely on stone pedestals and beams at top were resting on the posts directly or through corbels, without much of fixity. These pin jointed connections resulted in sway of the frames during tremors in most cases and in collapse of frames and roofs in some cases.

To avoid sway of frames and their collapse, fixity should be provided to the joints between members of frames. Knee bracing at top of frame is one such measure.
