## **SEISMIC RESPONSE OF A TWICE-RETROFITTED BUILDING**

David Murià-Vila, Gerardo Rodríguez, Arabella Zapata and Ana María Toro

### **ABSTRACT**

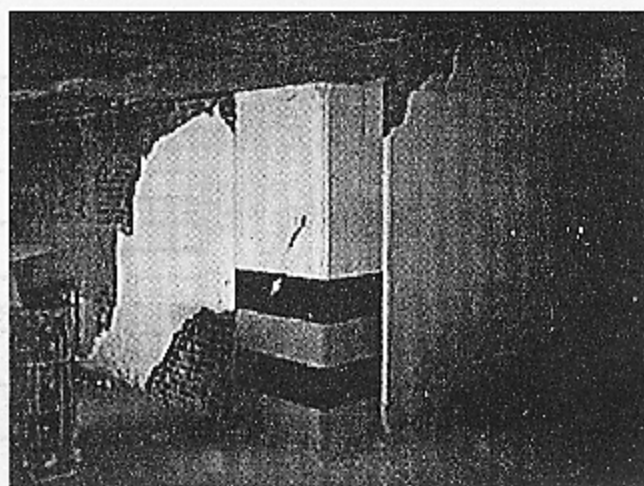
The June 15 and September 30, 1999 earthquakes, events 99-1 and 99-3 respectively, produced diverse damages in the building. On several stories, detachment of finished plaster and ceilings was observed and some suspended ceiling elements fell down. Some parapets in contact with the columns at the last garage storey showed some damage, except those with a flexible material joint. All the masonry walls were damaged (Figures 5 and 6).

Fig. 5 Reopening of cracking at basement column 2D, parking view

At the concrete shear walls around the elevator shaft and in several columns of the main structure (B4, C4, D4, D2, F1, F2, F3, F4) and of the three-level small adjoining structure (F1, F2, F3, F4), some cracks previously filled with cement were opened (Figures 5 and 6). In addition, new cracking bordering old cracking injected with epoxy resin in the previous rehabilitation was detected. Their widths were less than 1 mm.

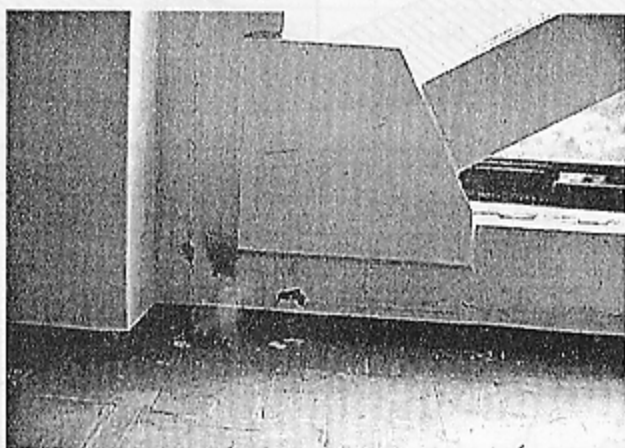
Some cracking at the perimeter of the concrete-steel and concrete-concrete interfaces between the old and new elements was detected (Figure 7). In addition, at the parking stories, light cracking, perpendicular or inclined with respect to the metallic elements, was perceived. Effects of the 99-3 event increased the number of cracks, and their widths were less than 0.2 mm.

Fig. 7 Perimeter cracking at concrete-steel and concrete-concrete interfaces between new and old structural elements

After the second rehabilitation, the deterioration in the interfaces between the new and old structural elements of the transversal façades caused a considerable observed reduction of lateral stiffness. This source of non-linear behaviour and those mentioned before contributed to the appreciable decrease of the vibration frequencies.
