## RESPONSE OF STRUCTURES IN BROACH EARTHQUAKE †

B.S. Bulsari\* and M.C. Thakkar\*

† Presented at the Fourth Symposium on Earthquake Engineering, Koorkee, November 1970.

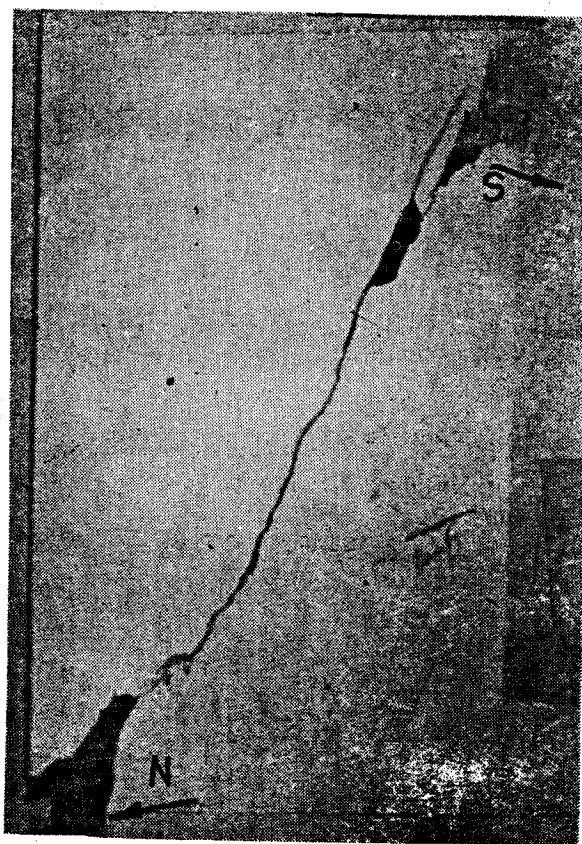
The major component of earthquake acceleration is N-S. This is very clear from the diagonal cracks on N-S walls. These cracks on larger panels are running from top at north to bottom at south, indicating the seismic force from north to south (Fig. 3). This direction is also very clear from fallouts of E-W walls. The photograph (Fig. 4) shows the shift of bench seat to south from the seat rests. Cracks produced by the earthquake at the surface of the ground at Kasia and Borbhata are approximately E-W, clearly indicating the N-S direction of seismic force (Fig. 5)

Figure 3. Diagonal Cracks bearing wall at Broach

This building is a two storeyed structure with one and half brick bearing wall in cement mortar construction on fairly level ground. Ground floor walls have cracked very heavily with the cracking pattern of Jayendrapuri Arts and Science College building. Photograph (Fig. 3) shows one of the typical cracks in this building. Western side (one and a half) brick wall of the big prayer hall, of length 12 to 15 metres and height of about 8 metres, had cracked very badly. It has partially survived because of its N-S direction. Had it been E-W, the failure would have caused a major disaster.

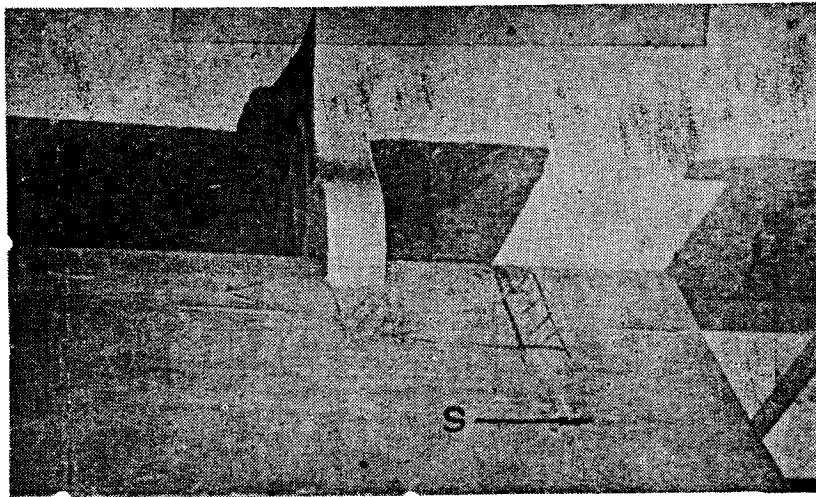
Figure 4. Shift of concrete bench seat at Broach.

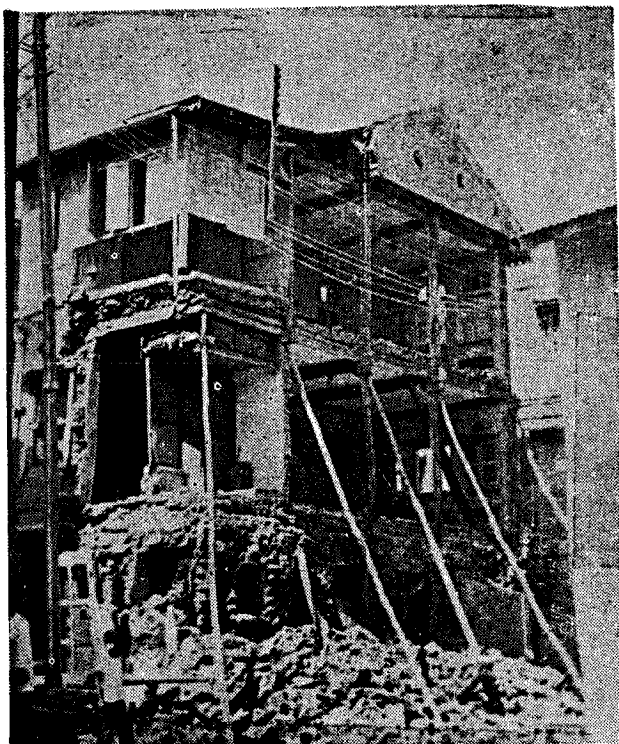
Figure 6. Failure of filler walls due to improper connections at Worwad, Broach.

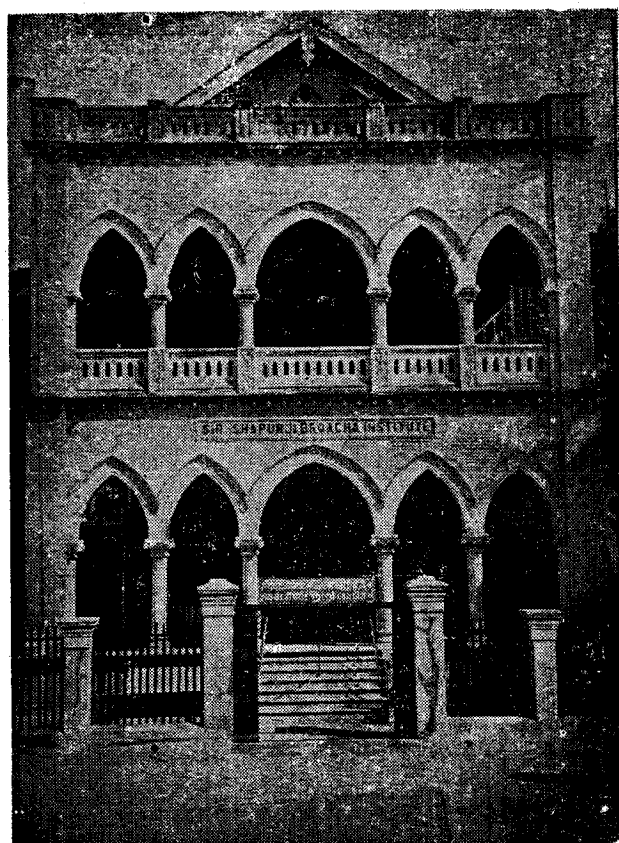
Figure 7. Bharucha Town Hall, Broach. Southern view before earthquake.

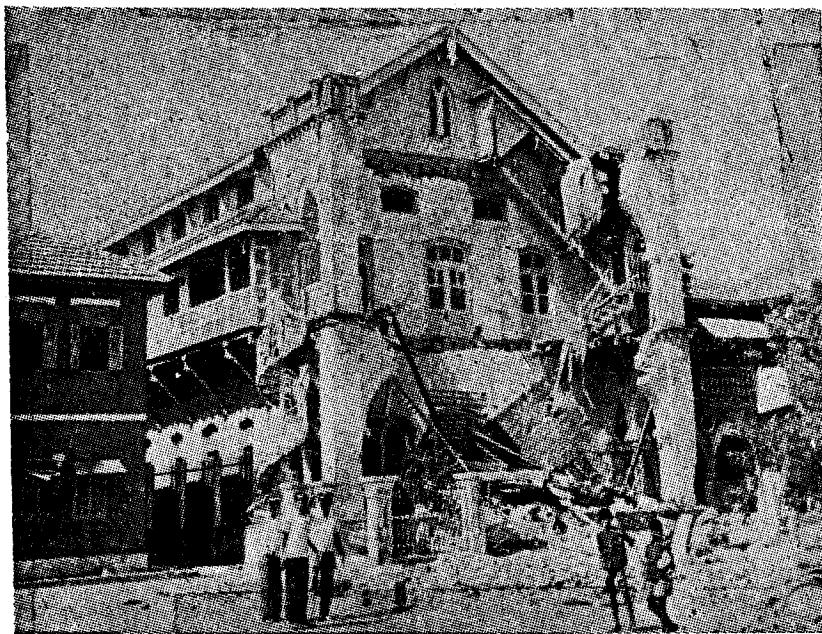
This structure located near Victoria Memorial Clock Tower, was built some 50 years ago, with load bearing masonry walls and brick arches over openings, with a pitched roof on steel trusses. The ground floor houses one of the oldest and best libraries of Gujarat and the first floor is utilized as a town hall. The southern side of the building had stone pillars and brick arches over which the floor was resting. This side is almost destroyed. The photographs Fig. 7 and 8 show that part before and after the earthquake. This collapse was primarily due to high arches, with stone pillars as supporting structural elements. The floor was transferring its loads on this system by N-S timber runners. These timber runners, as can be seen from the photograph (Fig. 8) were supporting only for gravity loads and were anchored poorly even for a small amount of horizontal pull. Moreover, the rotation was allowed to arches and pillars by spherical stone hinges at the capitals and pedestals. This, with no constraints on the sides had allowed for more deformations which caused the collapse.

Figure 8. Bharucha Town Hall, Broach, southern view after earthquake.

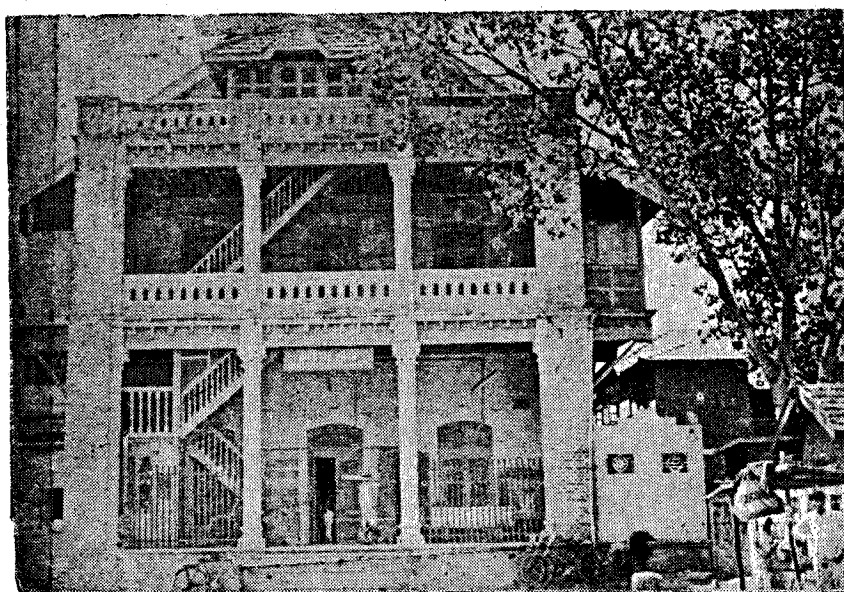
The northern side of the structure is absolutely different from the southern side (Fig. 9). Light construction by timber beams spanning over stone pillars is the root cause of its survival, as compared with heavy arches on stone pillars on the southern side.

Figure 9. Bharucha Town Hall, Broach, northern view after earthquake.

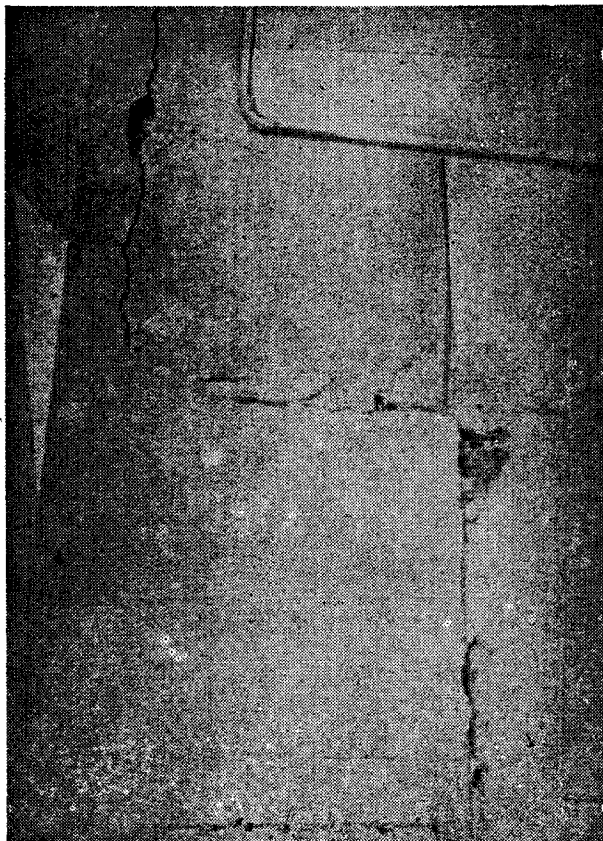
This is one of the very few RCC framed structures in the town. This is located near the railway station. Infilled walls are one-brick walls in cement mortar 1 : 6. Part of the structure is exploited for a mezzanine floor. RCC columns are finished with excessively thick terrazo. The photograph Fig. 10 shows the typical crack at the junction of the beam and the column. This crack is horizontal initially at the soffit of the mezzanine beam and it extends thereafter vertically in the column. Horizontal part of the crack seems to be due to the lack of proper construction joint between the column and the mezzanine beam soffit. Vertical part of the crack is due to excessive terrazo finish to cover up the plumb discrepancies.

Figure 10. State Transport Bus Stand.  
Broach - Cracking at mezzanine  
level in Beam-Column joints,

When Broach was revisited after a month, to inspect the progressive cracking in any of the structures, the diagonal cracks at quarter span in the terrace level beams were observed in this structure.

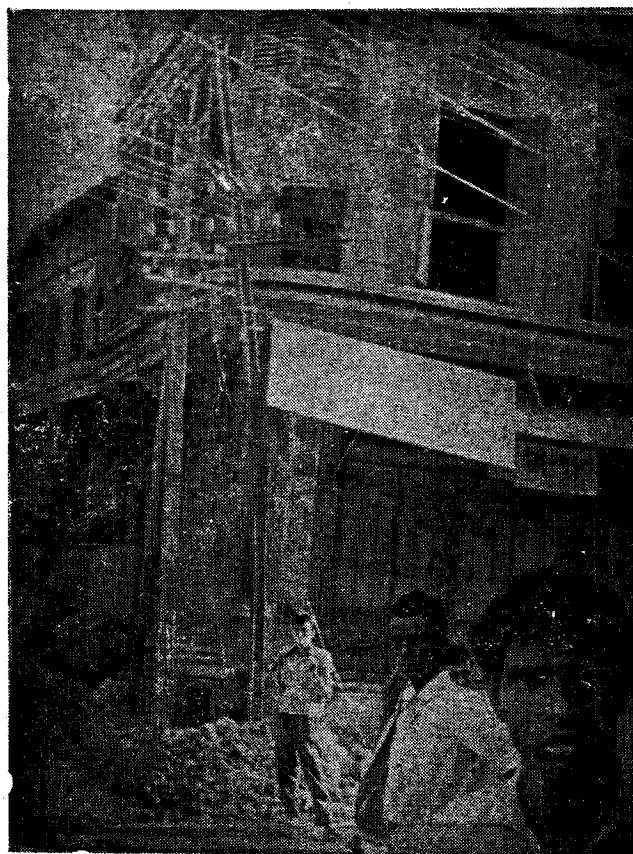
Figure 11. Bending of steel rail used as pole.

The failures of various minarets show similar pattern. All without any exception have toppled down as they are top heavy structures supported on slender brick pillars. Their failure have subsequently contributed to the secondary failure of nearby structures like old steel water tanks on timber standards. New RCC water tower have suffered no damage due to their ductile supporting structures. Brick chimneys with steel stiffeners and steel chimneys have stood very well. Railway bridge over river Narmada spans approximately N-S. Bolts of two rocker bearings on pier no. 2 and of one rocker bearing on pier no. 3 were sheared off in N-S direction. Bolts of many other rocker bearings were loosened. There was no other damage to the bridge. Road bridge over river Narmada has suffered no damage. Transmission line poles were damaged to certain extent. In village Manubar many prestressed concrete type poles were fractured above the level of first window from ground due to fall of debris on electric wires. Near Hajikhana Masjid, in Broach, one steel rail used as a pole, was bent up excessively (Fig. 11).
