DAMAGE TO RESIDENTIAL AREAS CAUSED BY LIQUEFACTION-INDUCED LATERAL FLOW DURING THE 2024 NOTO PENINSULA EARTHQUAKE AND SELECTION OF APPROPRIATE COUNTERMEASURES

S. Yasuda*

ABSTRACT

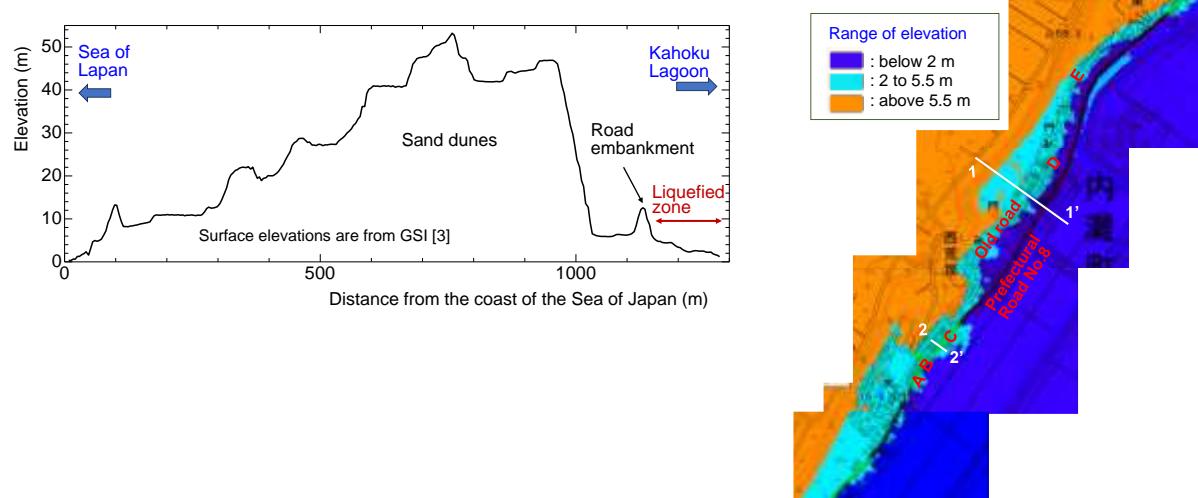
Fig. 6 Cross section across the sand dunes in the Nishi-Araya district Fig. 7 Topographical map from the Nishi-Araya district to the Muro district

The section of the area shown in Figure 2 that suffered the most damage was the northern half between Ohsaki in Kahoku City and Miyasaka in Uchinada Town. The Nishi-Araya district is located in the center of this section, and a cross section of the sand dunes passing through this district is shown in Figure 6.

Liquefaction and lateral flow occurred in the zone indicated as the liquefied zone in the Figure. Figure 7 shows a topographical map from the Nishi-Araya district to the Muro district. This area is divided into three, designated by colors: below 2 m above sea level, above 5.5 m above sea level, and in between. The old road is at an altitude of about 2 m, which is thought to have been the border between the sand dunes and Kahoku Lagoon. As will be described later, in this area, liquefaction and associated large ground flow occurred over an area roughly between EL. +2 m and +5.5 m.

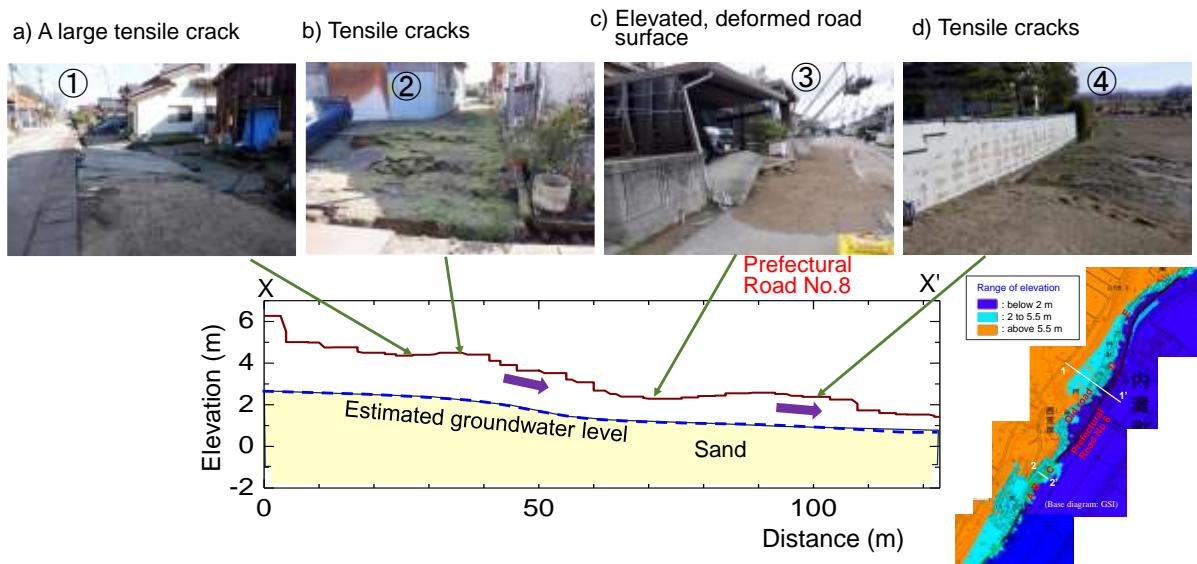
Fig. 8 Cross section along the 2-2' survey line and photos of damage along this cross section

A cross section along the 2-2' survey line is shown in Figure 8 with photographs of damage taken at four locations within the cross section. Since there is no previous boring data from this district, the groundwater level is estimated based on Figure 5. The horizontal distance along this line is approximately 120 m, the elevation difference is approximately 3.5 m, and the average gradient is only 1.7° , making the ground very slightly inclined. Photo a) was taken on the road one block west of Prefectural Road No. 8. A large tensile crack was observed between residential areas, suggesting that the flow began in this vicinity. Photo b) shows the alley between that road and Prefectural Road No. 8, where several cracks had appeared, indicating that the ground had been pulled toward the prefectural road. Photo c) shows the damage to Prefectural Road No. 8. The road surface was significantly raised and tilted, and the floor of the garage in the photo had risen, making it impossible to get the car out. In the downstream Photo d), cracks were also seen in the ground and wall.

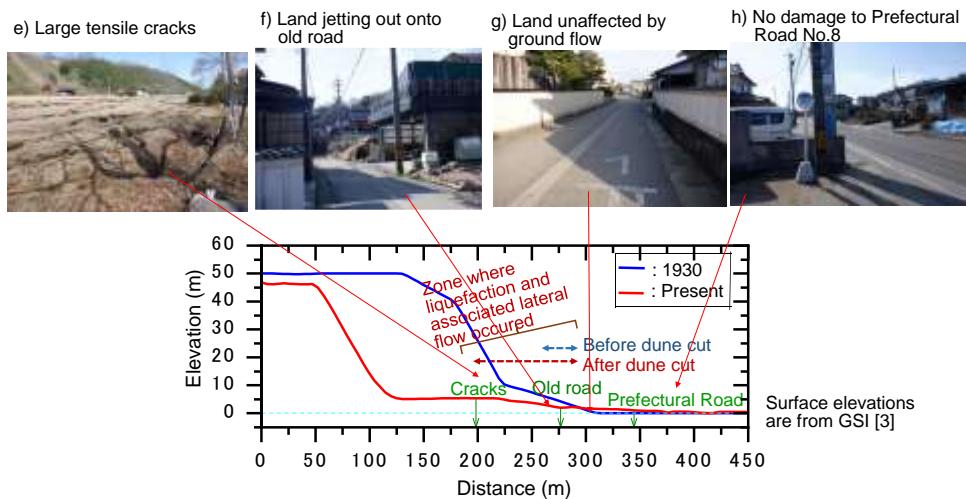
Fig. 9 Cross section along the 1-1' survey line and photos of damage along this cross section

Figure 9 shows a cross section along the 1-1' survey line, located 600 m northeast of the 2-2' survey line. As can be seen in photo e), there were several large tensile cracks, indicating that lateral flow had occurred from these points. The ground had flowed up to the area between the old road and Prefectural Road No. 8, and some residential land along the old road was jutting out onto the road, as shown in photo f). The elevation where the tensile cracks appeared and the flow began was approximately EL. +5.5 m, and the flow stopped at an elevation of approximately EL. +2 m. Liquefaction and flow occurred in a similar elevation range in Uchinada Town. Based on the relationship shown in Figure 5, the groundwater level at an altitude of EL. +5.5 m is estimated to be about 3 m deep. According to Ishihara's diagram showing the relationship between the depth of groundwater table and damage caused by liquefaction, if the groundwater table is deeper than 3m, no damage will occur to the ground surface even if the layers below that depth liquefy (Ishihara, 1985). It is unclear whether the same approach can be applied to the occurrence of lateral ground flow, but the authors would like to investigate this further using analysis.

The slope in Photo e) is the slope of a sand dune, but this slope was cut artificially. In the Uchinada Lagoon, reclamation work along the coast was carried out between 1961 and 1964. The sand used for fill was mainly from the sand dune cliffs behind each residential zone. Additionally, sand from the sand dunes in the Osaki district was used for the western polder dike and housing lots inside the polder. Since the ground surface elevation was significantly lower in the areas where these sand dunes were cut, it is estimated that the groundwater table was relatively shallow at the time of the Noto Peninsula Earthquake.

Figure 9 also shows the shape of the ground surface in 1930, before the sand dunes were cut. Assuming that liquefaction and associated lateral flow occurred in the zone with elevation of EL. +2 to EL. +5.5 m, it is estimated that if the sand dunes had not been cut, this area would have been too narrow for large flow to occur.

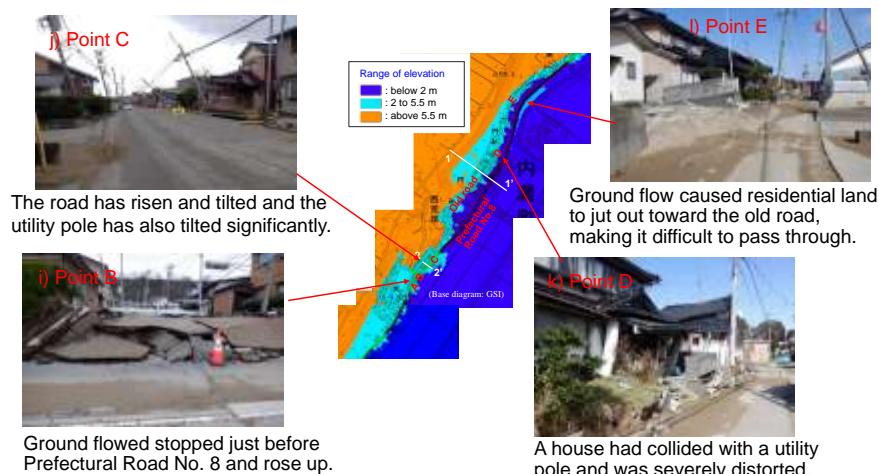
Fig. 10 Photographs of damages in other parts of the Nishi-Araya and Muro areas

Figure 10 shows photographs of damage in other parts of the Nishi-Araya and Muro districts. Point B, shown in Photo i), is about 60 m southwest of the site shown in Figure 8, where the ground that had flowed out stopped just before Prefectural Road No. 8 and rose up, blocking traffic. Point C, shown in Photo j), is 50 m northeast of the 2-2' line, facing south. The road has risen and tilted significantly due to flow from the sand dune on the right, and the utility pole has also tilted significantly. Furthermore, as shown in Photo k) at Point D, a house had collided with a utility pole and was severely distorted. At Point E, lateral flow caused residential land to jut out toward the old road, making it difficult to pass through, as shown in Photo l).

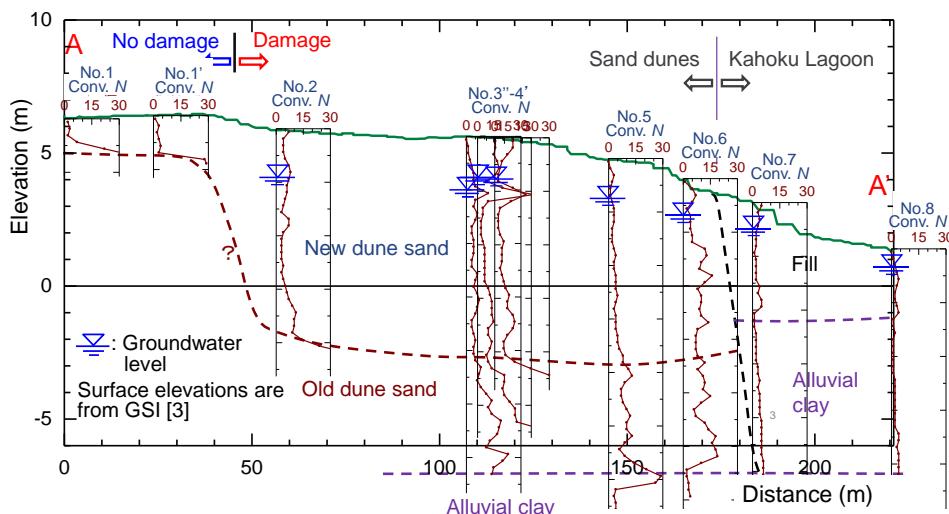
Fig. 13 Cross section estimated by SWS

The results are shown in Figure 13. The authors also conducted microtremor array observations and plan to use these to determine the soil layer boundaries in the future. For the time being, the soil layer boundaries estimated from the SWS data alone are shown in Figure 13. This reveals the following:

- 1) At undamaged No. 1, there is a dense alluvium sand layer at a depth of 1 to 2 m.
- 2) From No. 2 to No. 6, where liquefaction and flow occurred, a very loose dune sand layer with a converted N -value of around 5 is deposited.
- 3) Downstream from No. 2, the groundwater level was very shallow at about 1 to 2 m, and became shallower the further downstream.

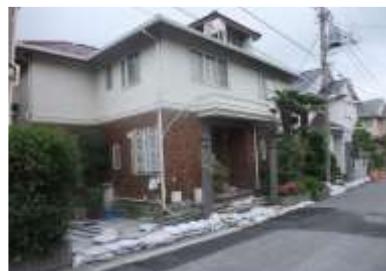
Fig. 14 Settled and tilted houses in Urayasu City

On flat land with a liquefied layer of uniform thickness, uniform subsidence occurred due to the change in volume of the liquefied layer and houses penetrated into the ground at some inclination due to the loss of bearing capacity or due to a decrease in the shear modulus of the liquefied layer, as shown in Figures 14 and 15. Two months after the Tohoku Earthquake, the Japanese Cabinet announced a new standard for the evaluation of damage to houses based on two factors, settlement and inclination. Houses tilted at angles of more than 50/1,000, of 50/1,000 to 16.7/1,000, and of 16.7/1,000 to 10/1,000 were judged to be totally collapsed, large-scale half collapsed and half collapsed houses, respectively, under the new standard, because in the steeply tilted houses, inhabitants felt giddy and nausea and could not live in their houses after the earthquake, though the walls, pillars and windows of the houses had no damage.

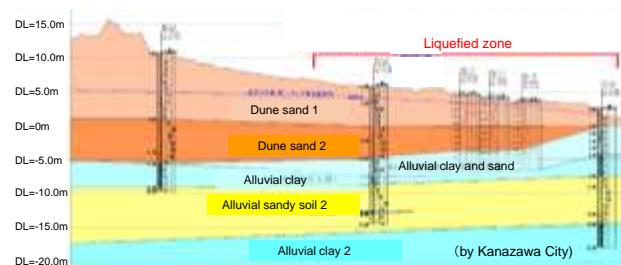
Fig. 31 Soil cross-section estimated based on the results of soil investigations [KCDATRC, 2024]

Figure 30 shows liquefied zone and locations of soil investigations conducted approximately eight months after the earthquake in the Awagasaki district of Kanazawa City [KCDATRC, 2024]. Figure 31 shows the soil cross-section estimated based on the results of these soil investigations. As shown in this cross section, a layer of loose dune sand is deposited on the surface. Plans are underway to conducting 3D analysis of groundwater flow and to determine the layout of an effective network of underground drainage pipes for lowering the groundwater level as schematically shown in Figure 32.

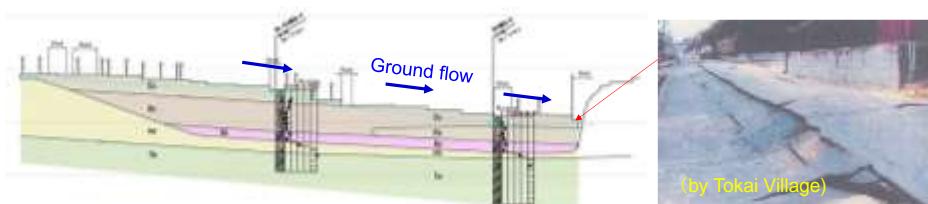
Fig. 33 Soil cross-section and upward thrust of a road surface caused by liquefaction-induced ground flow in Tokai Village during the Tohoku Earthquake

- (3) It is necessary to verify that lowering the groundwater level also reduces the amount of horizontal displacement due to ground flow. However, there has only been one case in which the amount of reduction was examined through analysis. The analysis was carried out during the restoration work after the gently sloping ground in Tokai Village liquefied during the Tohoku earthquake, causing the ground to flow as shown in Figure 33. The analysis was carried out using the simple residual deformation analysis code ALID Yasuda et al. (2017), and it was found that, as shown in Figure 34, if the groundwater level remained unchanged, a maximum displacement of 28 cm would occur, whereas if the groundwater level was lowered to GL-2m or GL-3m this would decrease to 12 cm or to 8 cm, respectively. Then, as shown in Figure 35, underground drainage pipes were installed to lower the water level to about GL -3m.
