THE GREAT HANSHIN MARTHQUAKE OF JANUARY 17,1995

G.R.Reddy, H.S.Kushwaha, S.C.Mahajan Reactor Engineering Division Bhabha Atomic Research Center Bombay-400085, India

Kohei Suzuki Professor, Department of Mechanical Engineering Tokyo Metropolitan University Tokyo 192-03, Japan

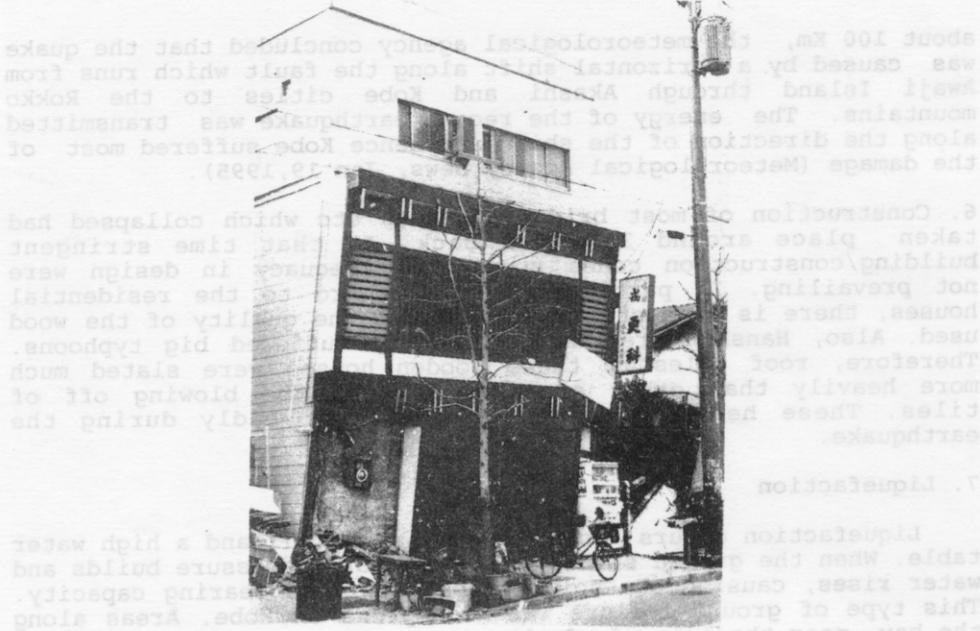
feetoog add. to Fig.3 Typical worden house failure and an aftor

(i) In Kobe a large number of buildings were structures with first floor used for commercial operations ranging from retail or restaurants to light industrial use and upper floors used for living space. However this construction creates a soft first storey (Hresh Shah, Jan 29, 1995). The residential building shown in Fig.3, though not completely collapsed has been severely damaged. This building may have failed because of weak first floor.

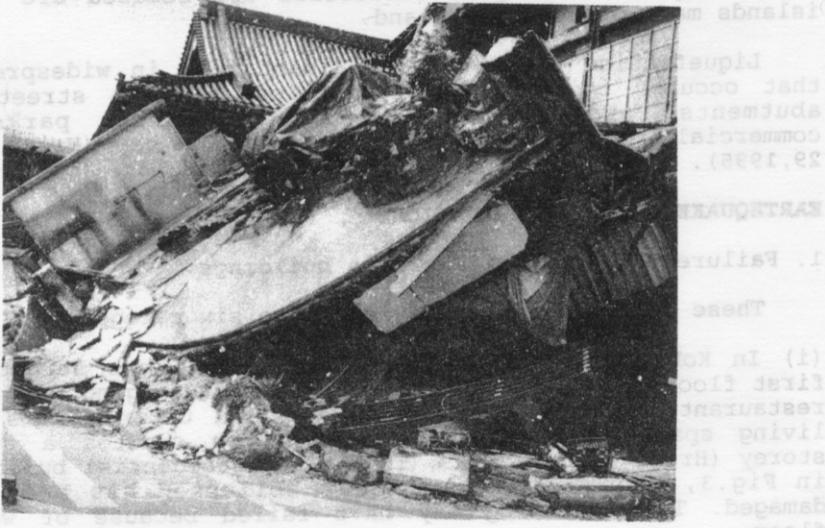
Fig.4 House failure due to heavy roof

(ii) Some buildings failed due to a heavy roof. Heavy roofs were used in Kobe city to avoid wind problems, as explained earlier. Fig.4 shows a typical residential building which failed due to a heavy roof.

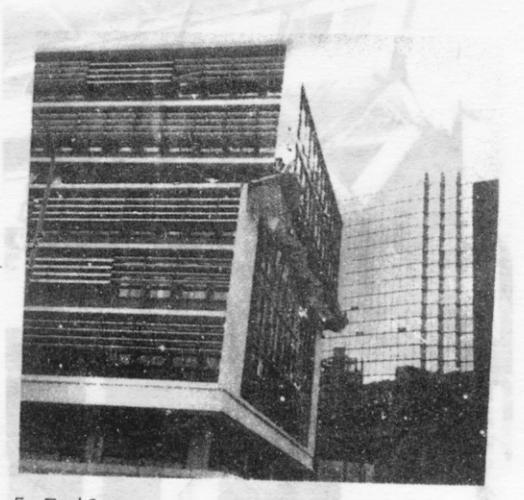
Fig.5 Failure of office building due to discontinuity in fifth floor

(iii) Some buildings got damaged due to the failure of intermediate storeys. They were of medium height with about 10 stories. Damage was concentrated around 4th to 6th storey (INCEDE news letter, Jan, 1995). The reason could be high ground acceleration, reduced density of walls in a particular floor due to office space use and higher mode of structural vibration. Some experts suspect that this type of damage may take place as a result of clash effects of vertical shock waves. Fig.5 shows failure of middle floor of an office building (Haresh Shah, Jan 29,1995).

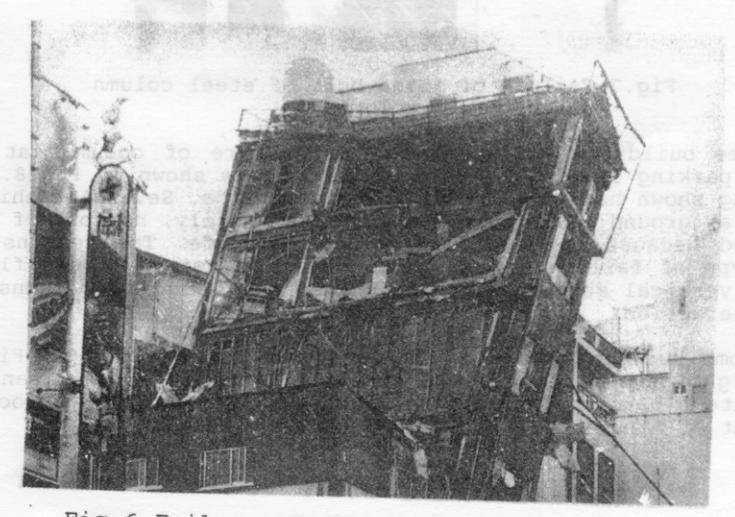
Fig.6 Failure of steel frame structure due to large ductile deformation

(iv) One type of steel structure failure was because of large ductile deformation due to severe ground motion and is shown in Fig.6. Another type of failure was due to shearing of bolts at joints of concrete and steel column. This failure may be due to large ground shaking or due to degrading of bolts. This type of failure is shown in Fig.7.

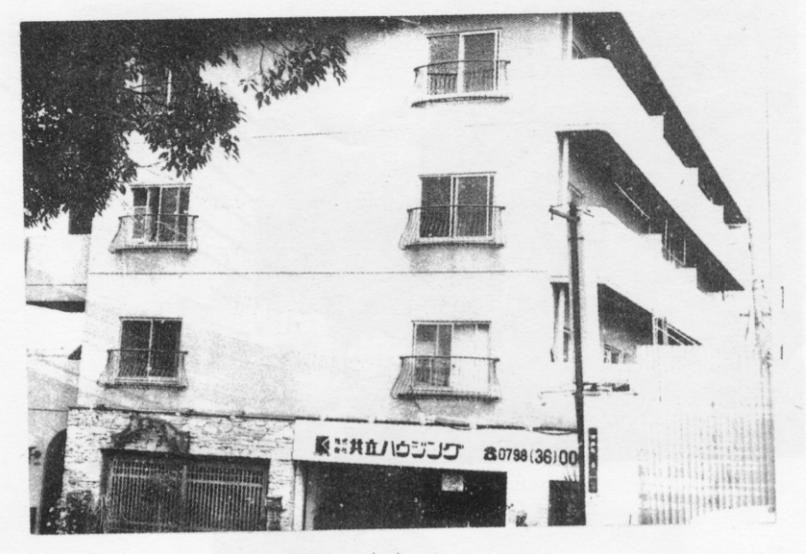
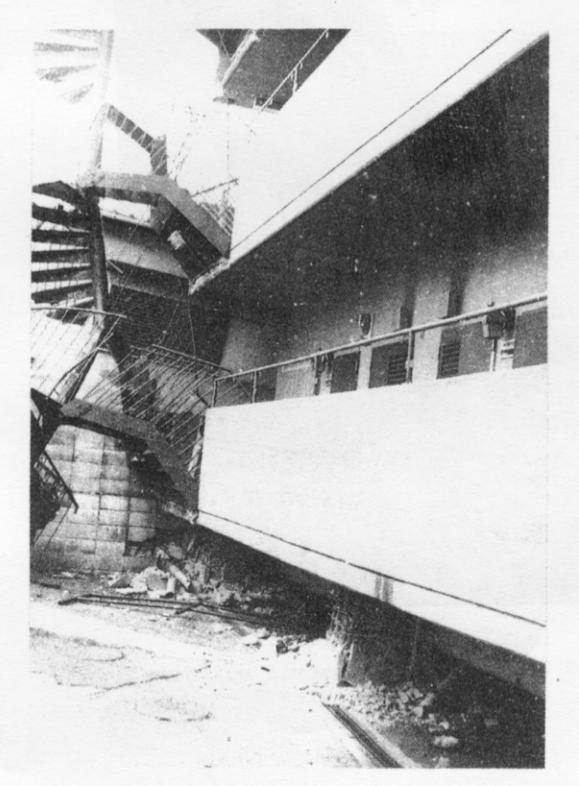
Fig.8 Failure of building due to weak columns (a) super structure (b) failure of columns

(v) Some buildings collapsed due to failure of columns at the ground/parking area. This type of damage is shown in Fig.8. The building shown had moved about 60 cm downwards. Several vehicles parked at ground level were damaged. Fortunately, no loss of life occurred because the super structure was safe. The reasons for this type of failure appear to be due to a heavy, strong floor, strong vertical acceleration and uneven settlement of columns due to liquefaction.

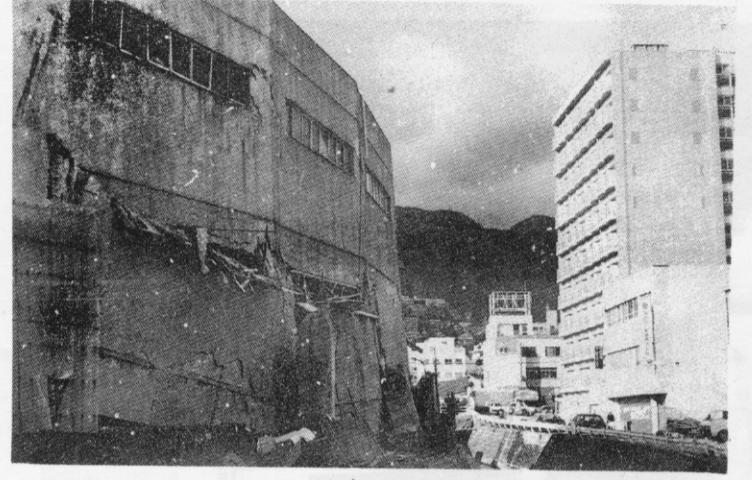
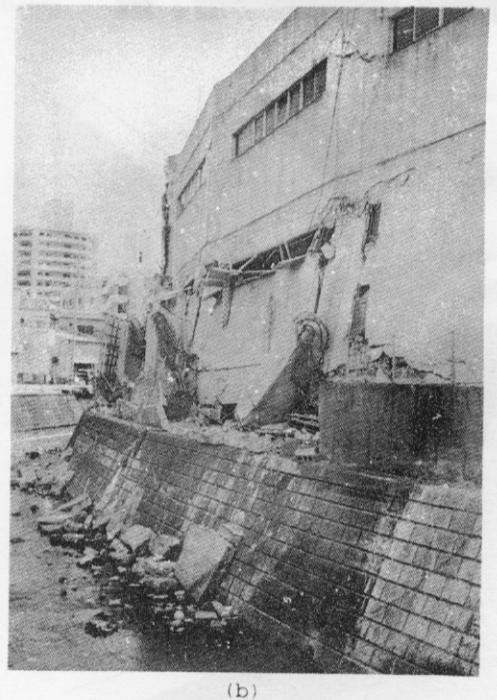
Fig.9 Failure of asymmetric building (a) view.1 (b) view.2

(vi) Some buildings failed due to asymmetry as shown in Fig.9. This might have failed due to strong ground acceleration and to some extent torsional ground motion. Torsional motion and rocking movement of monument is shown in Fig.10.

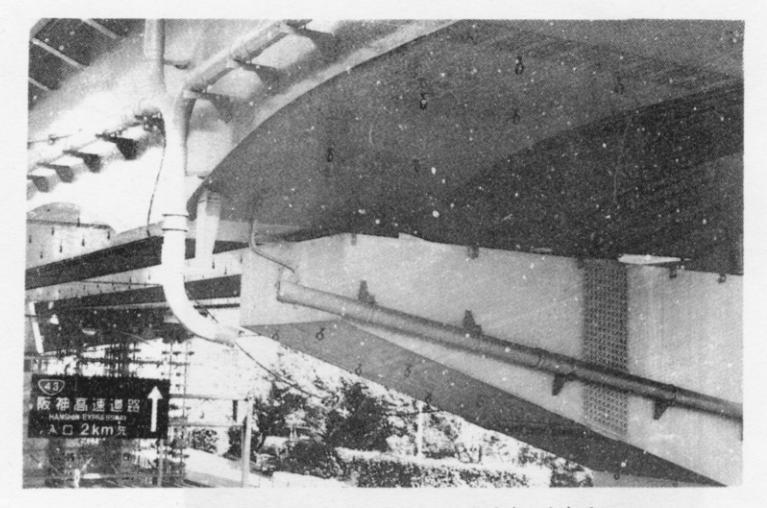
Fig.11 Slided girder of Hanshin highway

One of the surprising failures due to the earthquake was the collapse of Hanshin expressway. This was the main link between Osaka and Kobe cities. This portion of the expressway in Kobe was built about 30 years back. It is a mixture of two types of construction explained above. There were different modes of damage of the expressway. In the first type steel girders moved and slided (Fig.11) and in other places it fell down (Fig.12). There was local damage of girders at supporting points. In this situation concrete columns were generally safe. In another type the girder transmitted total load to the column with out falling/sliding and the resultant column failure is shown in Fig.12.

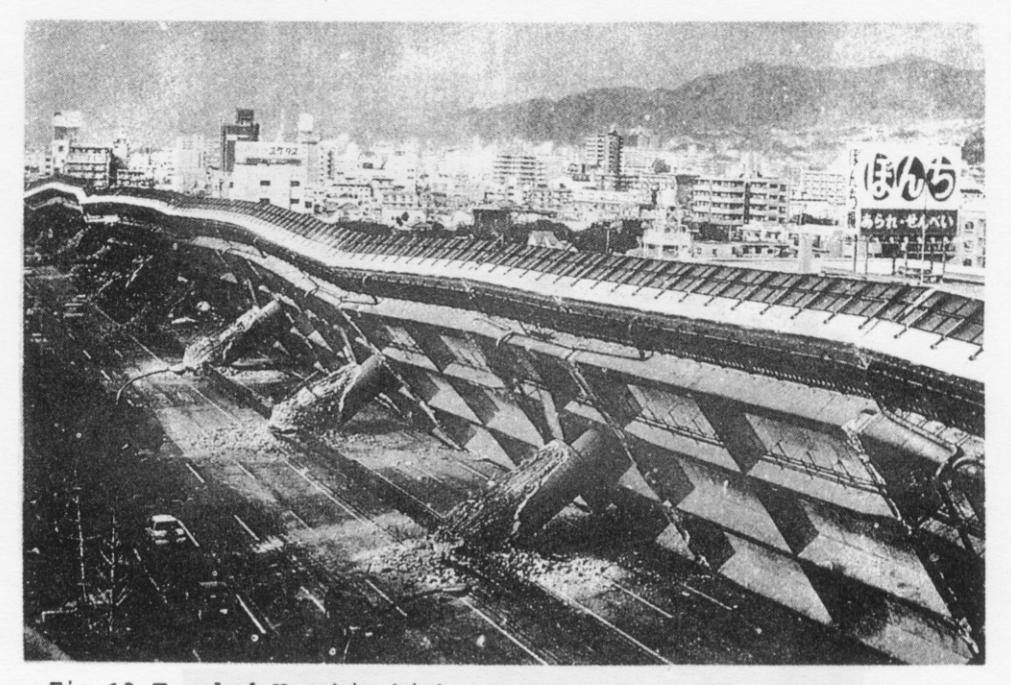
Fig.13 Toppled Hanshin highway (Kobe city, Higashinada ward)

In Hagishinada ward of Kobe city about 500 m span portion of the expressway toppled down as shown in Fig.13. In another place columns were damaged badly as shown in Fig.14 (INCEDE news letter, Jan, 1995). This may be due to weak columns and strong girders, strong ground shaking or uneven settlement of columns due to liquefaction.

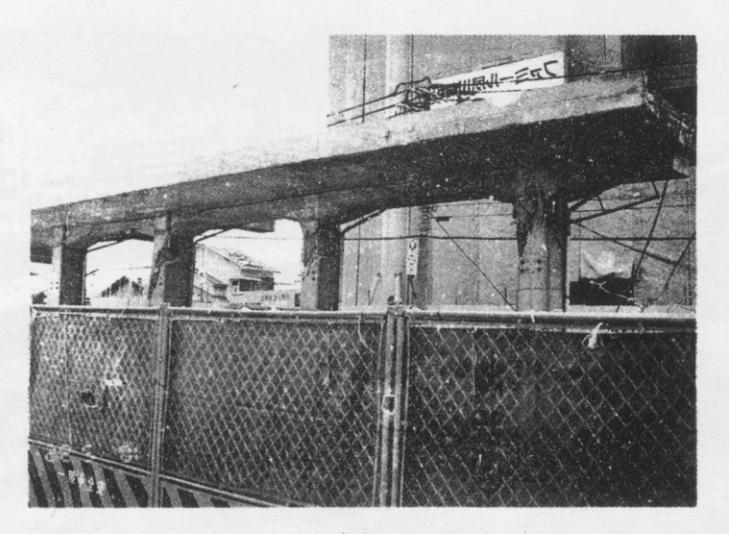
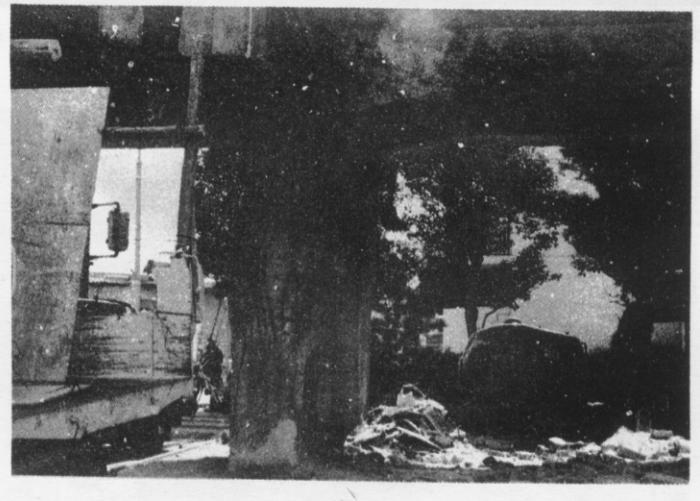
Fig.15 Failure of columns in Hankyu-Kobe railway line (a) shear failure (b) compression failure

Similar types of failures were observed in the case of elevated railway lines including the famous Shinkansen line, shown in Fig.15.

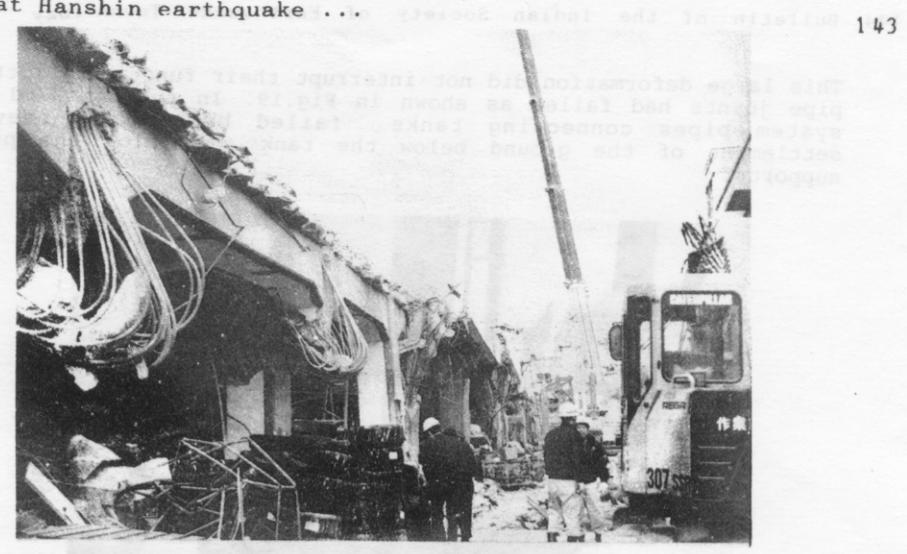
Fig.17 Failure of columns of train parking stand due to compression (Kobe city)

To save space, train parking area was provided on elevated platforms. The area under the platform was provided for shops. Dislocated trains in the parking area are shown in Fig.16. Failure of the parking stand columns are shown in Fig.17. The reasons for failure appear to be a strong floor weak column, asymmetry of the platform and uneven settlement of columns due to liquefaction.

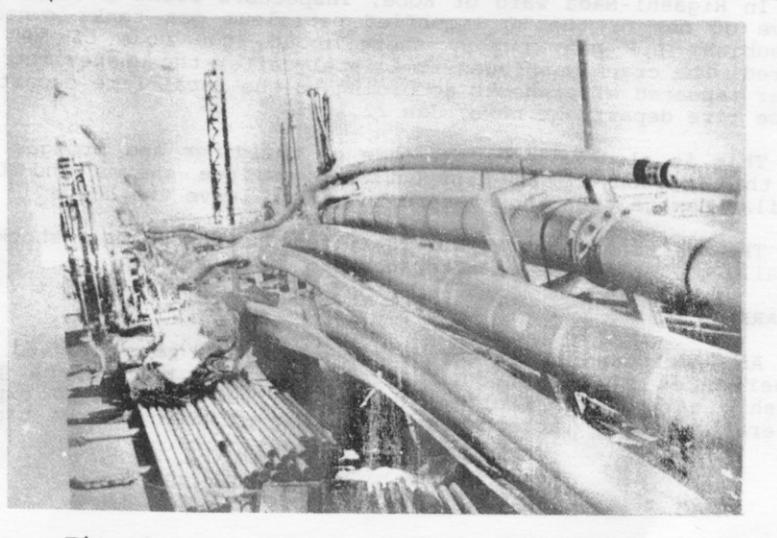
Fig.18 Large ductile deformation of pipes due to failure of supports

Failure of industrial pipelines: Pipe line supports failed causing large ductile deformation in the pipe lines (Fig.18).

This large deformation did not interrupt their function. Brittle pipe joints had failed as shown in Fig.19. In another kind of system pipes connecting tanks failed because of uneven settlement of the ground below the tank and below the pipe supports.

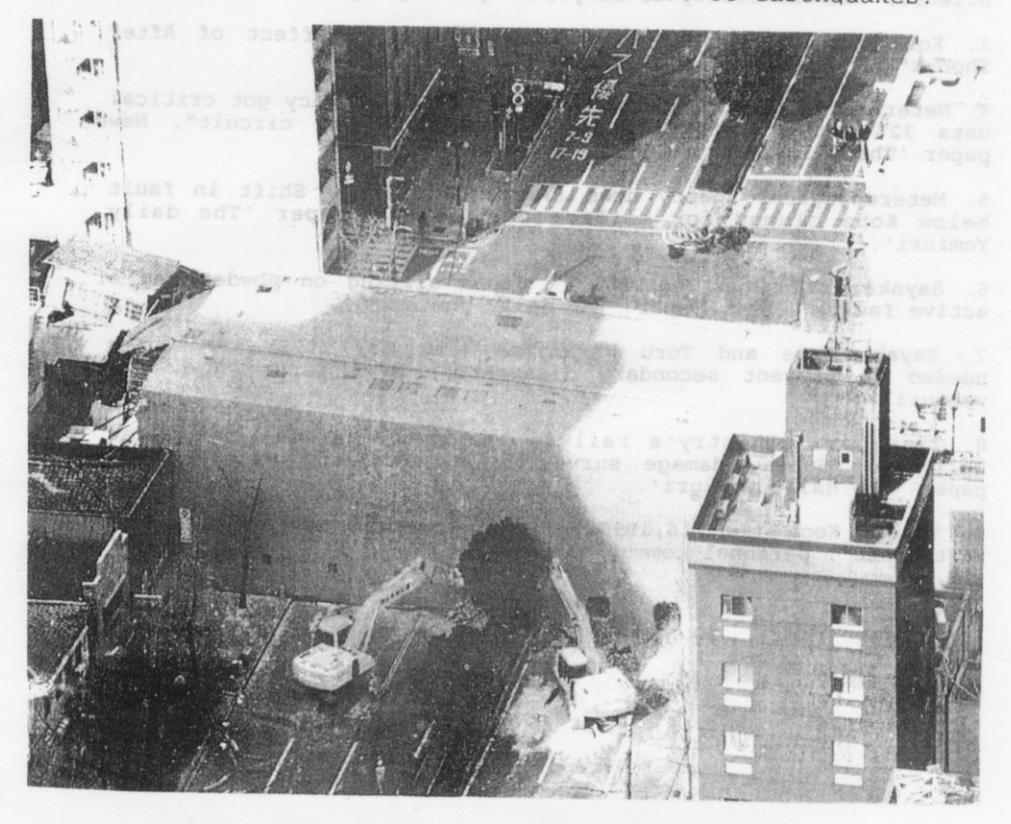
Fig.20 Collapsed building due to aftershocks

The building shown in Fig.20 tilted due to the main shock and totally collapsed due to aftershocks.
