STRUCTURAL DAMAGES ON THE COAST OF TAMIL NADU DUE TO TSUNAMI CAUSED BY DECEMBER 26, 2004 SUMATRA EARTHQUAKE

B.K. Maheshwari, M.L. Sharma and J.P. Narayan Department of Earthquake Engineering Indian Institute of Technology Roorkee, Roorkee-247667

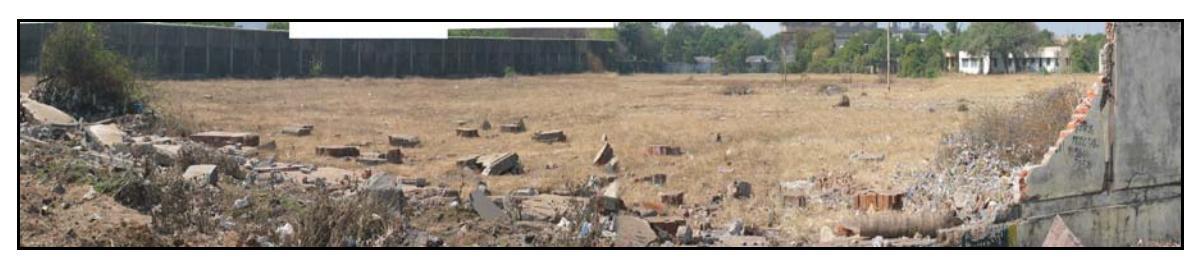
Fig. 3 The boundary wall of about 50 m length damaged in Cherain Nagar (Chennai)

Figure 3 shows the damage to a boundary wall near tollgate in Cherain Nagar (Chennai). Run-up observed in this area was 3-4 m (see Table 1). The wall was located about 50 m from the seacoast after crossing the 10 m wide road. The coast height near this locality was about 3 m only and tsunami waves could cross the breakwater made to prevent it. The boundary wall (made of brick masonry) was severely damaged. Damage was in partial length of wall only where the tsunami struck first and hydrodynamic force of the tsunami exceeded the bending capacity of the wall. Once water entered inside and pressure equalized on both sides of the wall, this reduced the overturning moment and further damage. Wall being unreinforced, this type of damage was inevitable. From Tables 2 and 3, the level of damage may be characterized as of Grade 4 in Type A structure.

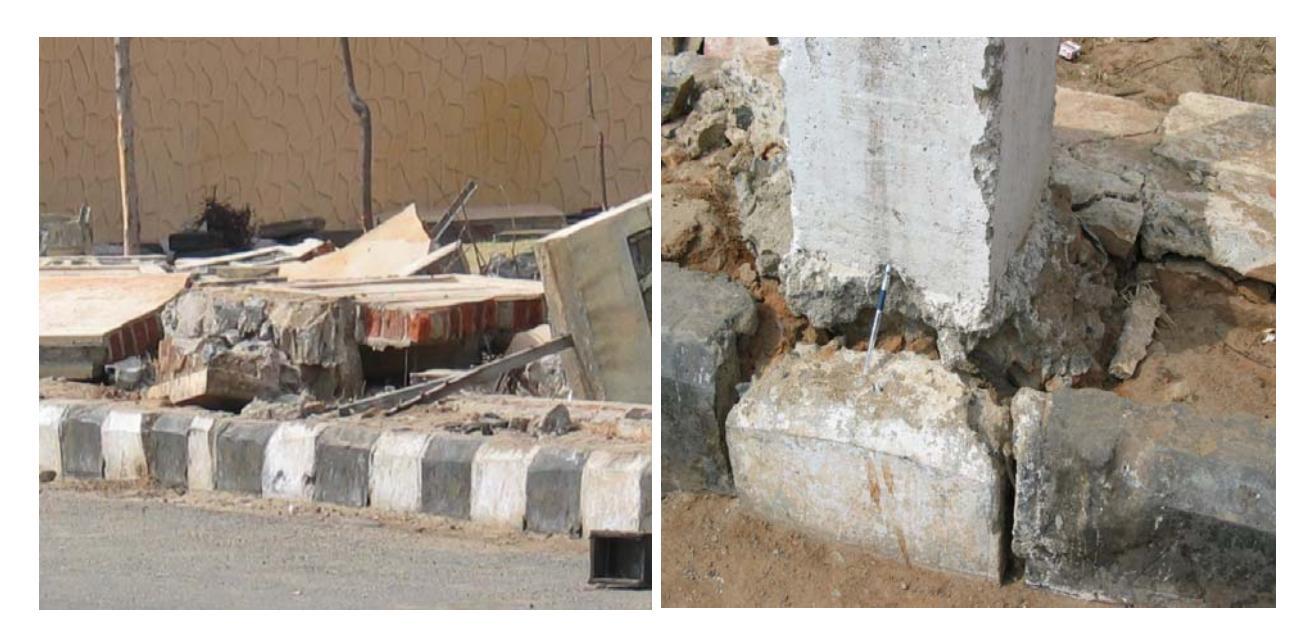
Compound wall of the Madras Lighthouse (Chennai) partially collapsed due to the tsunami (see Figure 4). According to Table 1, the run-up in this area was 4-5 m. Boundary wall was of brick masonry with concrete posts. A few concrete posts of the wall (to the south of the lighthouse) were even detached from the wall and damaged. It appears that the tsunami attacked the joints as posts were toppled from the joints with base. As shown in Figure 4, a post got displaced laterally by about 10 cm (after collapse of infill walls). Approximate size of a post was $0.45 \times 0.3 \times 1.5$ m, with a weight of about 5 kN. Displacement of such a heavy weight shows that the lateral force exerted by the waves was indeed intense. Also it can be observed that compared to Figure 3, quality of the material used (concrete) here was better and the damage can be classified as Grade 4 in Type B in the 4-5 m zone of tsunami run-up height.

Fig. 4 Collapse of the compound wall of Madras Lighthouse (Chennai) (concrete posts of the wall separated; second figure shows that another post is displaced laterally by about 10 cm)

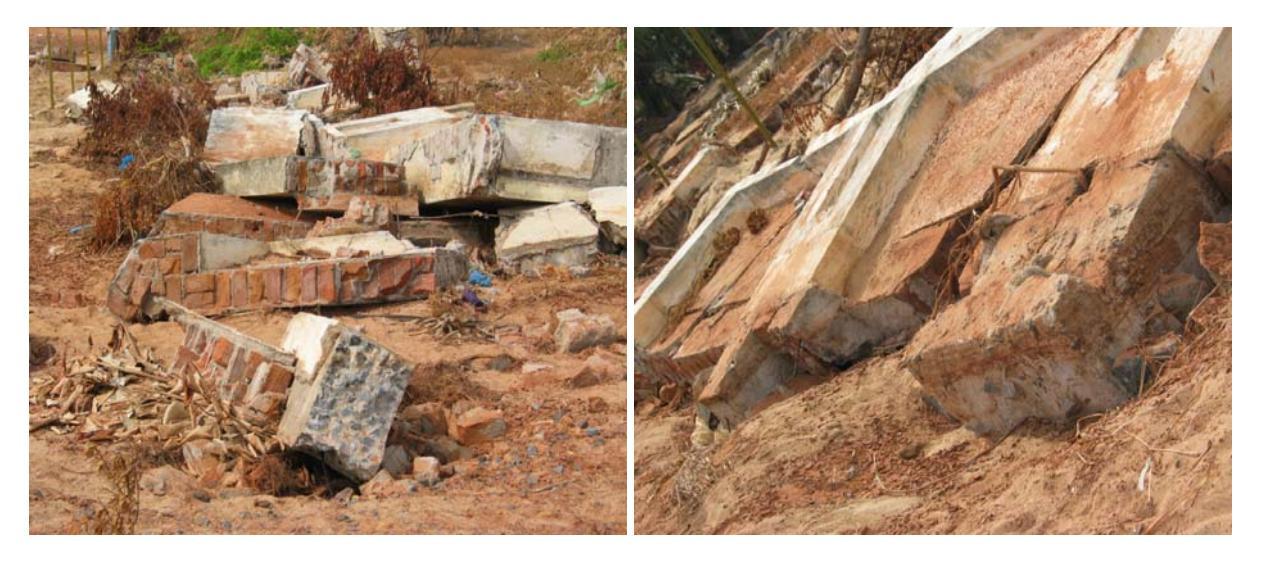
The boundary wall of a school in Chinapattam (run-up 4-5 m, see Table 1) was damaged as shown in Figure 5. Some of the parts of the wall were transported up to a distance of about 10 m. The wall was made of brick masonry with concrete posts. At most places the wall got uprooted from the base and toppled as a unit. Level of damage (Grade 4 in Type B) is due to high run-up elevation. Figure 6 shows that front (boundary) walls of few buildings got damaged while the roofs were intact. Brick masonry got damaged even when cement was the cementing material. It could be observed that though the boundary wall collapsed due to the tsunami, it helped to save the other parts of the building.

Fig. 5 Collapse of brick masonry compound wall of a school in Chinapattam (Pondicherry)

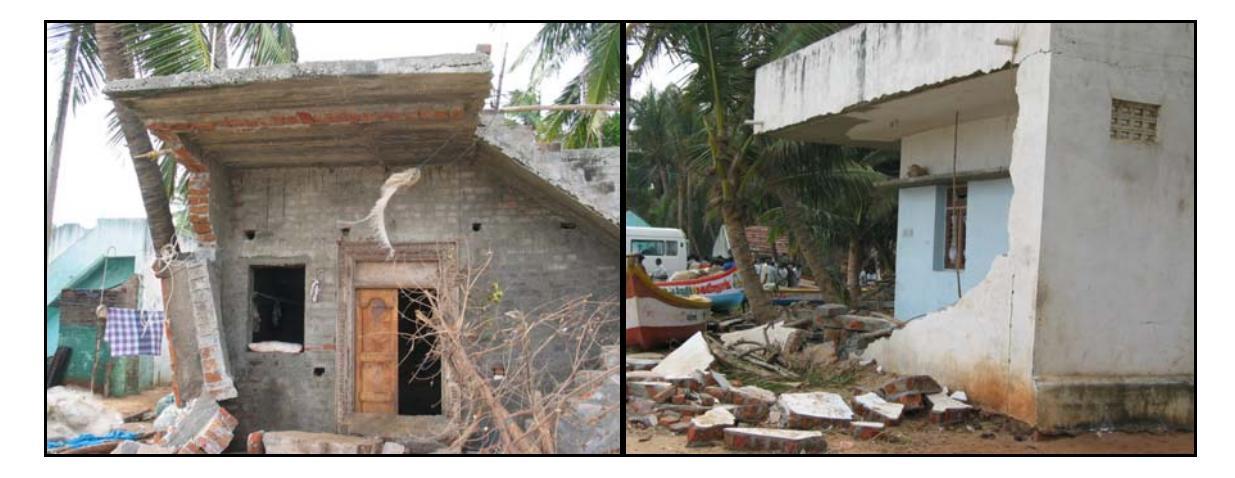
Fig. 6 Collapse of compound walls of residential houses in Chinapattam (these walls protected the houses from damage)

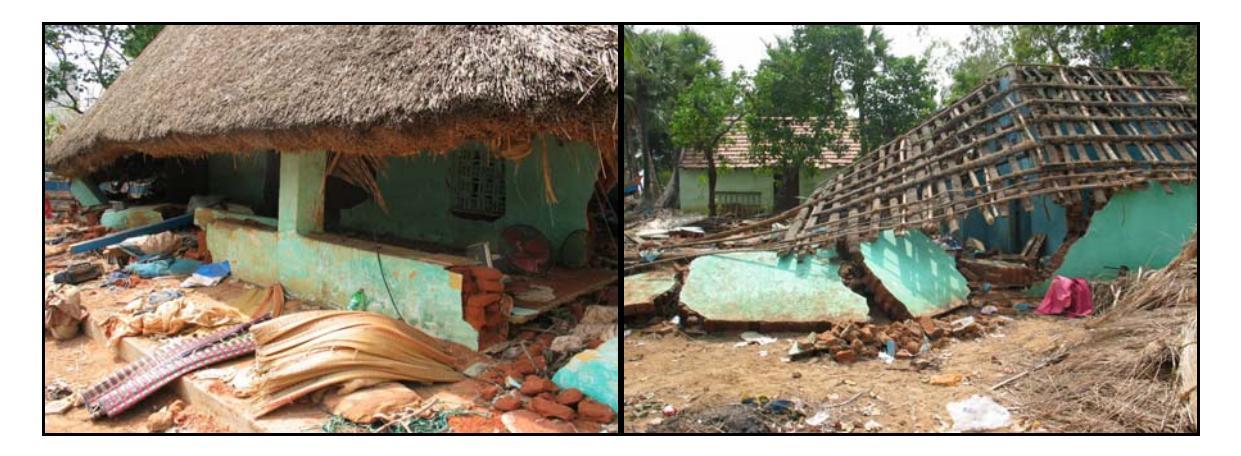
Fig. 7 Collapse of brick masonry houses in Kudukuppam (Villupuram)

Figure 7 shows the collapse of brick masonry houses in Kudukuppam (with run-up of 4.0 m). The huts collapsed as walls and columns were constructed by using mud as a cementing material, and had thatched roofs. The collapse was as anticipated due to the use of very poor cementing material in the construction. The damage can be characterized as of Grade 5 in Type A buildings.

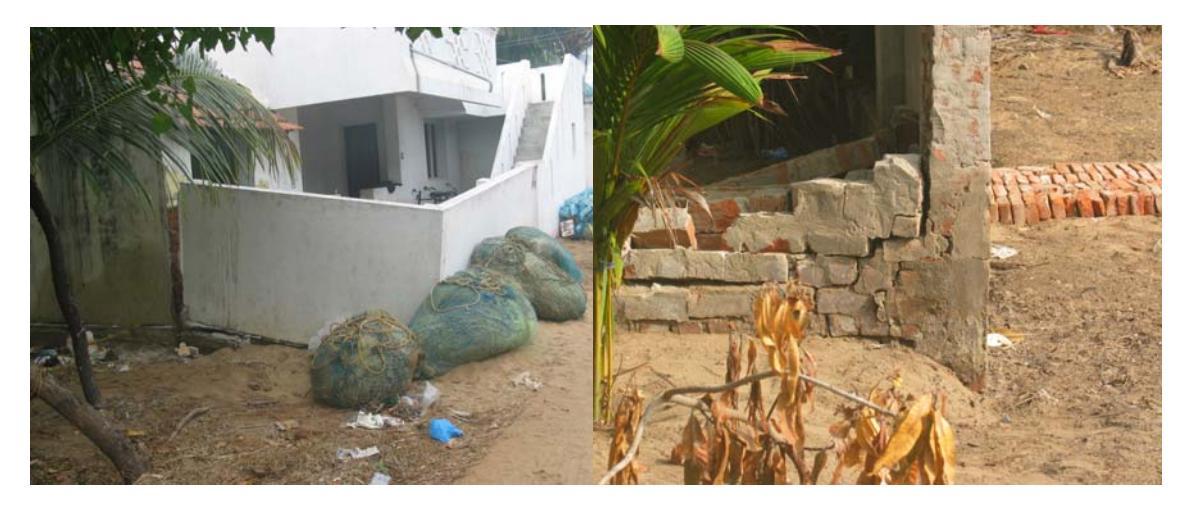
Some of the typical structural damage in the Talenguda village (Cuddalore) is shown in Figure 8. This area had the run-up of 5-6 m. It can be observed that even though the run-up is higher than that shown for Figure 7, the damage is not so severe because of the better quality of construction. Level of damage in the left photograph can be characterized as of Grade 4 in Type B. Joints of a compound wall (made of brick masonry) with the main wall opened and tilted due to settlement of the soil below. Right photograph of Figure 8 shows that the collapse was due to opening of joints and low bending capacity of the brick masonry. This indicates vulnerability of brick masonry to tsunamis.

Fig. 8 Damage to boundary walls in Talenguda (Cuddalore) due to damage to brick masonry

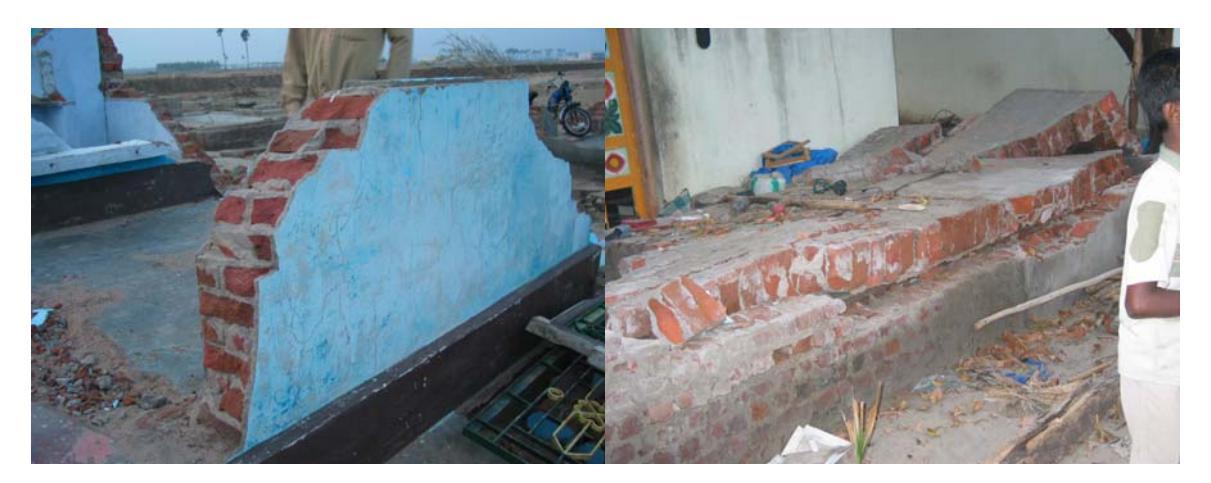
Opening of brick joints was observed at many other places also. For example Figure 9 shows collapse of a house in Amman Kerapattu village (in Nagappattinam district) near Karaikal due to breaking of bricks even when lime mortar (not mud) was used as a cementing material. This area had the run-up of 8-9 m (see Table 1), which is consistent with the breaking of bricks and collapse of walls observed here and thus with the damage of Grade 5 in Type B.

Fig. 9 Damage to brick masonry in Amman Kerapattu village (Nagappattinam) near Karaikal (even bricks used with lime mortar got broken here and wall collapsed)

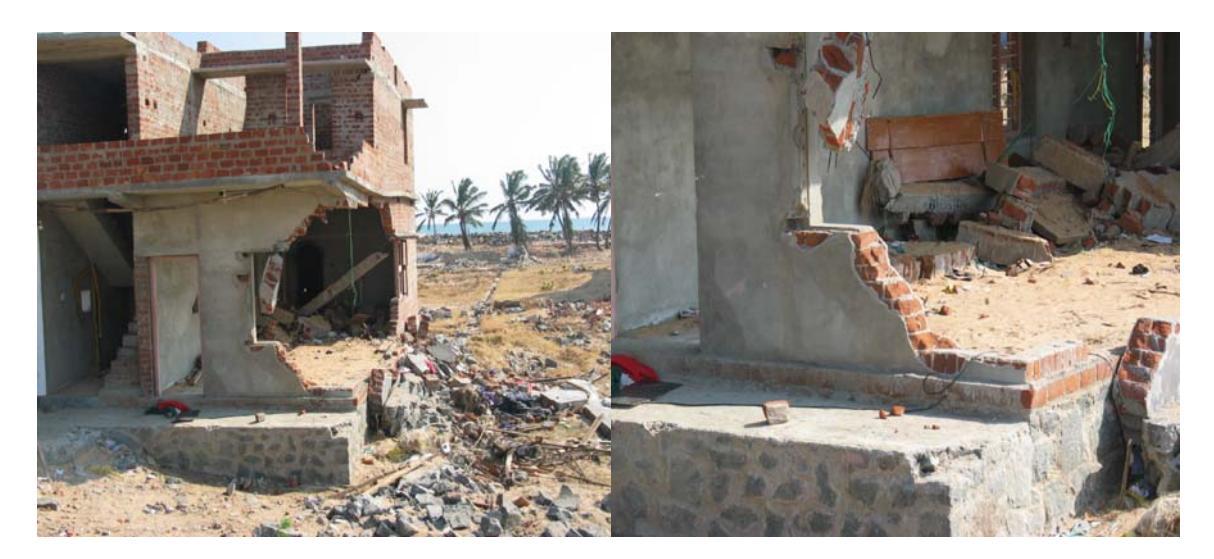
Tsunami caused heavy damage to brick masonry buildings not only on the east coast but also on the west coast. Figures 10 and 11 show heavy damages to the brick masonry buildings in Keelamankudy and Meelamankudy villages, respectively. Both villages are located on the west coast in the Kanyakumari district, and had run-up equal to 12 m. These villages are about 100 km North-West of Kanyakaumari

city. It can be noticed that this damage was severe even with the use of cement mortar. Level of damage may be characterized as "many buildings of Type B subjected to damage of Grade 5", which is consistent with the high level of run-up.

Fig. 10 Collapse of a brick masonry building under construction at Keelamanakudy (Kanyakumari)

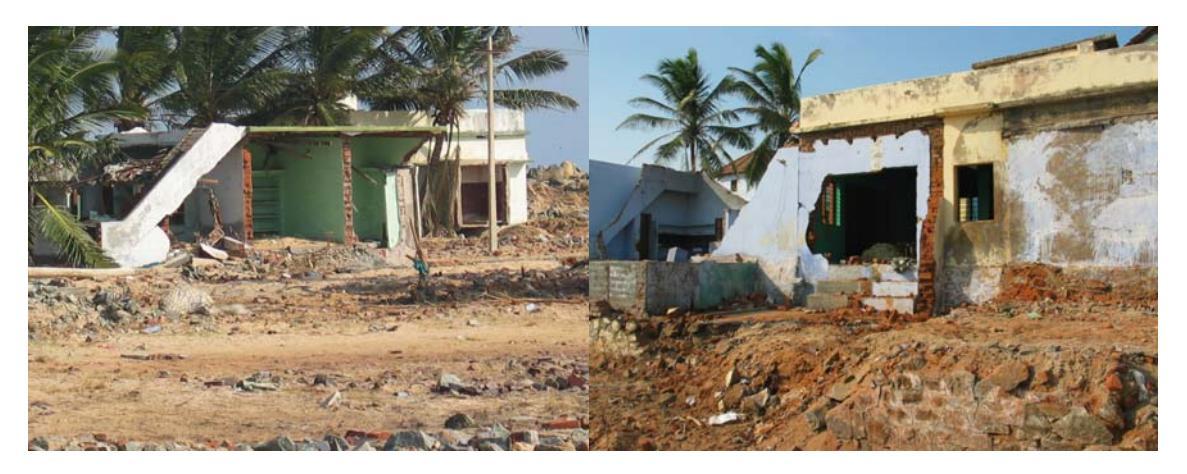
Fig. 11 Widespread damages to buildings in Meelamanakudy (Kanyakumari) (most of the houses were of brick masonry which performed poorly during the tsunami attack)

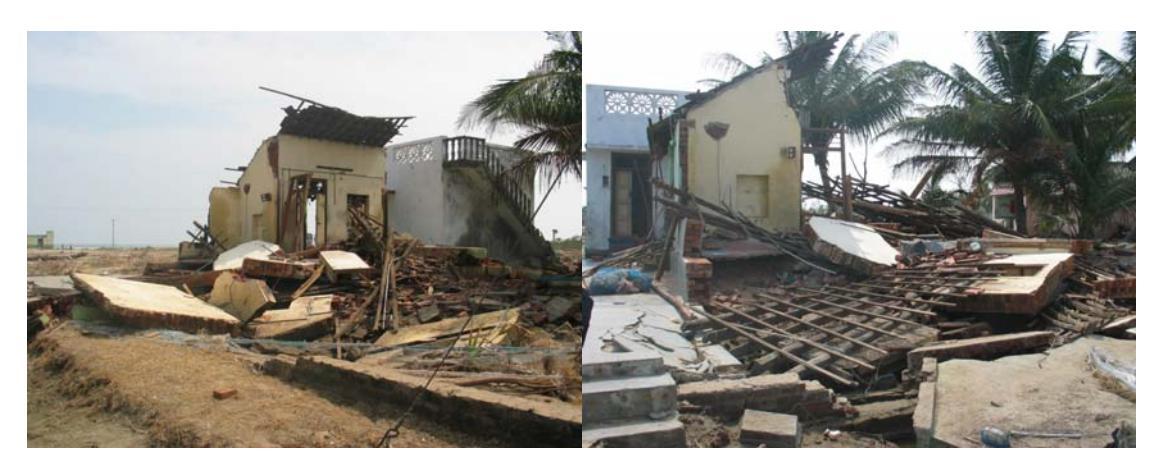
Figure 12 shows the collapse of fishermen's houses in Kuddukullam village just south of Cuddalore. Construction material used was very poor and the collapse of these houses due to the tsunami was obvious. Level of run-up in the area was also considerably high (8-9 m).

Fig. 12 Collapse of adobe houses in Kuddukullam village (near Cuddalore)

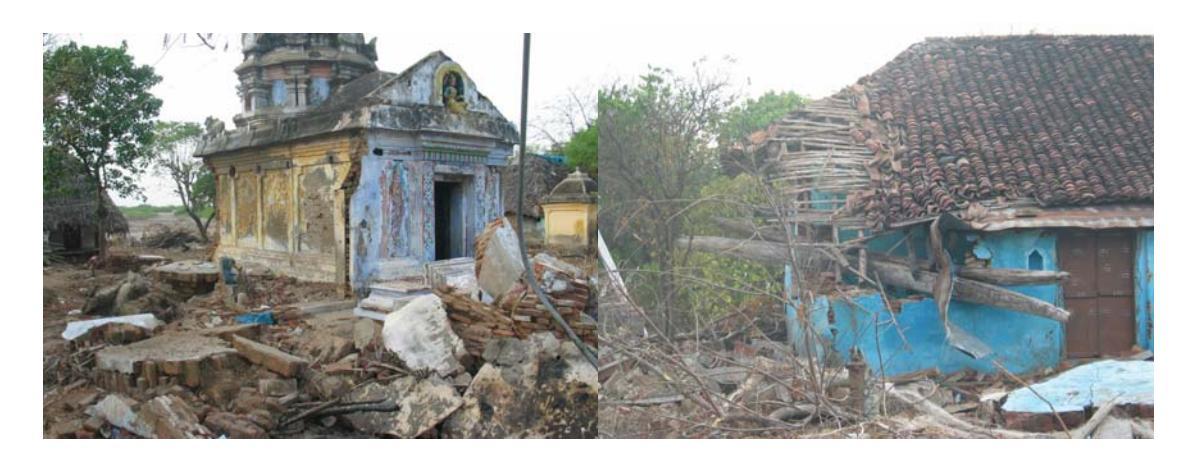
Figure 13 shows damage to the houses in Kuddupattanam (south of Chidambaram city) in the Nagappattinam district. Though level of run-up is high (8-9 m), damage is not so severe especially for the house in the left photograph of Figure 13. Reason for this is attributed to the Medu effect as described by Narayan et al. (2005). As these houses were situated on Medu (naturally elevated landmass), those were saved from collapsing. Fig. 14 shows collapse of the adobe houses in Nabiyarnagar (Nagappattinam). The level of run-up was 10-12 m and the collapse of these poorly constructed houses was as expected.

Fig. 13 Damage to small houses in Kuddupattanam (south of Chidambaram), Nagappattinam

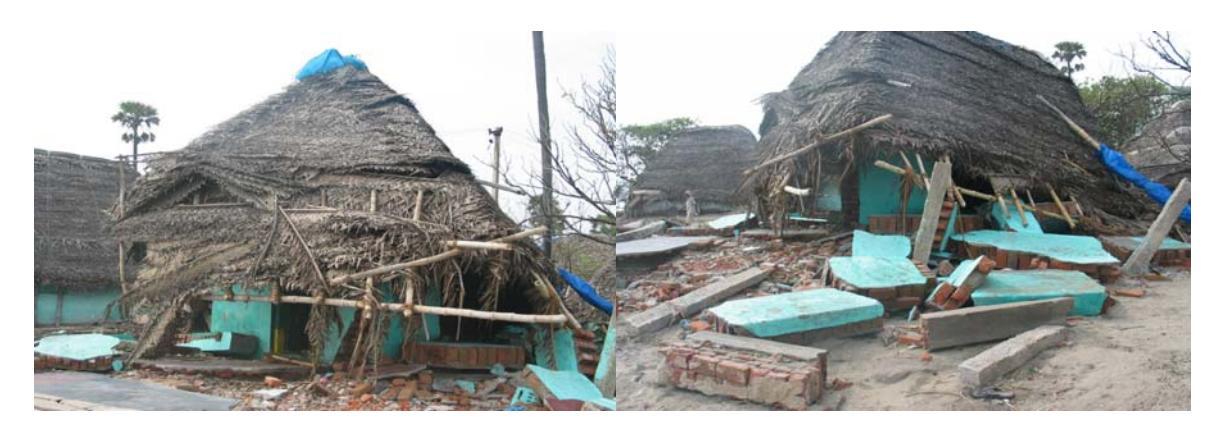
Fig. 14 Collapse of adobe houses in Nabiyar Nagar (Nagappattinam) due to tsunami

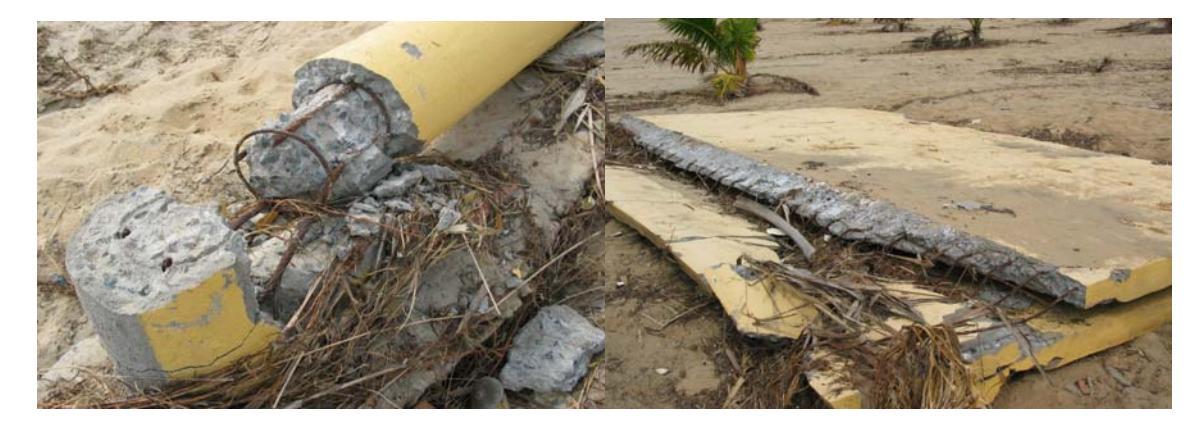
Figure 15 shows one of the collapsed columns of Sri Karneshwara Natraj Temple in Kudukuppam (Villupuram), where the run-up was 4.0 m. Damage may be classified as of Grade 5 in Type B, which is on higher side and not correlating well with the run-up. There are many reasons for this inconsistency. Though details about the amount of reinforcement were not available but general observations suggest that the reinforcement was inadequate with respect to cross-sectional area of the column. Thus flexural capacity of column was not enough to resist the hydrodynamic forces of tsunami. Moreover, at the base of the columns, isolated footings were used instead of combined footings, and failure of foundation also contributed to the collapse of these columns. Once columns collapsed, this led to toppling of roof and it moved few meters away. Here the run-up was not very high; however primary reason of the collapse was foundation failure as shown in Figure 16.

Fig. 15 Left: One of the failed reinforced concrete columns of Sri Karneshwara Natraj Temple, Kudukuppam (Villupuram); Right: Toppled roof, which moved few meters away

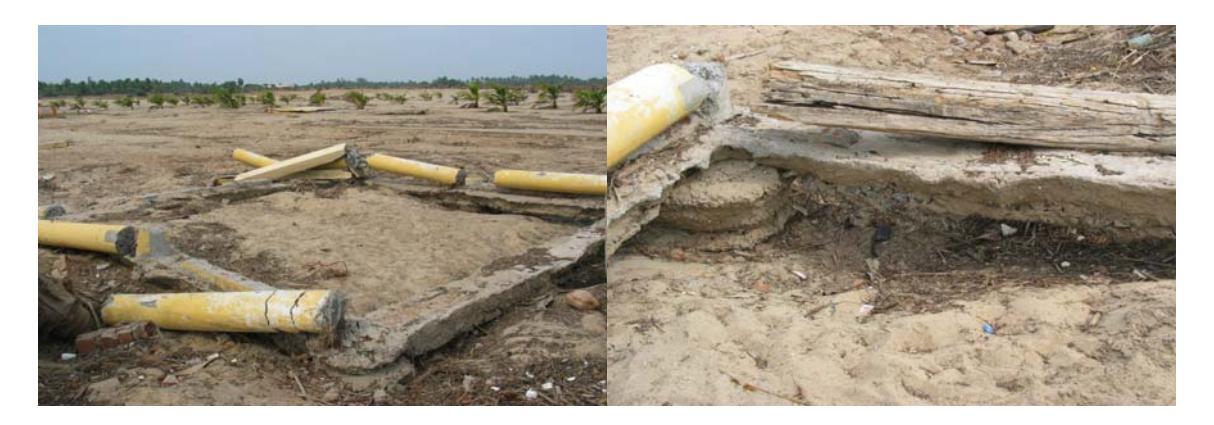
Fig. 16 Foundation of collapsed Sri Karneshwara Natraj Temple (Kudukuppam) (only isolated footings under the columns were used)

Figure 16 depicts the foundation of collapsed Sri Karneshwara Natraj Temple (Kudukuppam). It can be observed that foundation below the structure was very abnormal. Only isolated spread footings below the column bases were provided. There was no embedment/foundation below the square ring joining the column bases. No combined foundation was provided below these columns. It appears that the base ring (except below the columns) was directly placed on the soil (without any embedment) as can be seen in the photographs. Such footings cannot withstand the forces of tsunamis and the collapse was as expected.

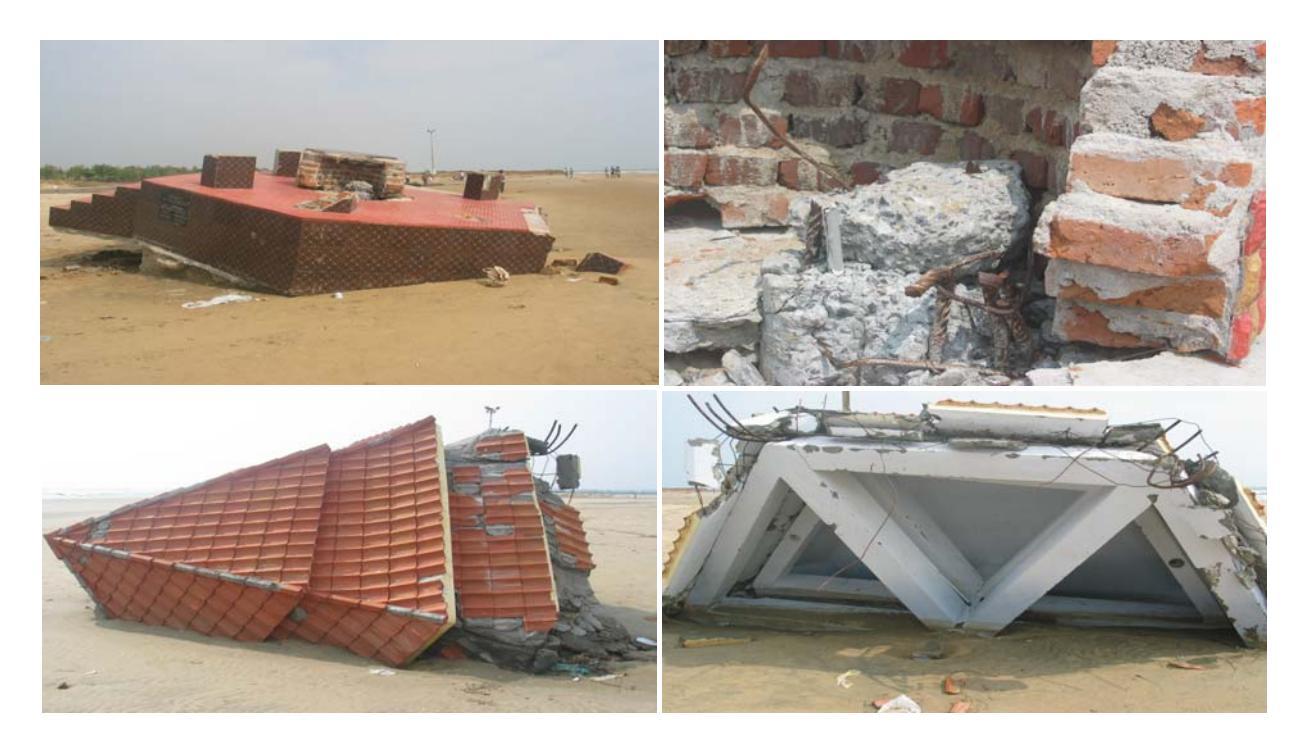
Figure 17 shows the collapse of a monument in Devanam Kuppam (Cuddalore), with a run-up of 6-7 m. Level of damage can be classified as of Grade 5 in Type B and many reasons of this damage could be observed. First, erosion and settlement of soil due to the tsunami tilted the base of the structure. Second, the roof was supported by just one column at the center, which collapsed. It may be observed that reinforcement used in the column was inadequate. Third, the roof was toppled and washed 20 m away. For the roof, quality of construction was relatively better and it remained relatively intact. Beams of the roof performed well and they kept the roof intact even after its displacement by a few meters.

Fig. 17 Damage and collapse of a small monument in Devanam Kuppam (Cuddalore) (top left: tilted base due to settlement and erosion of soil; top right: heavy roof supported by a single column only; a collapsed RCC column without adequate reinforcement; bottom: displaced roof that toppled and moved away but remained relatively intact due to adequate reinforcement)

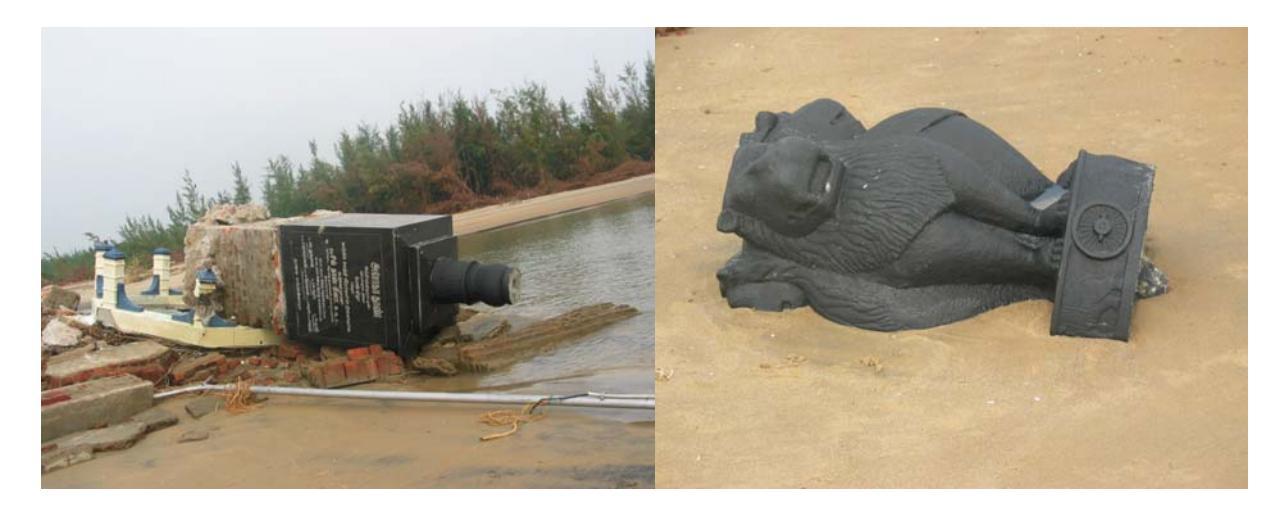
A memorial column at Nagappattinam beach, which was erected to celebrate Republic Day after the Kargil war got severely damaged (see Figure 18). It may be seen in the photograph that the Singnadh is broken from the post inside the memorial column. Broken post and its base can be clearly noticed. Also different parts and pieces of the memorial column, and an uprooted electric pole may be observed. Severe damage to the concrete post and many other concrete structures (i.e., Grade 5 in Type B) at the Nagappattinam beach is consistent with the high level of run-up (10-12 m in Table 1). It may be observed in Figure 18 that the depth of embedment of the footing was not adequate and that this also contributed to the damage.

Fig. 18 Memorial column at Nagappattinam Beach that got uprooted, and Singnadh (on top of it) that got broken and moved away (the column was erected to celebrate Republic Day after the Kargil war)

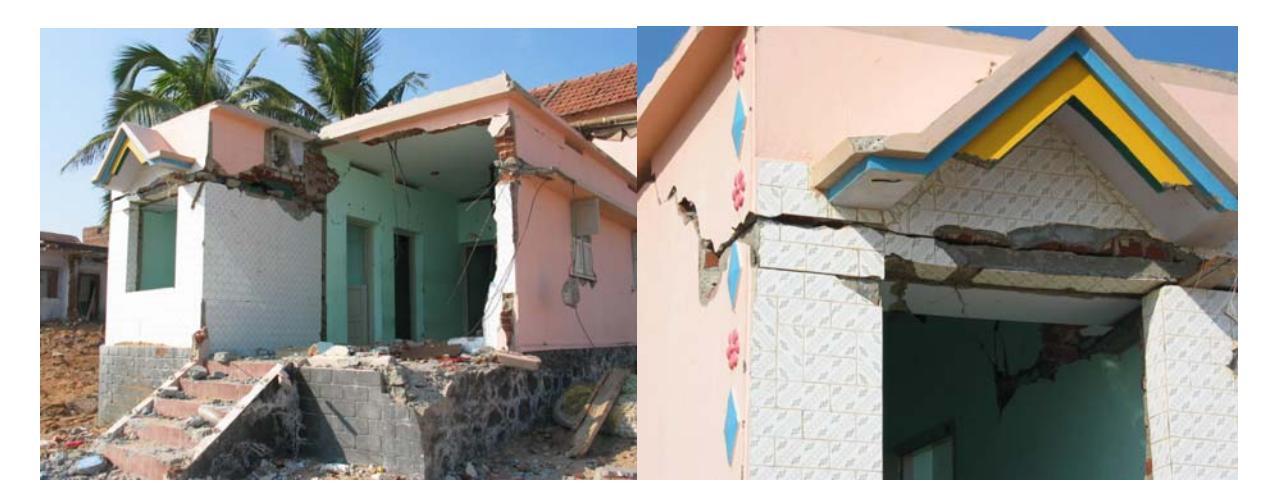
Widespread damage to masonry buildings, including those with good quality of construction, was noticed especially in the Kanyakumari district. Most affected villages were Keelamanakudy and Meelamanakudy (where the run-up measured was about 12 m). Some of the damages to the brick masonry in these villages have already been discussed in Figures 10 and 11. Further, Figures 19 and 20 show general collapse of newly constructed buildings in the Meelamanakudy village of Kanyakumari.

Fig. 19 Heavy damage to a building in Meelamankudy: (a) complete failure of joints at lintel band, (b) a close up view showing that there was lateral displacement of top part towards the right side

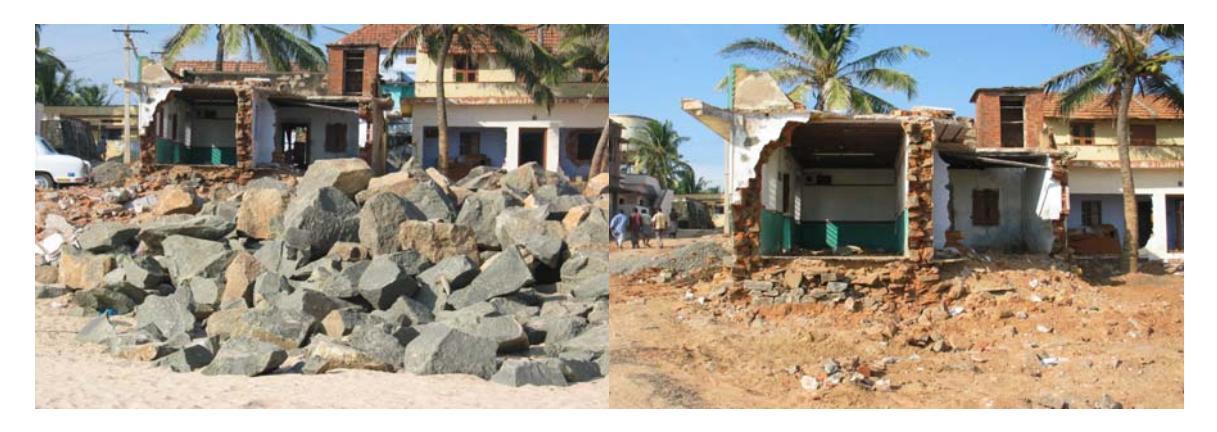
Fig. 20 Collapse of another building in Meelamanakudy (Kanyakumari) (close-up view of the collapsed front wall shows how vulnerable the brick masonry was to tsunami)

There were spectacular damages to the residential buildings in the Meelamanakudy village. All the houses, which are of single story, appeared to be modern type constructions. These were not fishermen's huts, but reinforced concrete frame buildings with masonry infills. Almost every house along the seashore suffered heavy damage even though the buildings looked relatively new. Damage was all over, from foundation to the roof level including walls and columns. Figures 19 and 20 show few of the damaged houses. All these damages were due to the tsunami only and patterns of damages even suggest that these were more severe than those due to an earthquake. In fact almost all houses of this village suffered intense damages with a few having partially/fully collapsed. This intense damage may be attributed to low-lying area and a high value of run-up (12 m). Inundation was very high (see Table 1). It caused heavy erosion to road also. Thus level of damage (of Grade 5 in Type C) is very much consistent with the level of run-up.

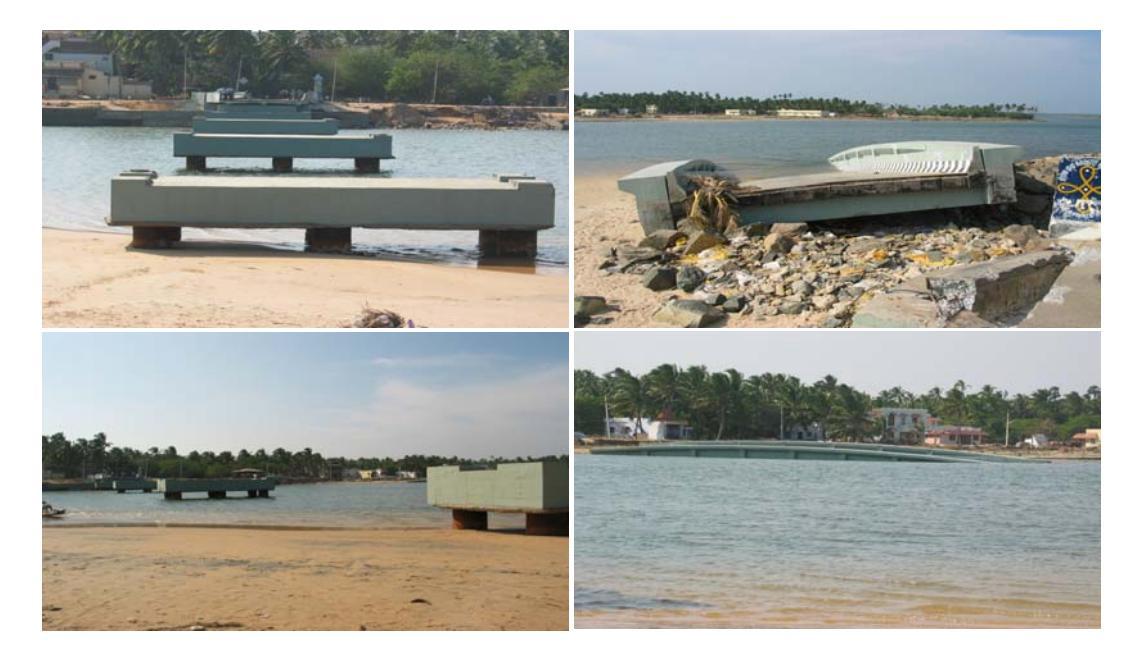
Fig. 21 Damaged bridge on the river Palyar in Keelamanakudy: (clockwise from top left) (a) the substructure left after 4 spans of the deck got washed away; (b) a span washed away by about 20 m; (c) another span moved by about 50 m; (d) bare substructure (with 2 spans still missing)

A bridge on the river Palyar, connecting the Keelamanakudy and Meelamanakudy villages has been badly damaged (see Figure 21). All the four spans of the bridge got washed away. Out of these four spans, two were still missing (up to the date of the survey) and two spans have moved away by about 20 and 50 m (see Figure 21). These spans got displaced from the bearings and separated from the substructure (pile foundation including pile cap). No damage was observed in the substructure and it appeared intact. It seems that the deck got separated due to the bearing failure. Broken parts of the bearings indicated that

mechanical bearings were used. With the help of the measured dimensions, it is estimated that the weight of a span would be about 200-300 tonnes. Displacement of such a heavy structure indicates the intensity of the hydrodynamic force applied by the tsunami. It was a tremendous pressure that washed away the spans. Washing away of bridge's deck may be classified as the damage of Grade 5 in Type C structure, which is again consistent with the level of run-up.

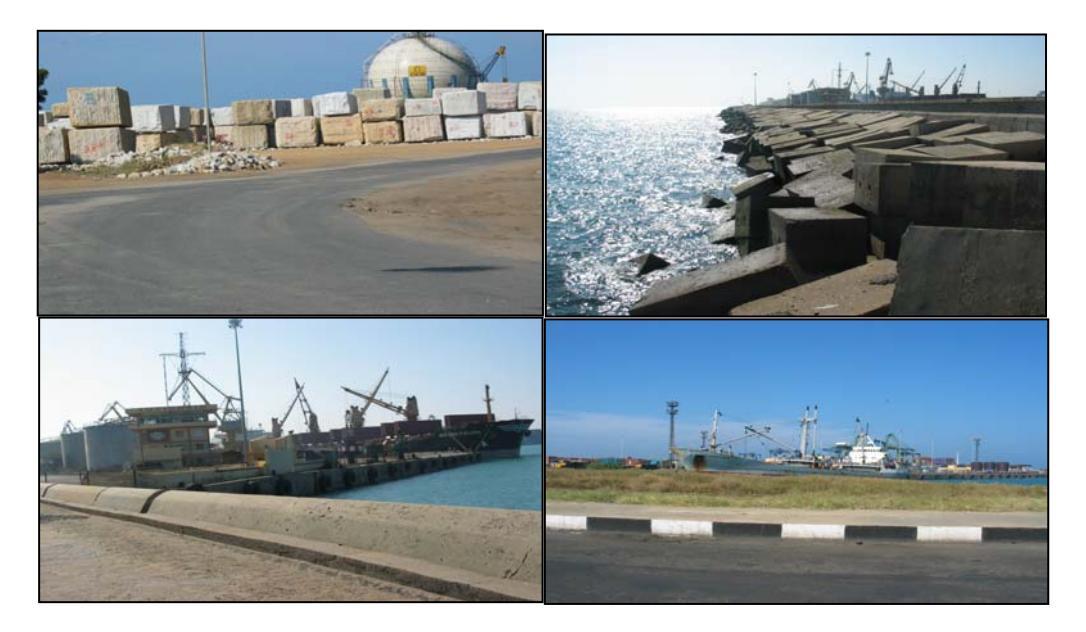
Size of the harbor area is approximately 4450×1250 m. On one side of this area is seashore, where administrative buildings of TPT are located while out of the two other sides, one is for pipeline and another is for approach road (see Figure 22). Closing these two sides are breakwaters (with large boulders) thus encompassing the whole area. Harbor was designed and constructed according to Indian Standard seismic codes and was commissioned in 1978. No damage has been reported to the harbor and facilities here, as the quality of construction is very good (based on personal communication with the TPT authorities). Moreover, being shielded by Sri Lanka, this area had a very low run-up (3.0 m). Here the level of damage may be categorized as of Grade 1 in Type C, which is very consistent with the run-up.

Fig. 22 Pictures taken at Tuticorin harbor showing no damage to the facilities there and life remaining normal at the port (clockwise from top left: an oil storage tank; very heavy stones (about 10 tonnes each) to protect the break-water; a ship moored near the seashore; close-up view of another ship)
