DYNAMIC TESTING OF AUTOCLAVED AERATED CONCRETE BLOCK MASONRY BUILDING MODELS

KEYWORDS: Semi-Engineered Masonry Building; Autoclaved Aerated Concrete Block; Shock Table; Dynamic Testing

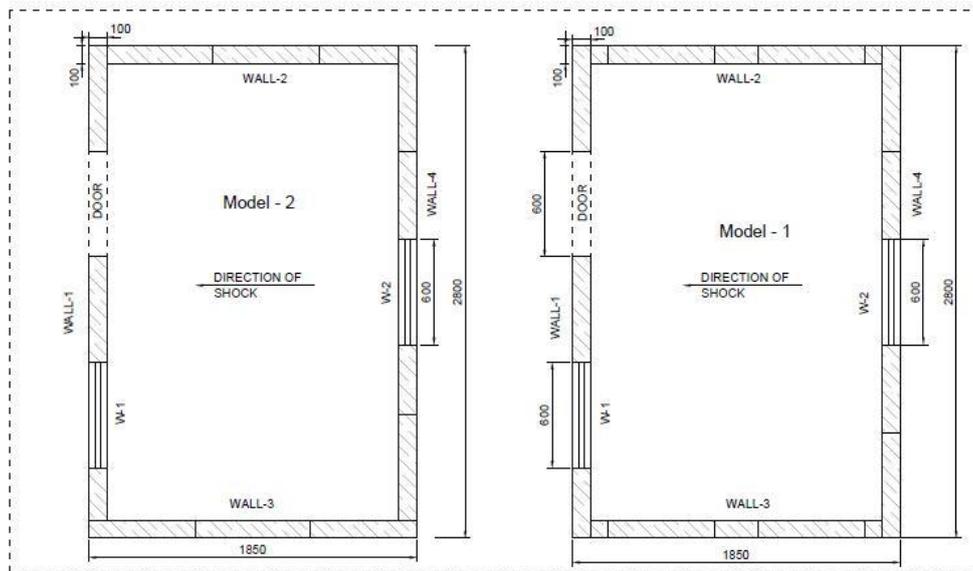
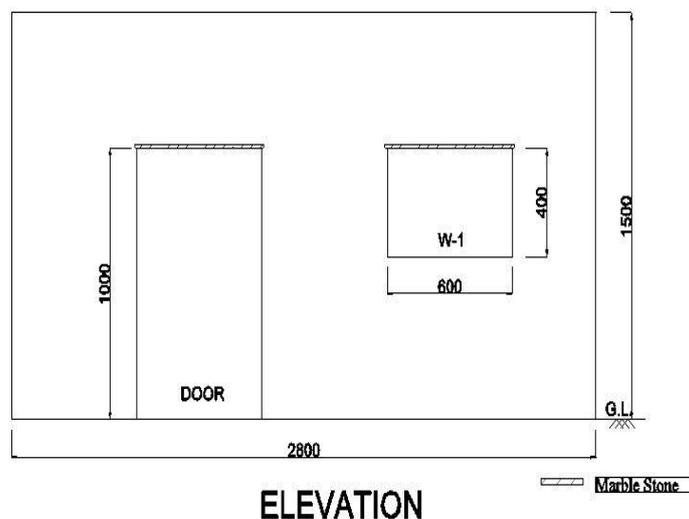
Fig. 1 Schematic Diagram of Two Half-Scale Masonry Building Models with AAC Block Units (a) Plan with Geometric Dimensions, and (b) Elevation with Dimensions

Figure 1(a) shows schematic diagram of building models plan bearing details of dimensions, wall notations, locations of openings and direction of the shock etc. Figure 1(b) shows elevation of wall W-1 for building models. Building models have been prepared using commercial sand based AAC block of size 600 mm (L) \times 100 mm (D) \times 200 mm (H). Door and two windows of reduced half-scale size are kept in both models to simulate physical attributes of realistic masonry building. Marble stone of 15 mm thickness was provided over door and window openings of building models to form a lintel. To ensure rigid diaphragm action for the building models, modular slab assembly of an equivalent weight against 80 mm thick reinforced concrete slab have been specially fabricated from equal angle steel sections and concrete cubes are placed uniformly in it as shown in Figure 2(d).

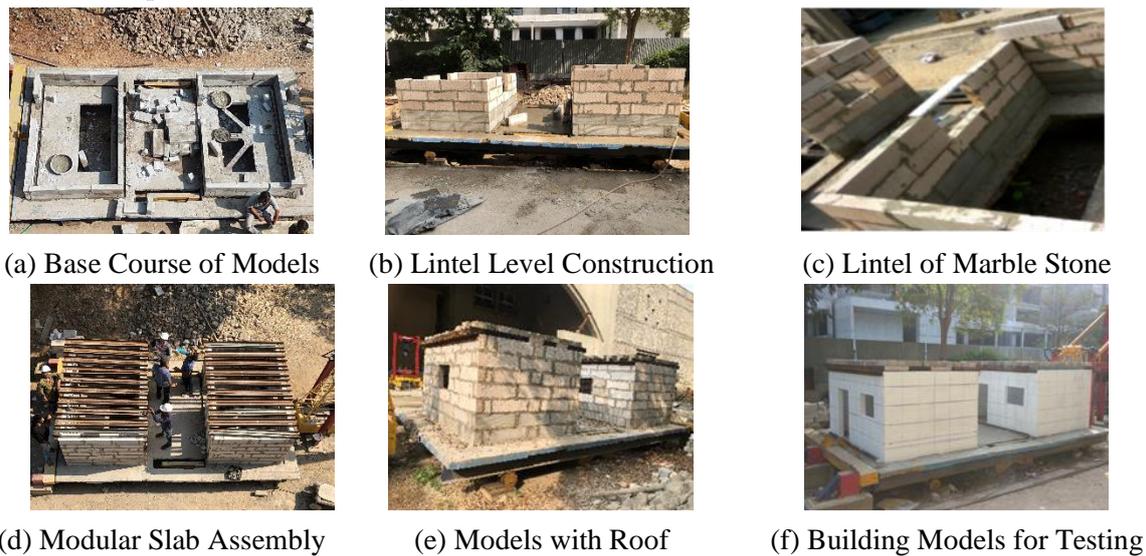
Fig. 2 Construction Phases of Half-scaled Masonry Building Models with AAC Blocks

Construction of AAC block masonry walls were completed in 3 working days which is almost half of the construction time for red-clay bricks/stones masonry walls constructed for other experimental studies at HSL in the past. Thus, construction of AAC block masonry walls substantially reduces construction efforts. Figure 2 presents various construction phases executed for half-scale building models on unique shock table facility.

Building models, shown in Figure 2(f), prepared following construction phases as discussed in Section 1, were instrumented with uniaxial accelerometers to measure acceleration at various locations under series of shock loading applied. Long walls of building models constructed perpendicular to the incident shock loading are expected to experience amplified acceleration at its top due to out-of-plane bending vibration. Therefore, 4 nos. of uniaxial accelerometers were attached to each long walls of the building models denoted with notations M1W1, M1W4, M2W1 and M2W4 wherein 'M' stands for model and 'W' for the wall. Short walls, parallel to the shock loading, of large in-plane stiffness are

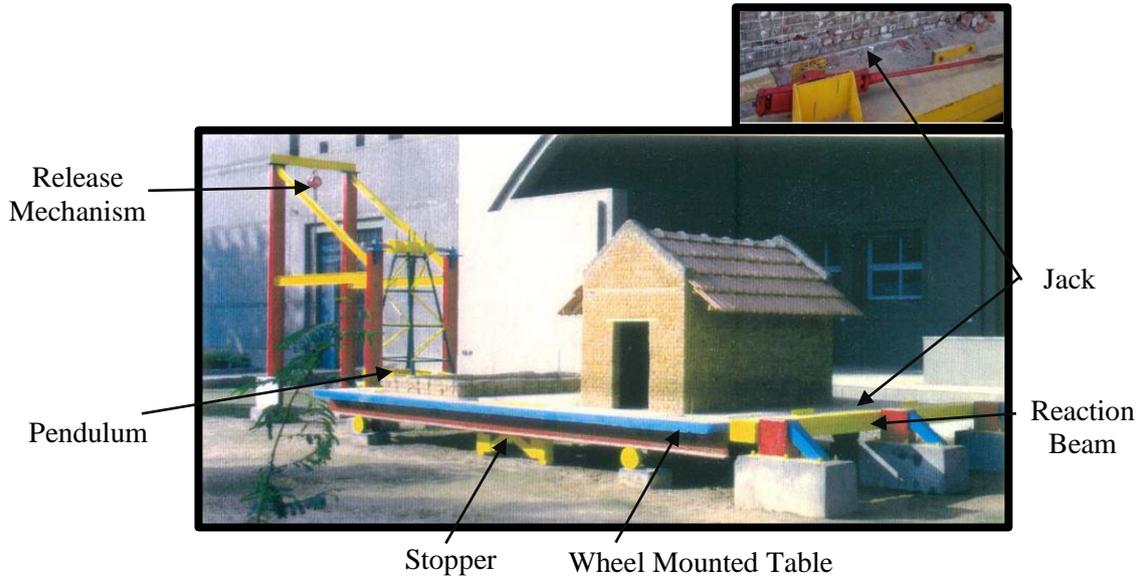
Fig. 3 Semi-sophisticated Shock Table Facility and its Components

Dynamic response of structures can be well studied by testing scaled model through sophisticated shake table facility in real time. However, high capital and heavy duty maintenance cost makes it non-affordable and thus, various researchers have used semi-sophisticated shock table facility of various forms [8] to study dynamic behavior of structures. In fact, shock table is a much cheaper alternative and still gives good enough insight to the dynamic problem. Shock table facility available at HSL comprises of a freely falling heavy pendulum imparting a shock to the concrete table mounted on roller. Figure 3 shows shock table facility with its components used in the present study as well as in past experimental studies [23]. Unlike in shake table where motion applied is controlled and back and forth, pendulum applies shock to the concrete table only in one direction. However, reaction beam as shown in Figure 3 imparts lower magnitude return shock when concrete table travel past the gap kept between concrete table and reaction beam before application of the shock for high energy impact shocks.

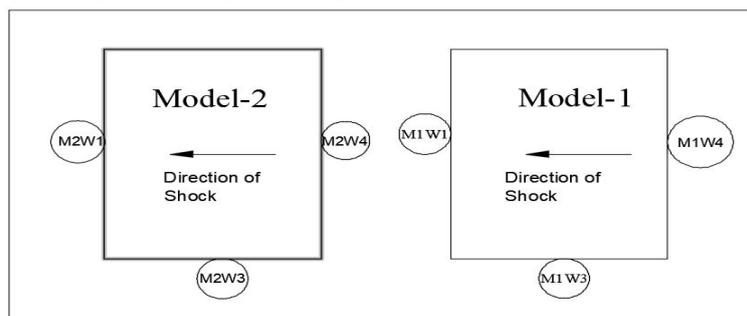
Fig. 4 Instrumentation Layout for Half-Scaled Building Models with Direction of Incident Shock Loading

Layout of accelerometer network with designated notation and direction of shock loading is shown in Figure 4. Wired uniaxial accelerometers are connected to data acquisition system from National Instruments (NI), USA and computer system to acquire real-time acceleration data during testing of building models and subsequent data processing.

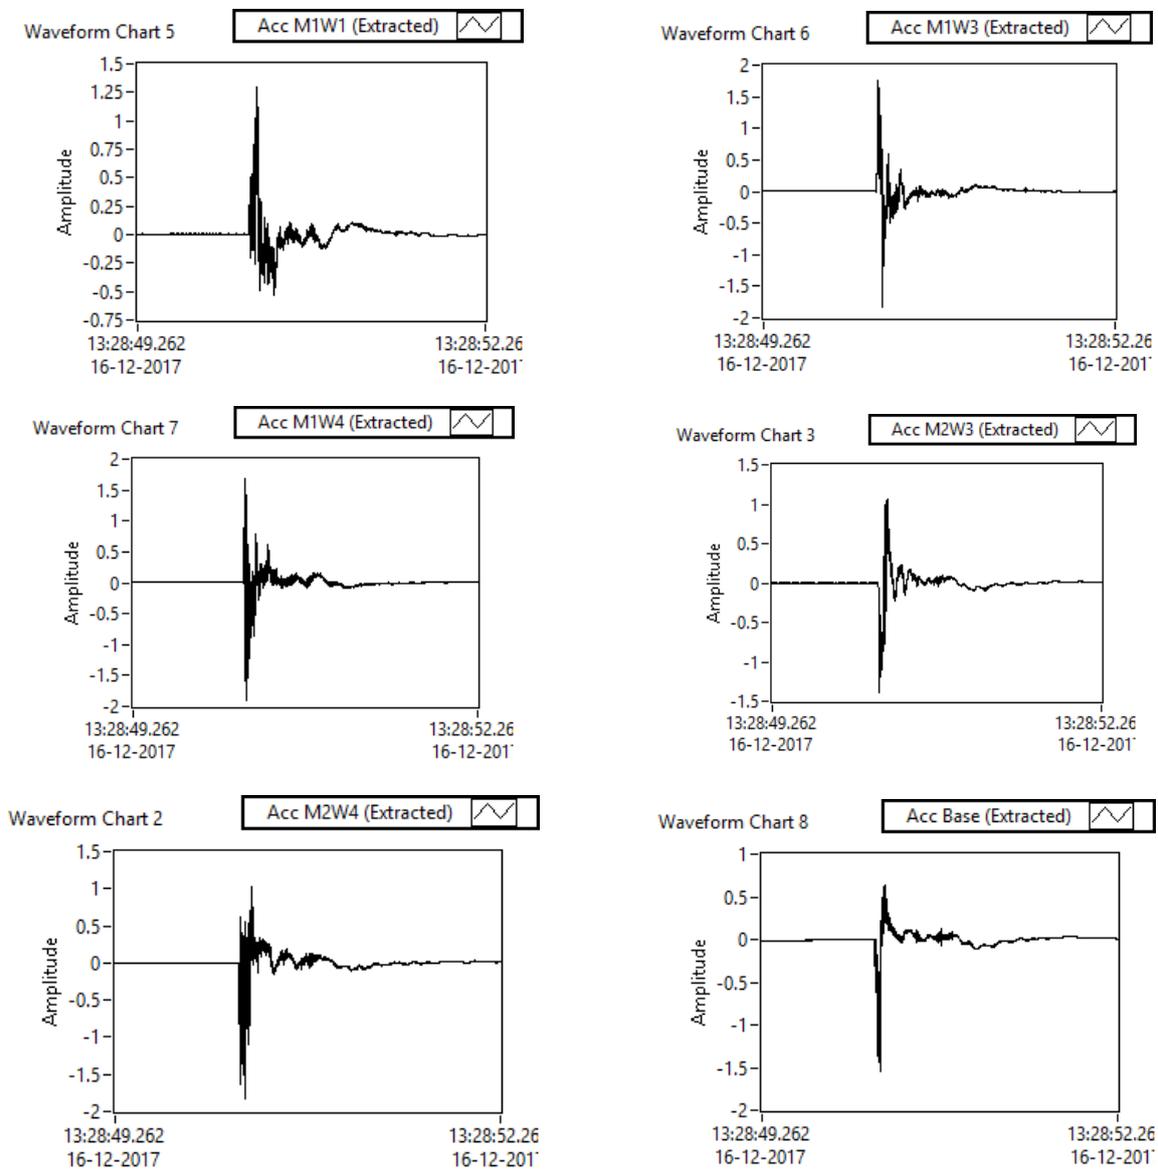
Fig. 5 Time-history Plot of Wall-1, Wall-3, and Wall-4 of Building Models for Shock No. 4 with Impact Angle 22.5°

Impact angle 15° produced same order of peak acceleration at base of building models $0.762g$ and $0.796g$, respectively. Wall-3 of both models showed peak acceleration of the same order that of base acceleration due to its rigidity. However, almost all long walls; wall-1 and wall-4 of building models yield amplification in peak acceleration due to out-of-plane bending and elastic stiffness. Impact Angle 22.5° , with an increment of 7.5° , resulted to $1.007g$ base acceleration with amplification in acceleration in almost all long walls of building models due to presence of minor cracks only. However, repeat

Acceleration data recorded in read-time are plotted for short and long walls of building instrumented with accelerometers under each shock loading applied. Figure 5 shows time-history plot of wall-1; wall-3 and wall-4 of building models and base acceleration under shock no. 4 with impact angle of 22.5°. It is evident that short and long walls of building models showed amplification in peak acceleration at top of the wall to base acceleration.

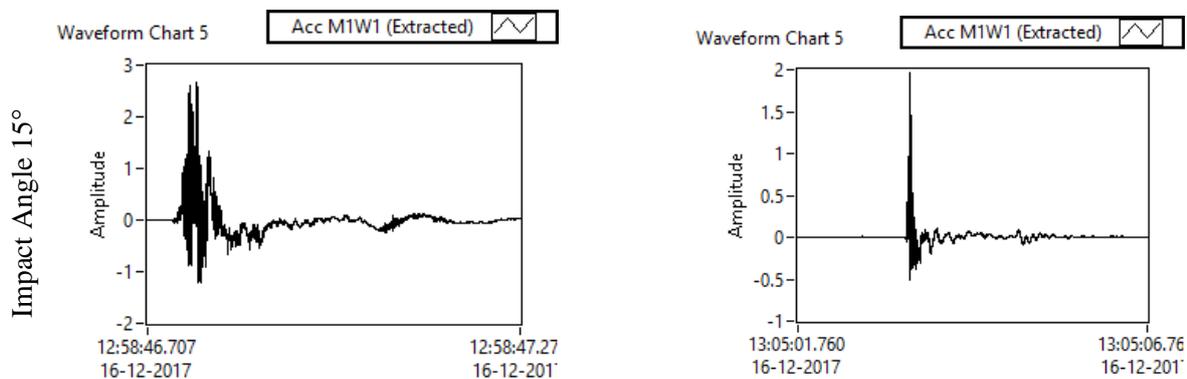
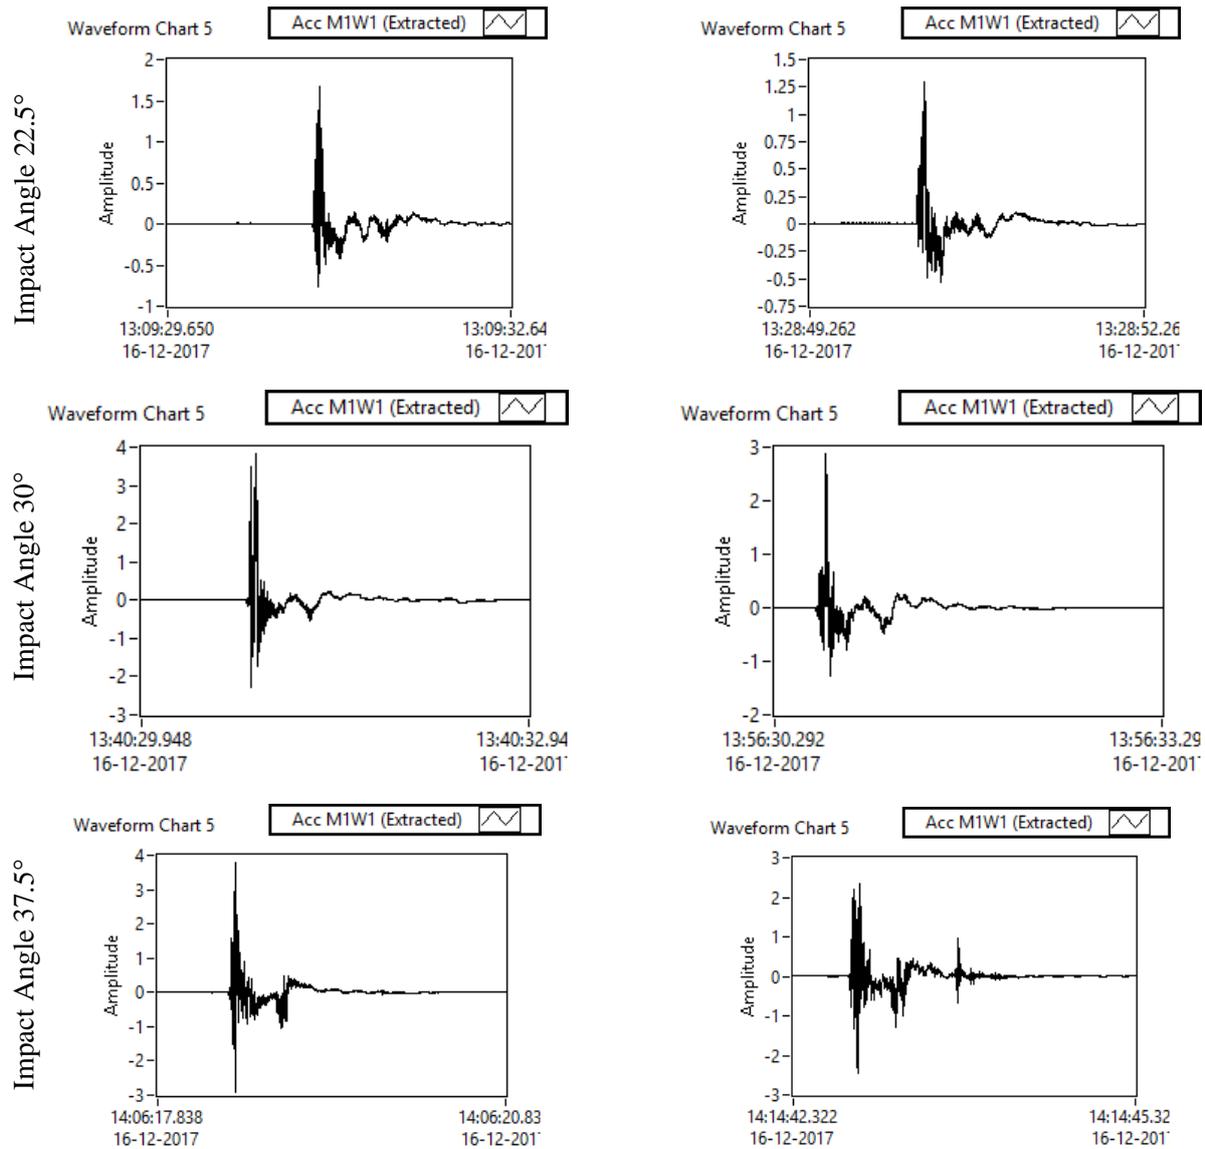
Fig. 6 Time-history Plot of Wall-1 of Model-I at Different Stages of Shock Loading

To understand dynamic behaviour of building models, time-history plot of each short and long wall were plotted for each shock loading. Figure 6 shows time-history plot of long wall; wall-1 of Model-1 at different stages (impact angle 15°-37.5°) of shock loading. Time-history plots for other short and long walls of building models were plotted but difficult to accommodate here.

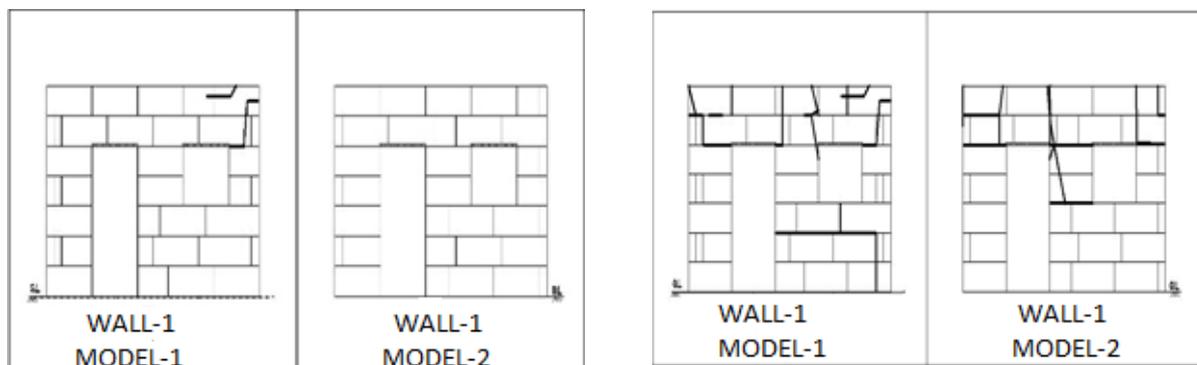
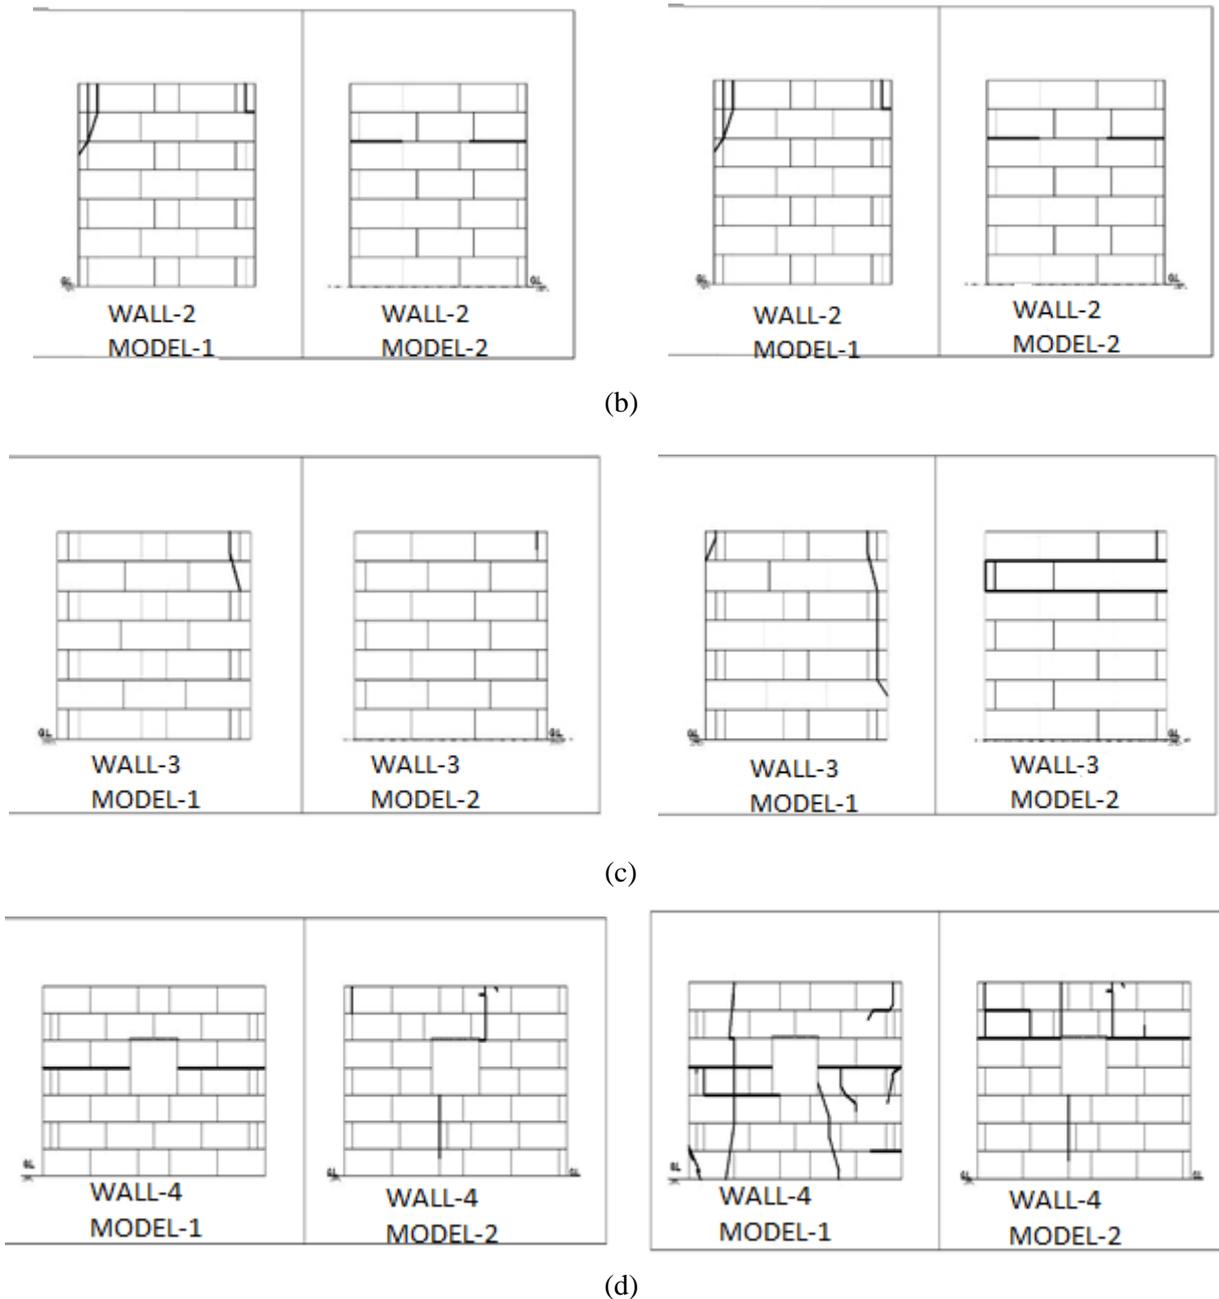
Fig. 7 Damage in the Representative Walls (a) Wall-1, (b) Wall-2, (c) Wall-3, and (d) Wall-4 of Building Models subjected to Shock with various Incident Angles

Figure 7(a) to Figure 7(d) shows crack pattern observed for walls; wall-1 to wall-4 of the building models constructed with AAC blocks to the representative shocks applied through pendulum released from 15° to 45° degrees as discussed above.

It is evident from Figure 7(a) to Figure 7(d) that both building models were suffered with through cracks in the AAC blocks as well as cracks in horizontal and vertical mortar bed joints across the height of the models. It has been observed that AAC building Model-2 built with stretcher bond withstand dynamic shocks relatively better than AAC building Model-1 built with English bond which suffered severe damages in various walls before it was collapsed.

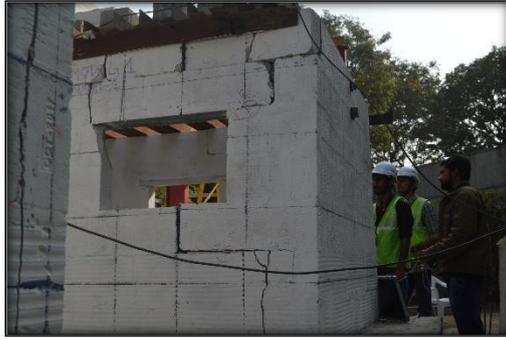
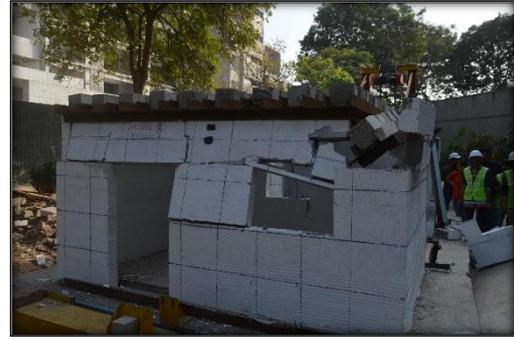
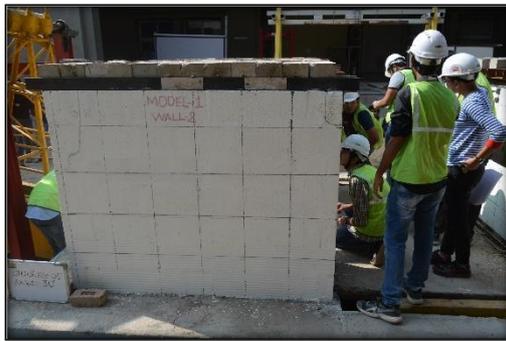
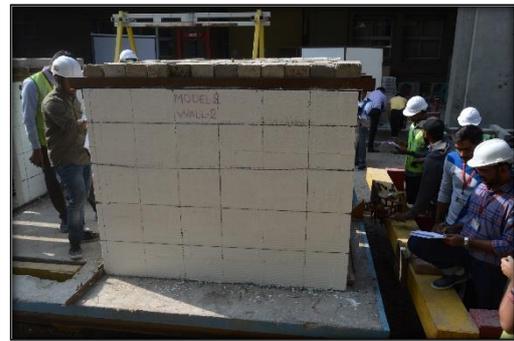
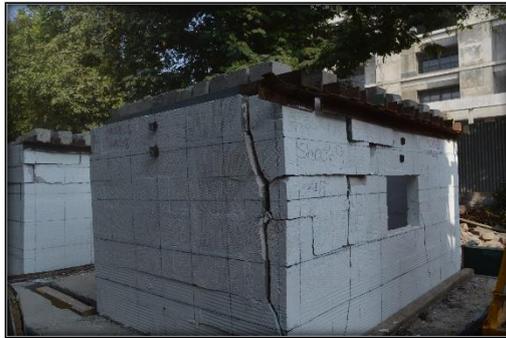
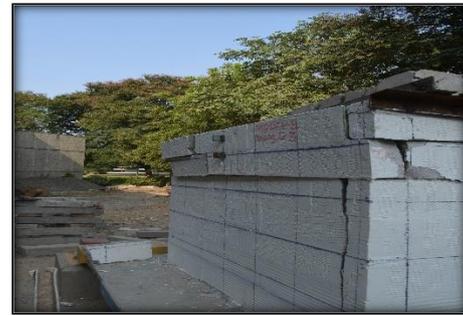
Fig. 8 Real Time Photographs of AAC Building Models with Damages in the Walls (a), Wall-1 (b), Wall-2 (c), Wall-3, and (d) Wall-4

Figure 8(a) to Figure 8(d) shows representative real time photographs captured at various stages of dynamic testing on building models built through AAC blocks.
