Bulletin of the Indian Society of Earthquake Technology

SEPTEMBER, 1967

SHUFFLING OF EARTHQUAKE DATA

LATERAL PRESSURE IN BINS DUE TO EARTHQUAKE TYPE HORIZONTAL LOADS

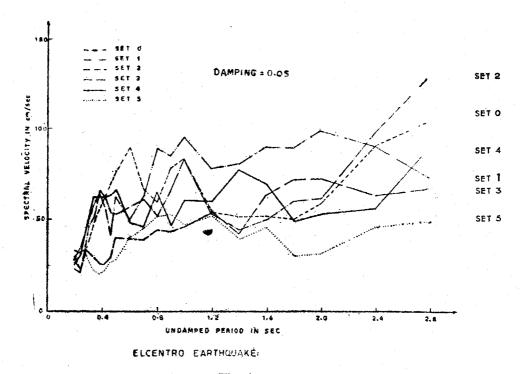
Fig. 1

The response has been obtained for two earthquake excitations namely Elcentro and Tast earthquakes and for various modified earthquakes for specified values of damping and period. Results have been obtained for various periods of vibration varying over a wide range from 0.2 sec. to 2.8 sec. The damping values considered are 5%, 10% and 20% of critical damping. Since the various responses, response spectral displacement S_d, response spectral velocity S_v, and response spectral acceleration S_a, are approximately related with one another by, simple relationships (2), for the purpose of discussion, velocity spectrum values are considered. These have been presented in the form of curves in figures 1 to 6. Spectrum curves for the modified earthquakes have been drawn on the same graph as for the original earthquake for comparison. It is noted that for large values of damping of the order of 0.20, there is no appreciable difference in response. Also for small values of period of vibration, the difference in the response is not significant. However for small damping values, the deviation in the response could be sufficiently significant.

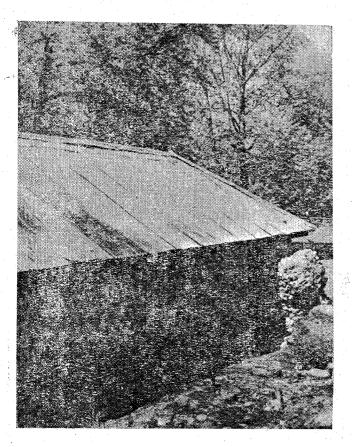
Fig. 3 Rolled Boulder which crashed into Dharam Shala in Mattan.

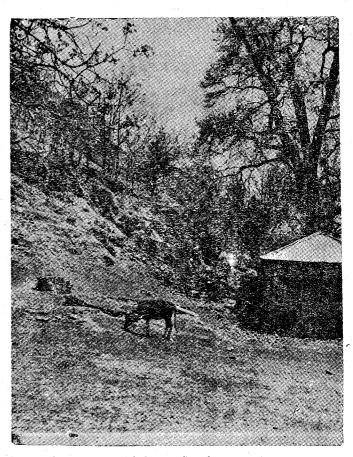
Fig. 4. View of the Hillside from where Boulder Rolled Down.

The plot of the isoseismals as shown in Fig. 2 is based on field data and on the spot questioning of the local people after the earthquake. Out of the worst affected places, Shangus, Hutmara and Mattan lie close to the left bank of the Lidder River; Sop lies on the right bank of the Bringi River and Doru on the right bank of the River Sandran, a few kilometres east of the confluence of this river and River Jhelum. Anantnag itself is just a few kilometres away from the right bank of River Jhelum. The damage in these places may be due to their situation on alluvium beds. Achabal, though it is situated within the triangle formed by joining Sop, Doru and Anantnag, and is only 34.1 Km. from the Epicentre, escaped vigorous shaking and had very minor damage. The Modified Mercalli Intensity value that could be assigned to this place is V. It is thus seen that the isoseismals plotted are neither circular nor elliptical—they appear to have been greatly influenced by the geological and soil conditions. Moreover, the instrumental epicentre, 33.5 °N, 75.5°E (approximately 41 Km. S.E. from Anantnag town) being near the Marbul Pass in the Pir Panjal Range of mountains, is a very sparsely populated area with practically no habitation. The absence of dwelling houses and buildings in the epicentral region thus leaves a void in the isoseismal study. It was fortunate that the epicentral tract was in the desolate mountains otherwise the damage would have been more itense and the toll of life would This earthquake and the Badgam earthquake of 1962 both were of have been larger. magnitude 5 5. Anantnag shock had a focal depth of 44 Km. However, larger number of lives were lost then-only one death (in Sop) has been confirmed for this earthquake. Reports of large scale slumping and fissuring of the earth have not been received, nor were such phenomena observed in the villages (and their neighbourhood) which suffered the maximum damage. There was, however, one instance in which an almost spherical boulder, 2.0 metres in diameter, rolled down a hillside in the precincts of the temple at Mattan. The boulder crashed into the rear wall of the temple "dharamshala" (Fig. 3) from a point cn a hillside about 15 metres away inclined at about 20° to the horizontal (Fig. 4).

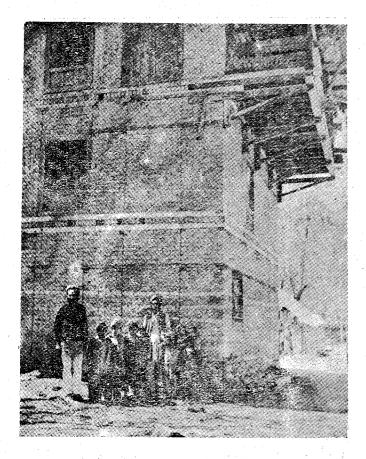
Fig. 5 "Dhajji-Diwari" Construction showing the Piers and the Infill. (Not the absence of bond between the two).

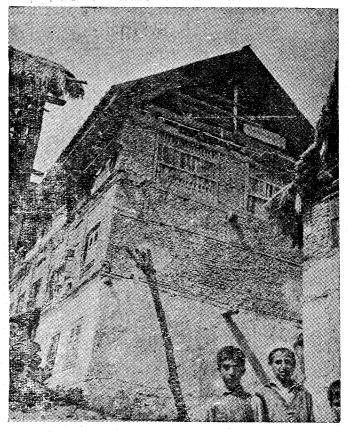
Fig. 6 Shoddy appearance of the Adobe Walls in Mud plaster

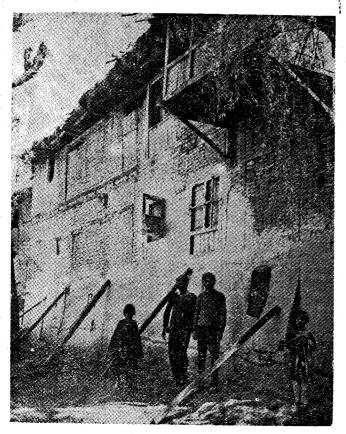
Fig. 7. Timber Rakers supporting out of Plumb Walls

Thus the construction appears to be such that a shock of intensity VI or even V (MMS) is sufficient to throw the wall out of plumb and even to cause damage beyond repair. Fig. 7 shows out-of-plumb walls supported by timber rakers. Fig. 8 is a close-up of the "dhajji-diwari" house shown in Fig. 7. The dressed exterior surface of the panel is separated both from the corner pier and remainder of the wall for lack of proper bond between themselves. The longitudinal section of an adobe pier is seen in Fig. 9. Absence of key stones is very conspicuous, both between the front and rear half of the pier and between the pier and the wall that has fallen apart altogether. Fig. 10 shows the damage of an upper storey wall and an adjacent pier. The mud-mortar which merely peeled off by the shock is seen lying on the floor. Fig. 11 shows the damage of a ground floor wall, and reveals the muck that is used for constructing such walls. Diagonal cracks may also develop in adobe walls bonded with mud mortar as in the case of the interior walls of the residence of the doctors of the Missionary Hospital in Anantnag (Fig. 12).

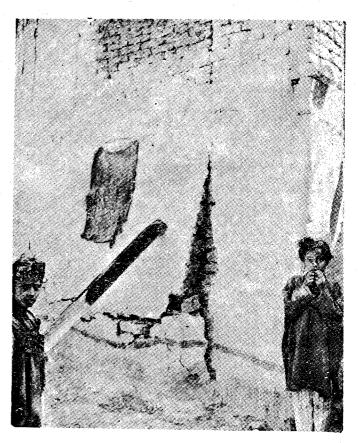
Fig. 8. Close-up of the Damaged Wall shown in Fig. 7

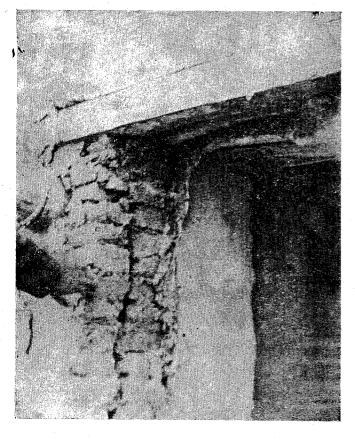
Fig. 9. Longitudinal Section of an Adebe Pier

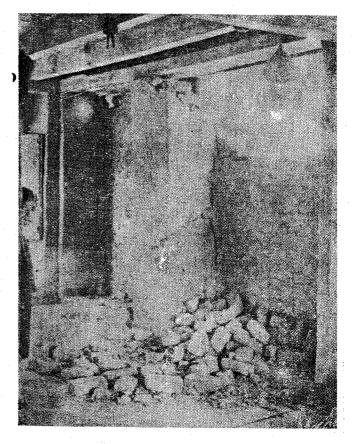
Fig. 10. Damage of Upper Storey Adobe Pier and Panel

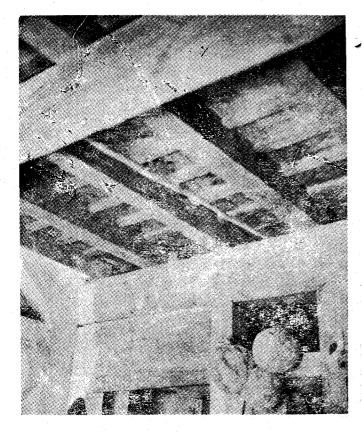
Fig. 13. Common Roofing System in a "Dhajji-Diwari"

The partition walls are usually brick-nogged, the timber framework consisting of vertical study usually 1 to 1.5 metres and horizontal timbers spaced 1 to 2 metres centre to centre. The cross sectional dimensions of these timbers vary, but are usually 75×40, 75×75, 75×100 mm. The partitions are usually half brick thick and laid in a stretching bond. No particular care or precaution is taken to prevent them from getting loose in case there is a mild tremor. Besides earthquakes, even the constant banging of the doors in the house is liable to shake the bricks loose and make the partition shaky since a proper bond between timber and brick is not easily achieved. Fig. 13 shows the brick infill shaken loose from the timber framework.

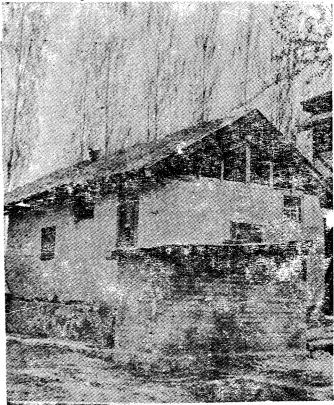
Fig. 14. "Dhajji-Diwari" with a Birch Bark Root

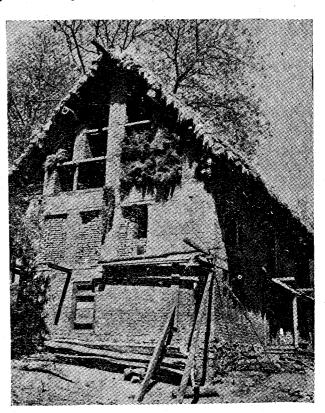
Fig. 16. Gable End of a Traditional Kashmiri "Dhajji-Diwari"

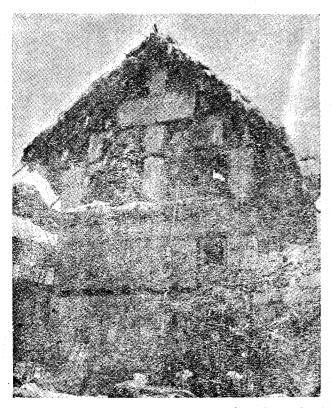
Fig. 17. Gable End of a Traditional Kashmiri "Dhajji-Diwari"

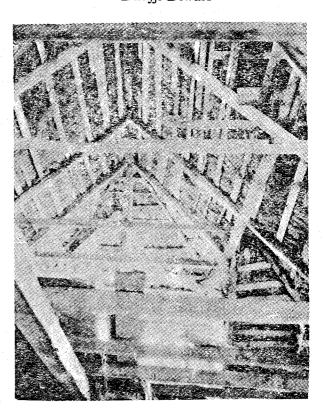
Fig. 18. Collar Roof Truss

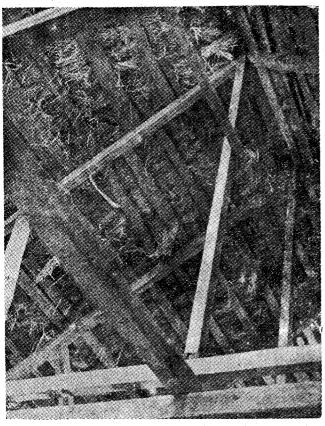
Fig. 19. Strutted Roof Truss

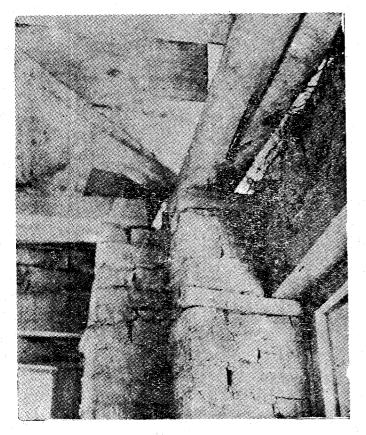
Fig. 21. Wall Plates of Short and Long Walls (Note the absence of connection between the two)

The trusses are simply nailed on the timber wall plates running over the long walls. In places where the wall is thin, the wall plates span over the adobe piers. In either case the wall plates are just held in place by mud mortar. In certain instances it was noted that there is absolutely no connection between the wall plates in the long and short directions (Fig. 22). This lapse in construction could prove (as it did in Anantnag earthquake) to be very costly since the various parts of the attic would vibrate independently rather than as a single unit in the event of an earthquake shock. Such a behaviour could lead to collapse of the roof and endanger the safety of the entire structure. The various elements of the truss are simply nailed apparently to reduce cost, and none of the better well known types of joints are adopted.

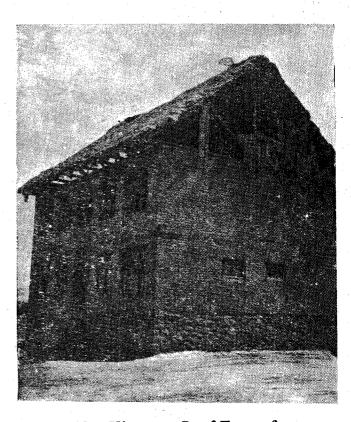
Fig. 20. King post Roof Truss of a "Dhajji-Diwari"

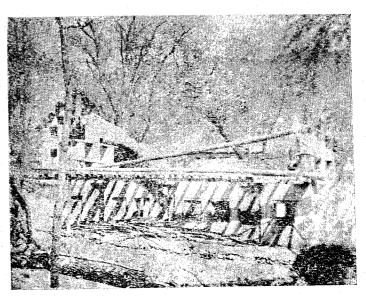
Fig. 22. Collapse of a "Dhajji-Diwari" in Batagund with pigeonhole type Gable

It was observed that "dhajji-diwaris" having roofing system of type (i) proved more hazardous than a trussed roof. This would appear to be obvious since the timber logs at ridge and eaves are supported on isolated adobe piers which experience vigorous shaking during earthquakes. Their strength in the lateral direction is almost negligibe and these are liable to collapse first, bringing down the whole roof along with them. Fig. 23 shows the collapse of such a house in Batagund (Isoseismal VI).

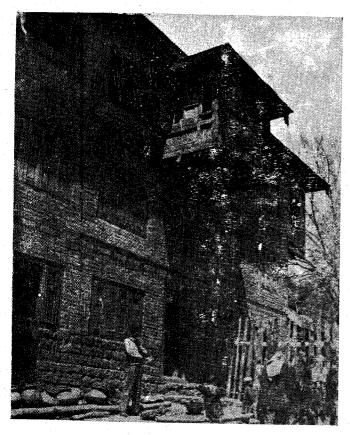
Fin. 23. "Dhajji-Diwari" construction having Double Timber Runners at the Rcof levels.

The most singular noteworthy feature of a "dhajji-diwari" is the embodiment of timber runners around the entire house, usually at the plinth and roof levels. These are known as "dassa" in the vernacular language, and provide a means of safety for the structure subjected

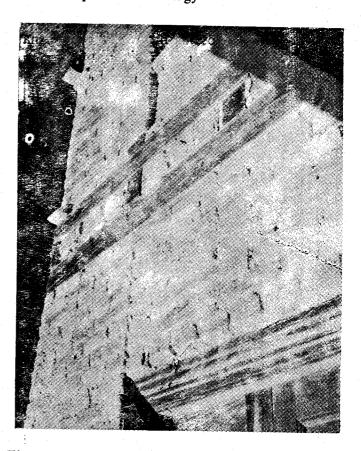
Fig. 24. Metal Straps connecting the Long and Short Wall Timber Runners at the Corner.

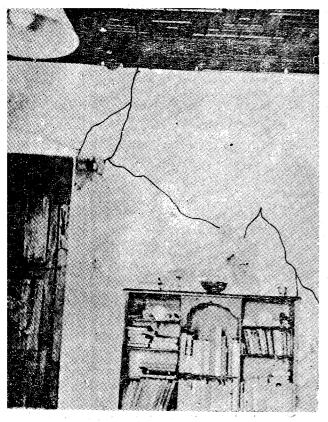
. 27. Diagonal cracking of interior Sun Dried Brick Masonry Wall in Mission Hospital, Anantnag.

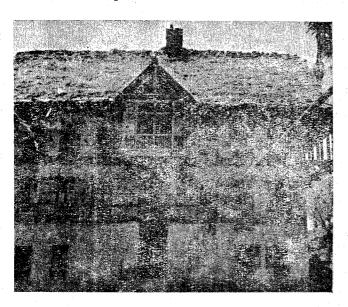
. 29. Undamaged "Dhajji-Diwari" house in Sop. (Note the large volume of timber used in the construction).

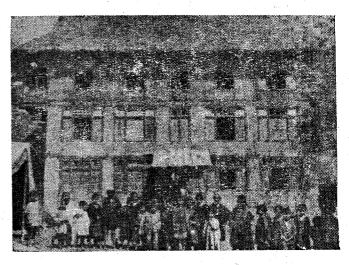
Fig. 28. Undamaged School Building in Batagund in which a large volume of Timber has beed used.

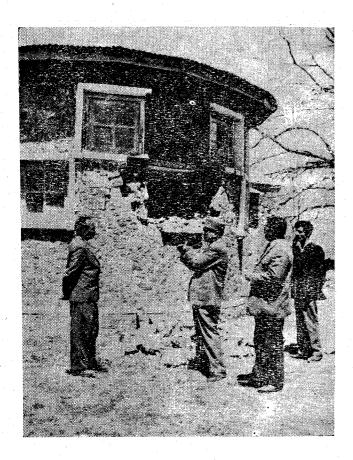
Fig. 31. Damage of Random Rubble Masonry Walls around Windows in B. D. O., Shangus.

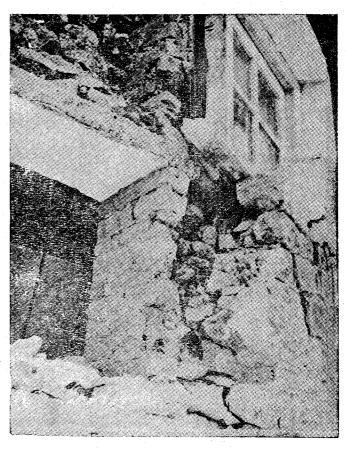
Fig. 32. Close-up of the Damaged Wall near Corner of Window seen in Fig. 31.

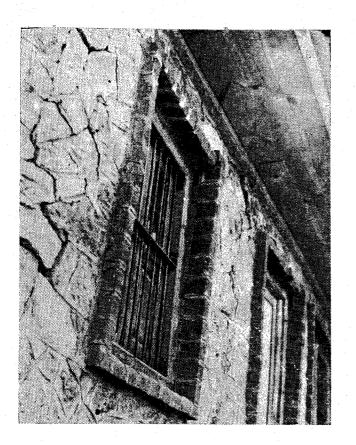
Fig. 35. Bulging of Random Rubble Masonry Walls of the Office of the Range Officer,
Mattan. (Note the difference between window frame and jamb).

The office building of the Range Officer, Lower Range, at Mattan was also badly affected and declared unsafe. It has a random rubble construction similar to the masonry work of B'ock Development Offices. The walls in this structure also were shattered beyond repair. At many places they bulged out due to lack of bond between the facing, hearting and backing From Fig. 35 it is to be noted that on account of bulging, there is a difference of about 25 mm between the jamb and the window frame.

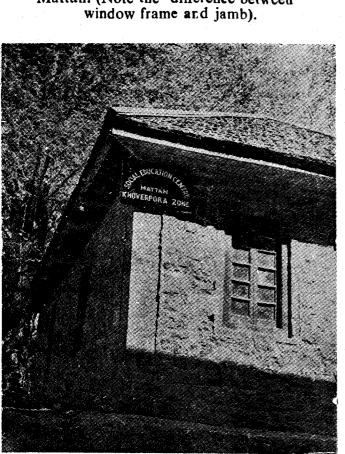
Fig. 37. Separation of the Brick Masonry Corner Pier from the Rubble wall.

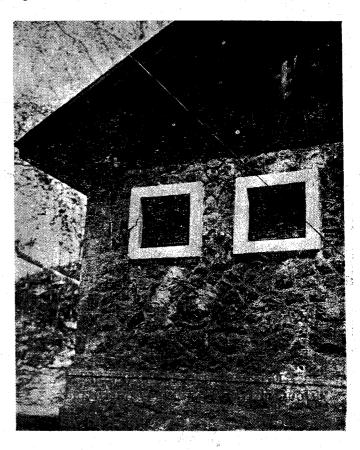
Fig. 36. Diagonal Cracking of Rubble Masonry Walls and Damage around Window opening of a House in Mattan.

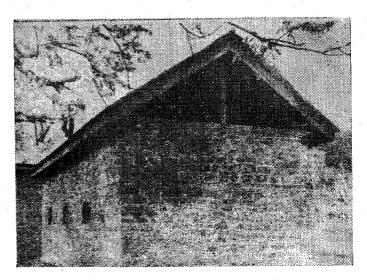
Fig. 38. Undamaged Coursed Rubble Masonry Construction with a Timber Runner at Lintel level in Mir Maidan.

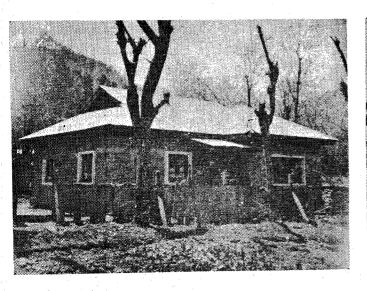
Fig. 39. Undamaged Random Rubble Masonry
House in Verinag with a Lintel Band

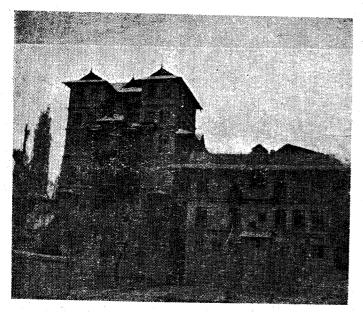
Fig. 43. Undamged Seven Storey Building in Anantnag.

stones: A seven storey structure with hipped roof covered with corrugated galvanised iron sheeting, and a three storeyed building with a birch bark roof are seen in Fig. 43. All these structures are seen to have the horizontal timber runners well connected at ends, and behaved admirably during the earthquake having very insignificant damage. This good behaviour may be attributed to better construction features and also due to the fact that they are situated in the outer northwestern section of the town which had a lower intensity.

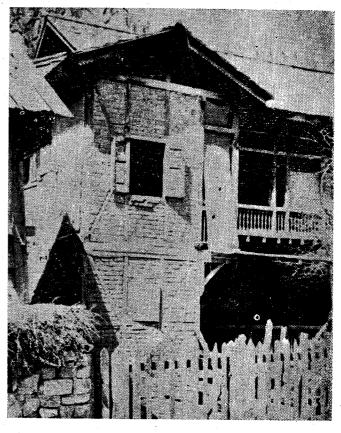
Fig. 44. Undamaged Brick-Nogged Structure in Mattan.

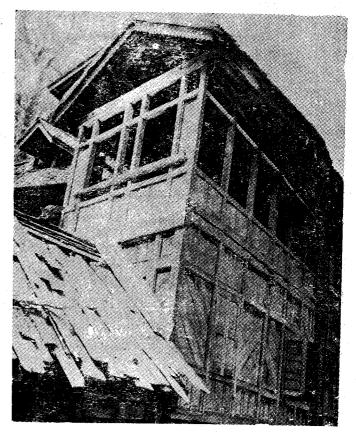
Fig. 48. Building in Mattan having Timber Panelled walls.

A building (in Mattan) having timber framework and wooden panelled walls, shown in Fig. 48, is earthquake resistant on account of its flexibility and ductility. Such structures are, however, recommended only with trepidation since there is always a danger of fire following the earthquake. The diagonally arranged wooden planks in the panels increase the strength of the walls in the horizontal direction.

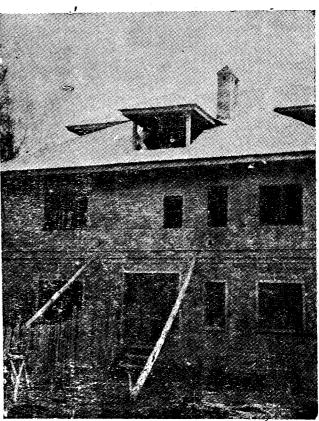
Fig 50. Damage of a New Brick Masonry Building in Mir Maidan.

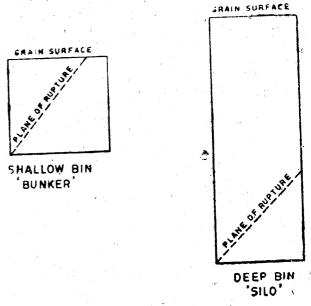
SILOS AND BUNKERS FIG. T

bins are called silos. (Figure 1).

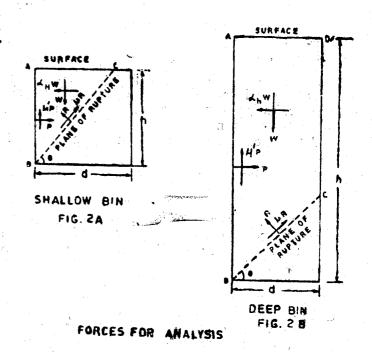
Shallow Bin (Figure 2A)

material between the wall and the plane of rupture. (Thus, they are due to mass ABC in case of shallow bin and mass ABCD in case of deep bin (Figure 2), where BC is plane of rupture).

The forces acting on the wedge are as shown in figures 2A and 2B. W is the weight of the wedge of material, α_H is the seismic coefficient, α_H W is the equivalent horizontal load, P is the total pressure on one wall and R is the reaction of wedge mass on the plane of separation, h is the height of bin, d is the lateral dimension of the bin, μ is the coefficient of friction of fill on fill, μ' is the coefficient of the fill and p denotes pressure at any depth from top.

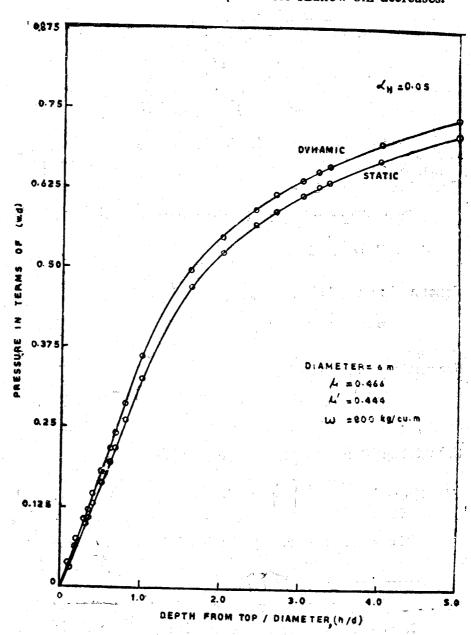
FIGURE 3

Tables 1 to 5 give static pressure as well as ratio of dynamic (seismic) to static pressure for the various conditions. The dotted line indicates the demarcation between shallow and deep bins. For one particular μ and μ' , namely for value of 0.466 and 0.444, graphs (figures 3. 4 and 5) have been plotted to indicate variation of pressures with respect to ratios.

It is observed that percentage increase in pressure is more for shallow bins compared to deep bins. Also, for a particular fill in shallow bins, the ratio of dynamic to static pressure is constant. For a s ismic cofficient of 0.10 and h/d ratio of 5.0 the maximum value of the ratio of dynamic to static pressure is about 10%.
