**45<sup>th</sup> ISET Annual Lecture**

**INSTABILITY OF MOUNTAIN SLOPES UNDERGOING LONG-TERM  
EFFECTS OF FAULT ACTION**

I. Towhata

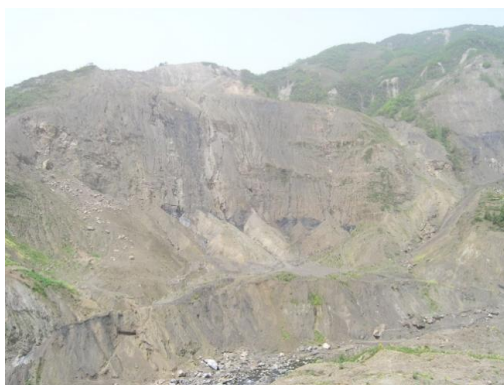
Fig. 3 One of the coseismic landslides triggered by the 2008 Wenchuan earthquake, China

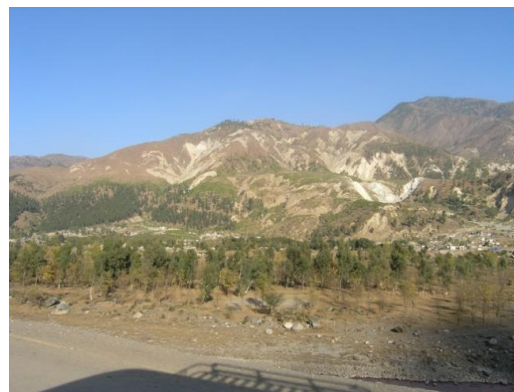
Fig. 4 Coseismic landslides in 2005 in Northern Pakistan, aligned along a fault valley near Balakot

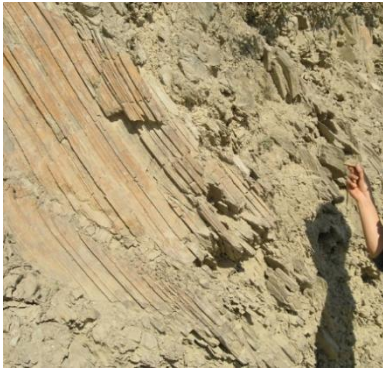
Fig. 5 Fractured rock near Muzaffarabad, Pakistan

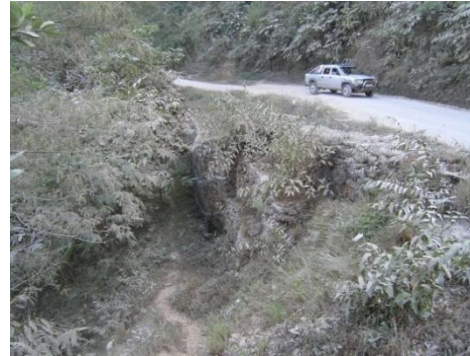
Fig. 6 Ground surface covered by powder of crushed siltstone, south of Tansen, Nepal

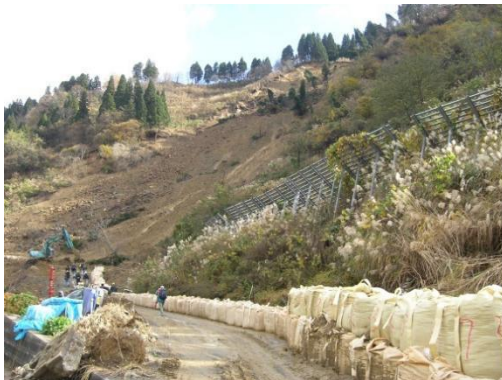
Fig. 7 One of the landslides in former Yamakoshi Village triggered by the 2004 Niigata-Chuetsu earthquake

The 2004 Niigata-Chuetsu earthquake of  $M_w = 6.6$  in Japan triggered many landslides in the Higashiyama Hills in the epicentral region (Figure 7). Being made of synclines and anticlines, this hilly terrain had been prone to landslides, implying the mechanical deterioration of the rock mass. Moreover, this hilly area had about 50% of its area composed of mud stone. It seems that, in the surface of slopes, the low confining stress allowed water absorption of mud stone and resulted in decay of the stone to just mud. This was particularly the case in road embankment made of crushed mud stone (Figure 8). Consequently, many coseismic landslides occurred and the rescue work by ground transportation became impossible.

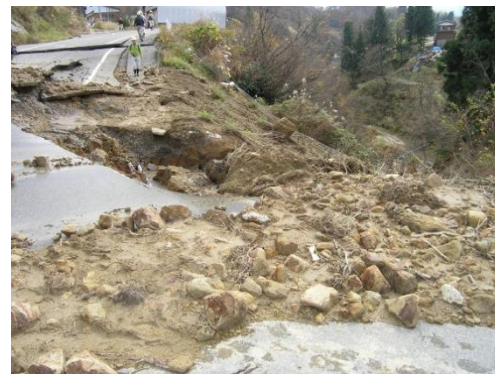
Fig. 8 Coseismic failure of road embankment in the same area as in Figure 7

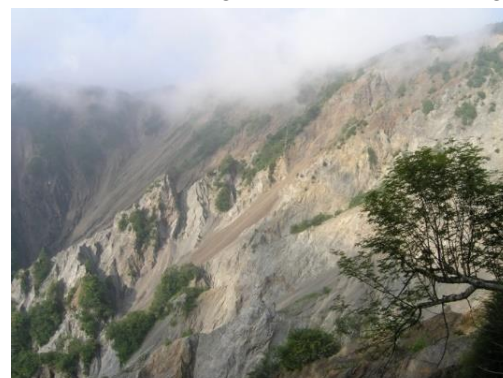
Fig. 11 Slope failure of Shichimenzan Mountain

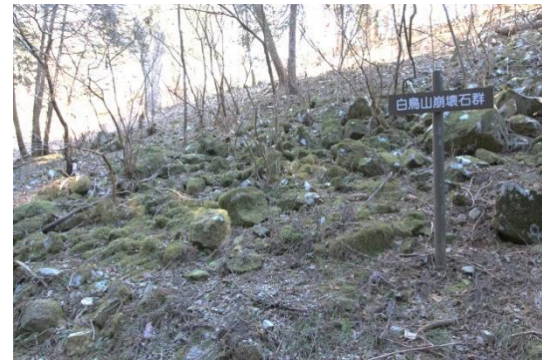
Fig. 13 Cobble deposit at the failure site of Shiratoriyama

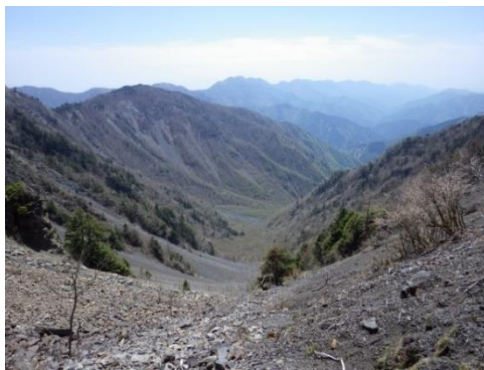
Fig. 14 Ohya landslide as seen down-ward from its top

The bigger Ohya Landslide (Figure 14) legendarily collapsed during the 1707 Hoei earthquake and, since then, has been unstable for three centuries. The rock at Ohya site is fractured into small pieces (Figure 15) and suggests the past deteriorating effect of tectonic actions of many faults in its vicinity (Figure 16). Furthermore, creep deformation in Ohya is verified by linear depression and the downstream river channel is filled with cobbles.

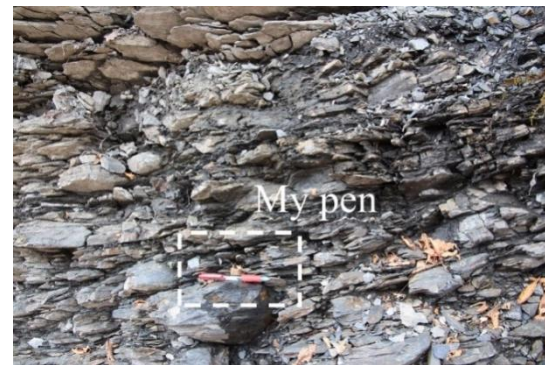
Fig. 15 Fractured rock of Ohya landslide site

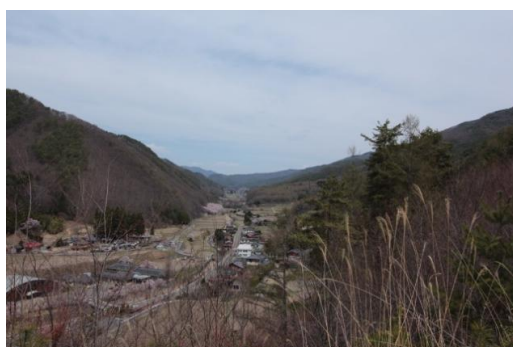
Fig. 17 Straight fault valley formed along the Median Tectonic Line (Ina Segment) in Central Japan

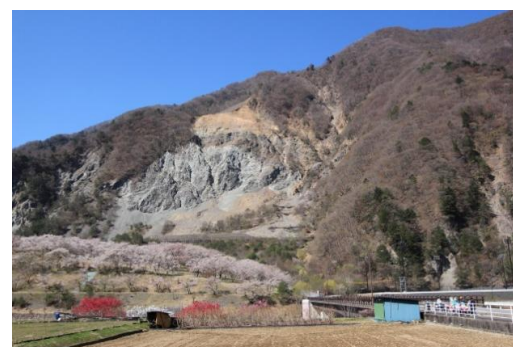
Fig. 18 Ohnishiyama rainfall-induced slope failure in apparently fractured geology, Ina segment of MTL

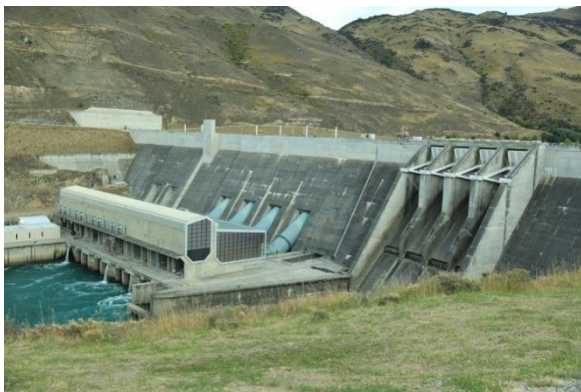
Fig. 20 Clyde Dam in Southern Island of New Zealand

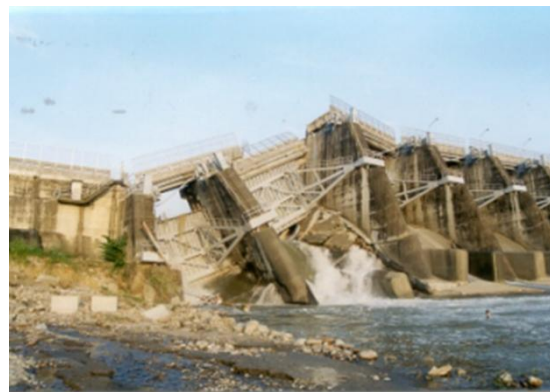
Fig. 21 Sigang Dam that was destroyed by fault uplift during the 1999 Chi Chi earthquake

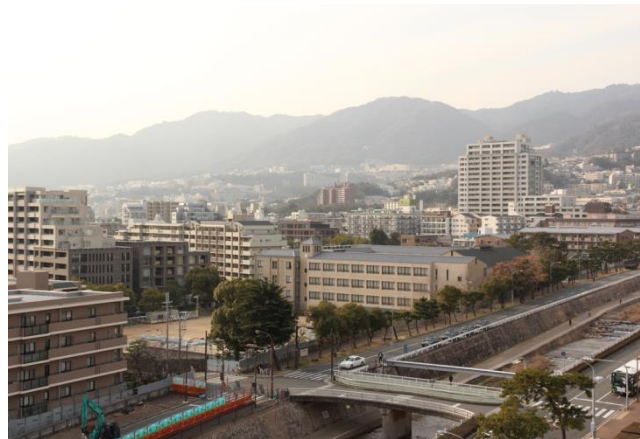
Fig. 23 Alluvial fan of the Sumiyoshi River

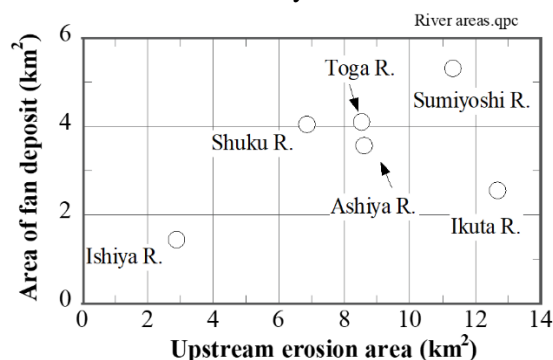
Fig. 24 Relationship between area of upstream river basin and the downstream alluvial fan of rivers ( $R = 0.51$ )

The watersheds and alluvial fans of the six studied rivers were illustrated in Figure 22. Then, their areas are examined in Figure 24 in which a positive correlation is recognized. This suggests that the bigger upstream area of erosion can produce the greater size of the alluvial fans. Although this point is understandable, the correlation coefficients,  $R$ , is 0.51 which is not satisfactory. The issue is that the product of mountain erosion can be more reasonably evaluated in terms of the sediment volume in place of area.

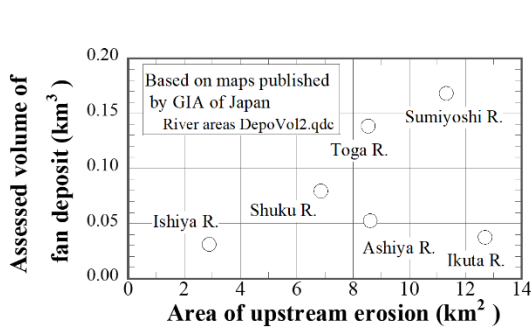
Fig. 26 Relationship between area of upstream river basin and assessed volume of alluvial fan ( $R = 0.35$ )

The volume of the deposit was assessed in an approximate manner as illustrated in Figure 25 in which the area of fan is denoted by  $A_f$  and the height of this deposit,  $H_e$ , was determined by the elevation of the tip of the fan (or exit of the river stream from mountains), while the elevation of fan perimeter was set at the sea shore (0 m above sea level). Note that the method in Figure 25 ignores the sediment that stays under the present sea level (the sea level used to be higher in warm periods and lower in glacial periods) or flowed into the sea and lost from the fan. The present study assumes that this type of ‘error’ affects the data of six rivers equally because they are located in very similar geological environment. Hence, no more discussion is made of this ‘error’. The results were plotted in Figure 26 and the correlation coefficient for the fan volume decreased to 0.35. Thus, the fan volume does not improve the correlation.

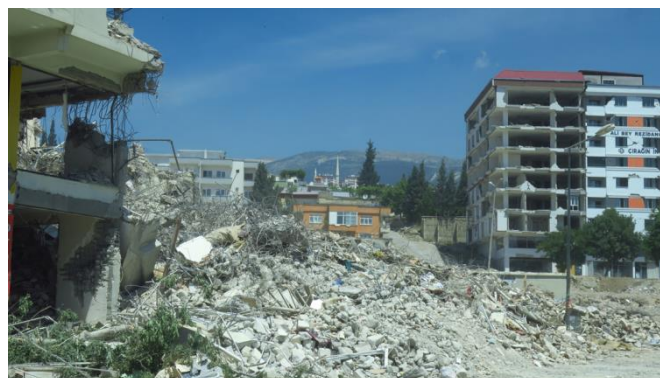
Fig. 28 Building damage in Kahramanmaraş

Heavy damage (Figure 28) was reported, first, in Kahramanmaraş in the central part of Figure 29. Furthermore, the damage was heavy as well in Antakya near the southwestern (SW) end of the fault-parallel coordinate in the figure. The author supposes that the Antakya damage was total devastation, while that in Kahramanmaraş was less devastating. Accordingly, the earthquake motion records over the entire region in Figure 29 were studied to find that the SW parts were hit by motion with stronger amplitude and longer period that appears more destructive to structures there. For publication, the research details were summarized in Towhata et al. (2024).

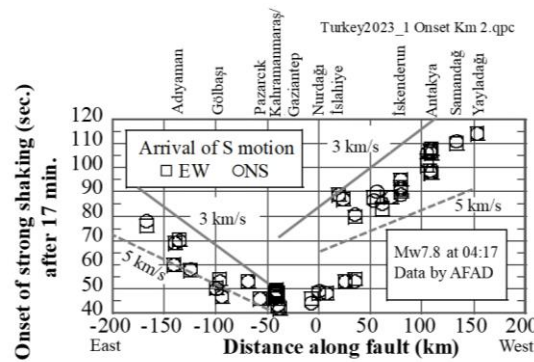
Fig. 32 S-wave arrival time in records at points along the fault coordinate

Figure 32 plots the arrival time of the main (S-wave) phase of ground motion at places close to the fault coordinate (see Figure 29). The first arrival occurred obviously near the epicenter and then the arrival took place to the east, then followed by the western part. Because the observation points are close to the fault coordinate, it is reasonable that the gradient of coordinate versus time stands approximately for the rupture propagation velocity,  $V_R$ , of the fault. The data in this figure suggests that  $V_R$  lies between 3 and 5 km/s in most part and particularly in the western segment of the fault. By reasonably assuming that the S-wave propagation velocity in earth crust is  $V_S = 3$  km/s, the following discussion is made of the phenomenon of supershear in which  $V_R > V_S$ .

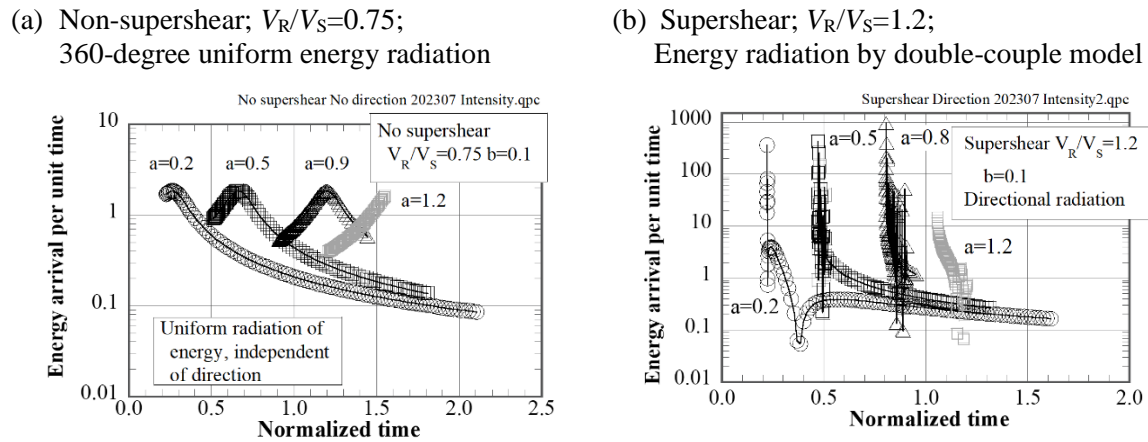
Fig. 35 Energy arrival per time or intensity of velocity response caused by supershear fault rupture (calculated at point of  $x=aL$  and  $y=bL$  with  $b = 0.1$ )

Figure 35 compares the energy arrival per unit time at points of  $y=0.1 \cdot L$ . The energy per time is theoretically equivalent with  $velocity^2$ . In case of non-supershear (Figure 35a), the peak energy arrival per unit time is approximately 2 (called normalized non-dimensional energy per time). Then, a supershear was calculated with consideration of the directional energy emission (double-couple mechanism) that is

maximum in  $x$  and  $y$  directions while zero in the intermediate directions. The total energy emission was held unchanged from that of the uniform emission. The results in Figure 35b indicates that the intensity of motion was nearly 500 times greater than the case of non-supershear. This difference is equivalent with approximately 20-times difference in velocity. Of further interest is that the maximum energy arrival increases from  $a = 0.2$  towards  $a = 0.8$  near the end of the fault, as observed in Antakya. Although these findings are affected by simplification in modelling, they are still consistent with the field observation.

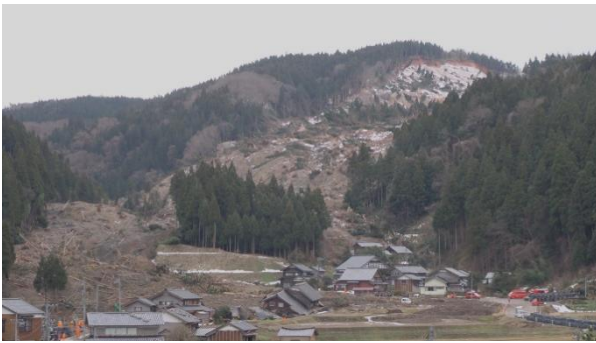
Fig. 38 Coseismic landslide at Ichinose, Noto Peninsula

The 2024 Noto Peninsula earthquake of  $M_w = 7.5$  triggered profound damage not only in buildings and infrastructures but also in mountain slopes and cliffs (Figures 38 and 39). Furthermore, a new negative experience for disaster mitigation discipline was the effect of coseismic uplift along the northern coast of Noto Peninsula (Figure 9). Because the causative fault mechanism off the coast was of a reverse type in which its southern side moved upwards, the coastal area underwent substantial uplift. Figure 40 indicates what happened in Kuroshima Harbor and the uplift was as large as 3 meters. This uplift dried up the harbor and made the access of fishing boats impossible. Figure 41 shows even a worse situation in Kaiso Fishing Harbor where the uplift was 4 m. This is the biggest uplift during this earthquake.

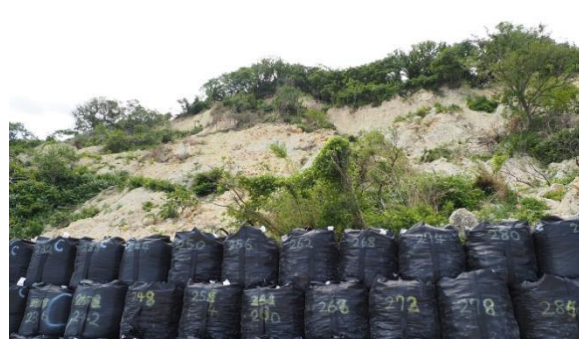
Fig. 39 Coseismic fall of sea cliff made of tuff, Nagahashi, Noto Peninsula

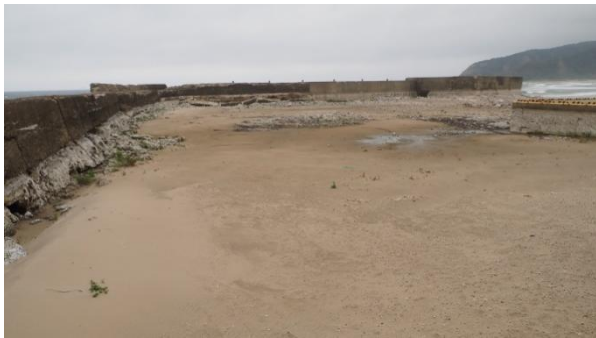
Fig. 40 3-m uplift of sea bed in fishing harbor of Kuroshima, Noto Peninsula

- One of the major industries in Noto Peninsula is fishing and the uplift of the fishing harbors (Figures 40 and 41) are fatal issues for sustainability of local communities. From the engineering viewpoints, the operation of the harbors can be resumed by digging the uplifted sea bed (as practiced in Muroto Harbor, Japan, after the 1946 Nankai earthquake of  $M_w = 8.4$ ; Muroto City Government, 1989) or constructing new harbors at offshore relevant locations. The problem is the needed cost, which
