SEISMIC PERFORMANCE OF REINFORCED CONCRETE BUILDINGS DURING BHUJ EARTHQUAKE OF JANUARY 26, 2001

Pankaj Agarwal*, S.K. Thakkar** and R.N. Dubey*

ABSTRACT

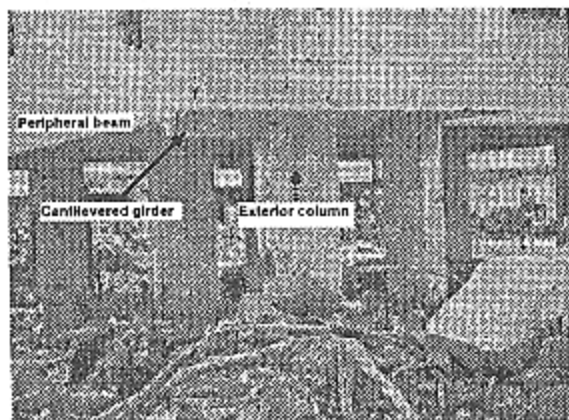
are generally constructed with infill wall made of unreinforced bricks, cut stones or cement concrete blocks. In major commercial cities, the ground floor/basement is often used for commercial and parking purposes, where the infill walls are omitted, resulting in soft or weak storeys. Most of the buildings have overhanging covered balconies of about 1.5 m span on higher floors. The architects often erect a heavy beam from the exterior columns of the building to the end of the balcony from the first floor onwards. A peripheral beam is provided at the end of erected girder to create more parking spaces at the ground floor and to allow more space on the upper floors. The upper floor balconies or other constructions are constructed on the peripheral beams. The infill walls, which are present in upper floors and absent in the ground floor, create a floating box type situation (Figure 2).

Fig. 2 Floating box construction in residential building in Ahmedabad (Goel, 2001)

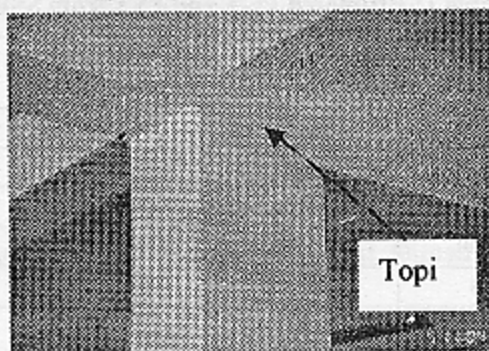
Columns in most of the buildings are of uniform sizes along the height of the buildings, with marginal change in the grade of concrete and reinforcement at ground floor. It is apparent that the columns are designed only for axial load, without considering the effect of framing action and lateral loads. The ground floor columns are not cast up to the bottom of the beam, and a gap of 200 mm to 250 mm is left, called as "topi", to accommodate the beam reinforcement, which makes the construction more vulnerable (Figure 3). Due to congestion of reinforcement in this region, the compaction of concrete is not properly done which results in poor quality of concrete and honeycombing.

Fig. 3 Typical construction detail of "topi"

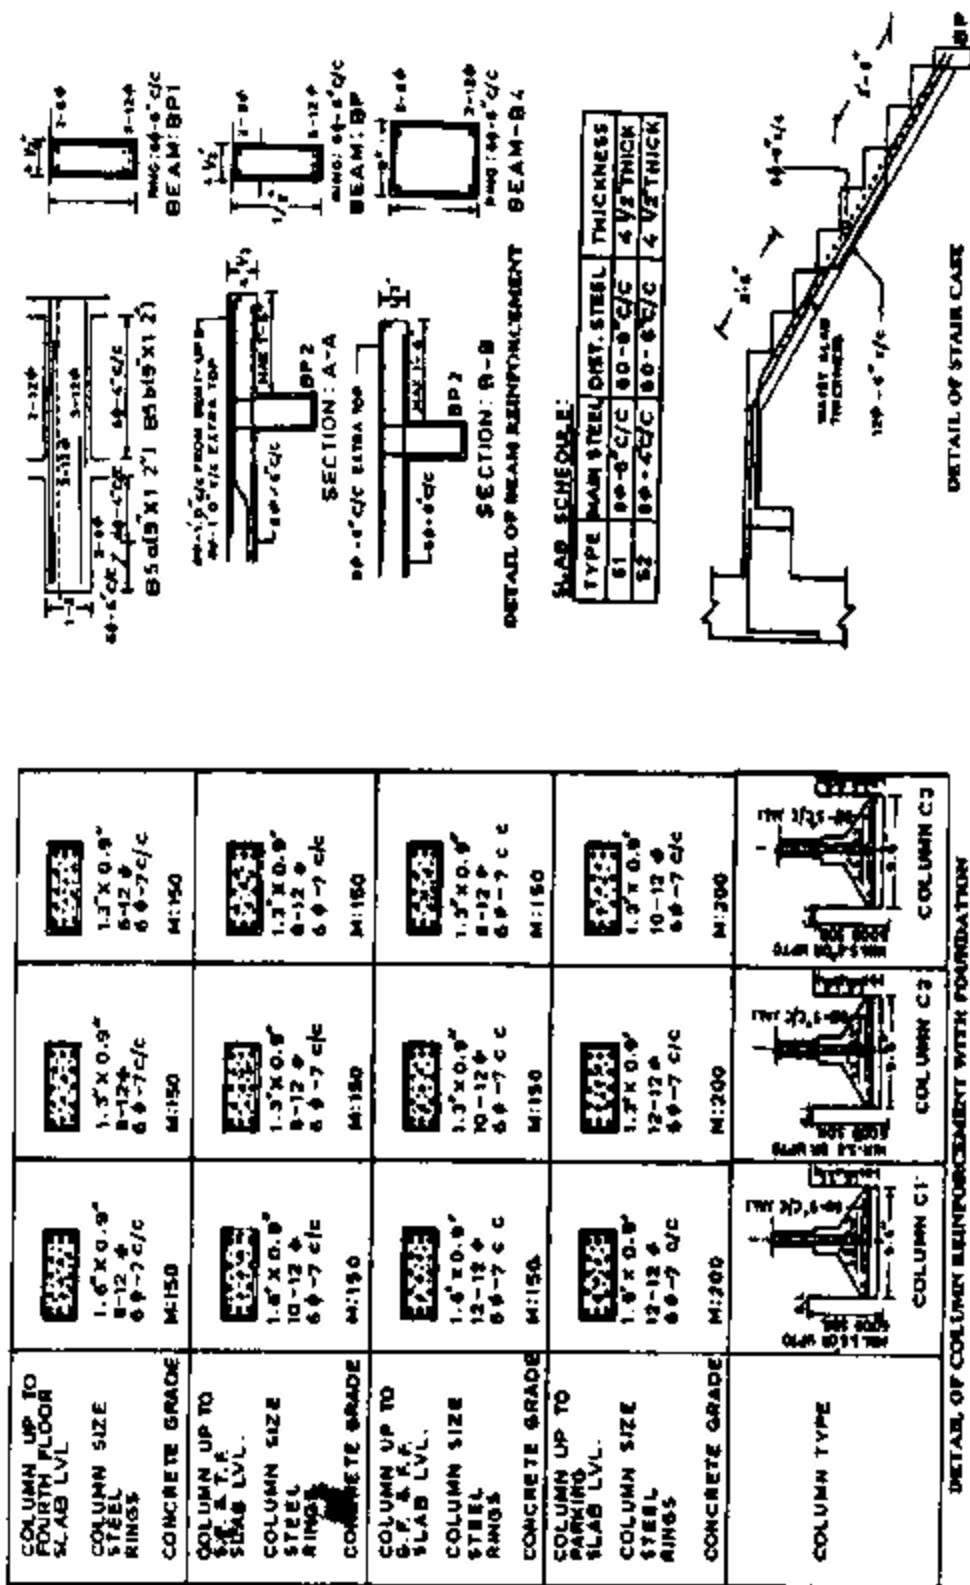
Fig. 7(b) Reinforcement detailing in structural members of a typical residential building (G+4) in Ahmedabad

Some of the design deficiencies which are clearly manifested are: the grade of concrete used in columns is M15, while the recommended value is M20, and isolated foundations with no tie beams. There is no sign of special confining reinforcement in any of the structural members.

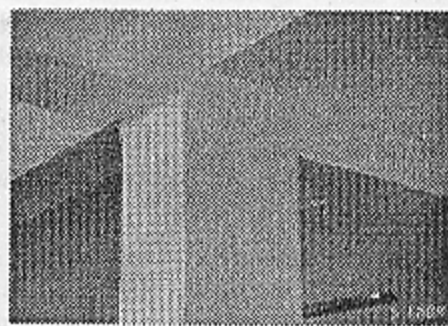
Buildings which were inspected during the team's visit, have been found with little evidence of failure of beams. There are numerous cases in which the beam-column joints of multi-storeyed buildings have been damaged. Figure 18a shows an example of damage at beam-column joint in a reinforced concrete building. One typical feature of joints constructed in RC buildings is shown in Figure 18b, where

(b) Detail of beam-column joint

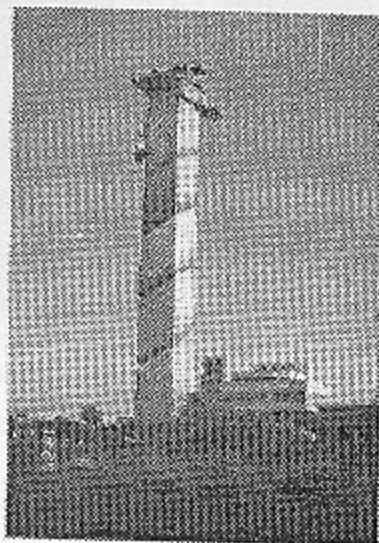
Figure 24 shows the undamaged lift core of a building during the earthquake at Gandhidham. Elevators constitute an integral part of building, and are vulnerable to earthquakes. It is important to prevent damage to the elevators for the following reasons: (i) there is danger to the passengers trapped during the event and there are difficulties in rescue operations, (ii) undetected damage can cause substantial danger in elevators used after the earthquake, (iii) vertical circulation systems (elevators and stairs) are essential in hospitals which deliver crucial health services after an earthquake.

Fig. 24 Undamaged lift core of a reinforced concrete building
