EFFECTS OF THE DECEMBER 26, 2004 SUMATRA EARTHQUAKE AND TSUNAMI ON PHYSICAL INFRASTRUCTURE

Murat Saatcioglu*, Ahmed Ghobarah** and Ioan Nistor*

ABSTRACT

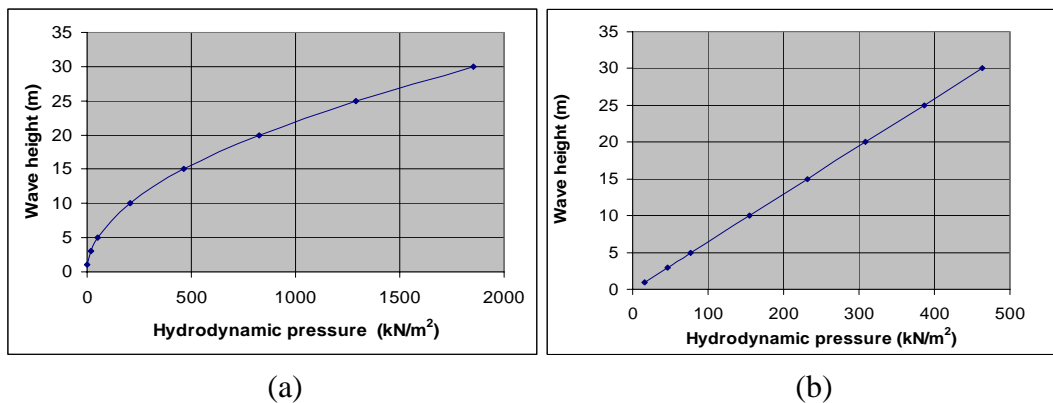
Equation (1) gives an empirical expression for the estimation of impulsive water pressure of breaking waves, developed by Goda (1985). Accordingly, wave impulse pressure is a function of specific gravity of water, water celerity, wave height and impact duration. The variation of wave pressure obtained from Equation (1) is plotted in Figure 12(a) as a function of water height:

A simpler expression that is more applicable to the mechanism of tsunami wave impact was suggested by Hiroi (1919) for the estimation of uniform dynamic pressure as a function of sea-water specific gravity and wave height. The expression is given in Equation (2). The variation of uniform lateral pressure, as computed from Equation (2), is plotted in Figure 12(b):

The hydrodynamic tsunami wave pressure obtained from Equation (2) was compared with wind design pressure specified in the National Building Code of Canada (CCBFC, 1995) on a building located at the coastal city of Vancouver, Canada. It was found that the tsunami pressure at the first floor level could be approximately 26 times the design wind pressure in Vancouver, explaining the widespread damage to masonry walls observed within the first stories of most buildings. Design lateral forces due to wind and seismic effects were compared with the estimates of lateral forces generated by a tsunami of 5 m water height. A sample 6-story, 3-bay reinforced concrete frame structure in Vancouver, Canada was used for this purpose. The comparisons of lateral forces are shown in Figure 13. It was found that the total base shear due to tsunami was about twice the base shear due to wind and 60% of that caused by elastic seismic forces and 2.5 times the inelastic seismic design base shear for a ductile moment resisting frame building. While this comparison is presented to provide a feel for the magnitude of tsunami forces on buildings in Thailand, it is important to recognize that the same comparison could give vastly different results for buildings with different heights, different exposure conditions and different structural mass, especially for different tsunami water heights. Another important aspect of tsunami pressures on structures is the nature of the exposed area. Because of the relatively high level of tsunami pressures generated, non-structural elements, like infill masonry walls, often collapse immediately after the application of tsunami wave pressure, and reduce the portion of the load transmitted to the structural elements. The non-structural elements, though suffer extensive damage under tsunami pressures, tend to act like a fuse for the load carrying system, reducing the amount of lateral loads transferred to the structure. Consequently, a more detailed investigation of the mechanism of tsunami load transfer among exposed elements should be conducted before the tsunami loads can be assessed accurately.

Fig. 12 Estimates of breaking wave impact pressure on a structure at the coast: (a) wave pressure as per Equation (1) (Goda, 1985); (b) wave pressure as per Equation (2) (Hiroi, 1919)

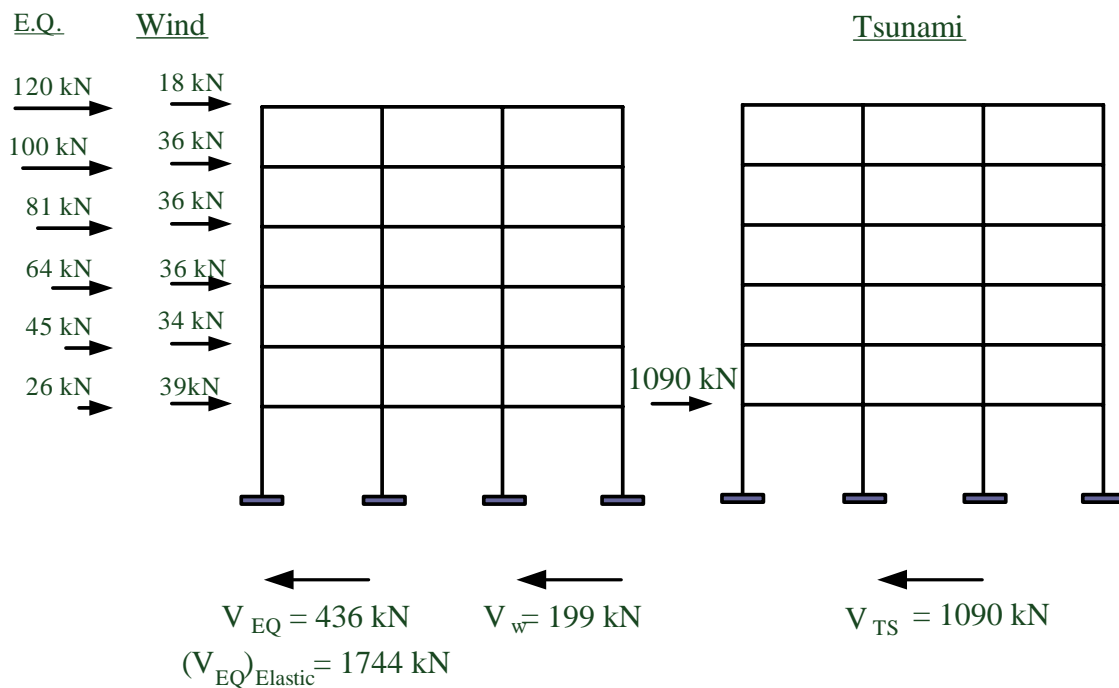
Fig. 13 Comparisons of lateral forces due to earthquake, wind, and tsunami for an interior frame of a 6 story reinforced concrete building in Vancouver, Canada for 5.0 m tsunami water height, 6.0 m transverse span length and seismic force reduction factor of $R = 4.0$

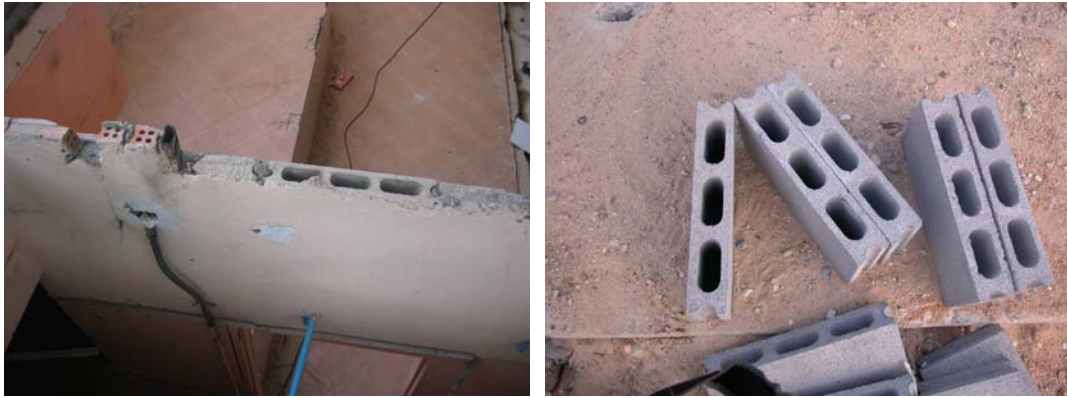
The majority of buildings in Thailand and Indonesia had frames infilled with unreinforced masonry walls. The masonry units used were consistently of the same type, with 50 mm thickness. Both hollow clay bricks and concrete masonry blocks of the same thickness were used, as illustrated in Figure 15. These walls suffered punching shear failures due to the tsunami wave pressure applied perpendicular to the wall plane. These resulted in large holes in walls, sometimes removing the masonry almost entirely. The remaining walls around the frames did not show any sign of diagonal tension cracks, contrary to expectations, unless the failure was caused by seismic excitations, which was limited to Banda Aceh only. Figure 16 shows the type of punching failures observed in masonry infill walls.

Fig. 15 Clay brick and concrete masonry block units with 50 mm thickness

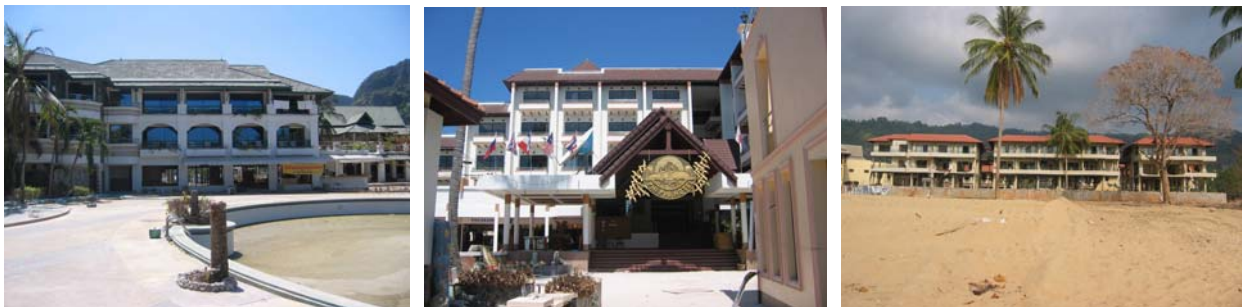
There were many low to mid-rise reinforced concrete frame buildings which appeared to have been engineered in the visited areas of Thailand and Indonesia. These frame buildings survived the tsunami pressure without structural damage, though they suffered damage to non-structural elements, especially the first story masonry walls. Figure 19 shows reinforced concrete hotel buildings in Thailand that survived the tsunami without any sign of structural damage, although nearby non-engineered buildings were either partially or fully collapsed. There were some exceptions to this observation in Nai Thon Beach, where water run-up affected slender reinforced concrete columns of a shopping centre, causing a partial collapse.

(a) Hotel on Phi Phi Island (b) Hotel on Phi Phi Island (c) Hotel in Nai Thon

Fig. 19 Engineered concrete buildings survived tsunami forces without structural damage

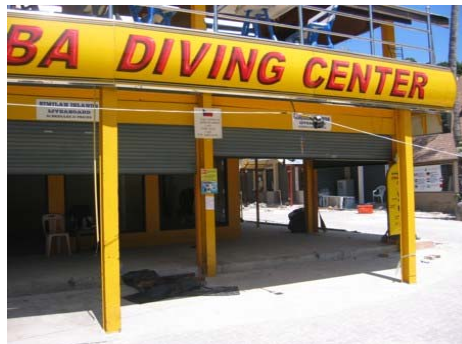
There was only one steel frame building that was investigated during the visit. The structure was located in Phi Phi Island in an area that was totally devastated by tsunami pressures. The frame consisted of steel “I” sections as illustrated in Figure 22. The building was not affected by tsunami forces and survived the disaster without any sign of structural damage.

Fig. 22 Steel frame structure in Phi Phi Island
