STUDY OF DAMAGES AND THROWS IN KOYNA EARTHQUAKE*

R. N. Joshi, Chartered Engineer

Synopsis

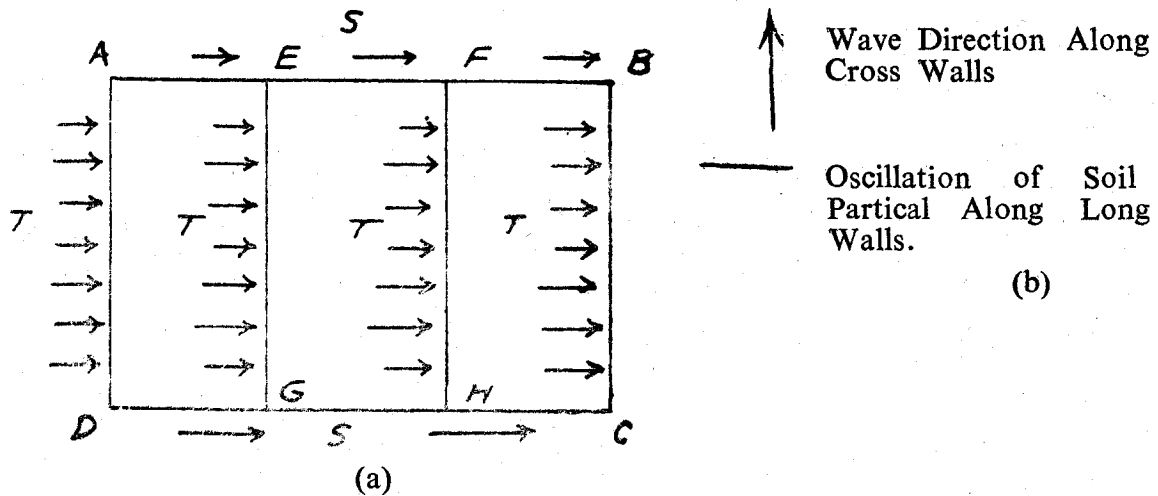
Considering the effect of a wave proceeding in the direction of the cross walls of a room, so that the ground particle describes simple harmonic motion in the direction of the long walls of the room, such wave shall produce shear forces on the long walls and side thrust on cross walls. (Fig. 7)

Fig. 7. Effect of Transverse Oscillation on Walls

Under the action of thrust forces T on cross walls shown in Fig. 7, the wall is loaded on its face with a more or less uniform load. With such loading, walls, AB, EG

and FE in Fig. 7 will be subjected to a uniform loading, the walls being supported at their edges. The bottom will draw its support from the plinth beam, the top from the slab or roof to the extent such support is available, and on the sides the support will be afforded by long walls acting as buttresses (Fig. 9).

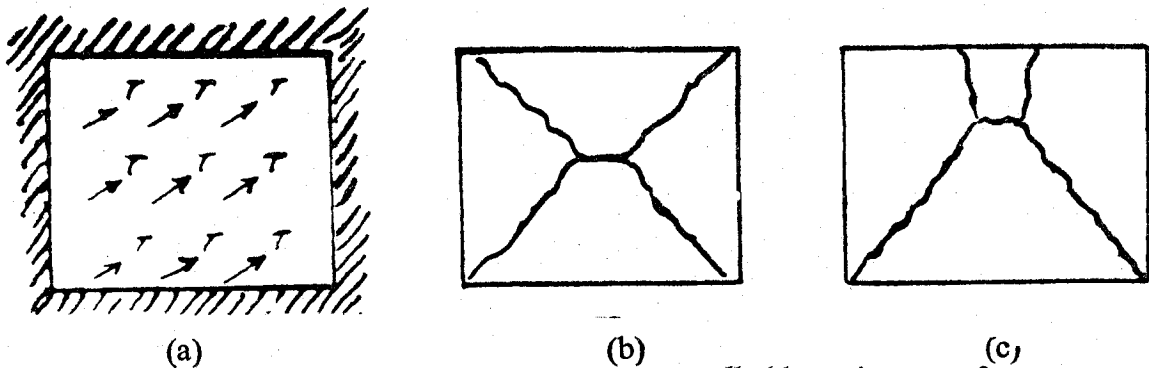
Fig. 9. Crack Pattern of Walls with Side Thrust with adequate support on all sides in case of no top support
