EFFECTS OF THE DECEMBER 26, 2004 SUMATRA EARTHQUAKE AND TSUNAMI ON PHYSICAL INFRASTRUCTURE

Murat Saatcioglu*, Ahmed Ghobarah** and Ioan Nistor*

ABSTRACT

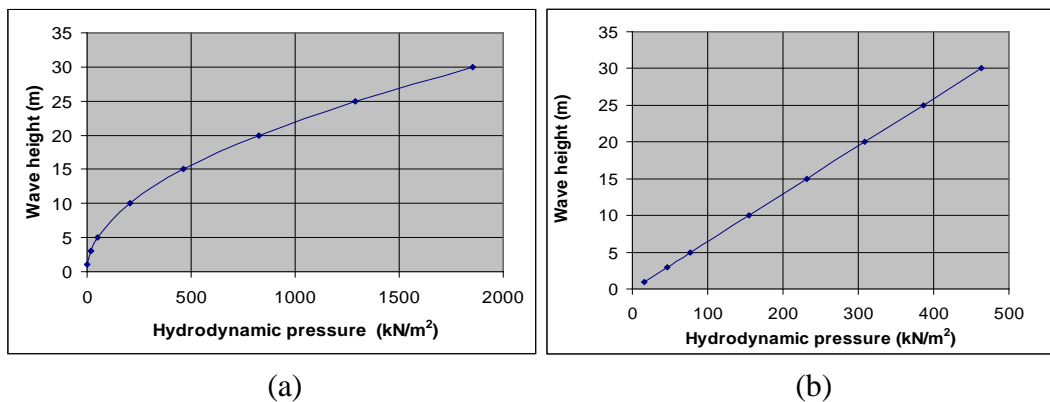
Equation (1) gives an empirical expression for the estimation of impulsive water pressure of breaking waves, developed by Goda (1985). Accordingly, wave impulse pressure is a function of specific gravity of water, water celerity, wave height and impact duration. The variation of wave pressure obtained from Equation (1) is plotted in Figure 12(a) as a function of water height:

A simpler expression that is more applicable to the mechanism of tsunami wave impact was suggested by Hiroi (1919) for the estimation of uniform dynamic pressure as a function of sea-water specific gravity and wave height. The expression is given in Equation (2). The variation of uniform lateral pressure, as computed from Equation (2), is plotted in Figure 12(b):

Fig. 12 Estimates of breaking wave impact pressure on a structure at the coast: (a) wave pressure as per Equation (1) (Goda, 1985); (b) wave pressure as per Equation (2) (Hiroi, 1919)

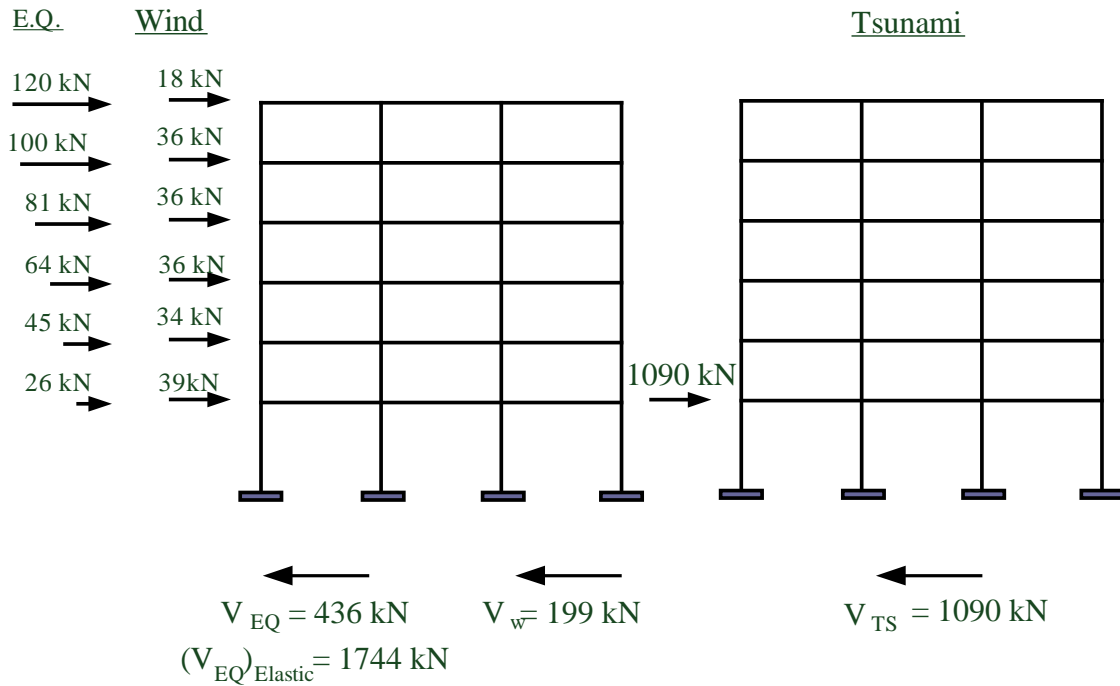
The hydrodynamic tsunami wave pressure obtained from Equation (2) was compared with wind design pressure specified in the National Building Code of Canada (CCBFC, 1995) on a building located at the coastal city of Vancouver, Canada. It was found that the tsunami pressure at the first floor level could be approximately 26 times the design wind pressure in Vancouver, explaining the widespread damage to masonry walls observed within the first stories of most buildings. Design lateral forces due to wind and seismic effects were compared with the estimates of lateral forces generated by a tsunami of 5 m water height. A sample 6-story, 3-bay reinforced concrete frame structure in Vancouver, Canada was used for this purpose. The comparisons of lateral forces are shown in Figure 13. It was found that the total base shear due to tsunami was about twice the base shear due to wind and 60% of that caused by elastic seismic forces and 2.5 times the inelastic seismic design base shear for a ductile moment resisting frame building. While this comparison is presented to provide a feel for the magnitude of tsunami forces on buildings in Thailand, it is important to recognize that the same comparison could give vastly different results for buildings with different heights, different exposure conditions and different structural mass, especially for different tsunami water heights. Another important aspect of tsunami pressures on structures is the nature of the exposed area. Because of the relatively high level of tsunami pressures generated, non-structural elements, like infill masonry walls, often collapse immediately after the application of tsunami wave pressure, and reduce the portion of the load transmitted to the structural elements. The non-structural elements, though suffer extensive damage under tsunami pressures, tend to act like a fuse for the load carrying system, reducing the amount of lateral loads transferred to the structure. Consequently, a more detailed investigation of the mechanism of tsunami load transfer among exposed elements should be conducted before the tsunami loads can be assessed accurately.

Fig. 13 Comparisons of lateral forces due to earthquake, wind, and tsunami for an interior frame of a 6 story reinforced concrete building in Vancouver, Canada for 5.0 m tsunami water height, 6.0 m transverse span length and seismic force reduction factor of $R = 4.0$

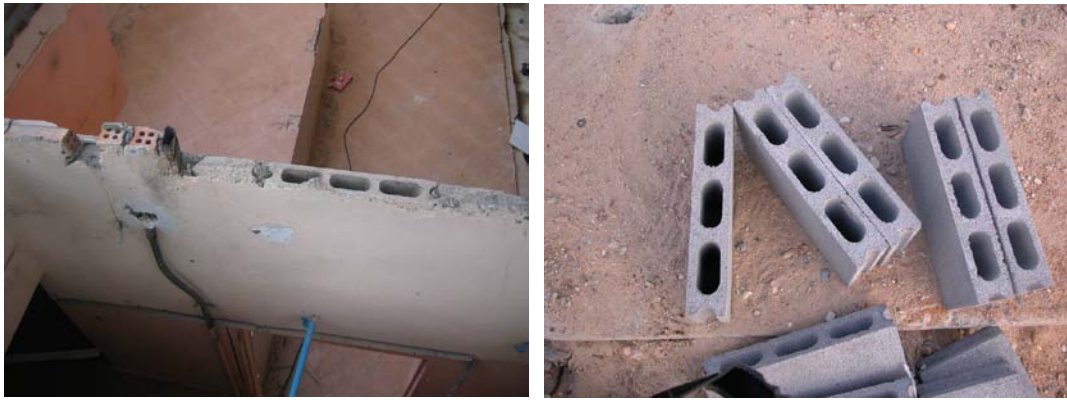
The majority of buildings in Thailand and Indonesia had frames infilled with unreinforced masonry walls. The masonry units used were consistently of the same type, with 50 mm thickness. Both hollow clay bricks and concrete masonry blocks of the same thickness were used, as illustrated in Figure 15. These walls suffered punching shear failures due to the tsunami wave pressure applied perpendicular to the wall plane. These resulted in large holes in walls, sometimes removing the masonry almost entirely. The remaining walls around the frames did not show any sign of diagonal tension cracks, contrary to expectations, unless the failure was caused by seismic excitations, which was limited to Banda Aceh only. Figure 16 shows the type of punching failures observed in masonry infill walls.

Fig. 15 Clay brick and concrete masonry block units with 50 mm thickness
