## **DAMAGES DURING DHAMAR EARTHQUAKE OF DECEMBER 13, 1982 IN YEMEN ARAB REPUBLIC**

**A.S. ARYA, L.S. SRIVASTAVA AND SATYENDRA P. GUPTA\***

The Dhamar province of Yemen Arab Republic was shaken on December 13, 1982 by a moderate earthquake. The earthquake caused considerable loss of life and different degrees of damage to the traditional houses in the area. The most prevalent form of construction consisting of stone masonry and adobe suffered very extensive damage. The destruction of houses was mainly due to failure of superstructure and none due to movement of foundations. Ground ruptures, failure of dry packed stone retaining walls, rock fall and rupture of stone on hill sides were also observed. An above ground reinforced concrete water tank also collapsed. An isocismal map of the earthquake damaged area has also been presented.

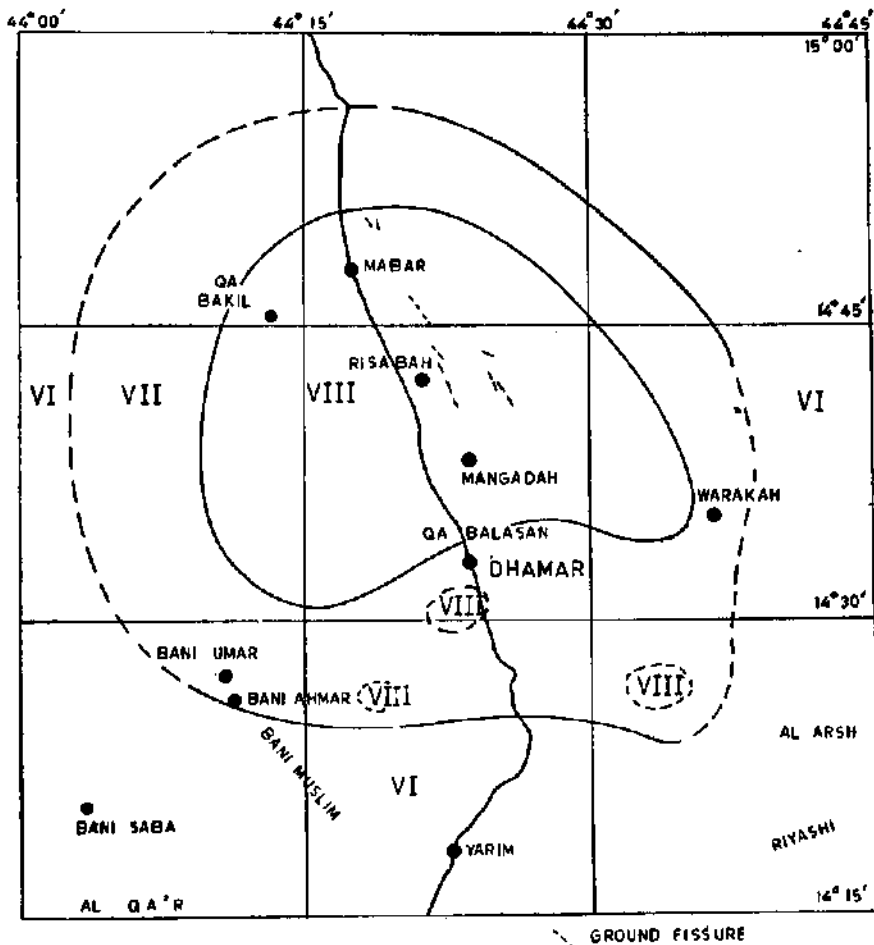
Figure 3 shows the isoseismal map of the region demarcating zones of

Fig. 3. Isoseismal map for December 13, 1982 Dhamar Earthquake Y.A.R.

MMI VIII, VII and VI and represent the integrated effect of the main shock and after shocks. It is noted that masonry as well as mud buildings located on rock suffered more severe damage as compared to those situated over recent sedimentary deposits around Dhamar-Ma'bar area, which indicates rapid attenuation of intensity of short period vibrations over alluvial tracts. It is also observed that ground motion intensity decreases faster in the area east of the ground fractures as compared to the hilly terrain on west which suffered severe damage over a larger area. Severe shaking was felt by people in the area with rumbling sounds during the earthquake. No major land slides or rock falls were reported to have occurred in the region. However, isolated large rock boulders (upto 60 cm in diameter) got detached and rolled down on steep slopes and edge of terraced fields at many locations in isoseismal VIII. Slumping of dry packed stone retaining walls supporting the edges of terraced fields was also observed at several locations within isoseismal VIII.

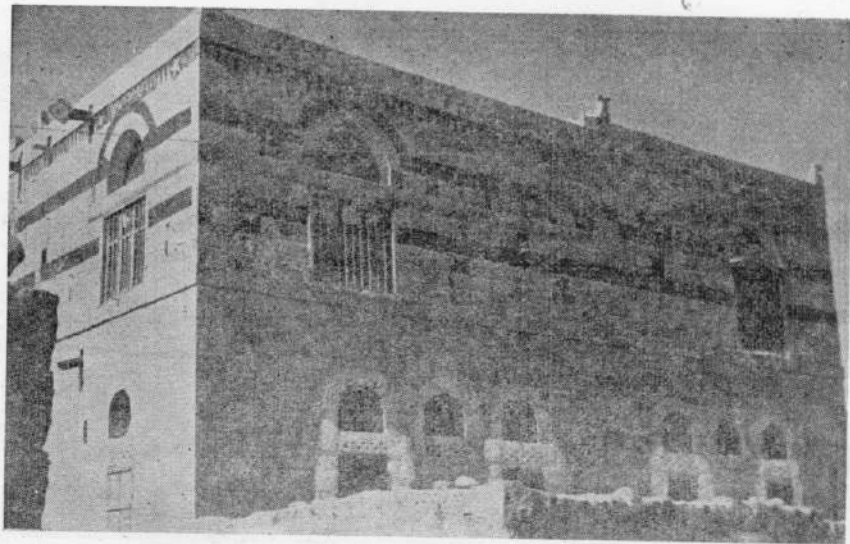
Photo 20. Dressed stone two storied house in village Dhi-Hawlan, use of wood piece at corner of walls and over window. Apparently no damage.

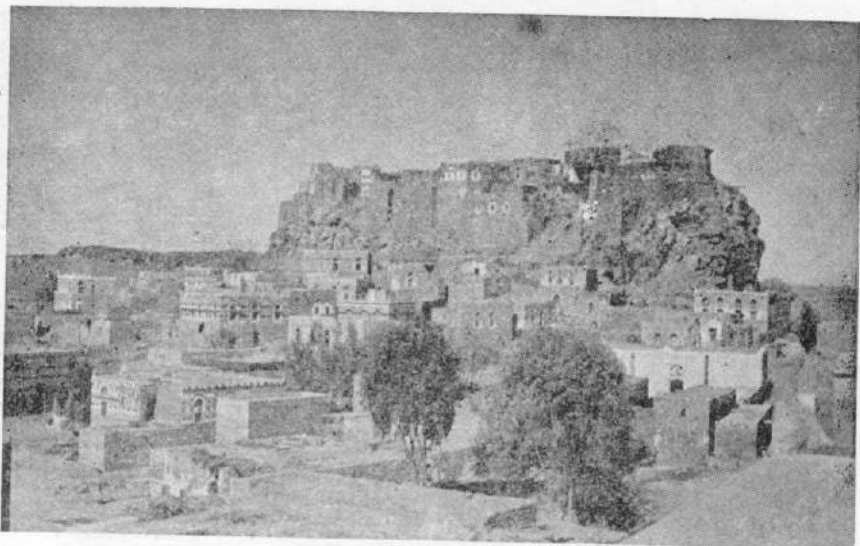
(b) *Foundation of Stone Masonry Walls*—Most old buildings are built on cliffs as shown in photo 21 and hill sides (photo 24) resting on exposed rock directly. Where they rest on soil, foundations are dug to shallow depths and packed with stones with or without mud.

(e) *Roof and Intermediate Floors*—In almost all houses using stone masonry or adobe construction for walls, the roofs are flat type (photo 21). The traditional roof has wooden rounds, half rounds or roughly dressed joists or proper rectangular joists placed parallel to each other across spans of 3 to 3.5 m at a centre to centre spacing of about 45 cm. This limits the width of the rooms which may, however, be made to have long lengths, even as much as 12–15 m. Across the wooden beams and over them are laid thin wooden planks or bushes or weeds to form the deck for receiving clay topping. The clay topping thickness may vary from 15 cm to 25 cm. When used as floor, a concrete screed with plaster on top is some times used. The roof requires

Photo 21. General view of random and coursed stone and adobe construction with houses on hill top at village Dhi-Hawlan.

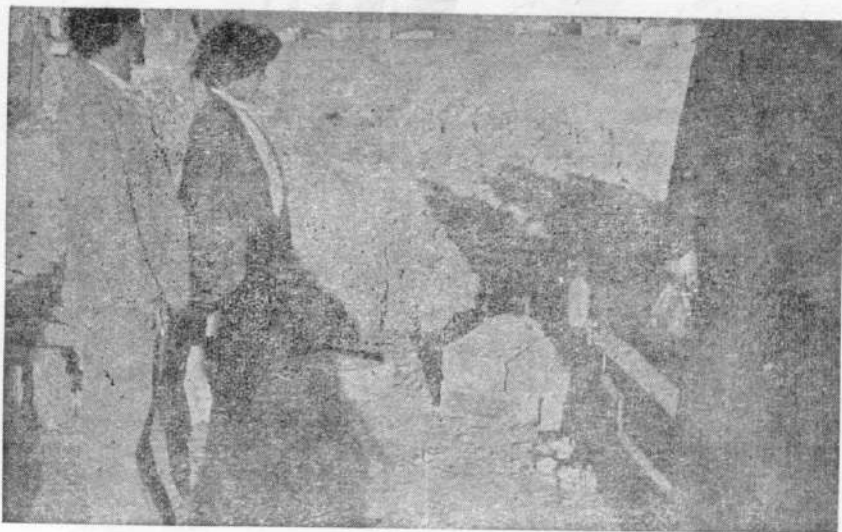
(d) *Adobe Block Walls*—In adobe construction also there is usually no foundation provided and the wall making starts right from the ground level. Generally 37 cm × 25 cm × 11 cm size blocks of adobe (photo 25 and 26) are used which permit use of a good bond breaking the vertical joints. Site test indicated that this adobe can bear the weight of a person weighing about 75 kg on a clear span 25 cm, hence having good enough tensile and compressive strength. Three storied houses were seen to have been constructed using this type of adobe.

Photo 25. Adobe making in progress in village Al-Olayb. Corner wall construction shown size of adobe is such that breaking of vertical joints in different courses is perfectly arranged.

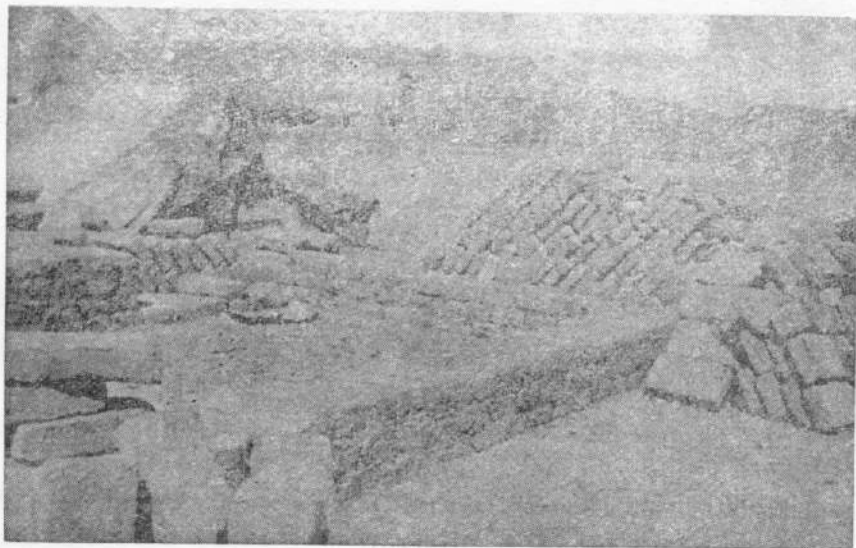
Photo 26. Adobe construction in progress in village Wasta.

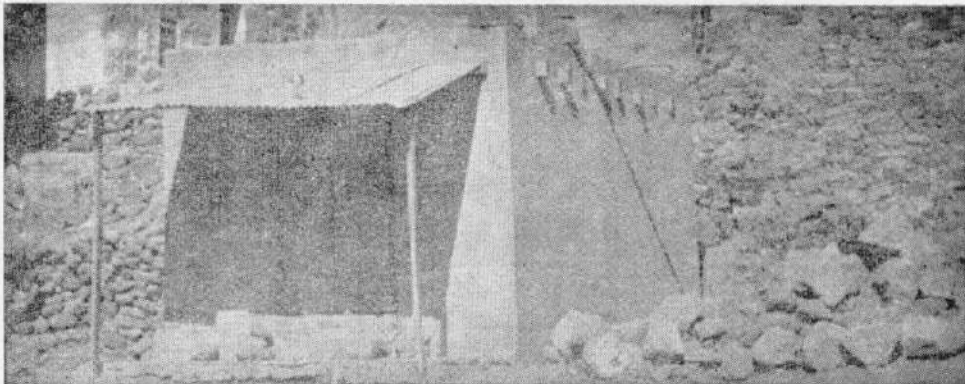
Photo 32. A single storied (apparently newly built) ration shop located at the foot of the hill was not damaged in village Dohran. See cement plaster outside the walls.

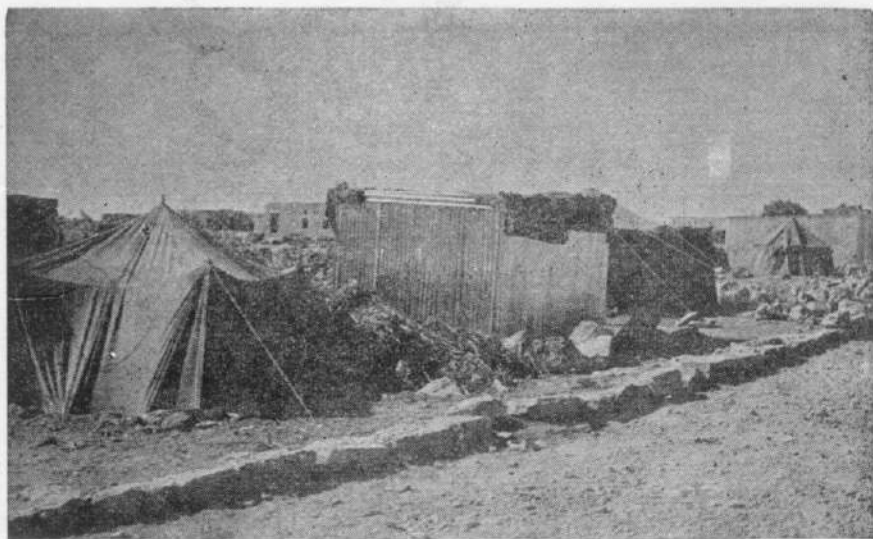
Photo 40. Tents and Tin sheds provided to the people as a relief measure at Village Hizrat Mangada.
