## DAMAGE DURING NOVEMBER 27, 1971 ROCKBURSTS IN NUNDYDROOG MINE IN KOLAR GOLD FIELDS

A. S. ARYA\* AND L. S. SRIVASTAVA\*\*

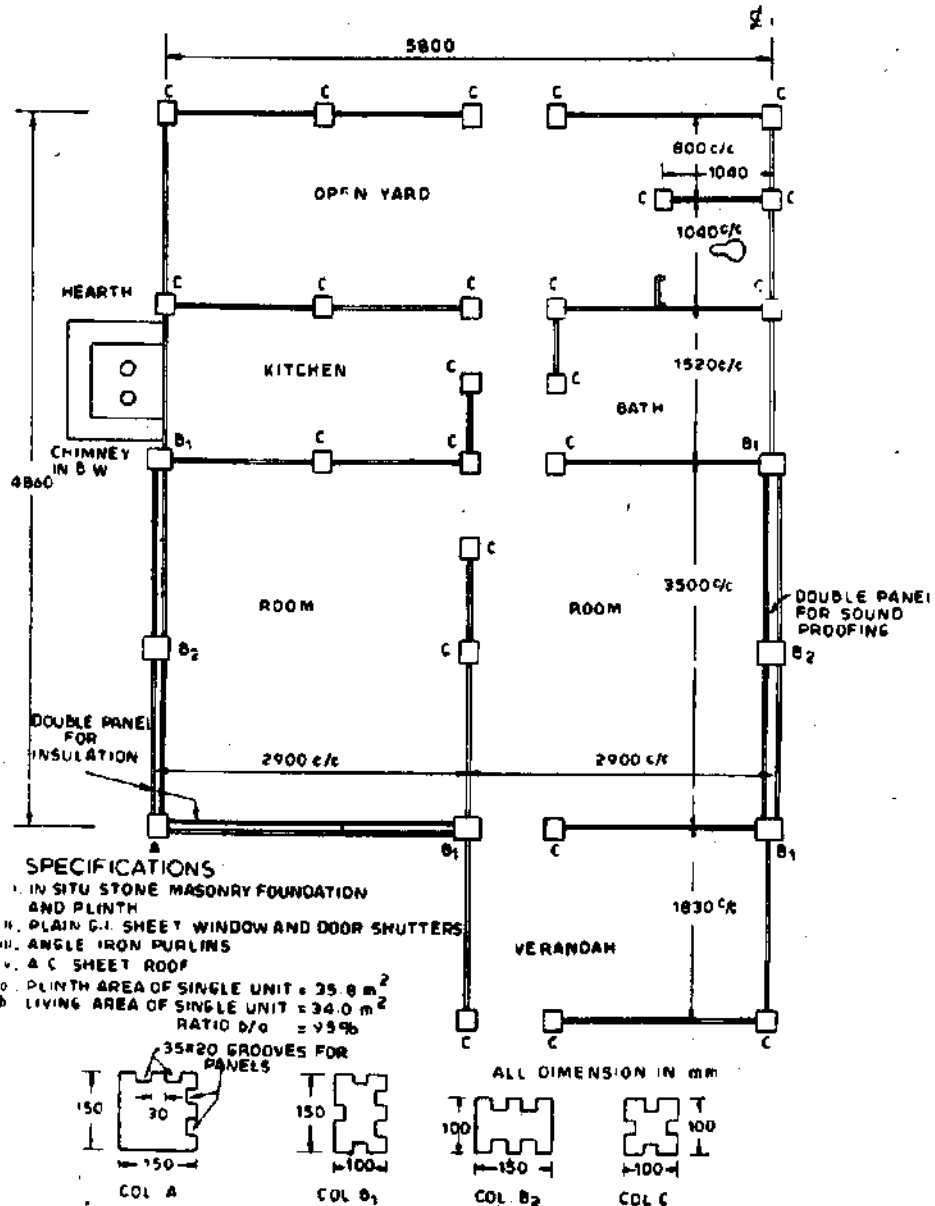
Fig. 27. Prefabricated post panel construction.

- (vii) Prefabricated reinforced concrete column-panel construction for single storey labour quarters would be better in relation to masonry construction. Comparing the relative merits and demerits of the two, it is noted that the prefabricated reinforced concrete column panel construction will be most suitable from rockburst point of view. These will require practically no maintenance effort later due to rockbursts. Moreover this types of houses will be damp proof, provide much larger living area for the same given plinth area (95% in precast post-panel construction against 75% for 23 cm (9 inch) brick-wall construction) and will be safe against termites. However, as the panel wall on the exterior may be cold during winter and hot during summer, the design may be modified to have double wall panels on the exterior of living rooms as shown in Fig. 27. It is recommended for adoption in future construction in such areas, which will provide insulation from exterior heat and cold and additional strength to the structure.
