BIGGEST EARTHQUAKE IN JAPAN

DR. M. HOSHIYA¹, PROF. T. CHIBA², DR. T. KATADA³, MR. E. SAITO⁴,
 PROF. H. OHNO⁵, DR. J. N. MANDAL⁶ AND MR. K. YAMAMOTO⁷

The investigation team, composed of the writers, with the first name designed as the Team Leader, rushed to the distress spot immediately after the earthquake occurred. It is the nation's worst earthquake in 35 years in Akita.

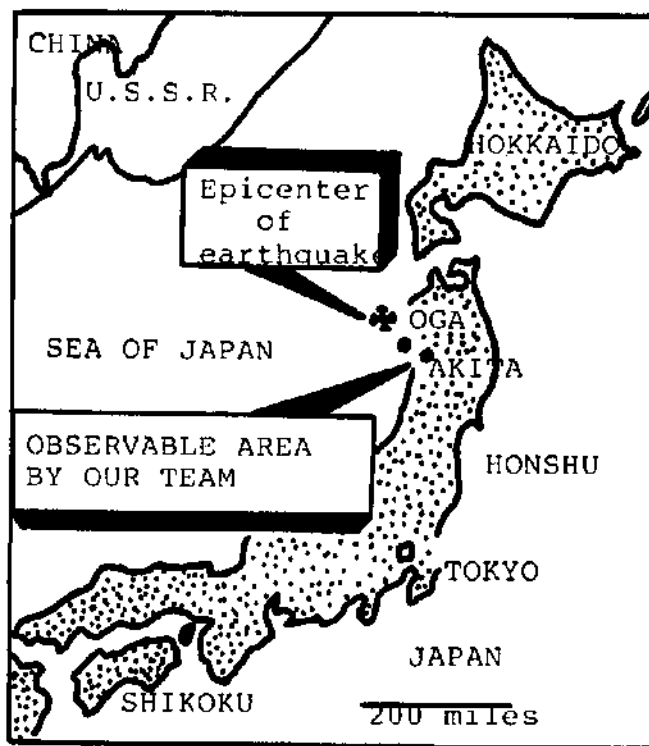
Fig. 1. Epicenter of Recent Earthquake in Japan.

The epicenter of earthquake was located about 40 kilometers below the sea of Japan and about 160 kilometers away from the coast of Akita in the Japan sea (Fig. 1). The intensity of present earthquake in different places of Japan are shown in Fig. 2 on the Japanese scale of 7. The shaded areas were hit by tsunami also hit the south Korean coasts almost 90 minutes after the earthquake.

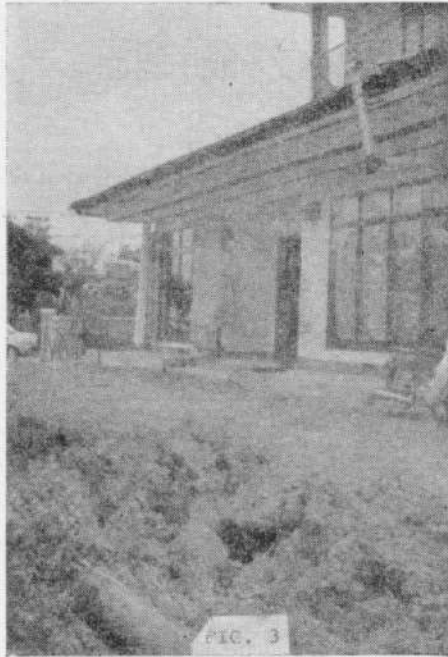
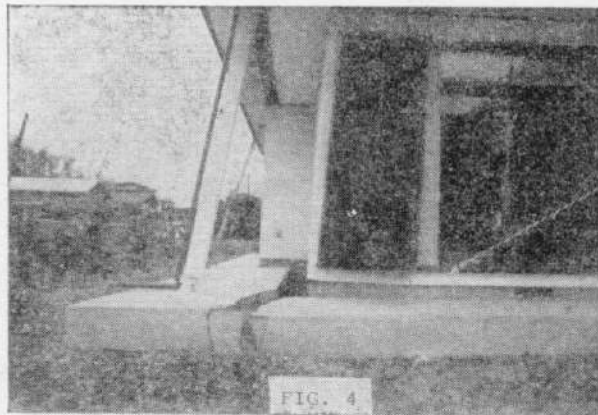
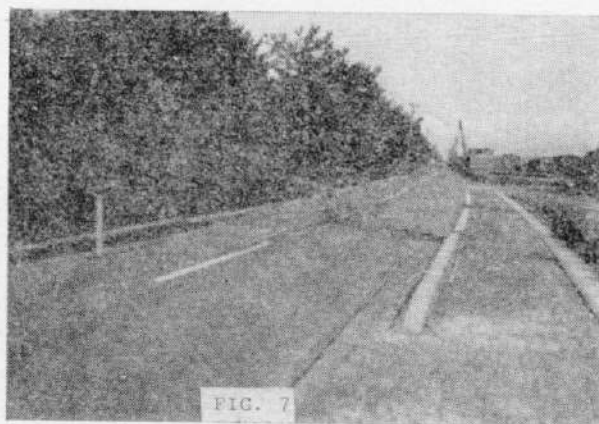
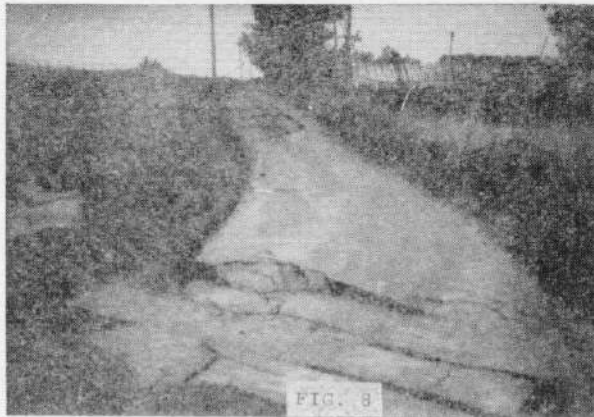
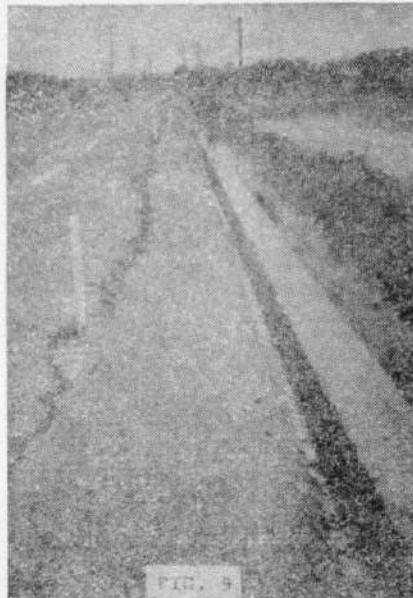
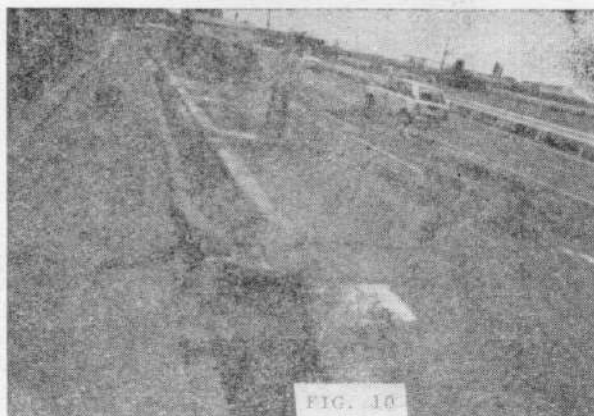
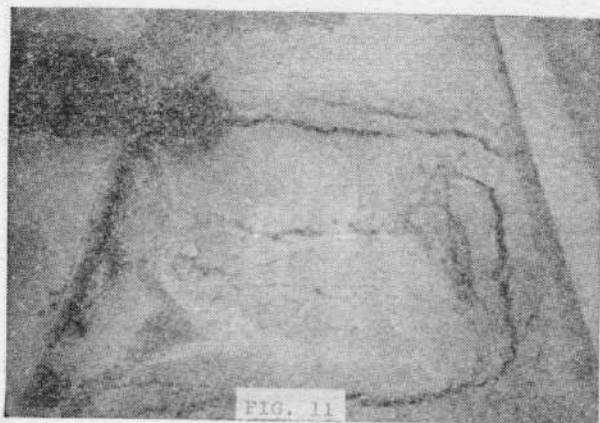
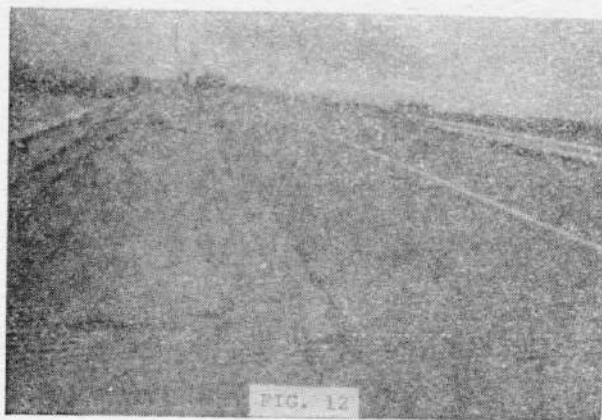
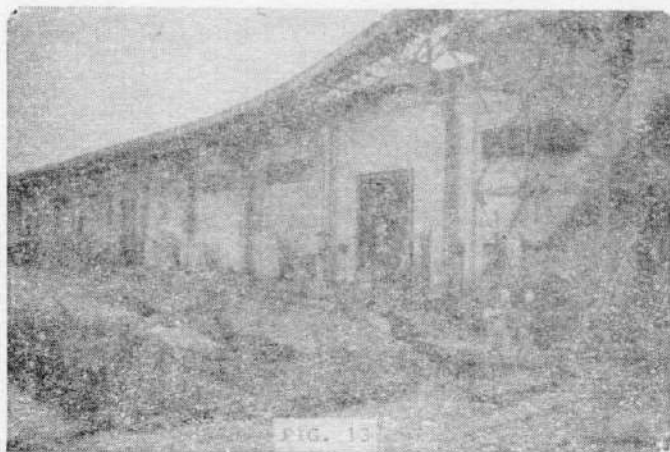
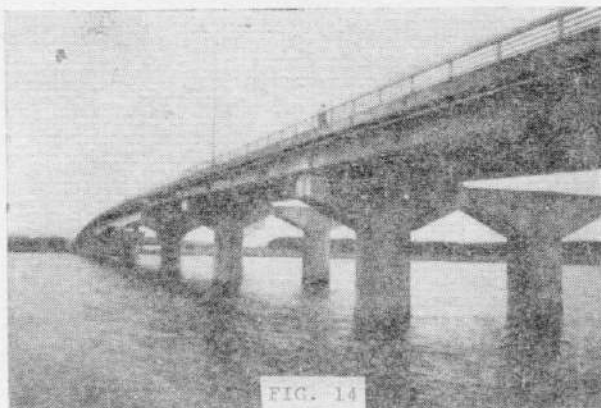
The recent earthquake and tsunami spread over the eight prefectures of Japan. The residential buildings, numerous roads, highway and bridges of Akita have been shown cracks due to the earthquake as given in Figs. 3 to 14.

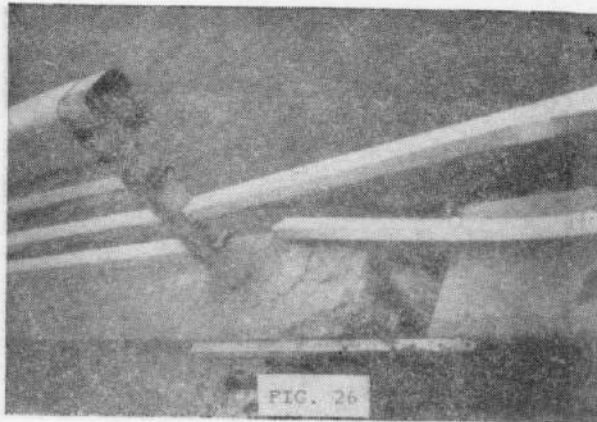
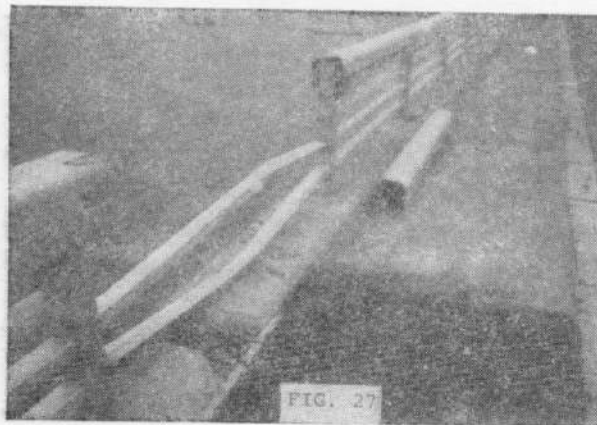
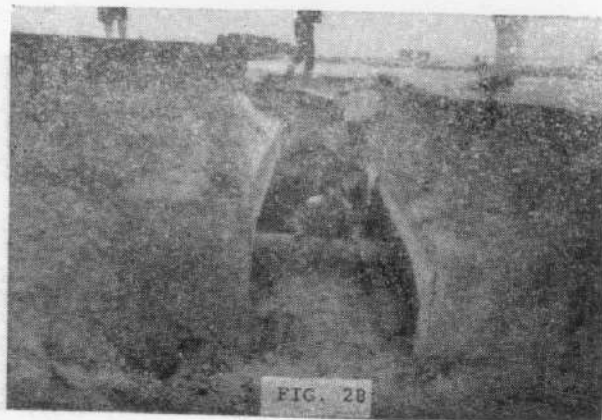
liquefactions are shown in Figs. 21 to 25. The railing of the road has been shifted due to earthquake (See Figs. 26 and 27). The pipe line, the sea port and the crane have also been damaged as shown in Figs. 28 to 31 due to recent severe earthquake in Japan.
