RESPONSE OF STRUCTURES IN BROACH EARTHQUAKE †

B.S. Bulsari* and M.C. Thakkar*

† Presented at the Fourth Symposium on Earthquake Engineering, Koorkee, November 1970.

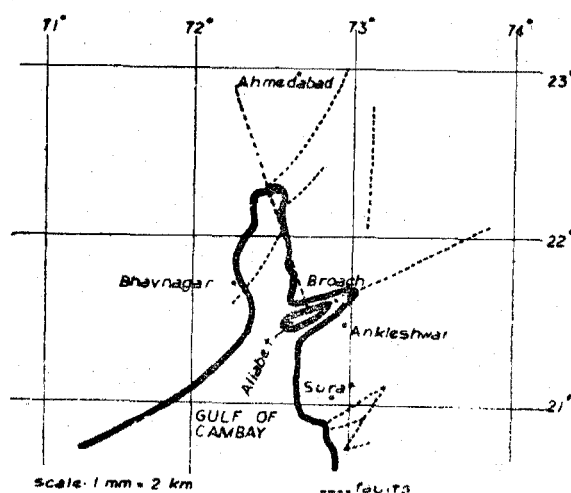
Fig. 2. Network of faults in Broach district and nearby area.

along a hinge type fault ⁽⁶⁾ with Broach, Kantharia, Manubar, Karmad on the downthrow side and the Ankleshwar region on the upthrow side. This is evident from the damage suffered by the areas of Broach, Karmad region and comparatively negligible damage in the Ankleshwar region.

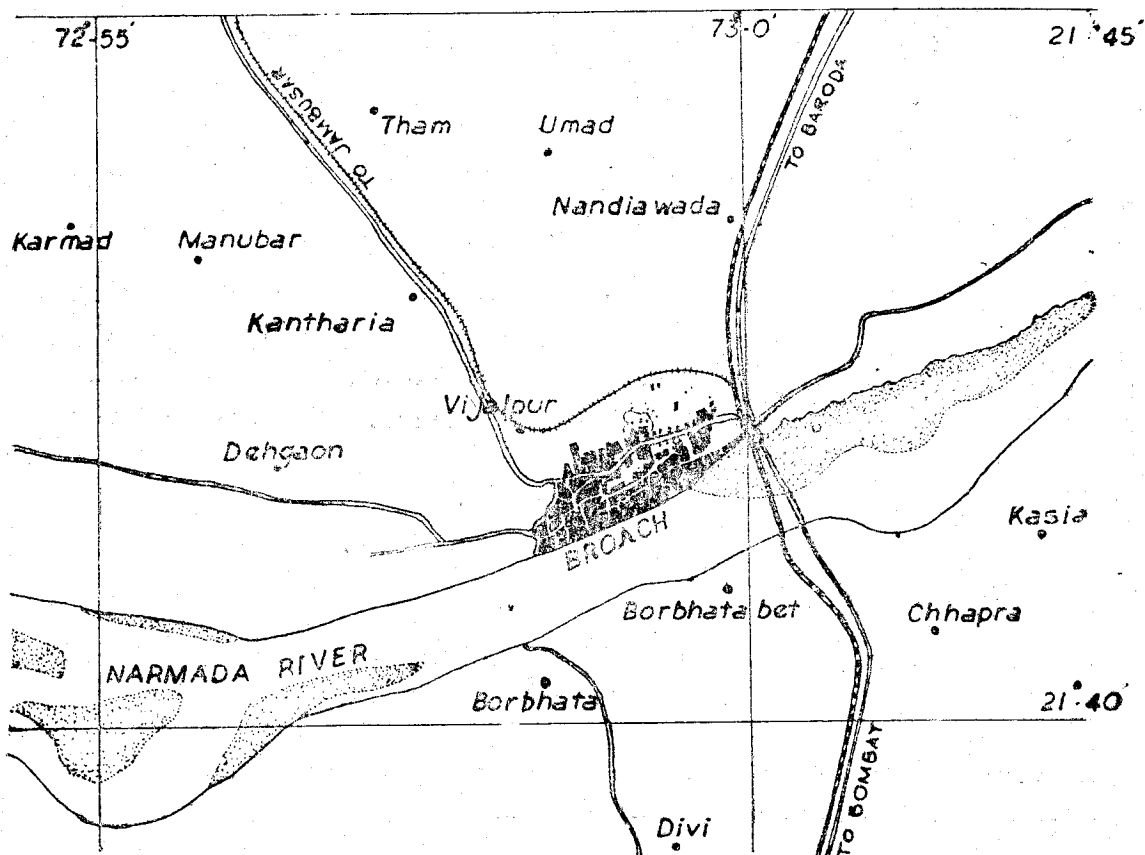
Figure 5. Map of Broach District.

The major component of earthquake acceleration is N-S. This is very clear from the diagonal cracks on N-S walls. These cracks on larger panels are running from top at north to bottom at south, indicating the seismic force from north to south (Fig. 3). This direction is also very clear from fallouts of E-W walls. The photograph (Fig. 4) shows the shift of bench seat to south from the seat rests. Cracks produced by the earthquake at the surface of the ground at Kasia and Borbhata are approximately E-W, clearly indicating the N-S direction of seismic force (Fig. 5)

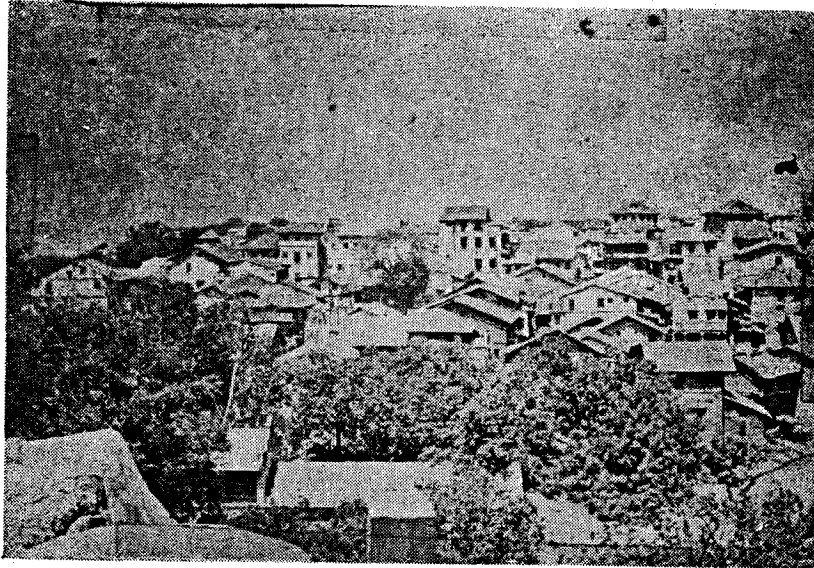
Fig. 1. Structures in Broach

Broach developed on the northern bank of the river Narmada, due to abundance of water and good fertile land, which were the principal factors for habitation in pre-historic periods. Due to proximity of sea, Broach was once a good port, the fact which contributed to the development of the town. However, with the coming up of Bombay as an international port and the technology of ship building evolving larger and larger vessels, the Broach port suffered a set back. Now the main revenue of the town and district is only on the cultivation of fields for cotton and tobacco. The possibility of industrialisation is also rare as the town is flanked by Surat on one side and Baroda on the other, where industrial estates are fast developing ; while Ankleshwar the nearby town is coming up rapidly due to oil and gas fields. The only importance of Broach town is that it is the governmental headquarters of the district. It is fairly covered by jungles yielding good timber. Broach is, therefore, principally a town covered by the residential structures of the type prevalent before reinforced concrete structures were adopted, with a very few RCC structures built recently. The photograph, Fig. 1, gives the general idea of the residential structures in the town.

Buildings in this town are of medium rise or low rise types. No building having more than 4 floors is constructed. Buildings with lighter roof stood well except the portions of the masonry gable ends. Such a gable end gave way, distorting the supporting roof and causing impact failure of floor. Portions of roof supported on trusses have remained undisturbed, indicating the failure of gable due to its inertia and facilitated by improper connections.
